Kiel High School

Swimming Pool Audit

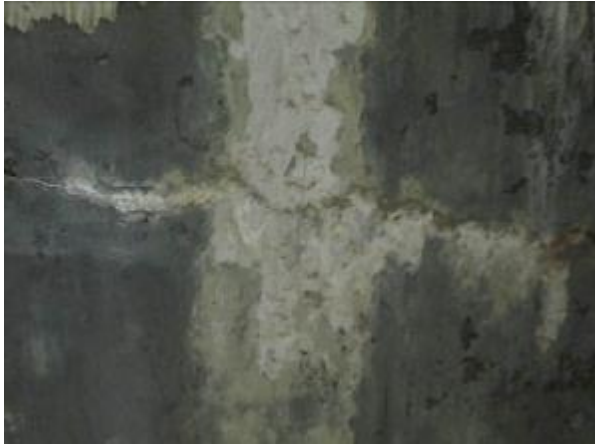
Image 5: Crack in the Pool Structure

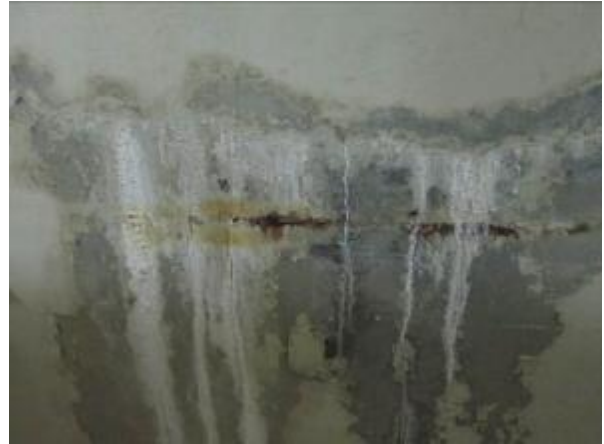
Image 6: Crack in the Pool Structure and Calcification

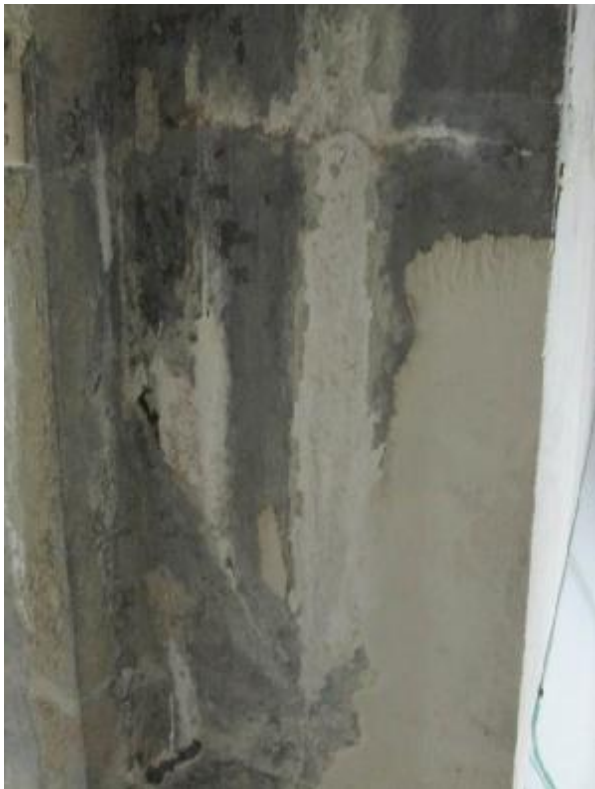
Image 1: Crack in the Pool Structure

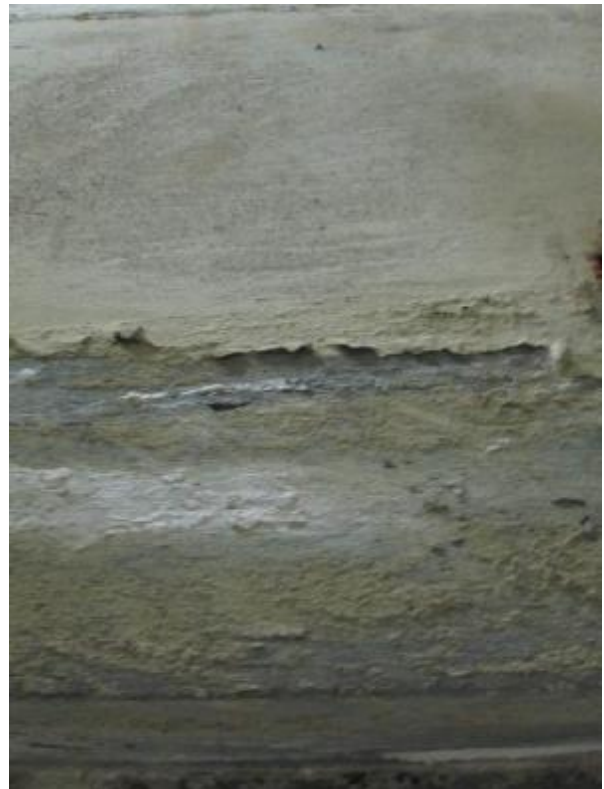
Image 2: Crack in the Pool Structure

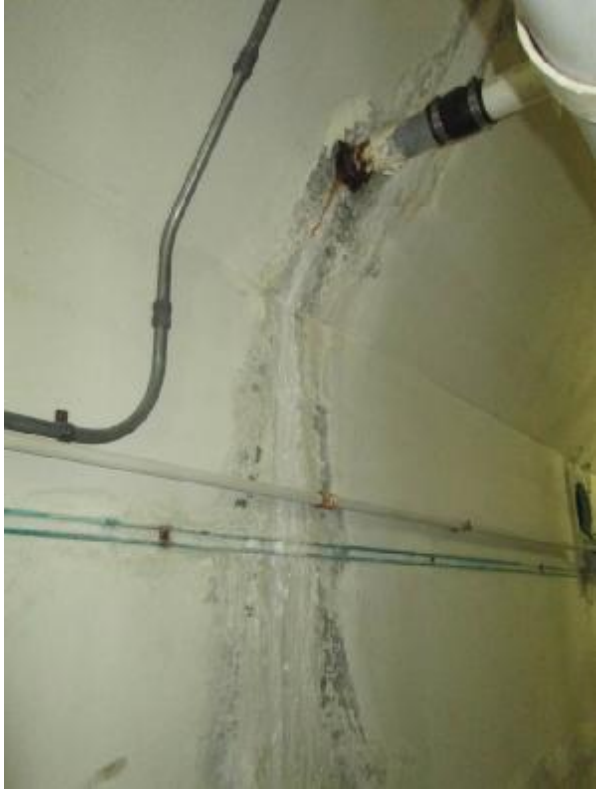
Image 3: Pool Leak Emanating from Pool Piping

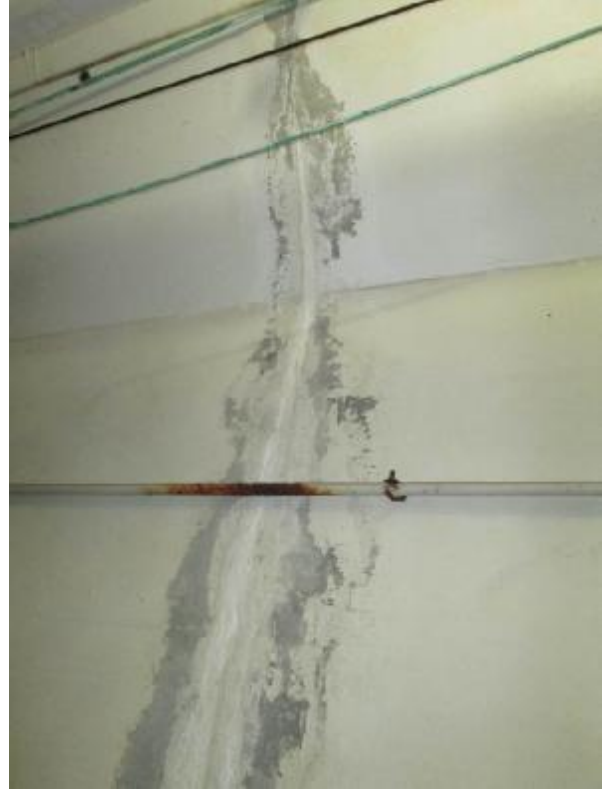
Image 4: Vertical Crack in the Pool Structure

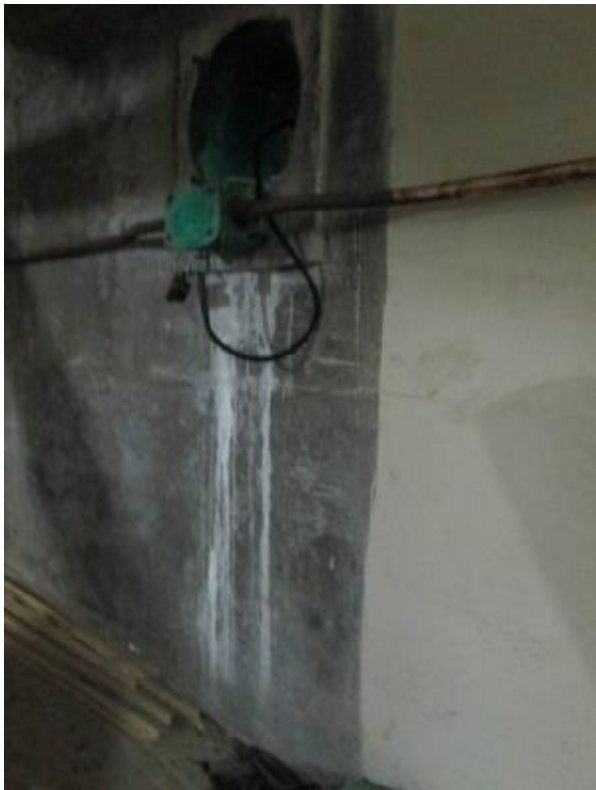
Image 11: Pool Leak at Light Niche

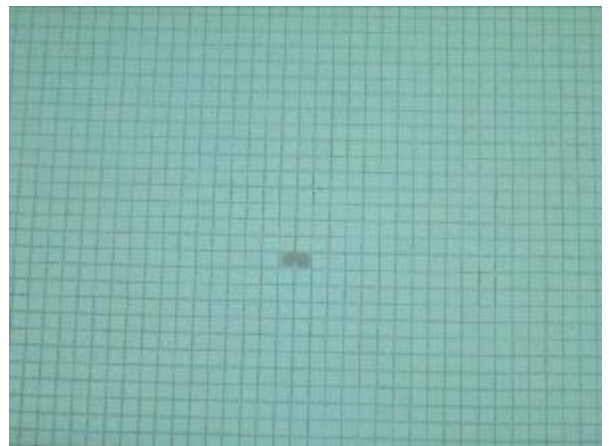
Image 12: Missing Tiles in the Shallow End

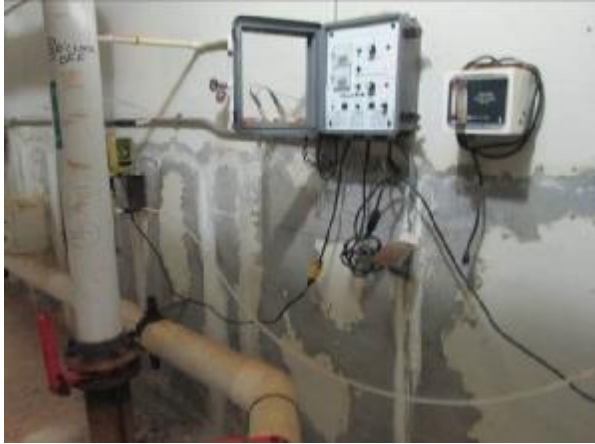
Image 7: Crack in the Pool Structure

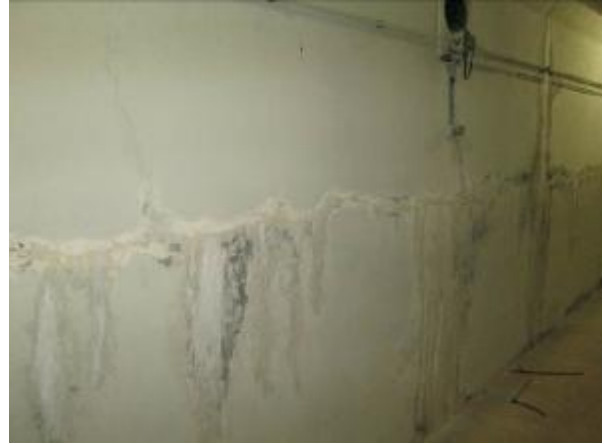
Image 8: Vertical Crack in the Pool Shell at the Interface of the Sloped Deep End Floor and the Pool Wall

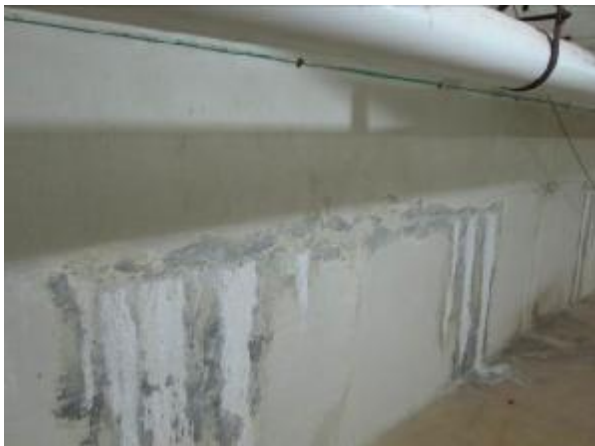
Image 9: Crack in the Pool Structure

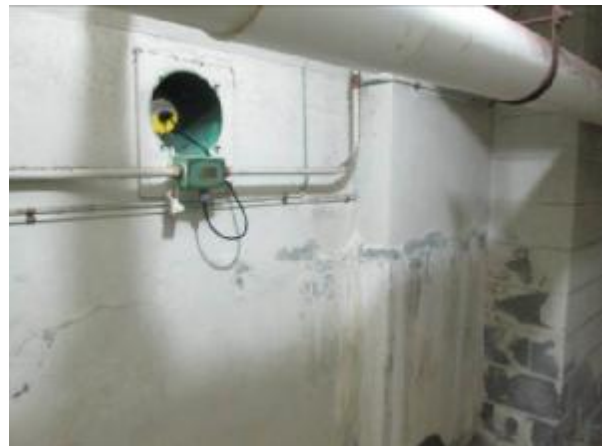
Image 10: Crack in the Pool Structure

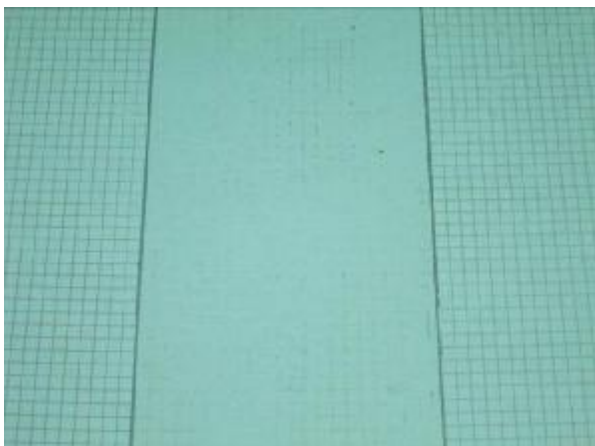
Image 13: Lime Build-Up and Missing Grout

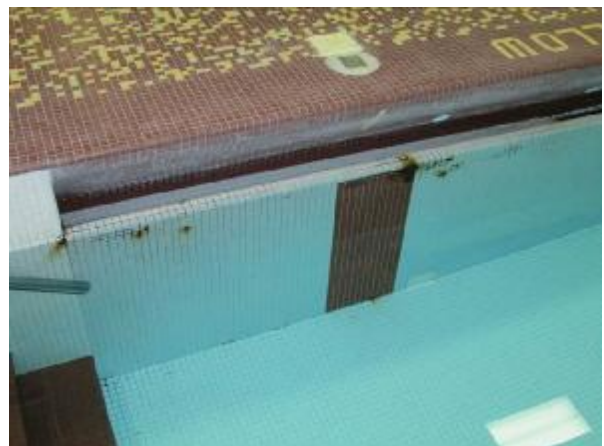
Image 14: Corrosion at the Water Line Handhold

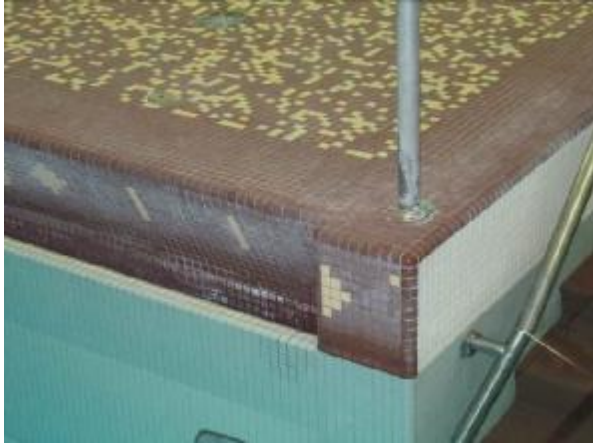
Image 15: Calcium Build-Up on the Rollout Gutter Curb above the Water Line

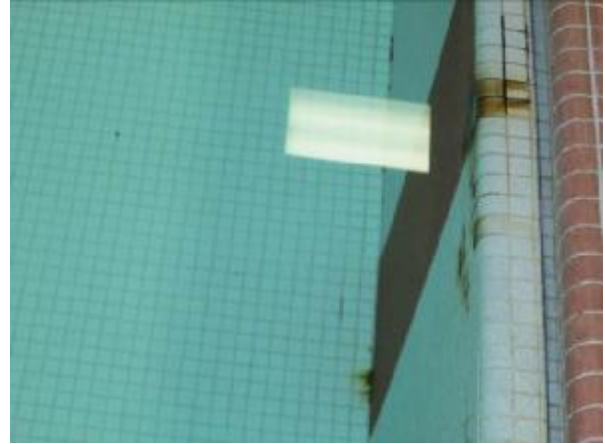
Image 16: Corrosion at the Water Line Handhold

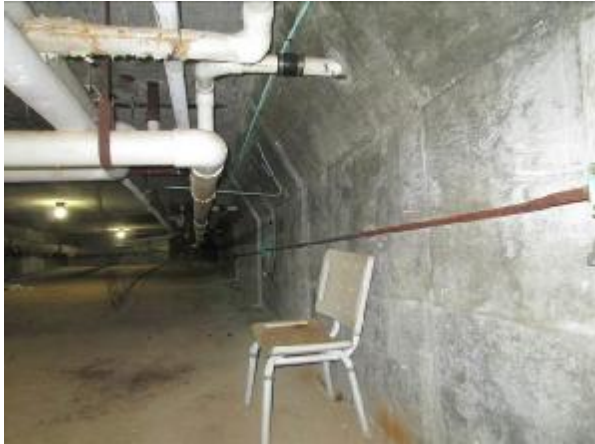
Image 17: Tunnel Corridor with Exposure To the Surge Tank

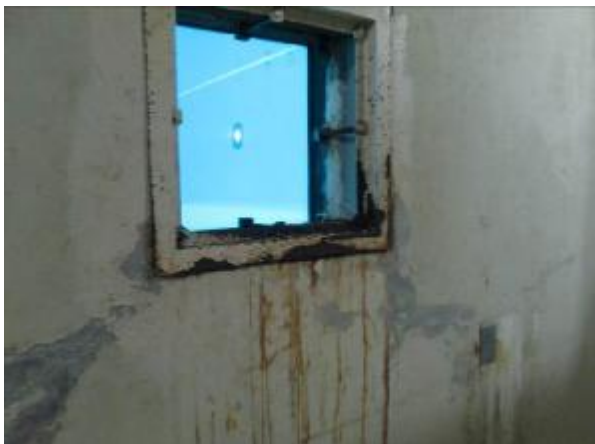
Image 19: Corrosion and Cracks around the Underwater Pool Window

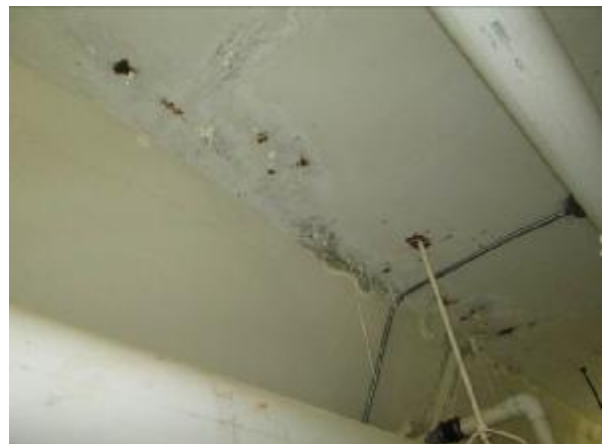
Image 20: Stalactites from the Underside of the Pool Deck

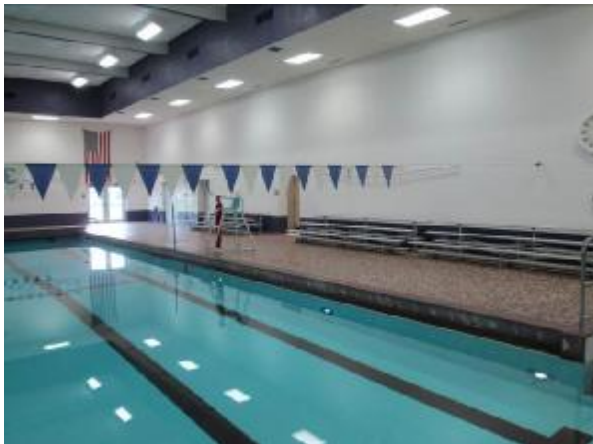
Image 21: Rollout Perimeter Overflow Gutter along the Length of the Pool

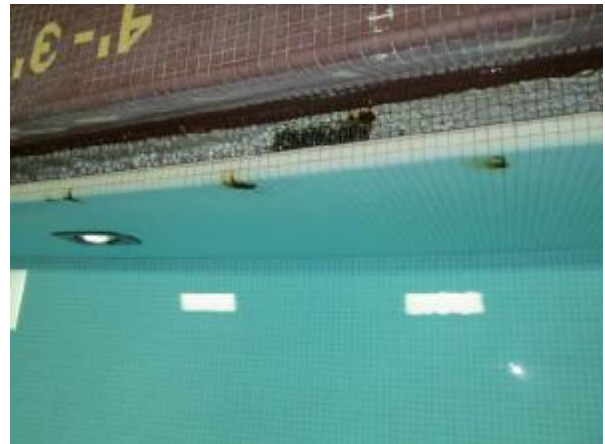
Image 22: Metallic Gutter Dropout and Handhold Corrosion

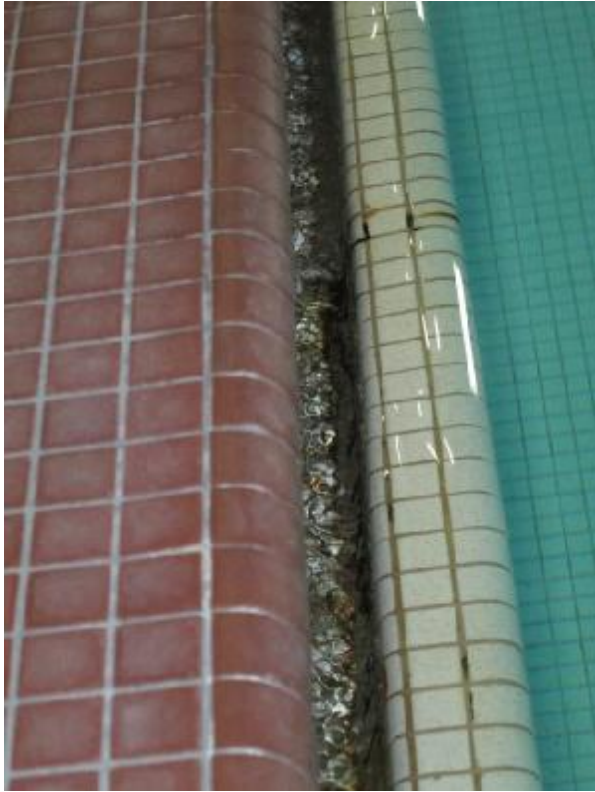
Image 23: 2" Gutter Lip Handhold

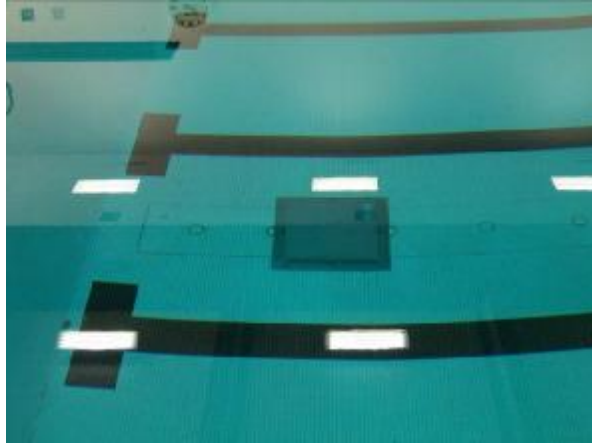
Image 25: Pool Main Drain Cover

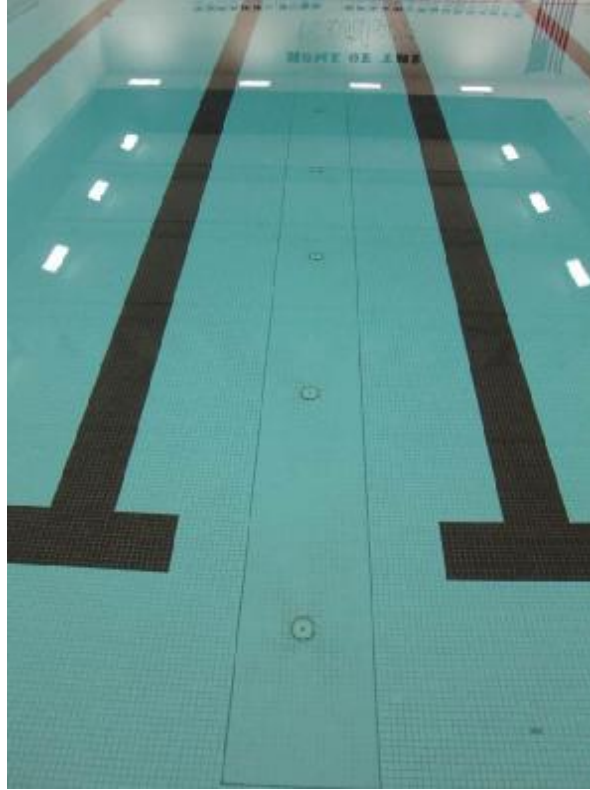
Image 26: Pool Floor Return Inlets

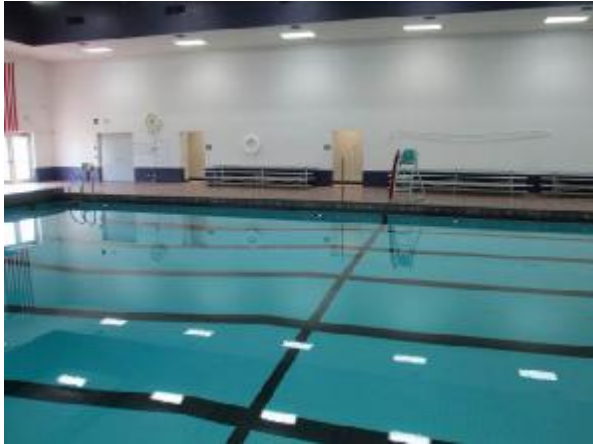
Image 27: Swimming Pool Underwater Lighting

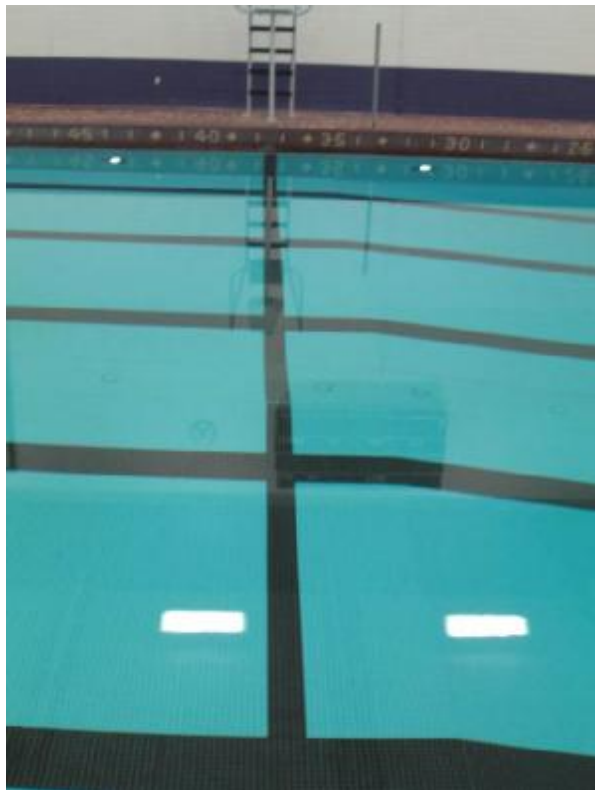
Image 30: 5'-0" Depth Contour Safety Marking

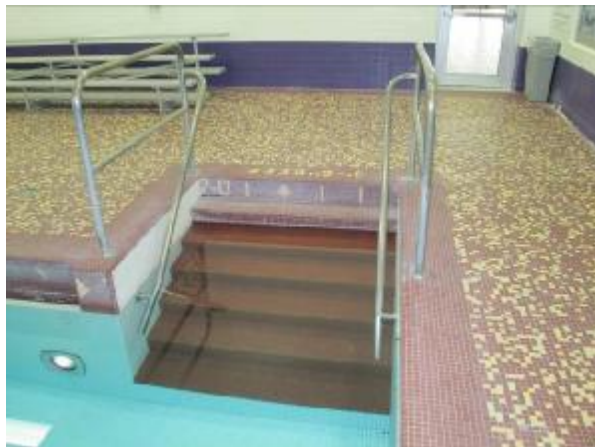
Image 32: Shallow End Entry Stairs

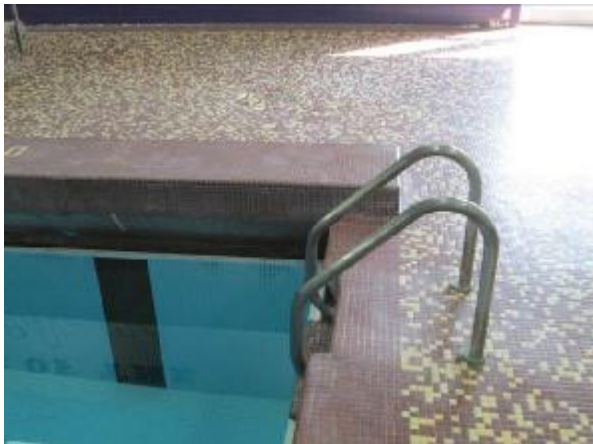
Image 34: Grab Rails

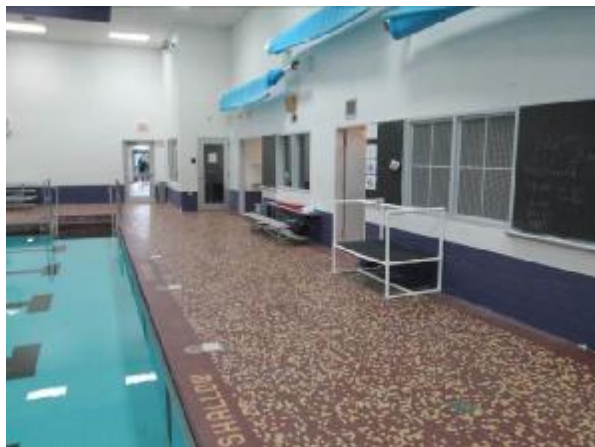
Image 41: Shallow End Pool Deck

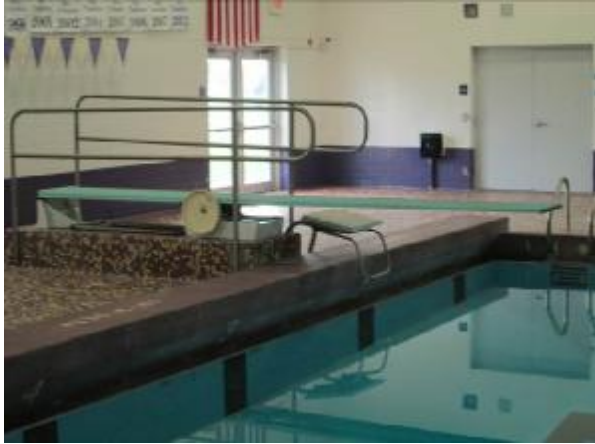
Image 43: One Meter Springboard

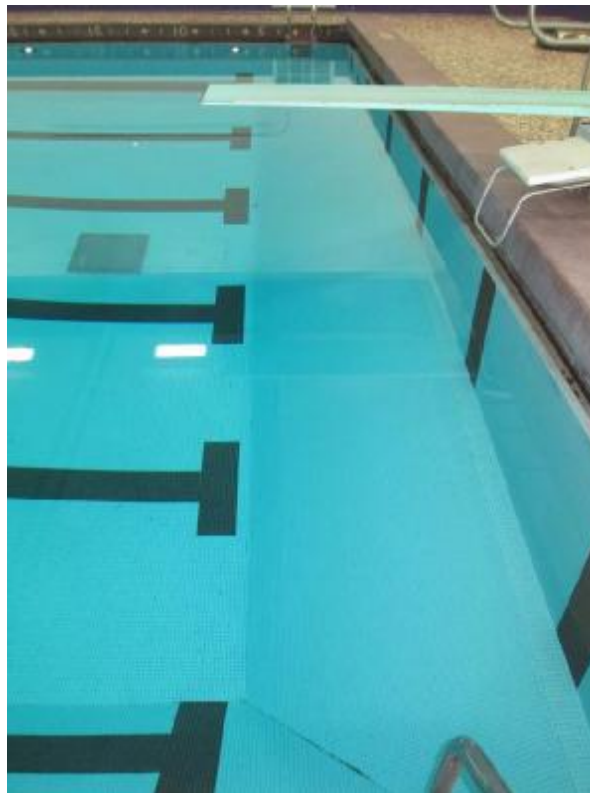
Image 45: Inadequate Depth Profile at Diving Board Plummet

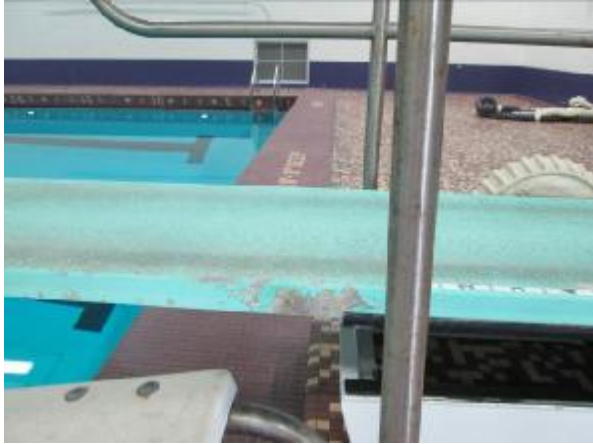
Image 46: Delamination of Diving Board Board

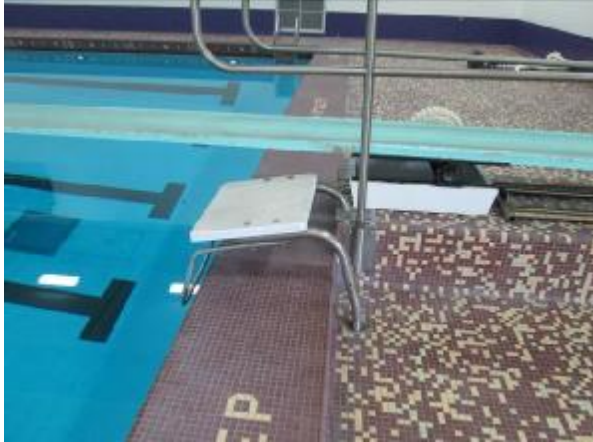
Image 48: Starting Block

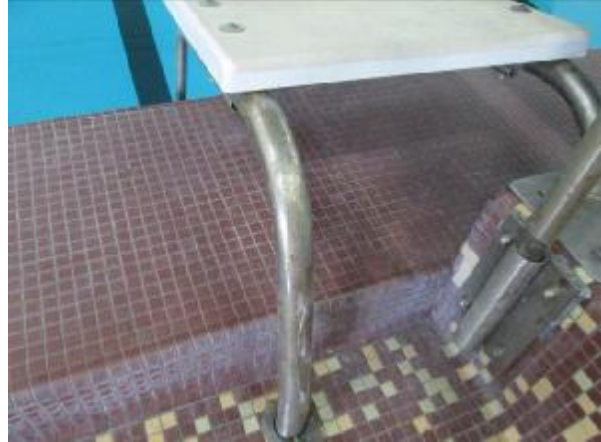
Image 49: Mild Corrosion on Stainless Steel Starting Block Posts

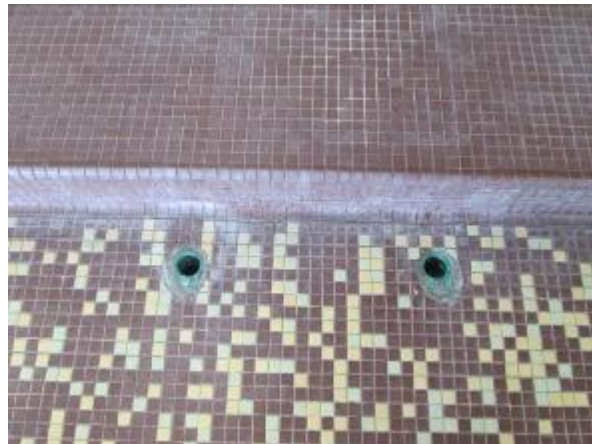
Image 50: Patina at Starting Block Anchors

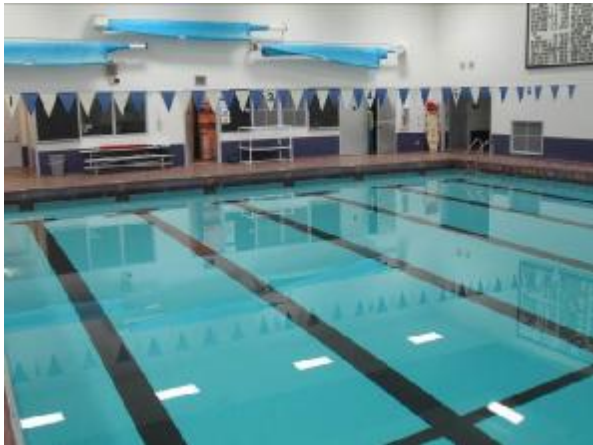
Image 51: Backstroke Flags and Location

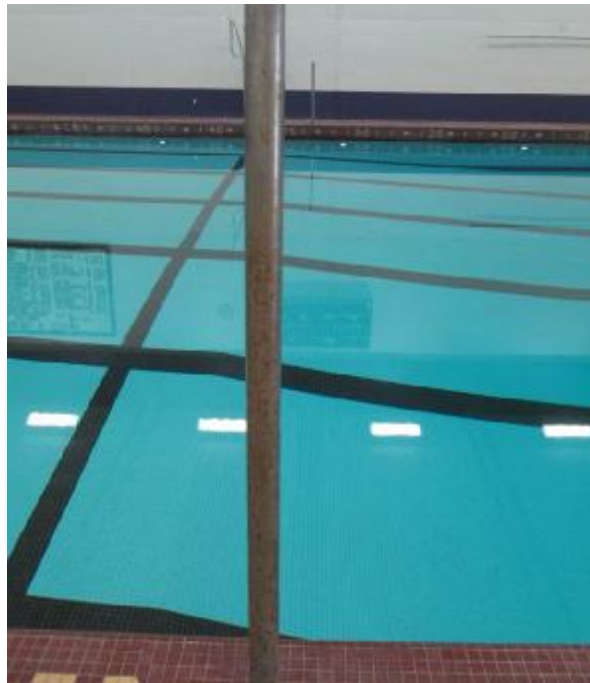
Image 53: Corrosion on Stanchion Post

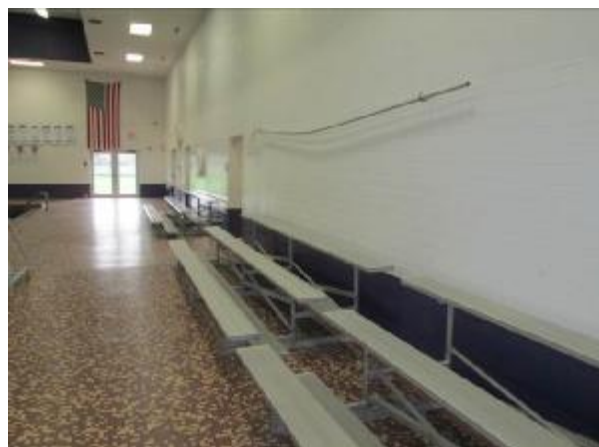
Image 54: Bent Wall Mounted Shepherd's Hook

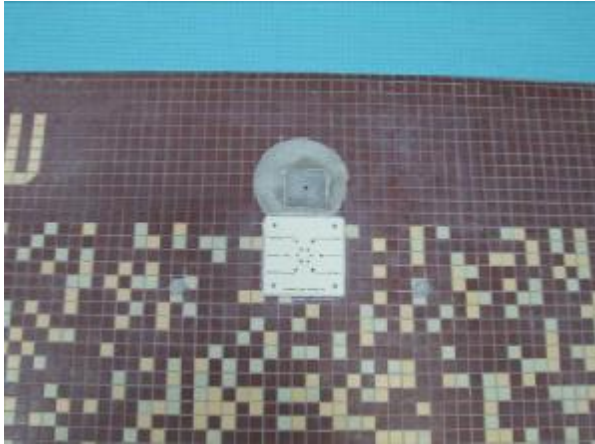
Image 57: Shallow End Deck Plate

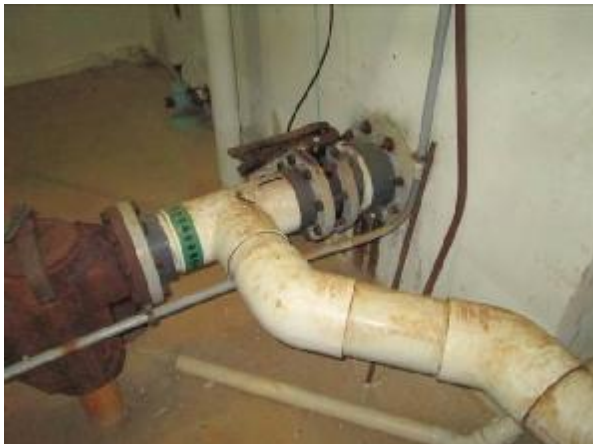
Image 66: Suction Piping

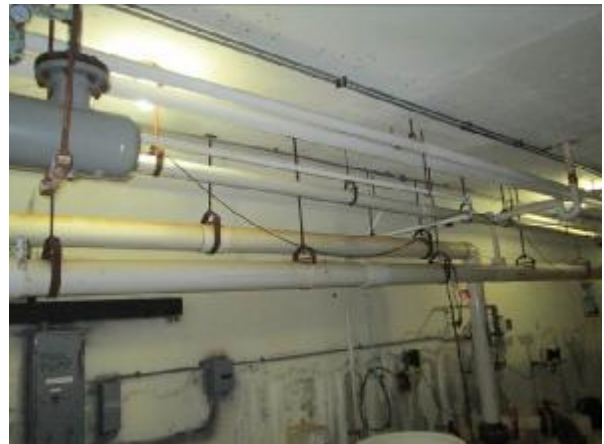
**Image 67: Corroded Mechanical Room
Pipe Hangers and Supports**

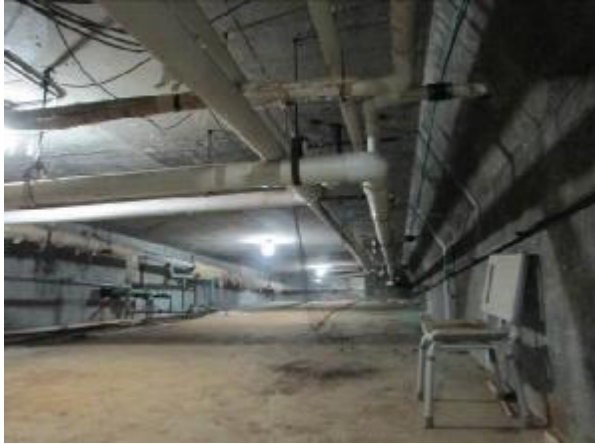
Image 68: Piping and Hangers near Surge Tank

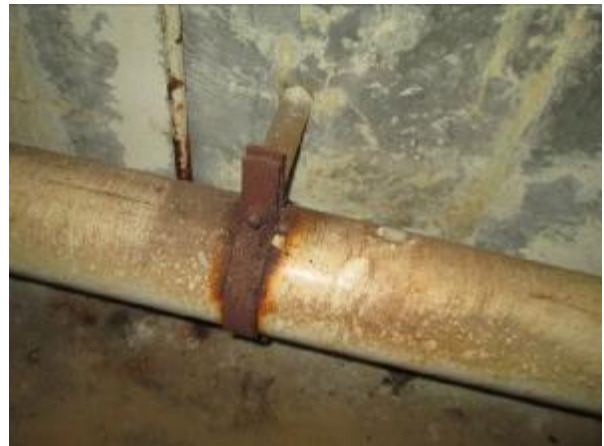
Image 73: Corroded Pipe Support

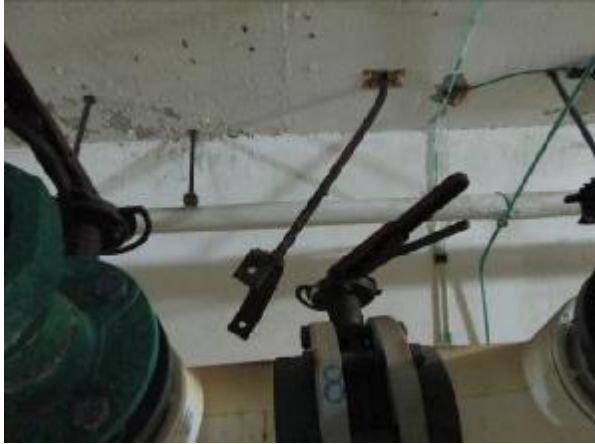
Image 74: Example of Corroded Pipe Hanger Failure

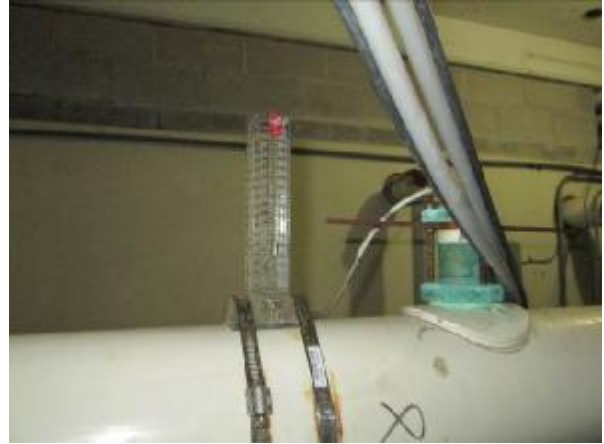
Image 75: Impact Flow Meter for Filtered Water Return

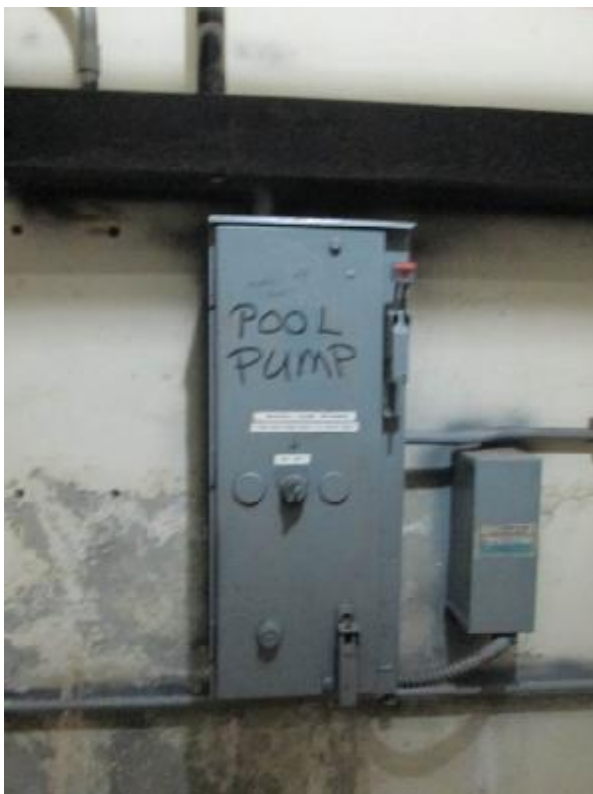
Image 78: Pump Starter

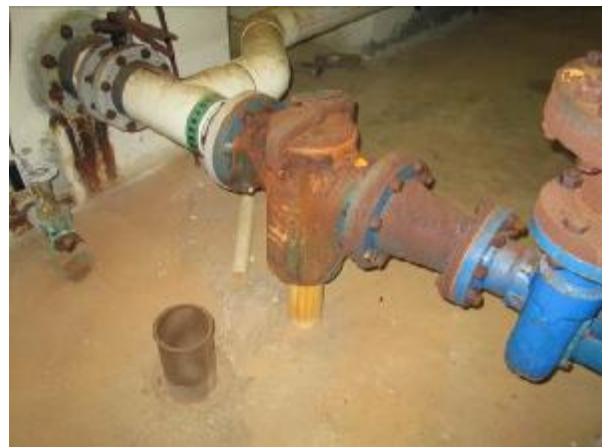
Image 79: Corroded Hair and Lint Strainer and Reducer

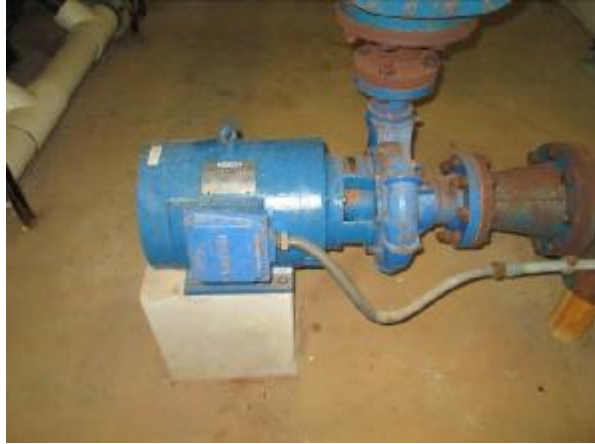
Image 80: Recirculation Pump and Base

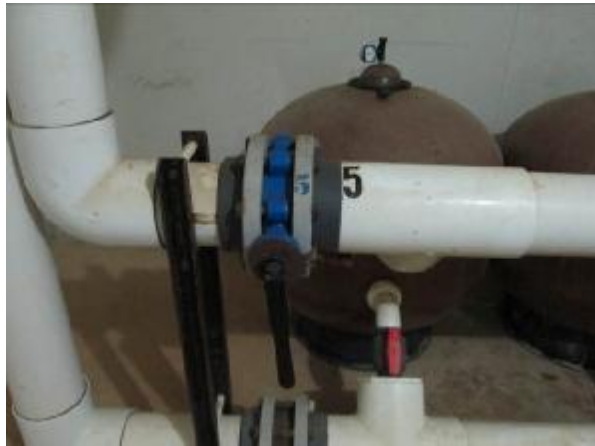
Image 82: Filter Butterfly Valve

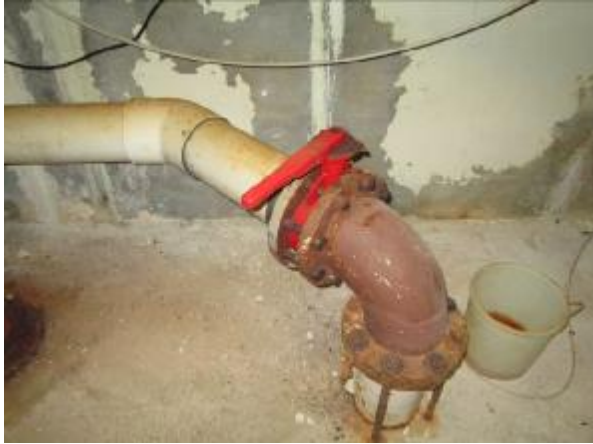
Image 88: Main Drain Suction Butterfly Valve

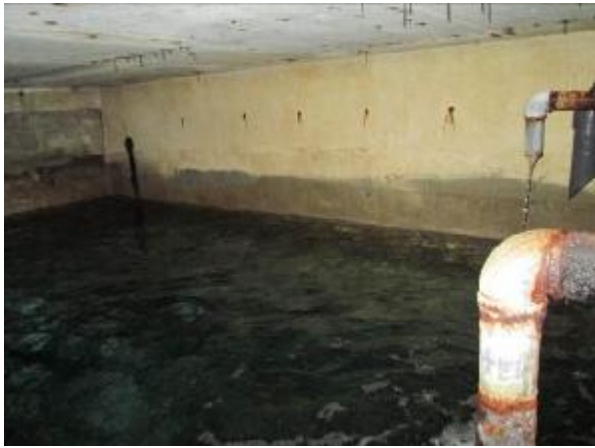
Image 90: Interior of Surge Tank

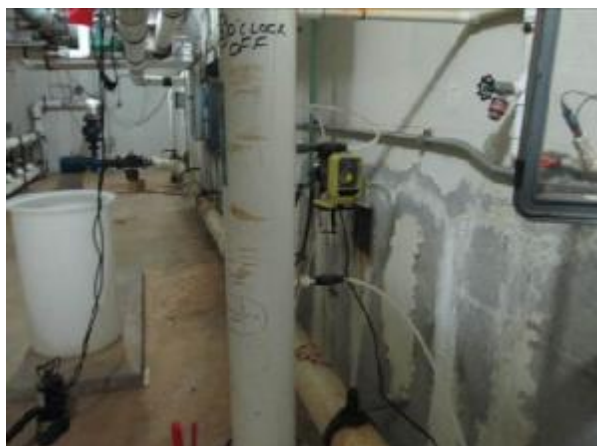
Image 96: Pool Chemical Feed Location

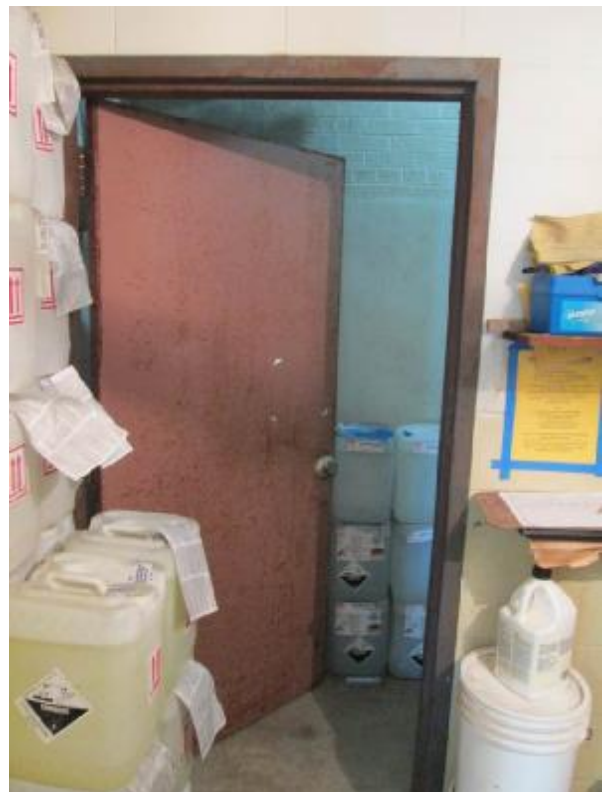
Image 101: Chemical Storage and Corroded Door and Frame

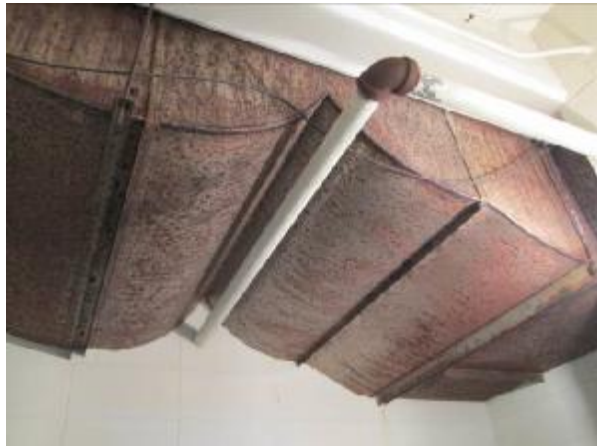
Image 102: Corrosion in Chemical Storage Area

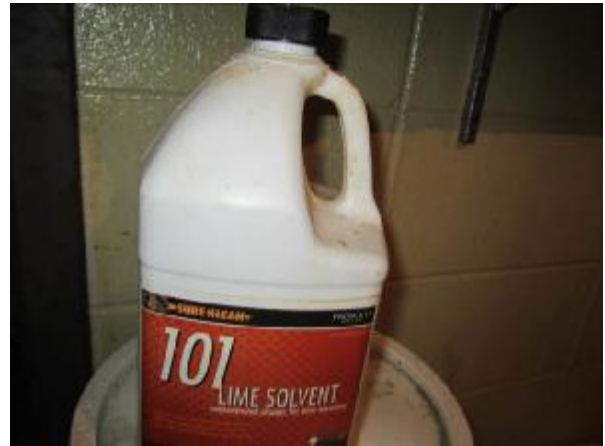
Image 103: Lime Solvent

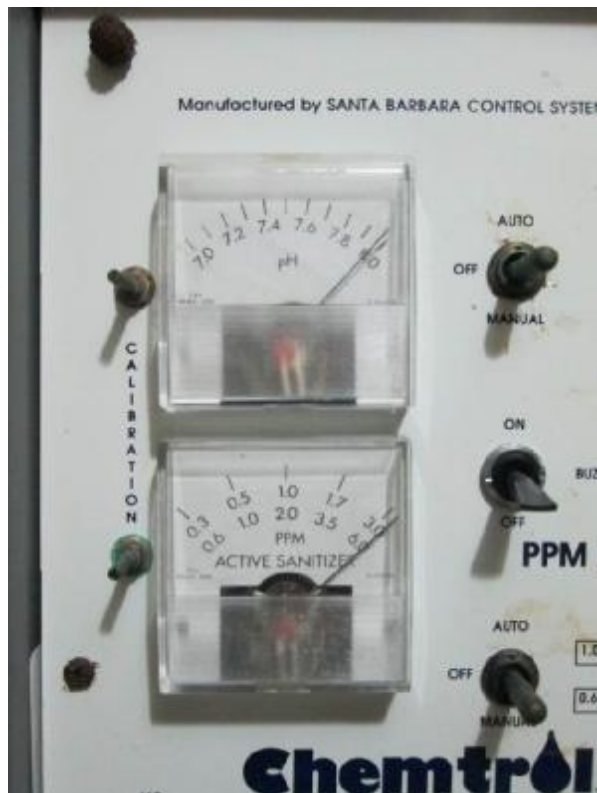
Image 107: Water Chemistry Controller Meters

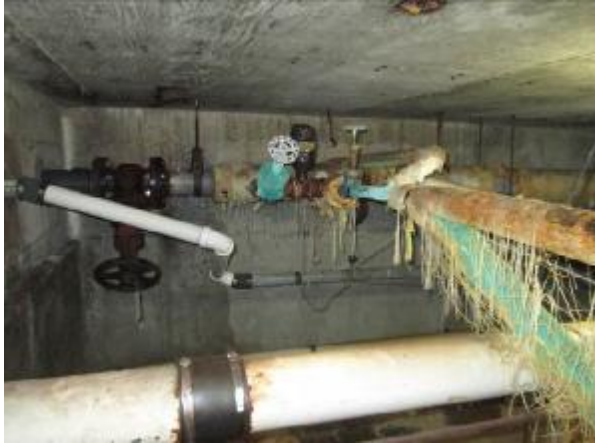
Image 111: Domestic Water to Pool System
