# Kiel Area School District

District-wide Facilities Study

# STUDY DOCUMENT

August 2022

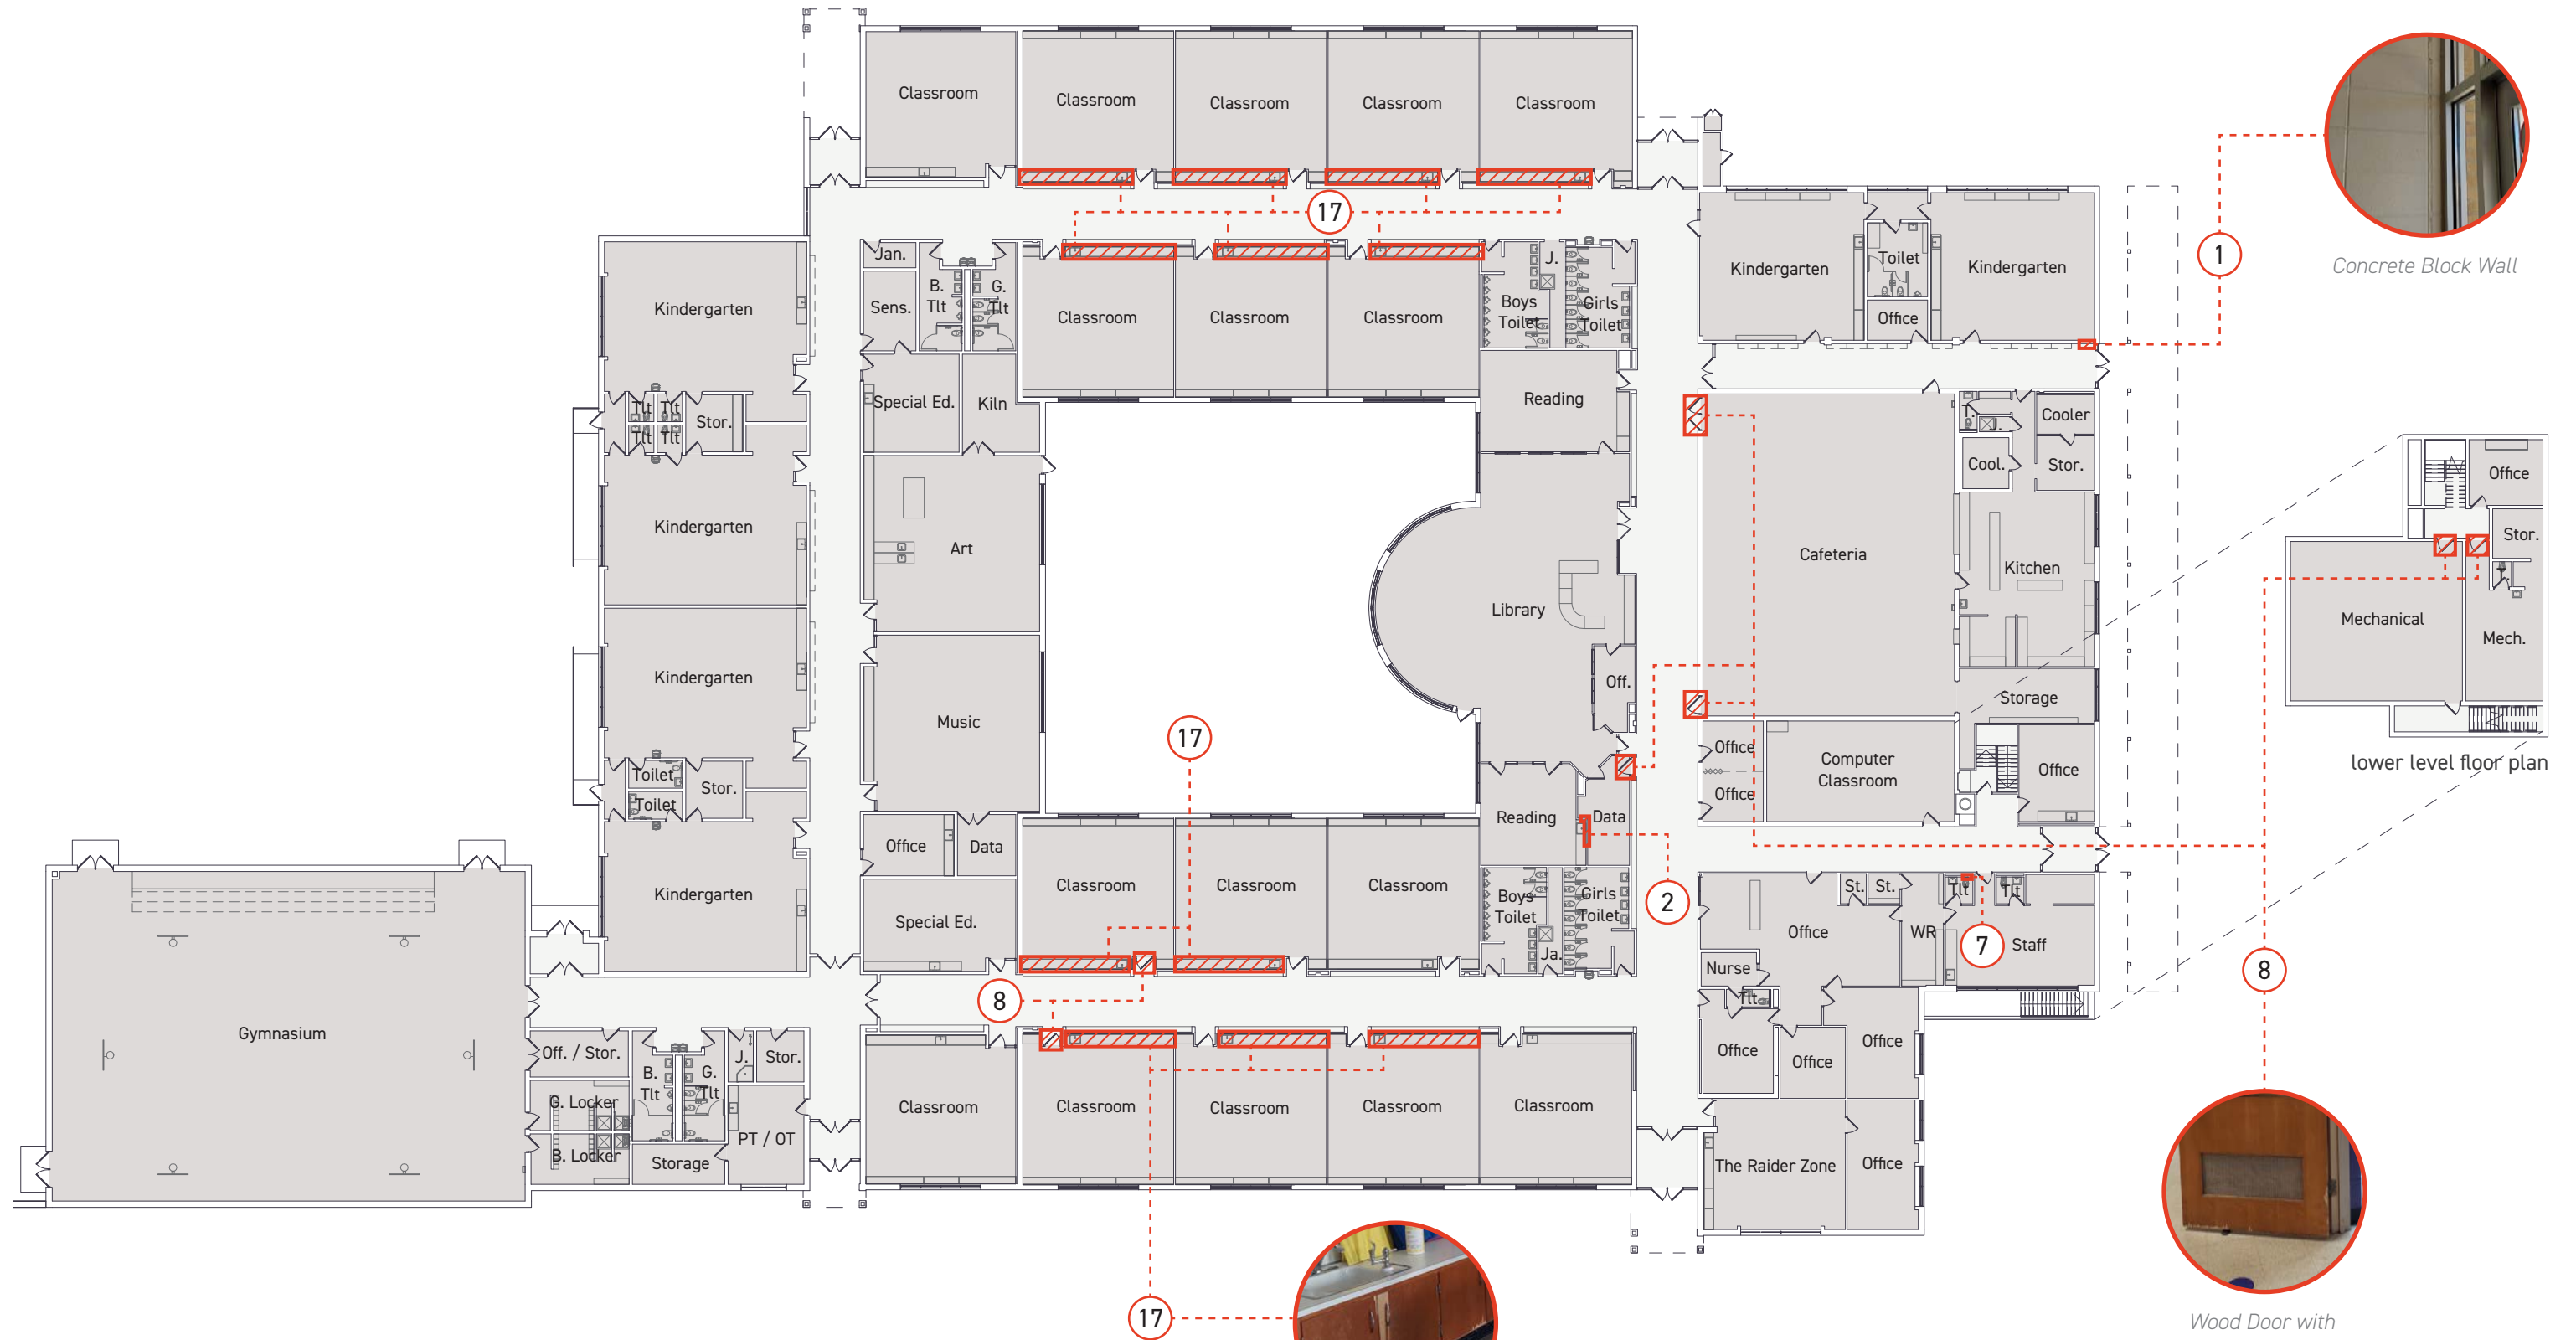
# zielanis elementary interior identifications + analysis | first floor

- Majority of laminate casework located within classrooms appears to be newer and in good condition.
- Wood and laminate casework located within classrooms is in poor condition to due to surface scratches and finish peeling off.
- Majority of the wood doors located throughout the building are in fair condition.
- There are few instances of concrete block walls cracking and crumbling.

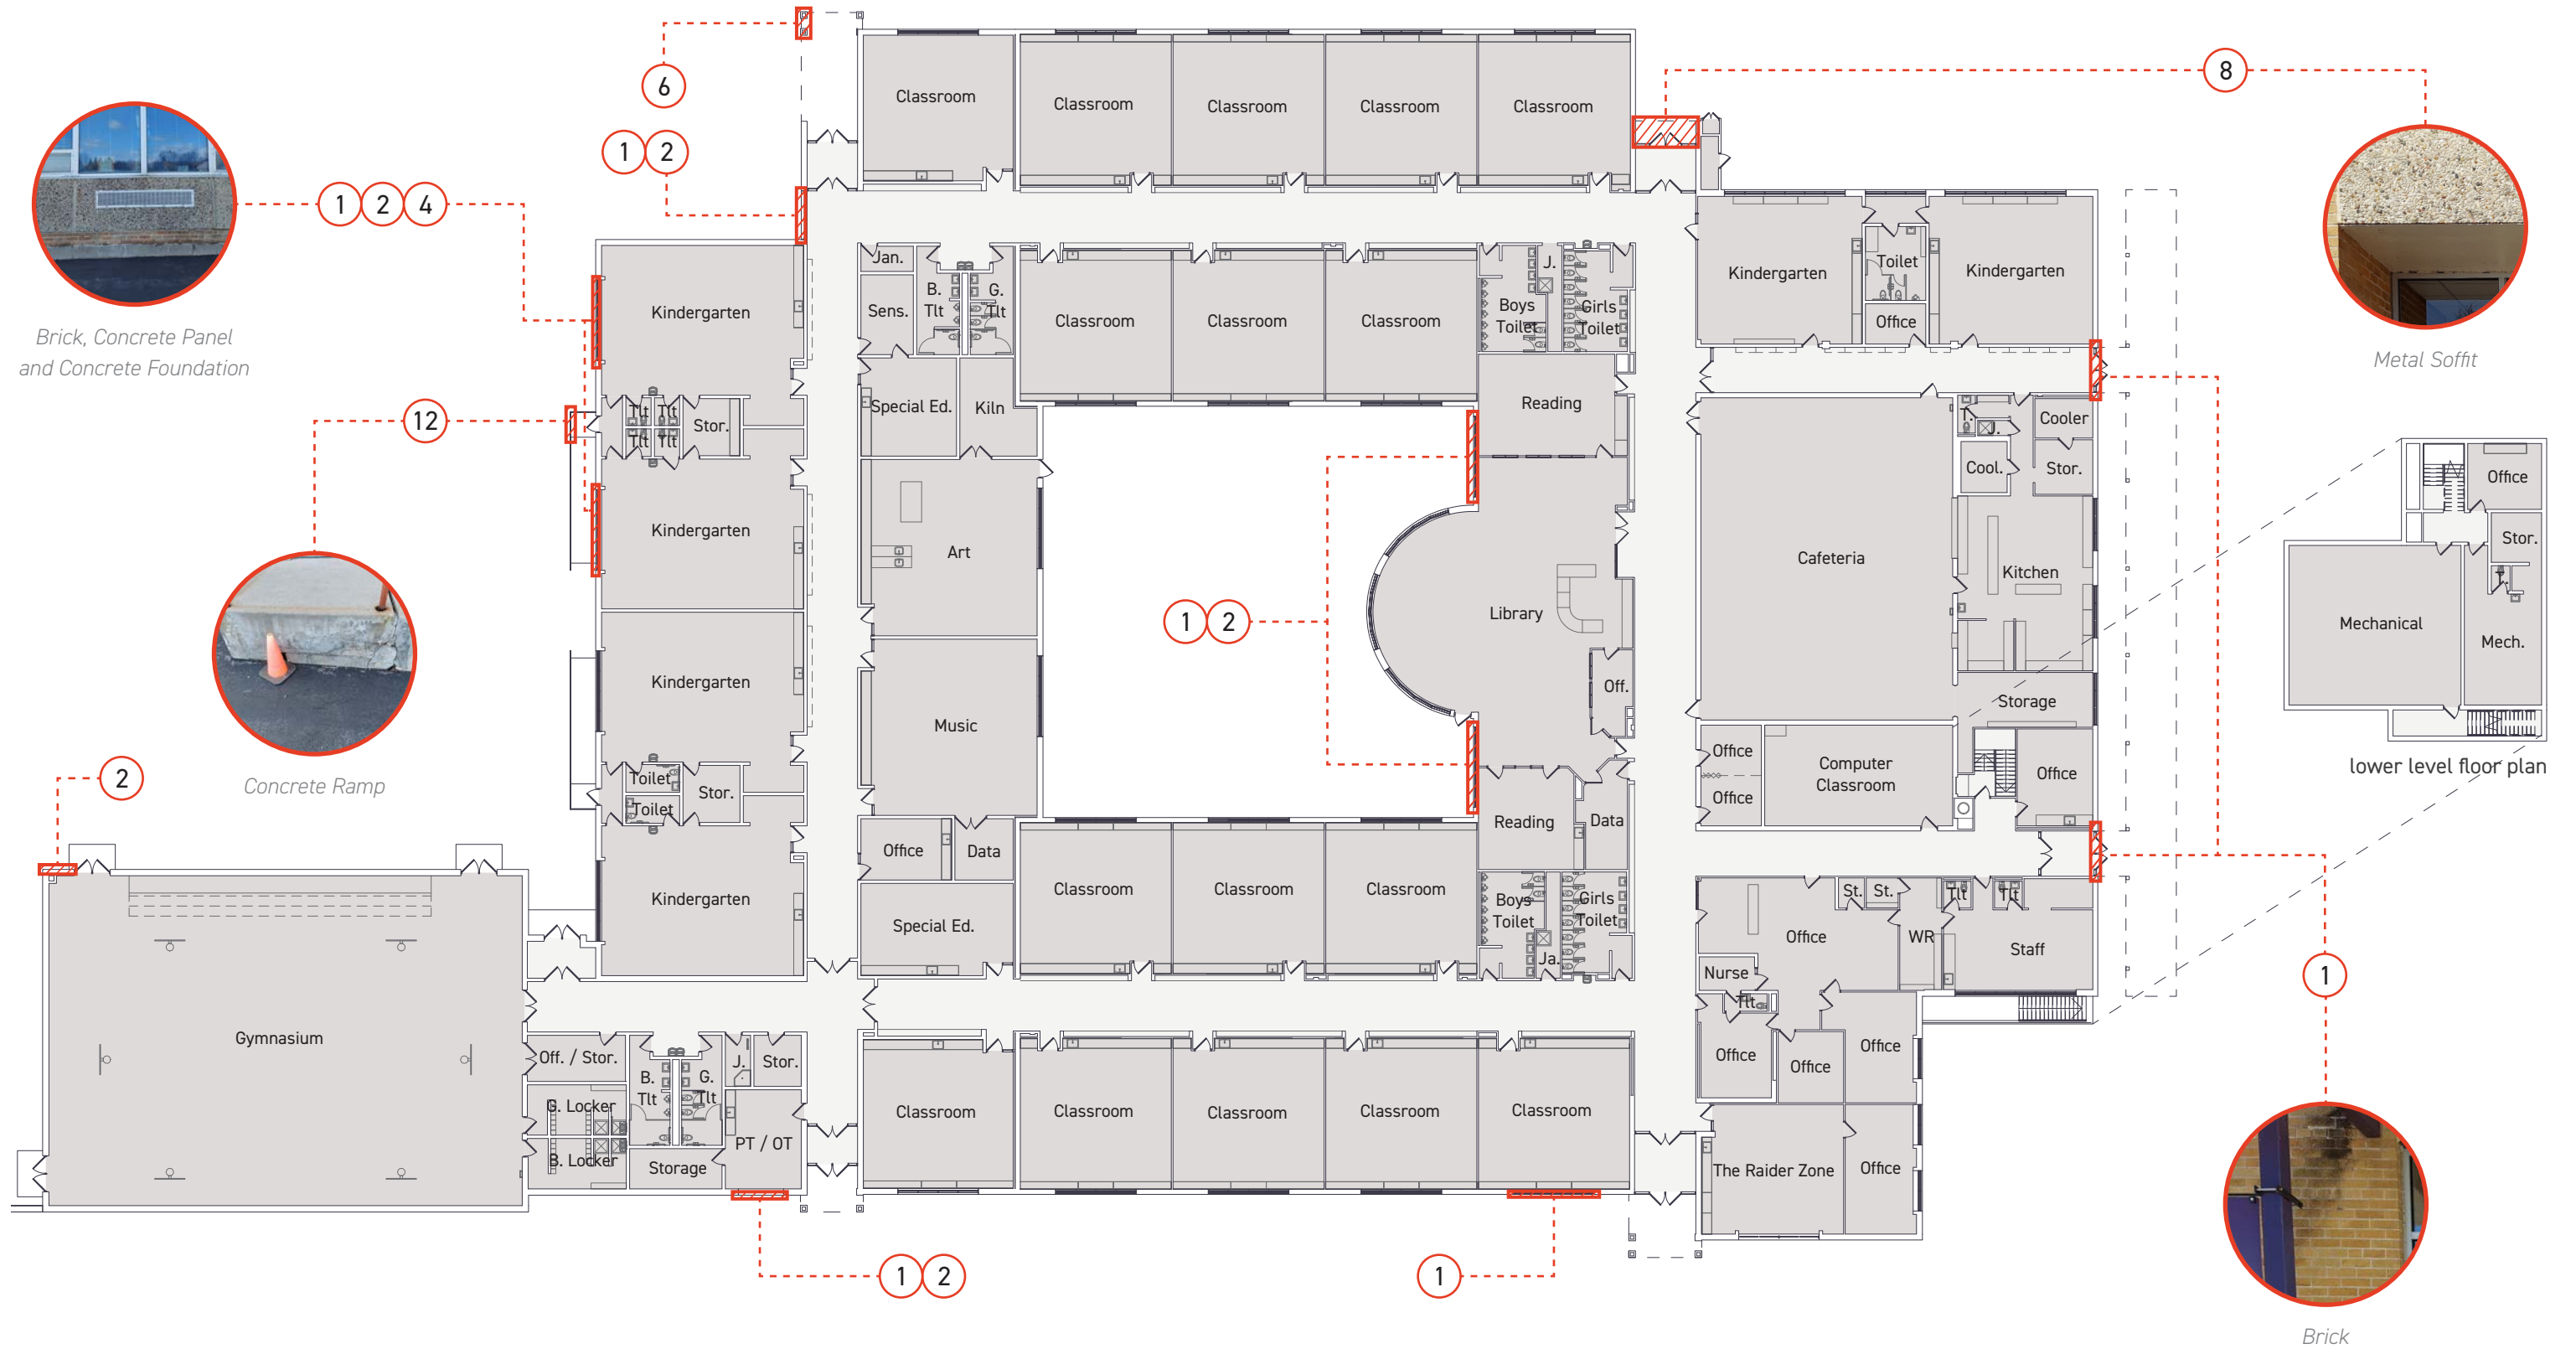
# zielanis elementary exterior identifications + analysis

- Majority of the exterior concrete wall panels are in fair condition due to staining.
- The metal soffit is in poor condition due to rusting.
- The concrete ramp is in poor condition due to cracking and crumbling.
- Majority of bricks are in fair condition due to instances of staining, especially near windows and openings.

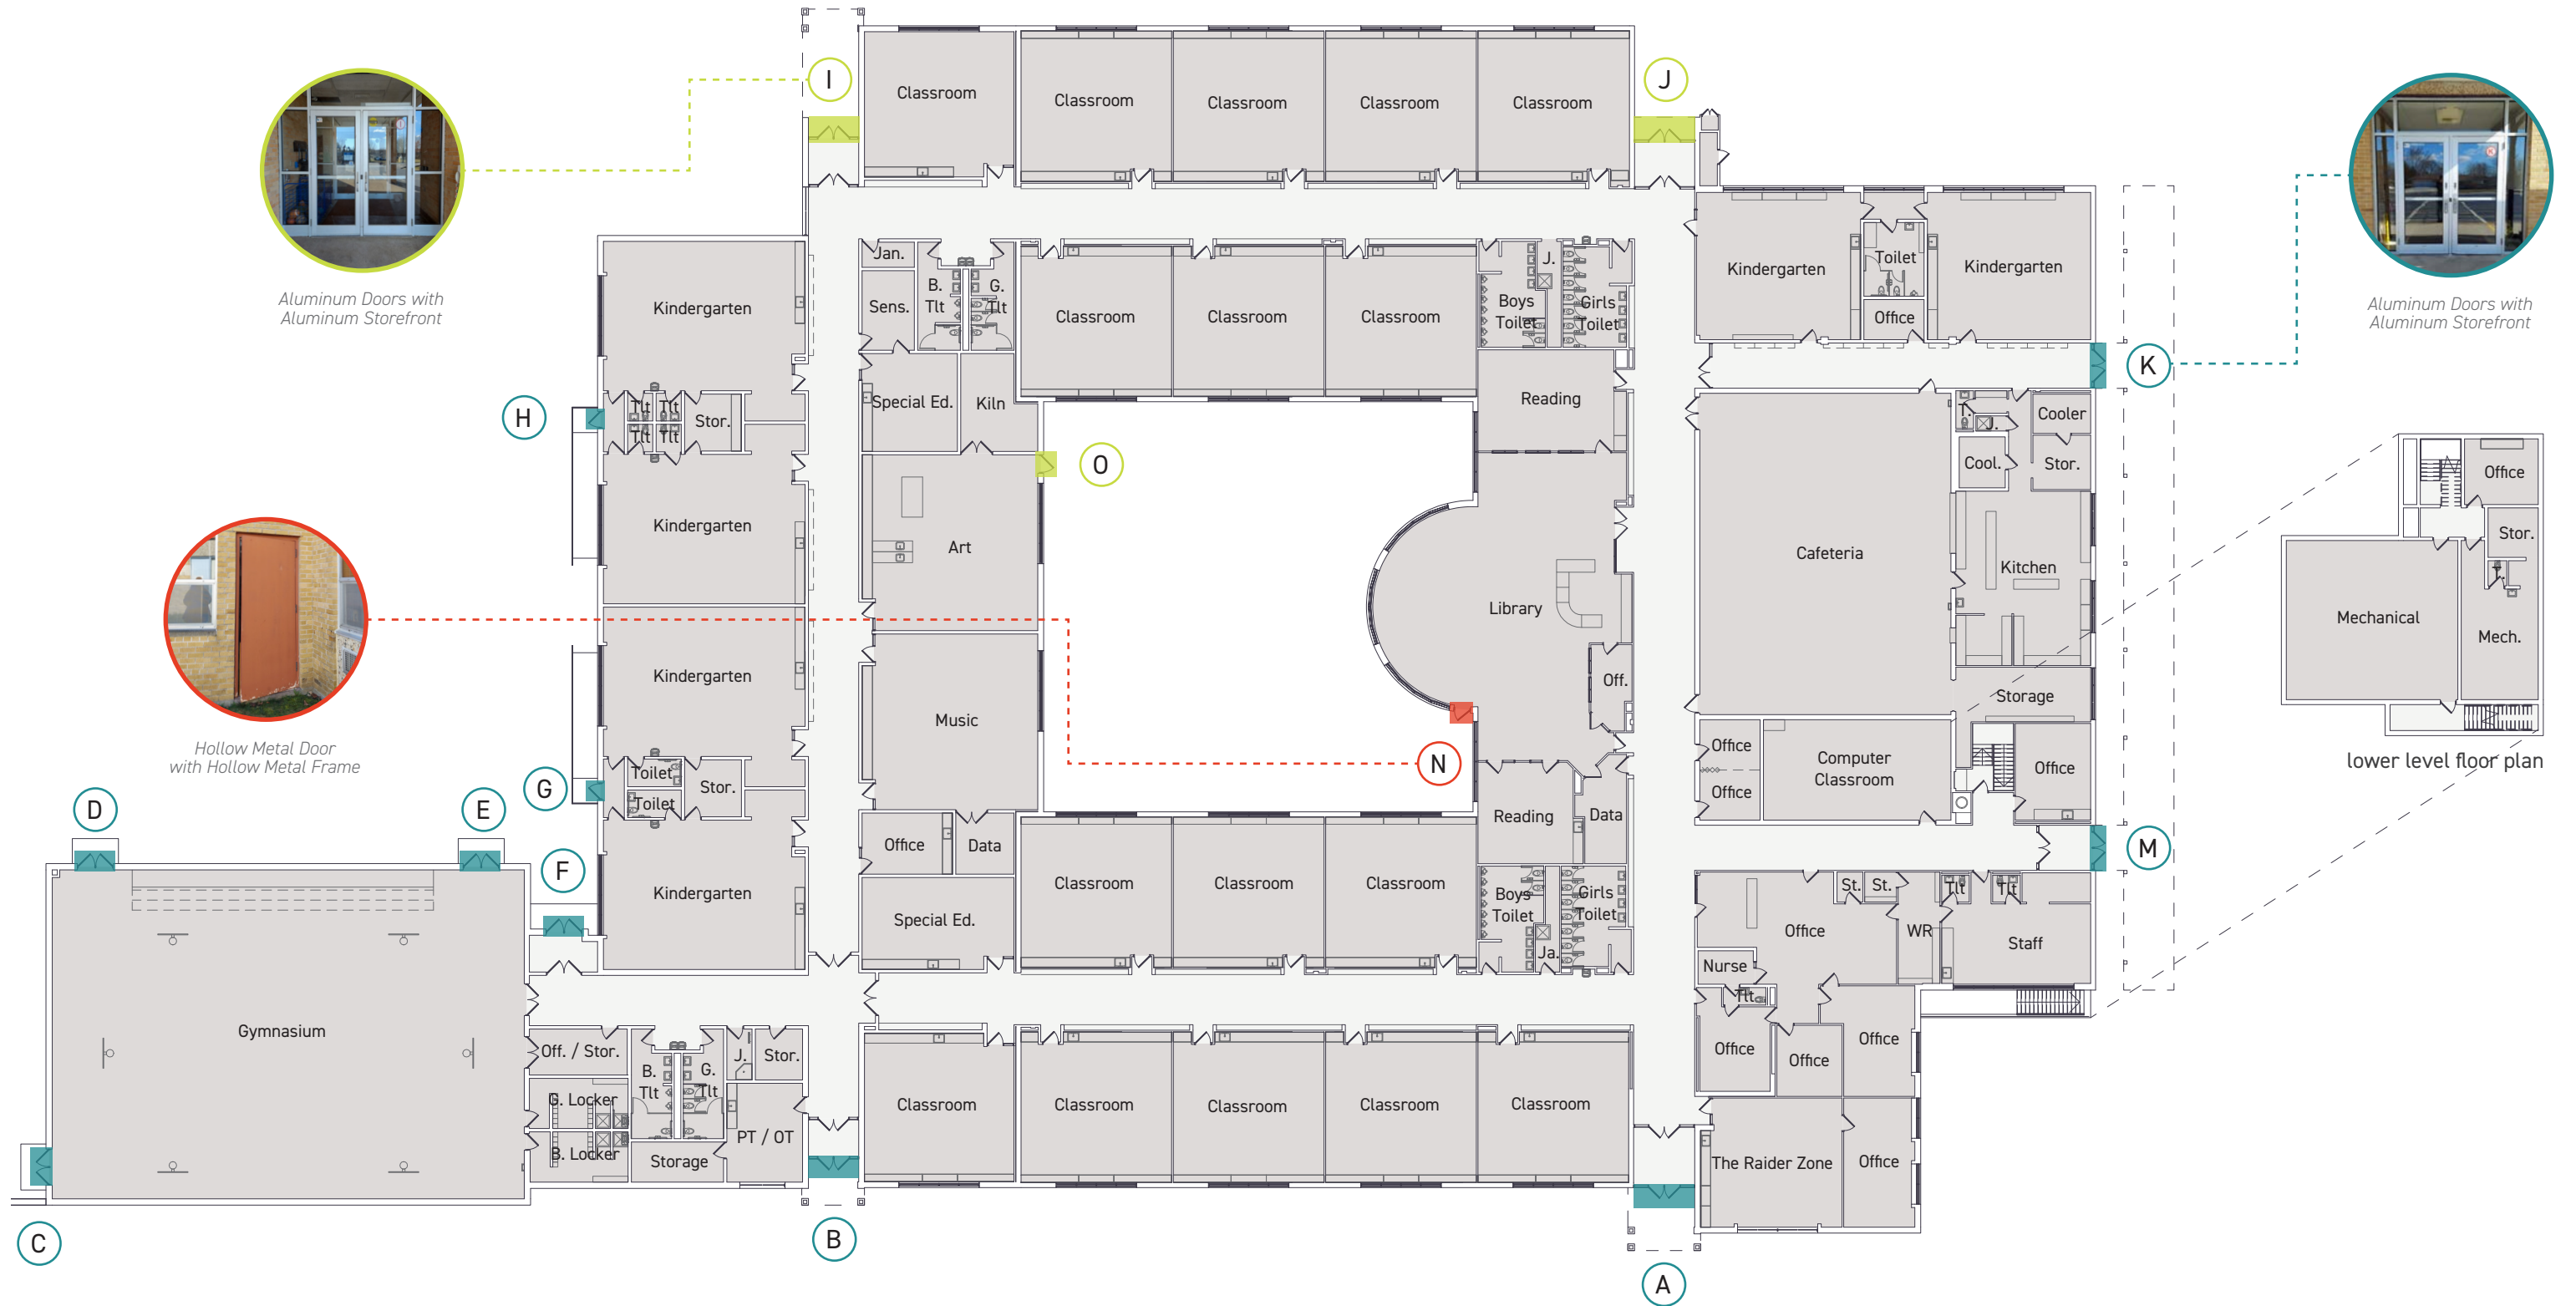
# zielanis elementary exterior door identification + analysis

- Majority of aluminum doors with aluminum storefront framing are in good condition.
- Door N is in poor condition due to rusting, denting, and paint peeling off.
- Doors I and J are in fair condition due to denting and surface scratches.

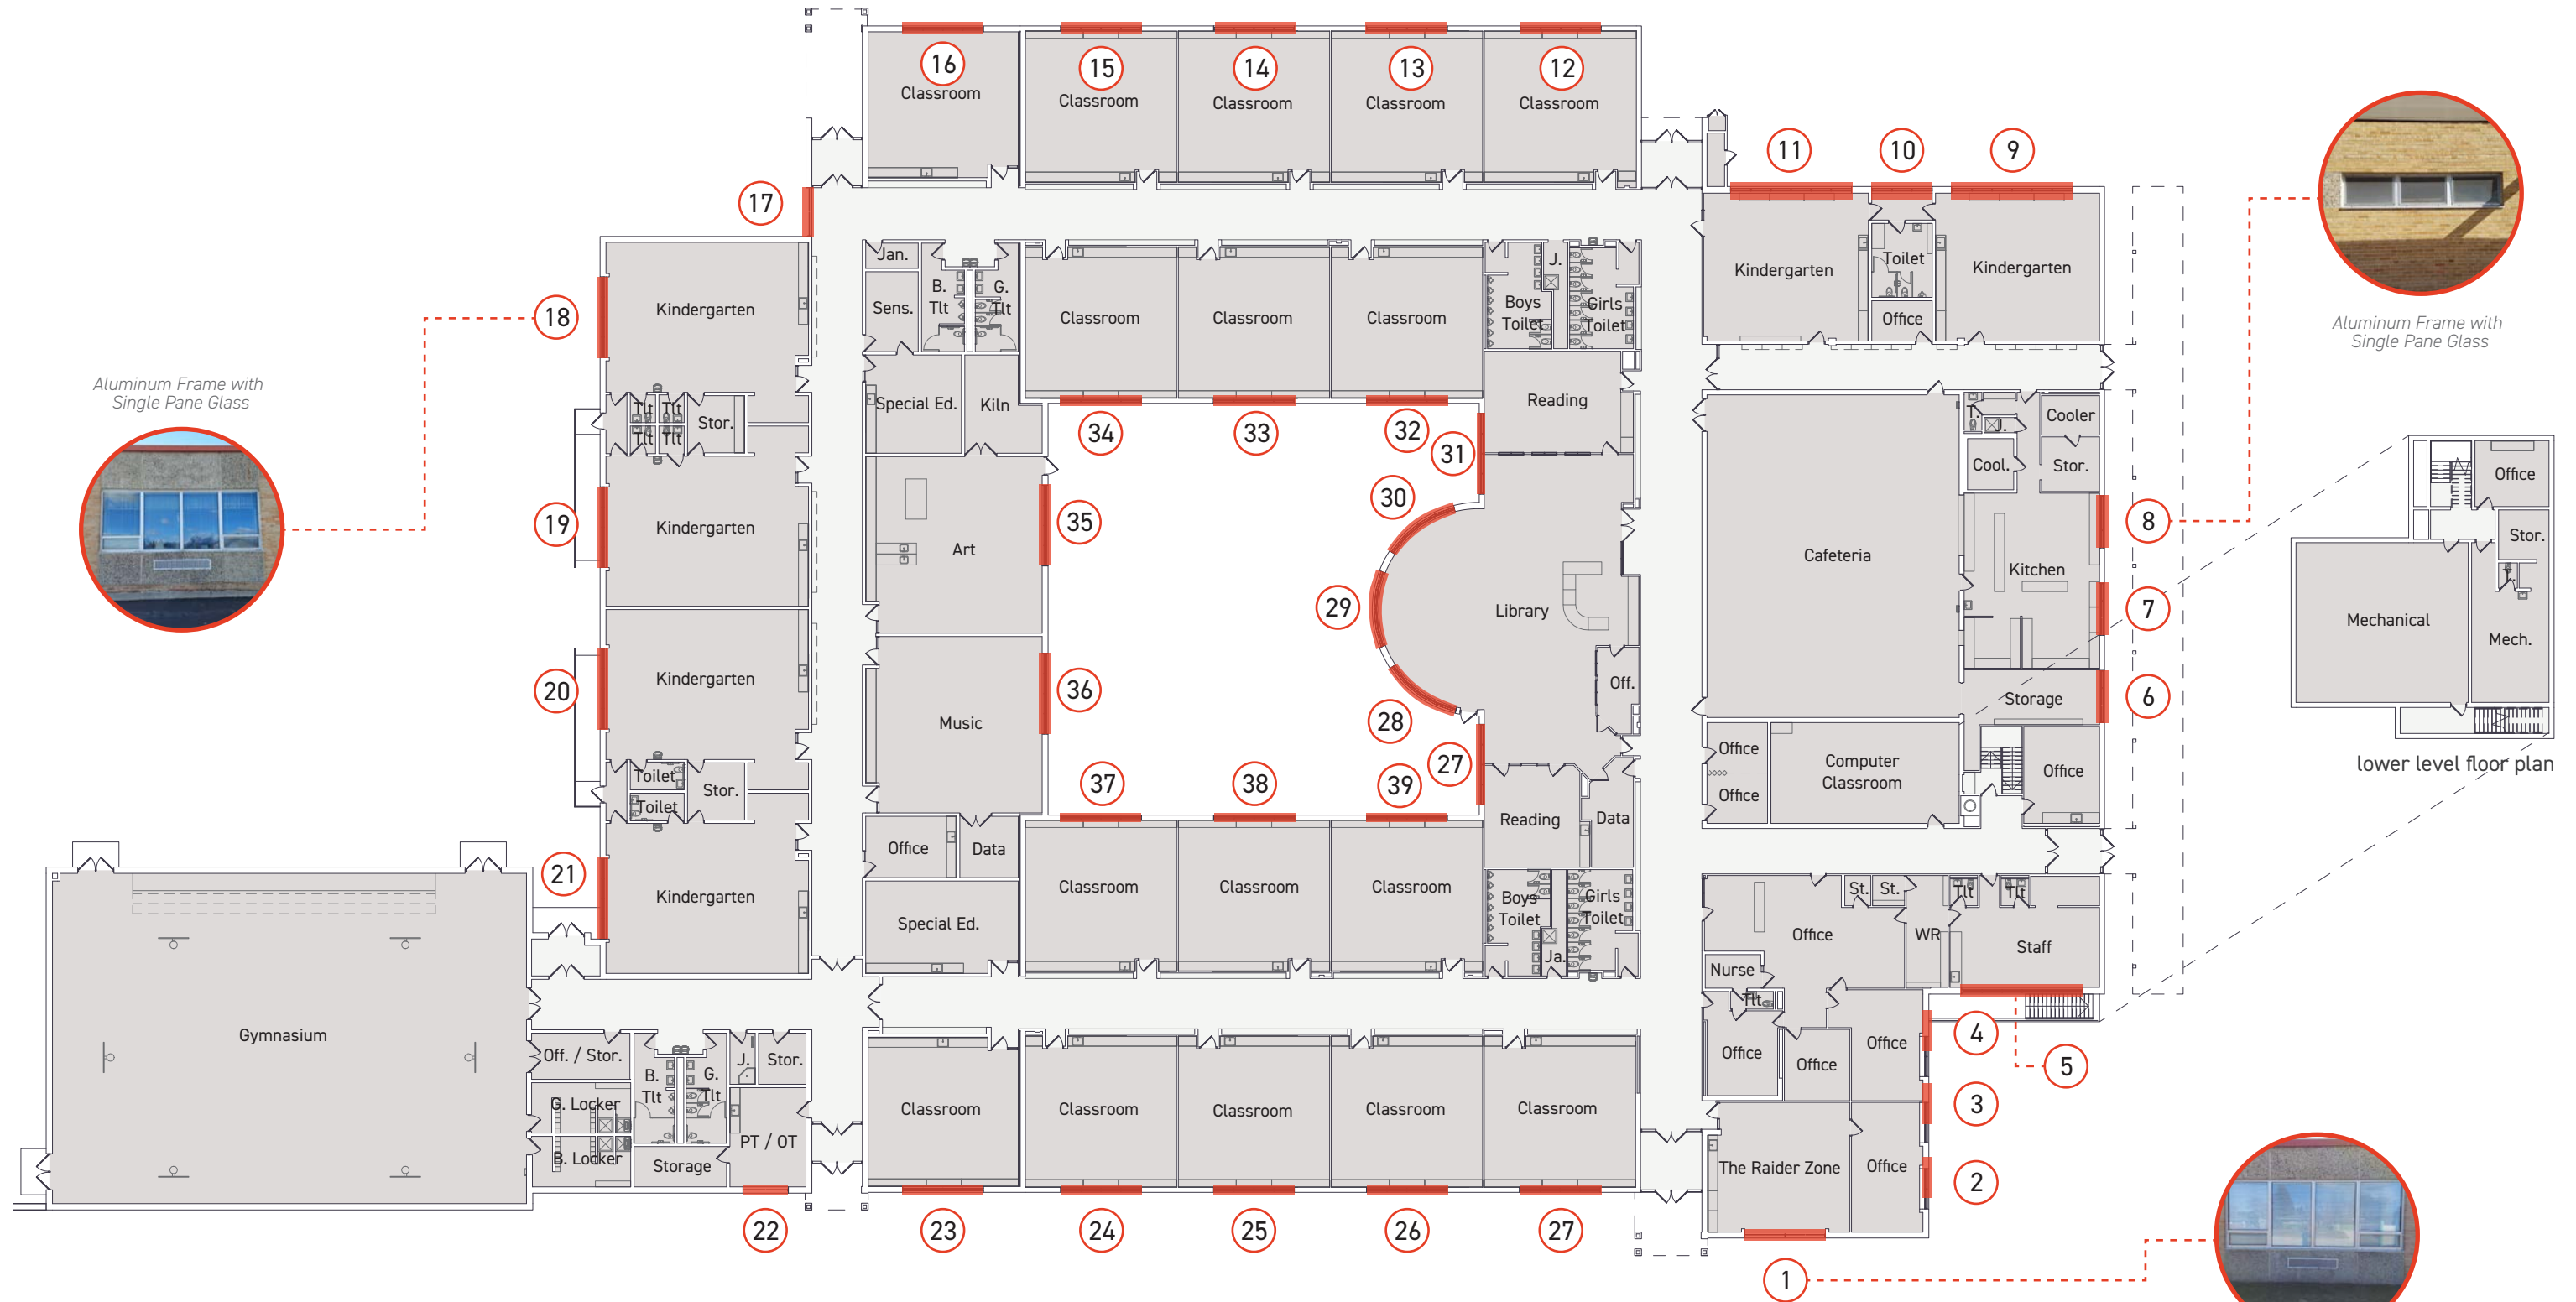
# zielanis elementary exterior window identification + analysis

- Some windows have additional sliding windows and/or tackboards on the interior side of the window. Any glass within these sliders is single pane.
- There is an instance of staining at window 36.
- Windows containing single pane glass are considered as in poor condition.

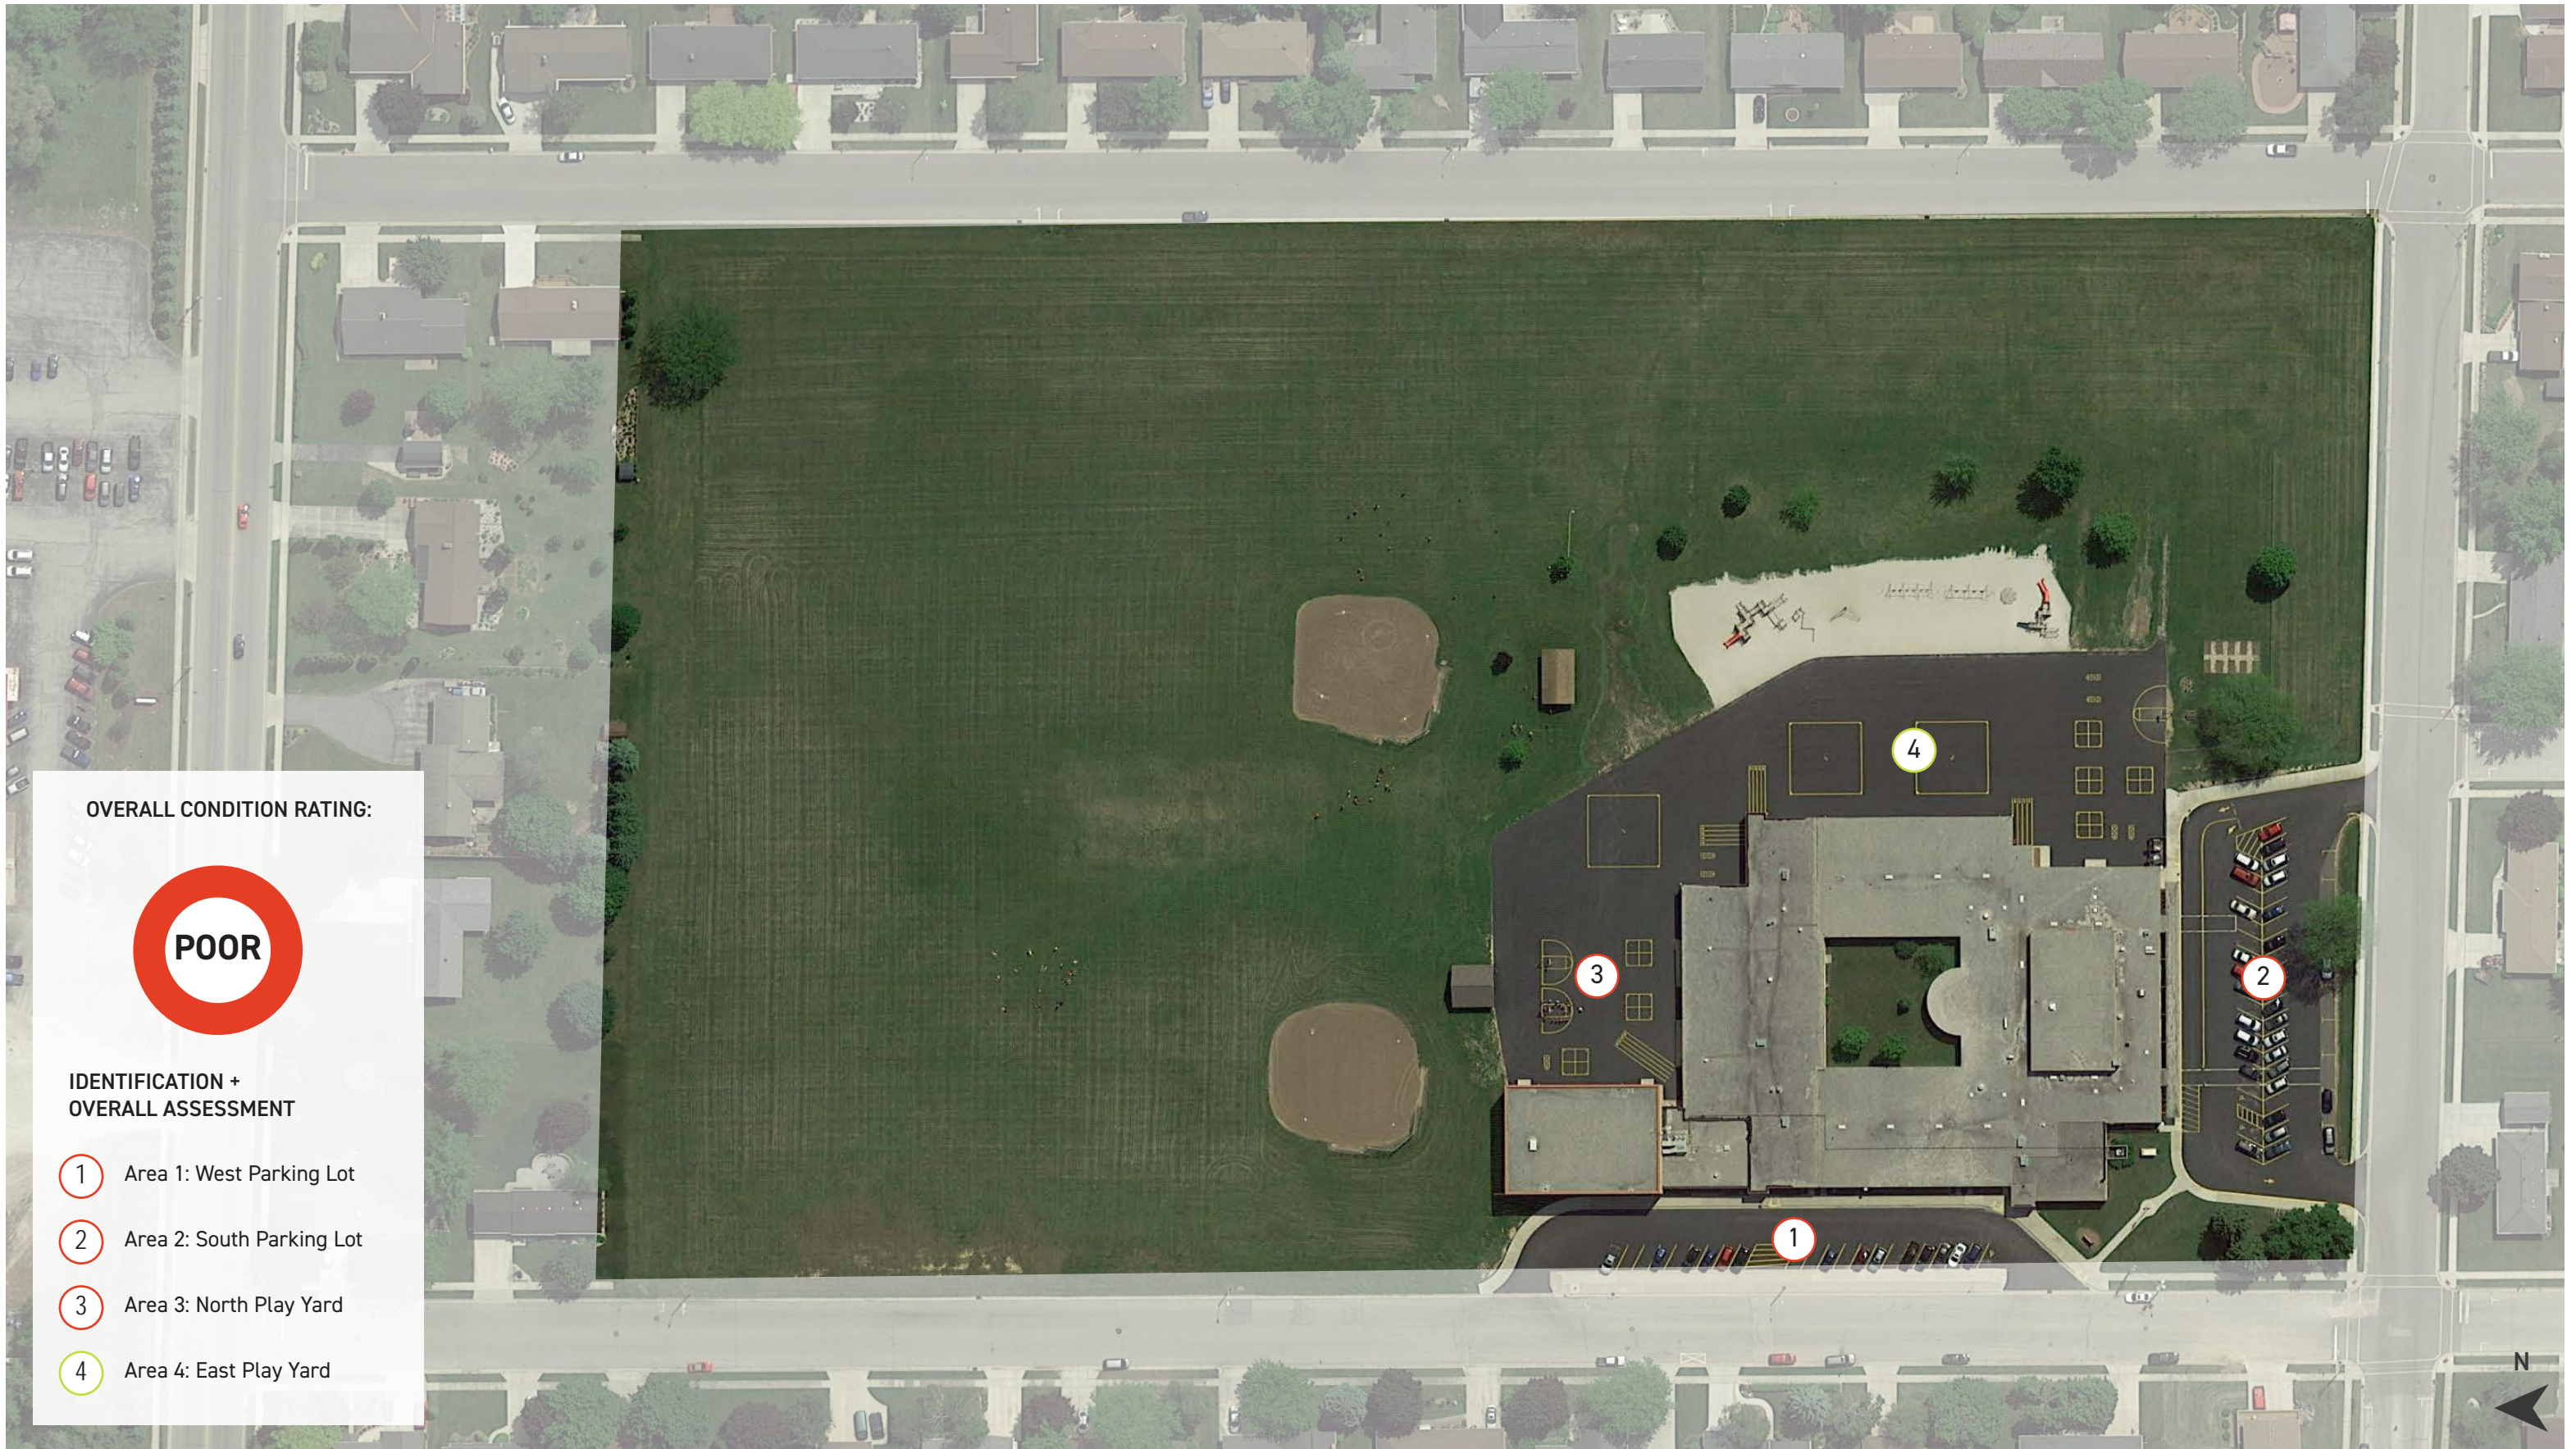
# zielanis elementary site assessment

Asphalt Driveway	●	Driveway aprons have edge cracking on all edges and cracking in the concrete gutter.
Asphalt Driveway	●	Driveway aprons have edge cracking on all edges and cracking in the concrete gutter.
Asphalt Parking Lot	●	North end has alligator and block cracking. There are large areas covered in crack sealant, and many of the sealed cracks are expanding.
Concrete Sidewalk	●	Severely cracking and uneven in multiple areas.
Curb + Gutter	●	Extremely worn and many pieces of concrete are breaking off.

Asphalt Parking Lot	●	Several areas of severe alligator cracking. Settlement is causing additional cracking, such as longitudinal, transverse, and block.
Concrete Sidewalk	●	Appears very worn with some areas of cracking concrete.
Curb	●	Gaps between sections and pieces of concrete broken off.
Trash Enclosure Gate	●	Uneven gate on north-east portion.

Asphalt Play Area	●	Longitudinal cracking and settling towards the middle. Fading pavement markings.
Ball field	●	Poorly maintained and covered with weeds. Ball field fencing needs repair.
Covered Picnic Table	●	Good condition with no cracking present.
Concrete Seating Area	●	Some chipped edges.
Concrete Ramps	●	Severe cracking and rusting metal railings.

## Parking Lot Repair

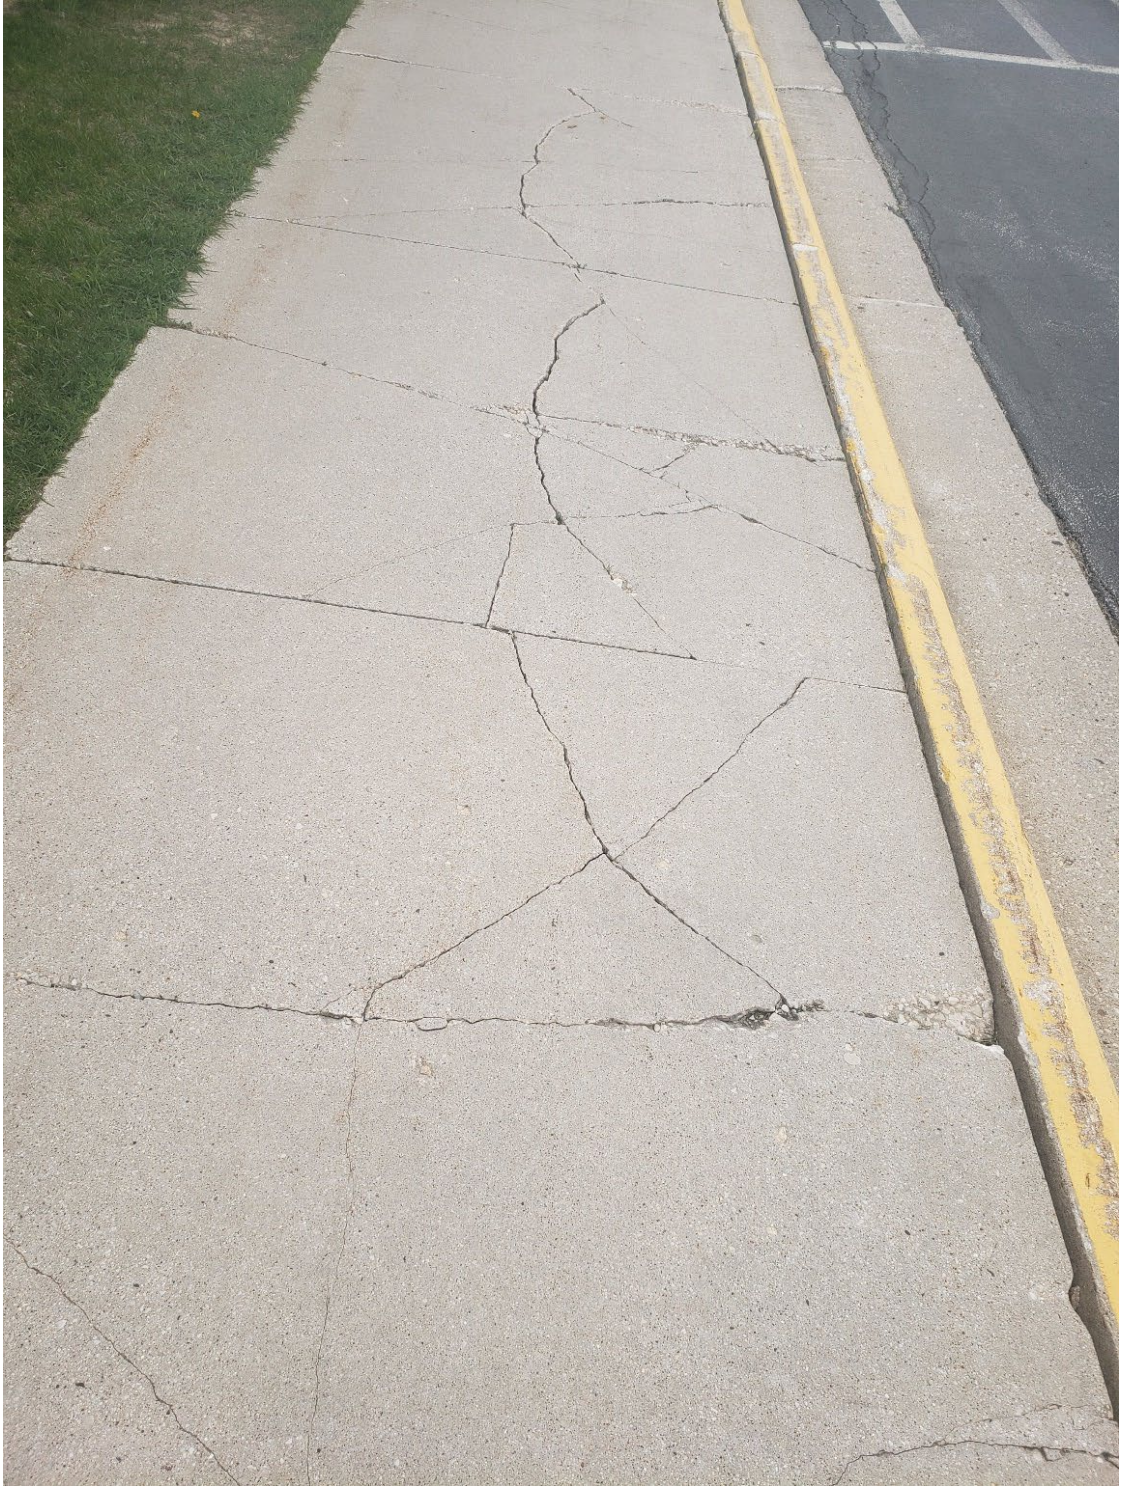
*Figure 5: Severe cracking in sidewalk by north doors on west side of school.*

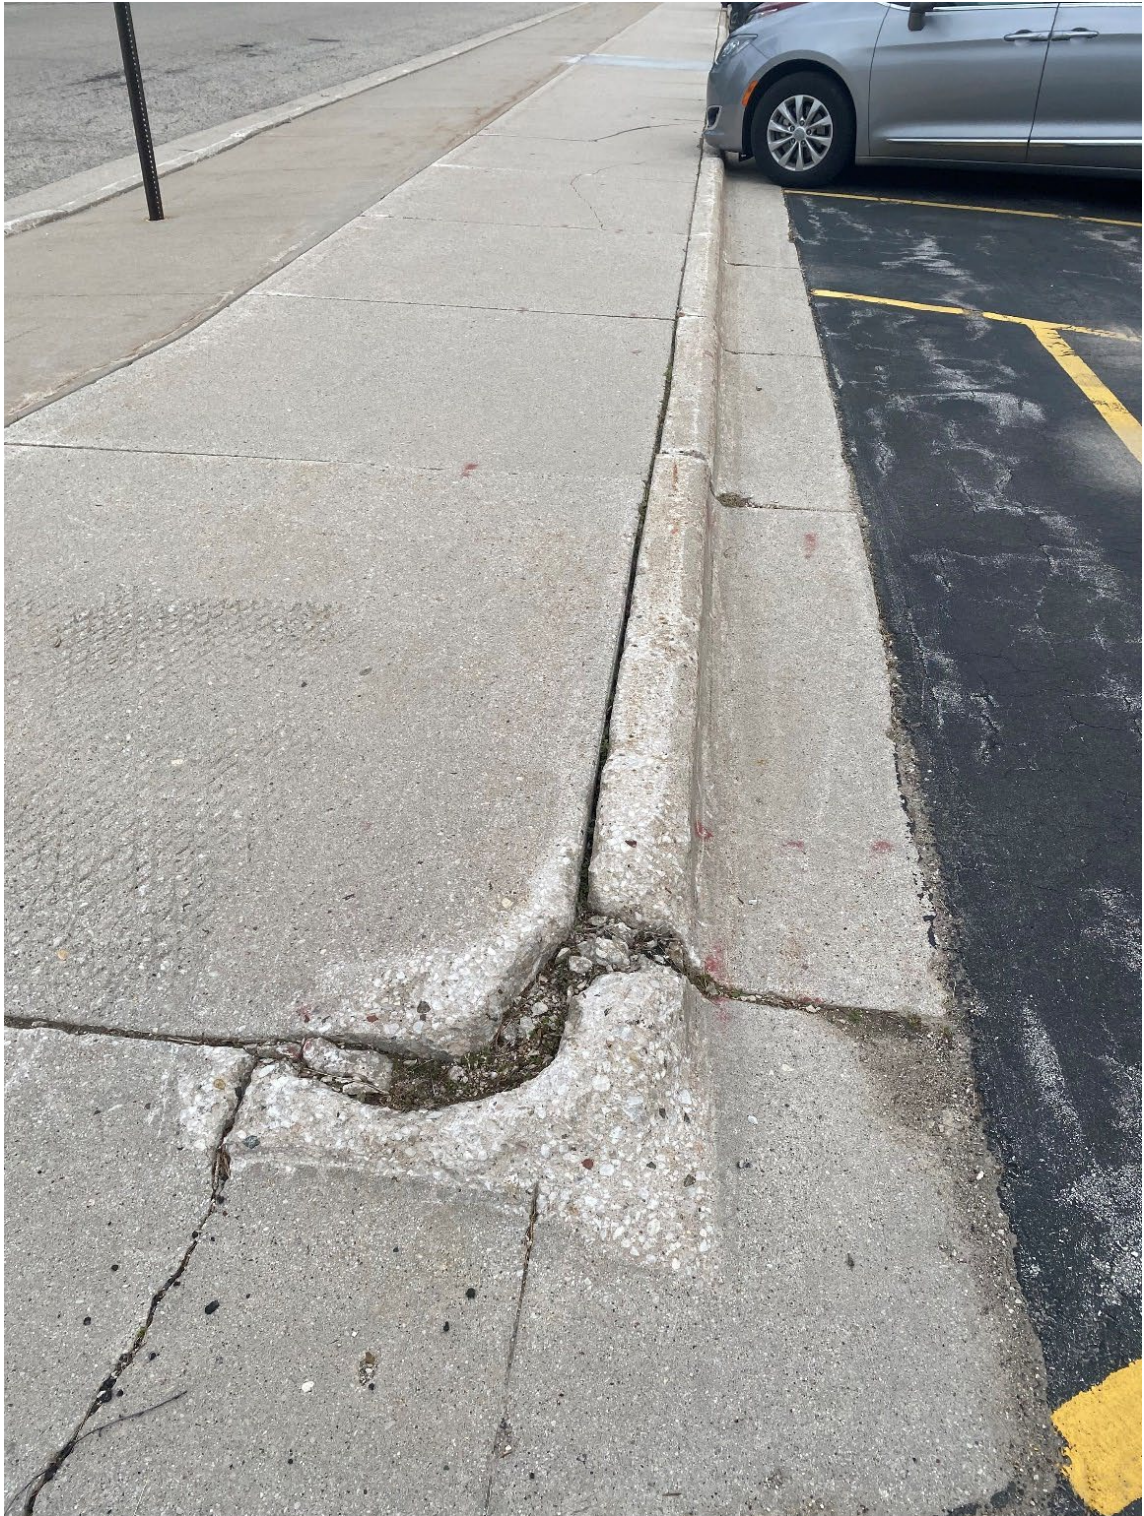
*Figure 6: Deteriorated curb near south-west driveway apron*

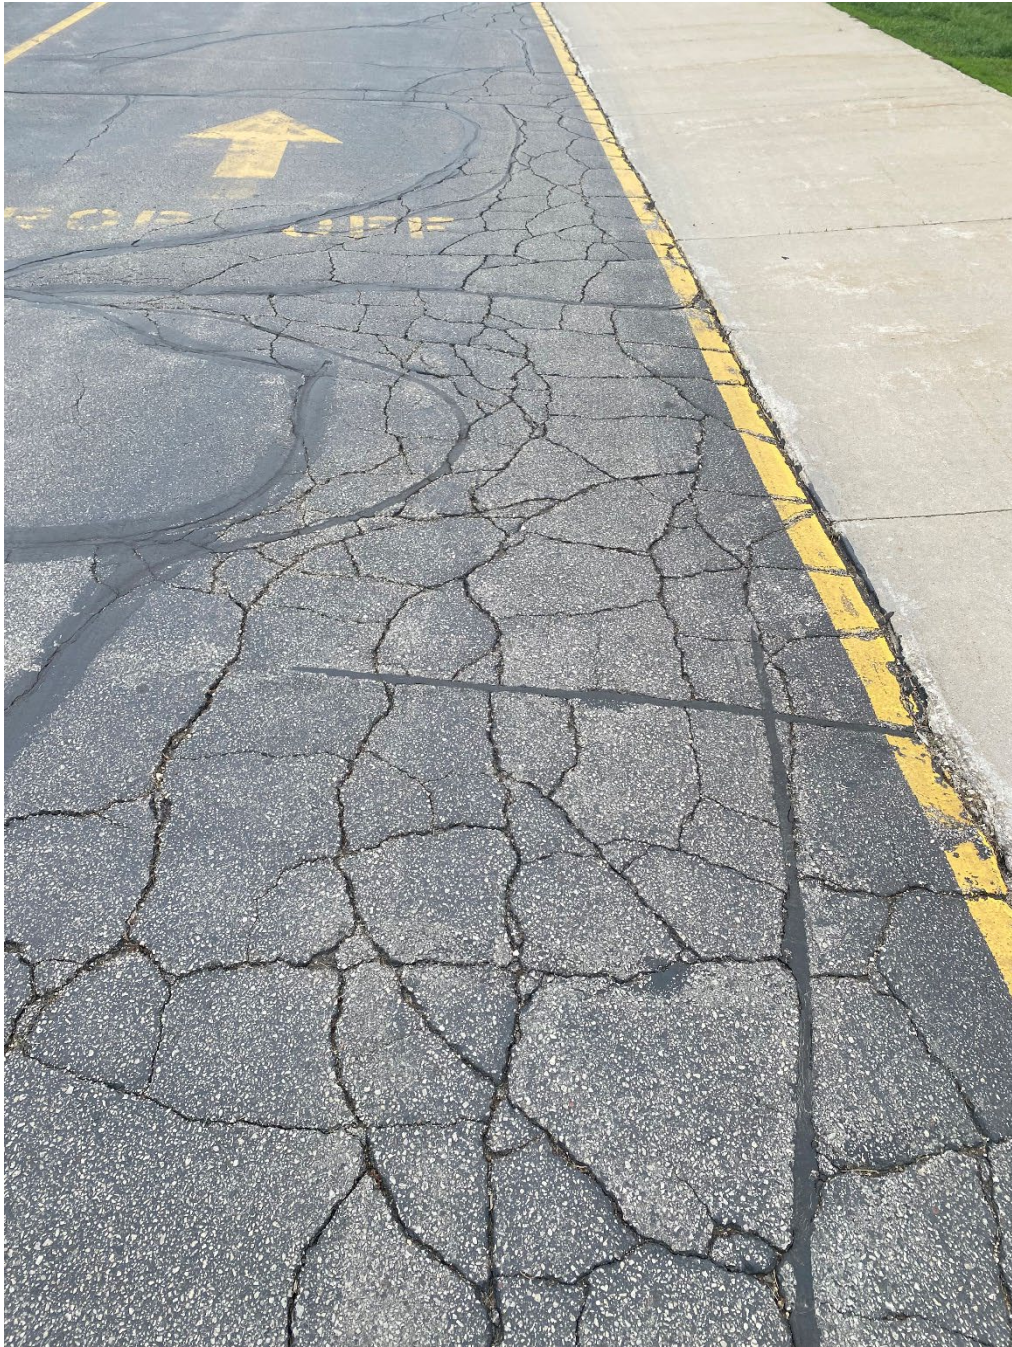
*Figure 8: Alligator cracking in east driveway in south parking lot*
