# Kiel Area School District

District-wide Facilities Study

# STUDY DOCUMENT

August 2022

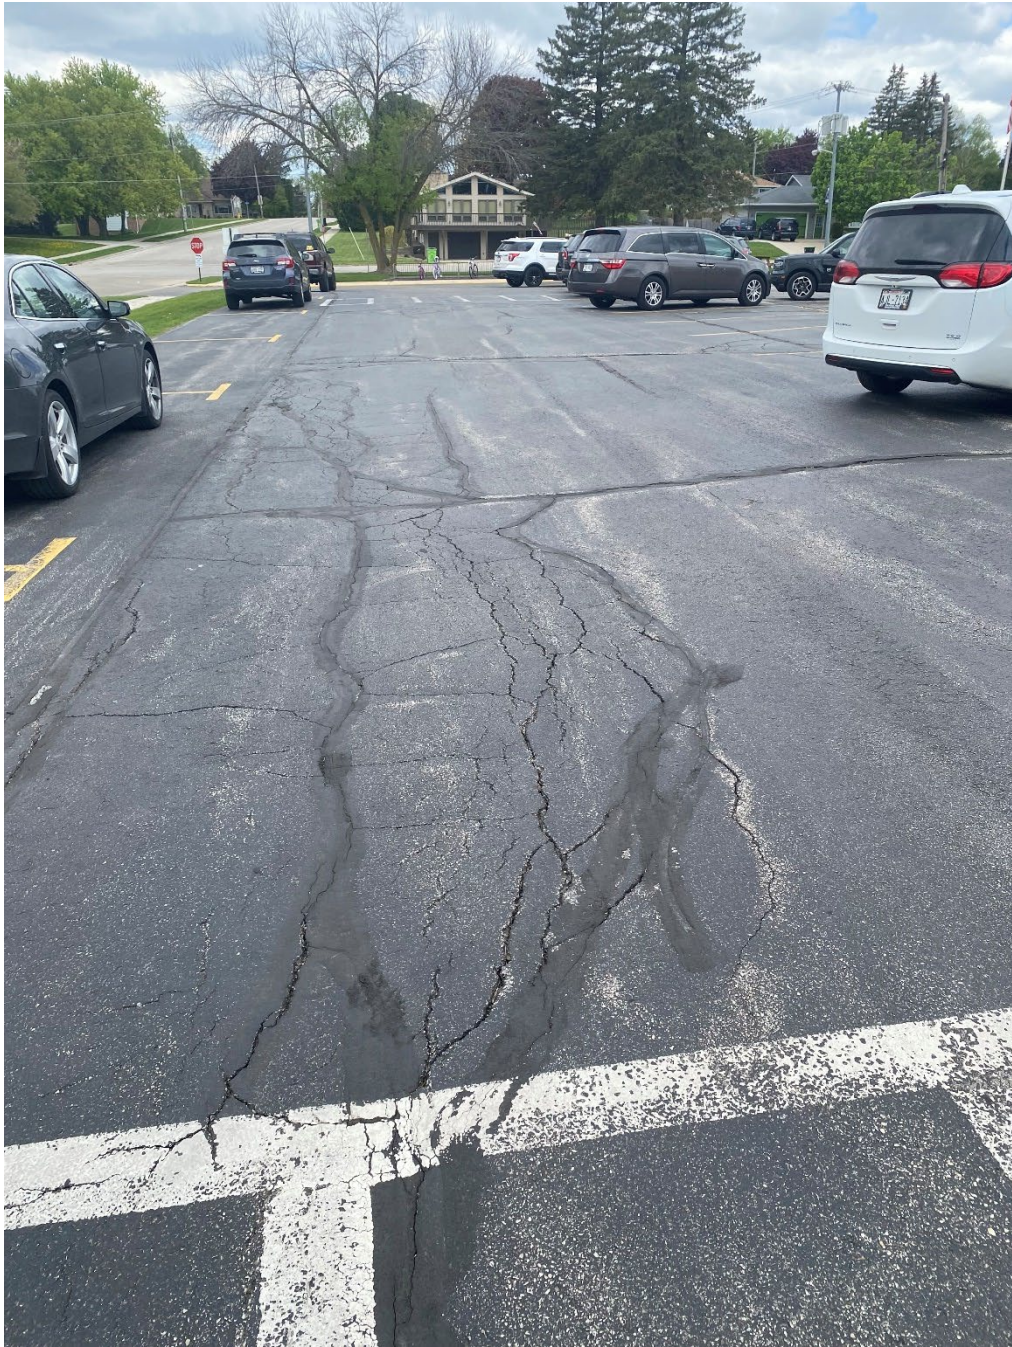
*Figure 9: South parking lot cracking*

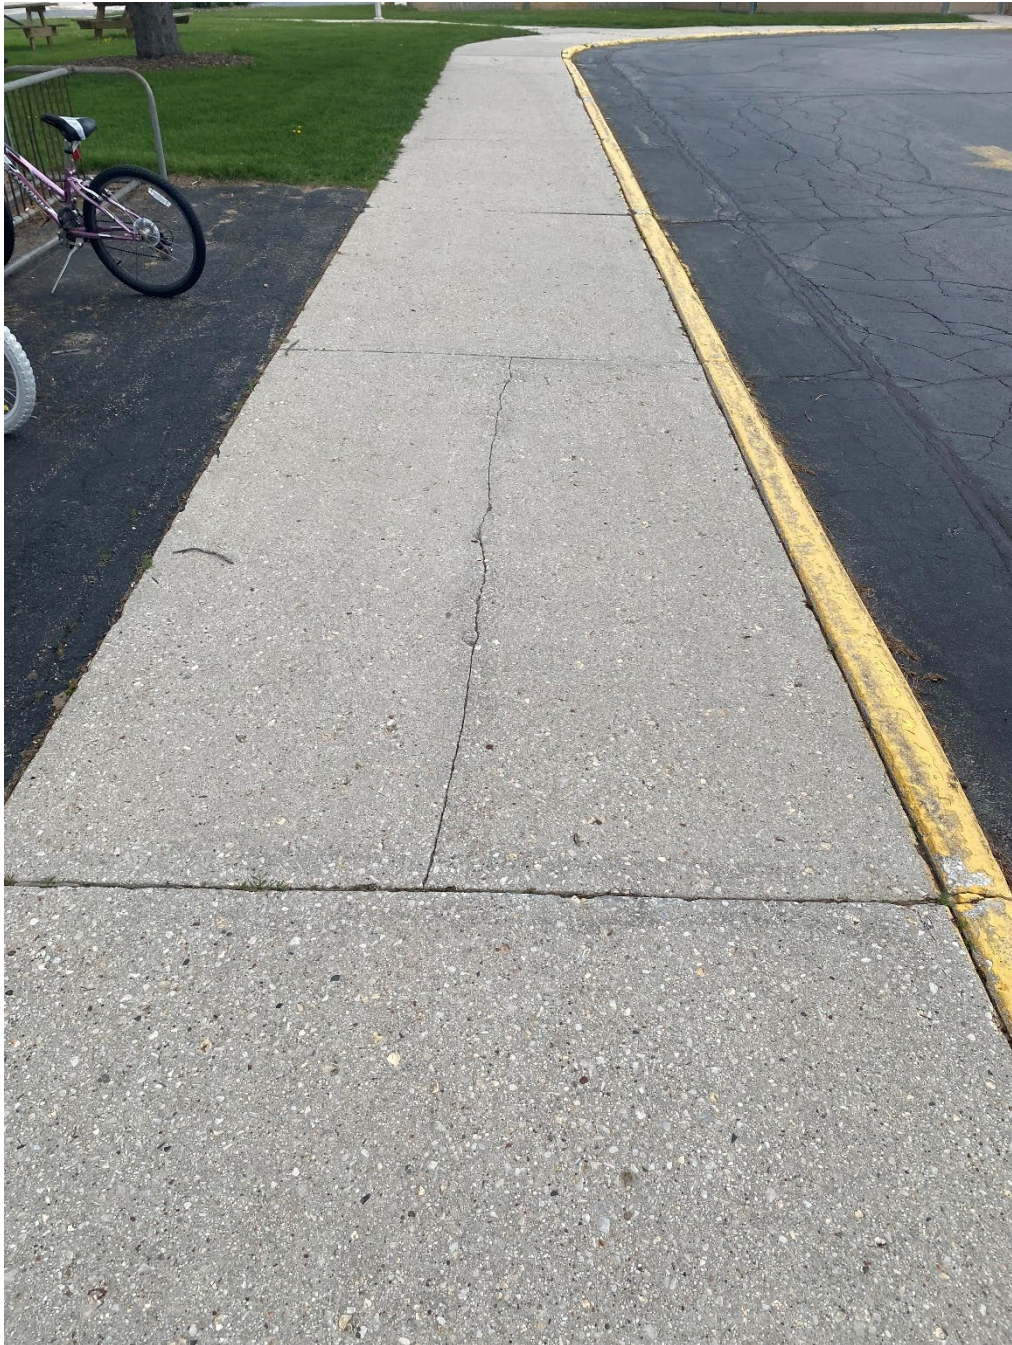
*Figure 10: Crack in west sidewalk*

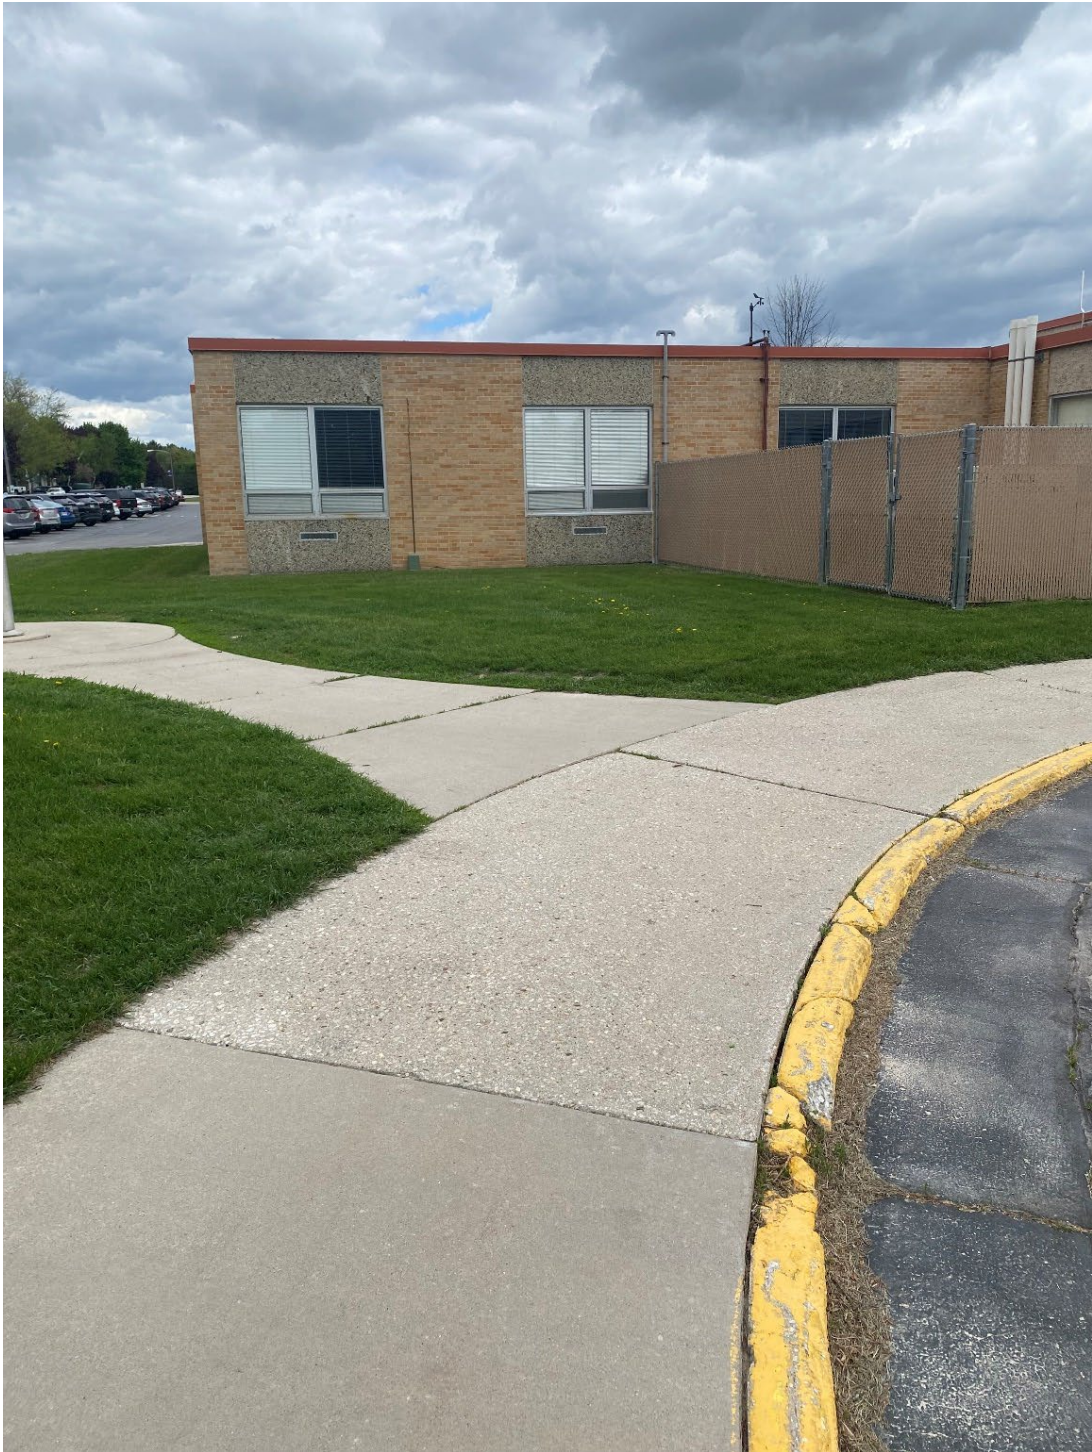
*Figure 11: Cracked and deteriorating curb in north-west corner of south parking lot*

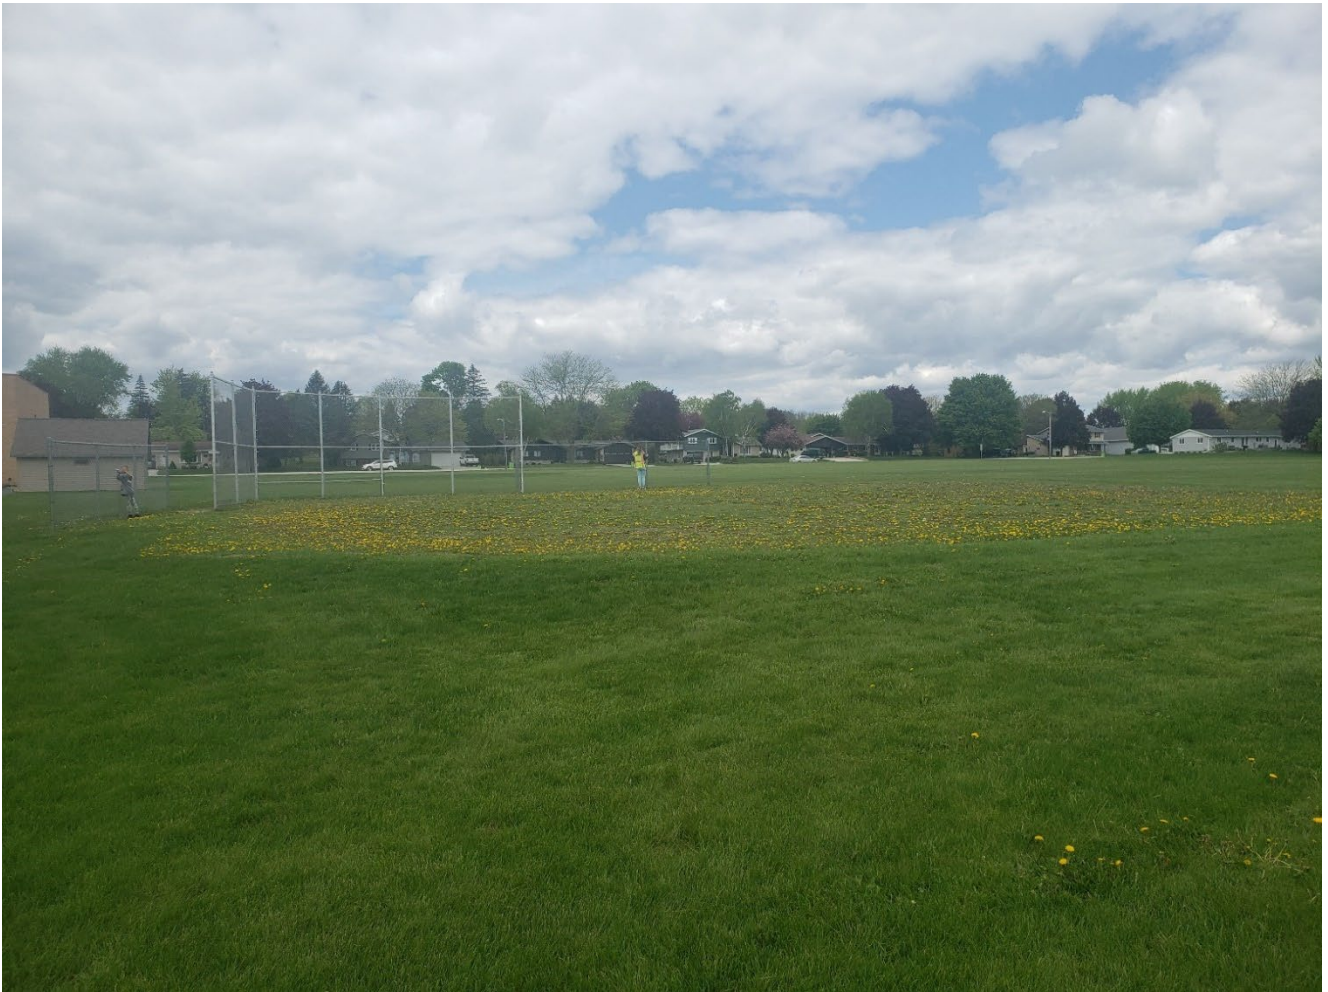
*Figure 14: Existing ball field in poor condition*

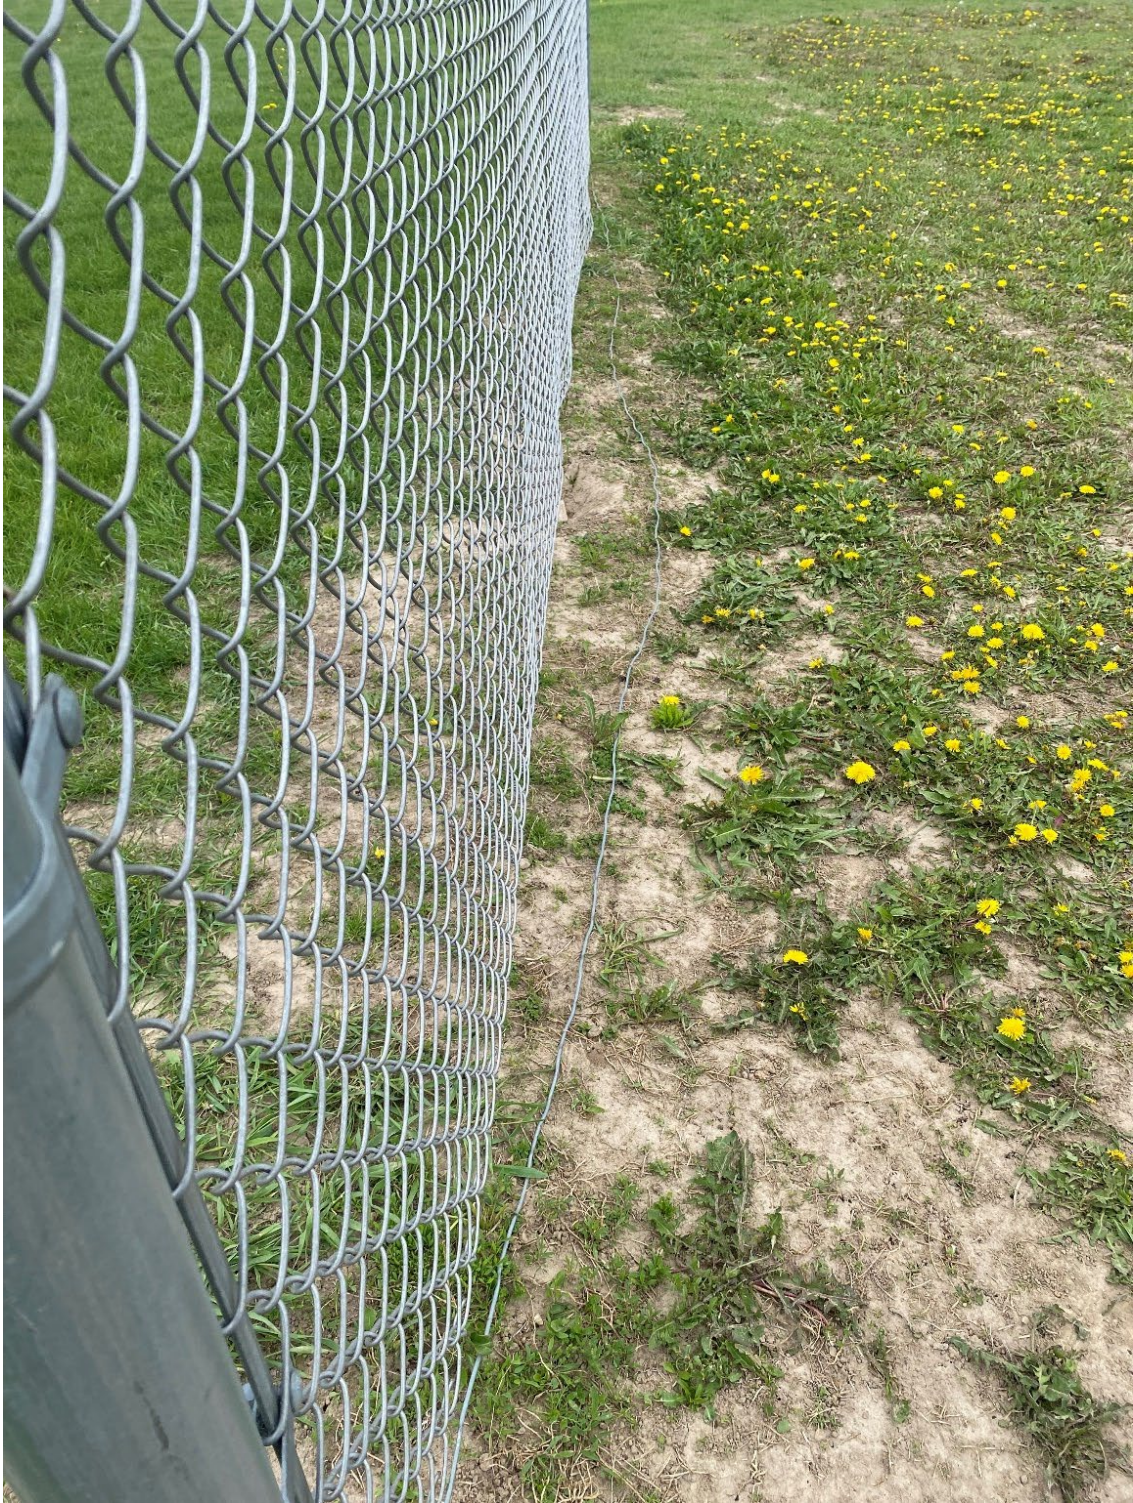
*Figure 15: Broken fence with loose wire next to ball field*

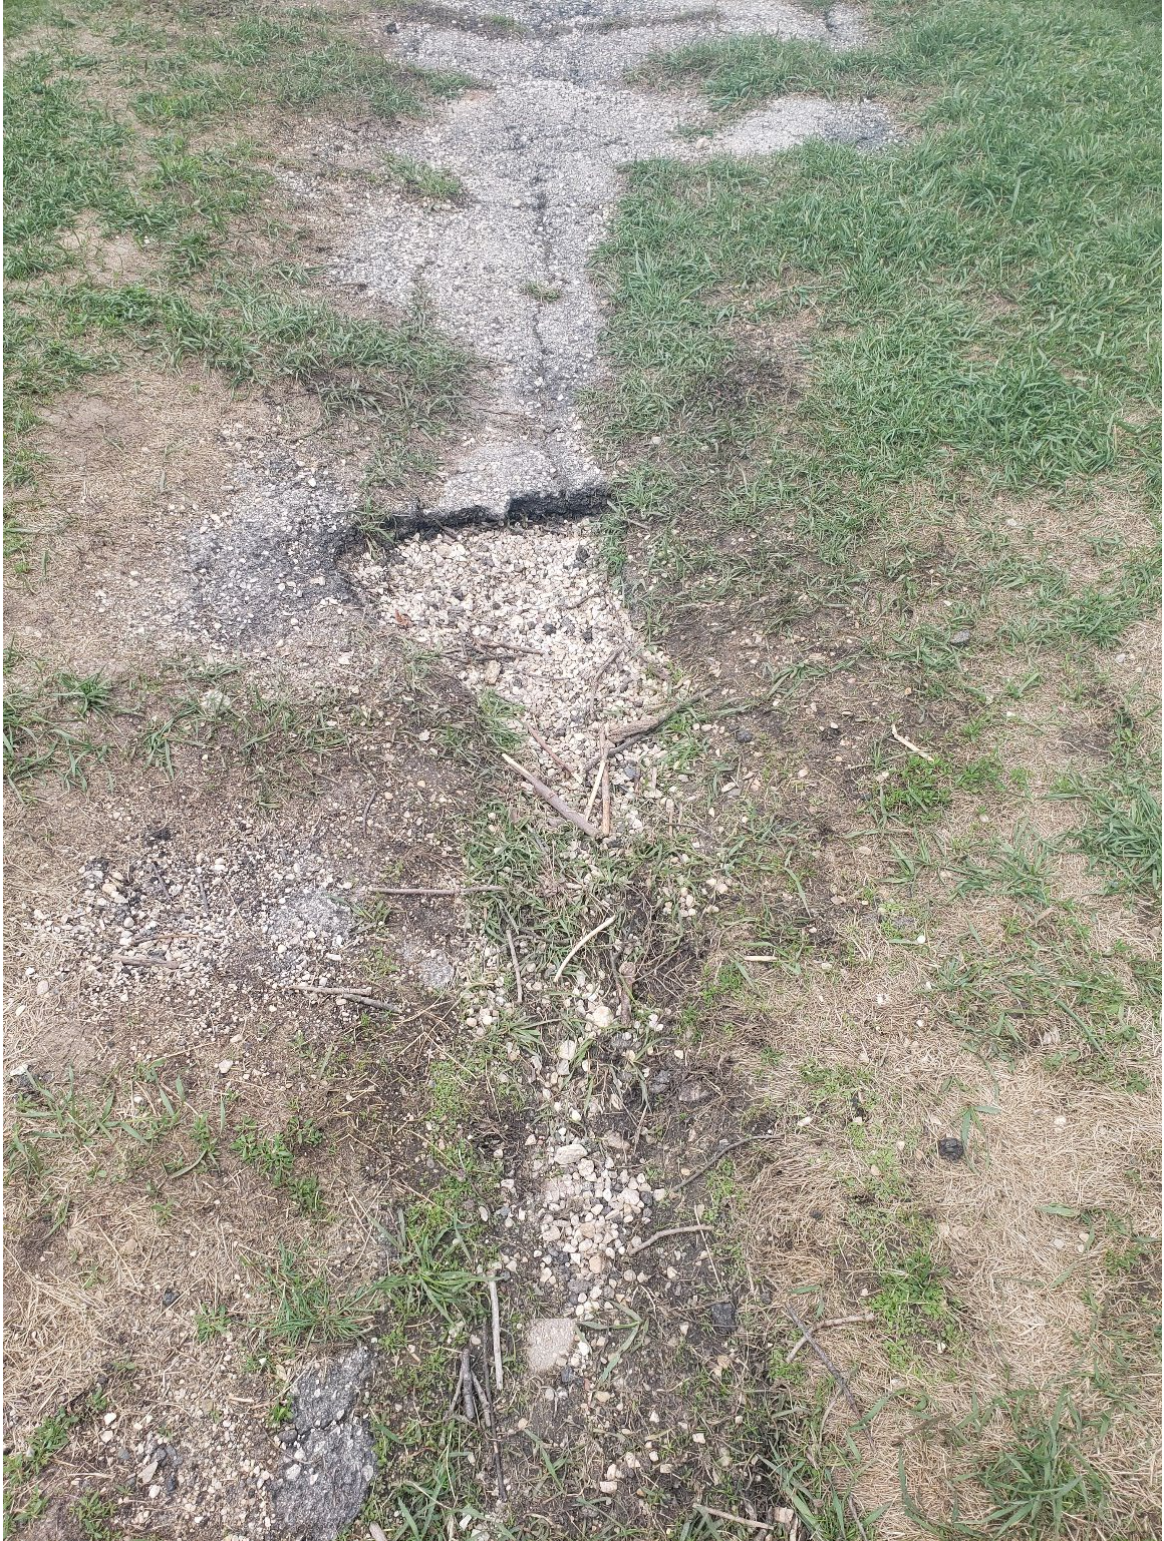
*Figure 16: Swale near NE portion of play yard in poor condition*

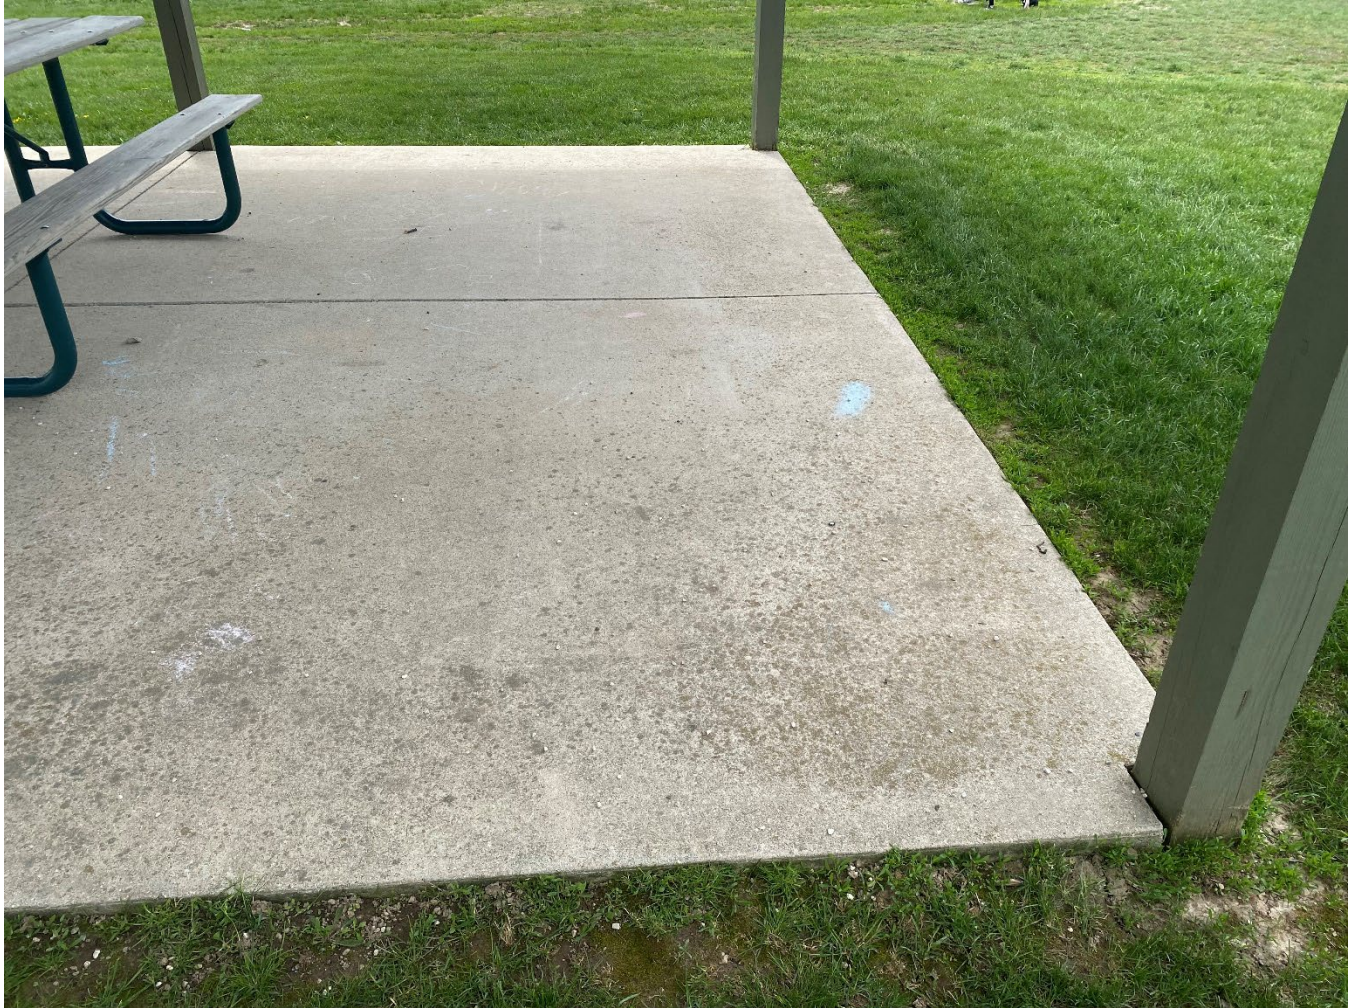
*Figure 17: Concrete picnic table pad in good condition*

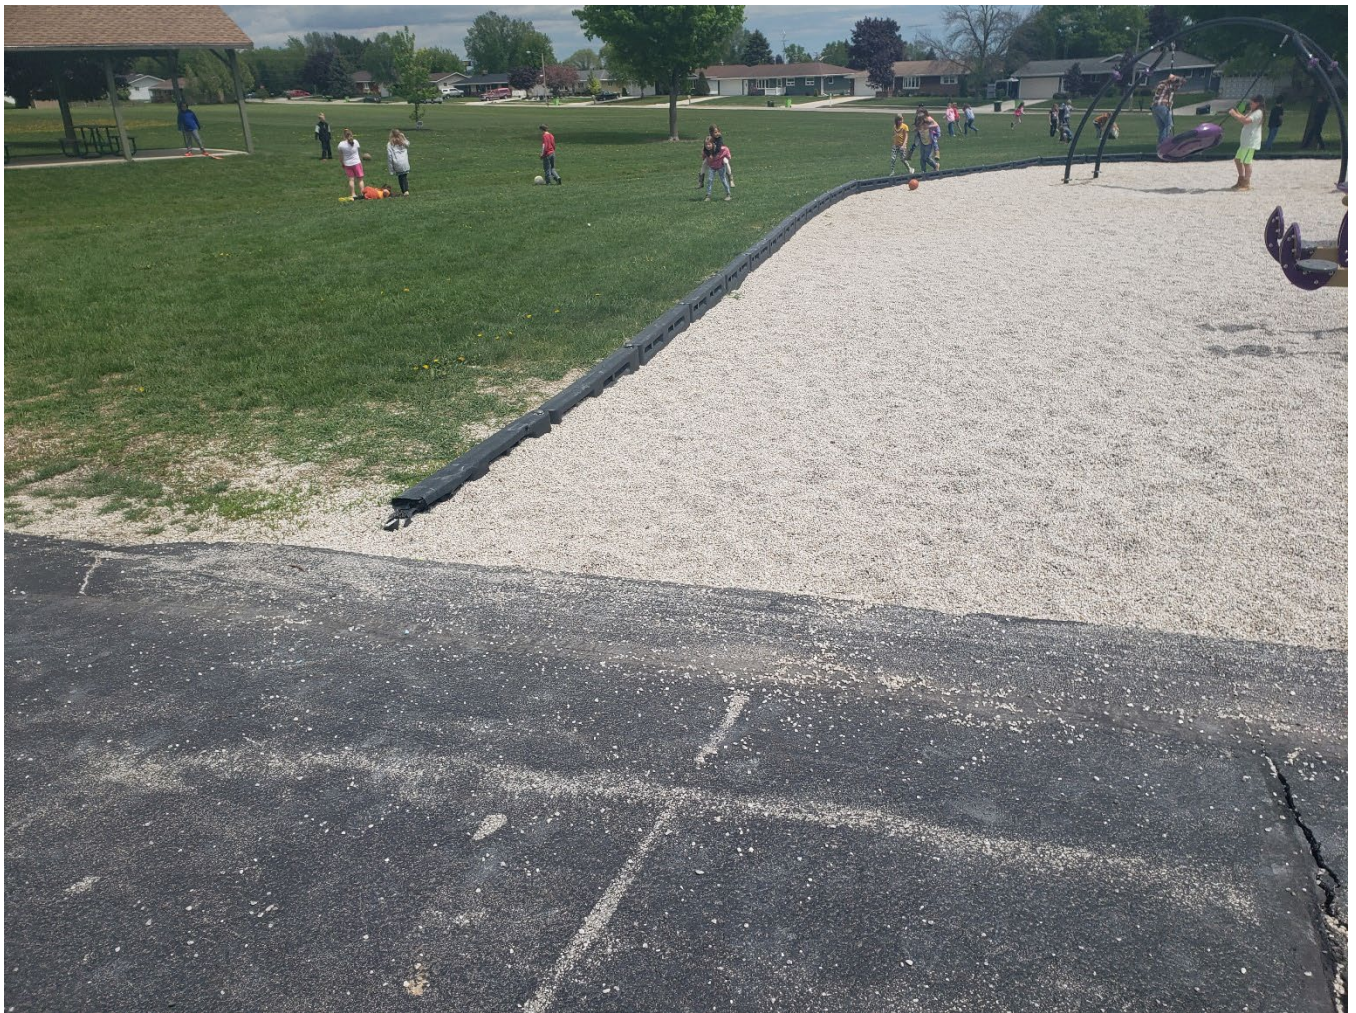
*Figure 22: Gravel play area in good condition*

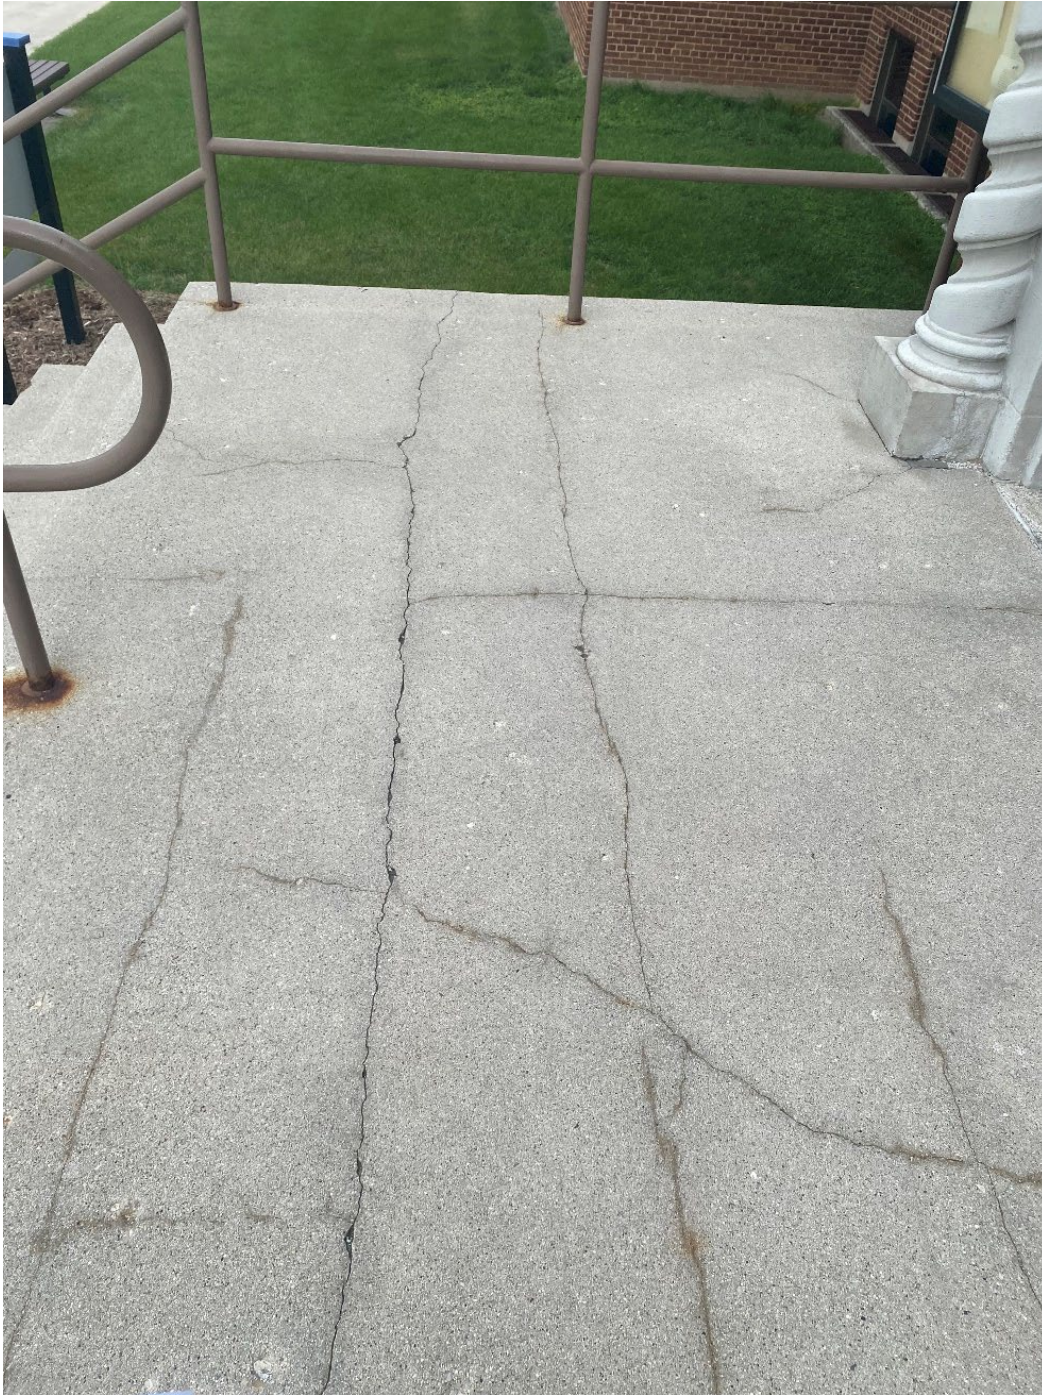
*Figure 14: Top of front center west stair in poor condition.*

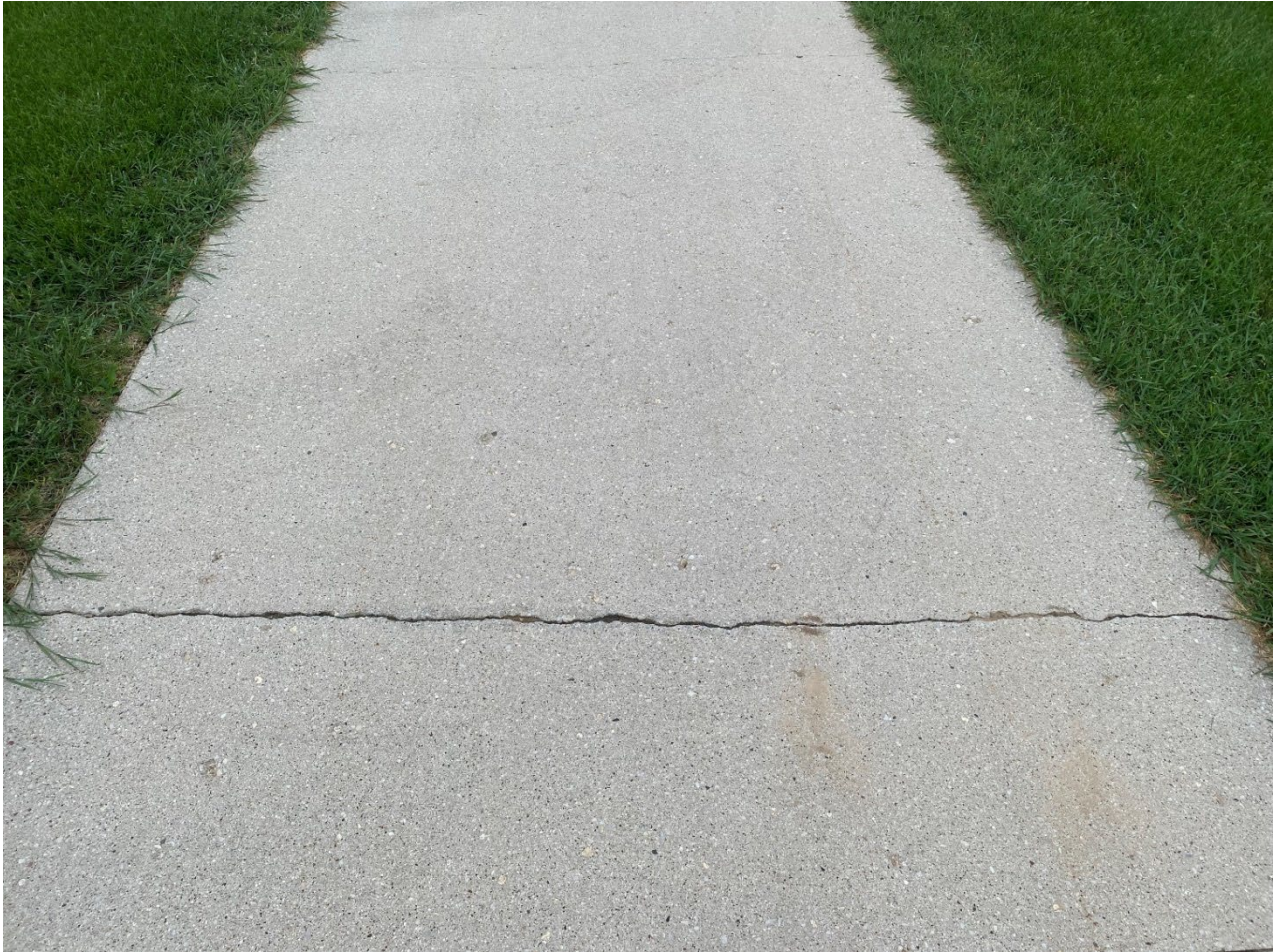
*Figure 15: Horizontal crack in front center west sidewalk.*

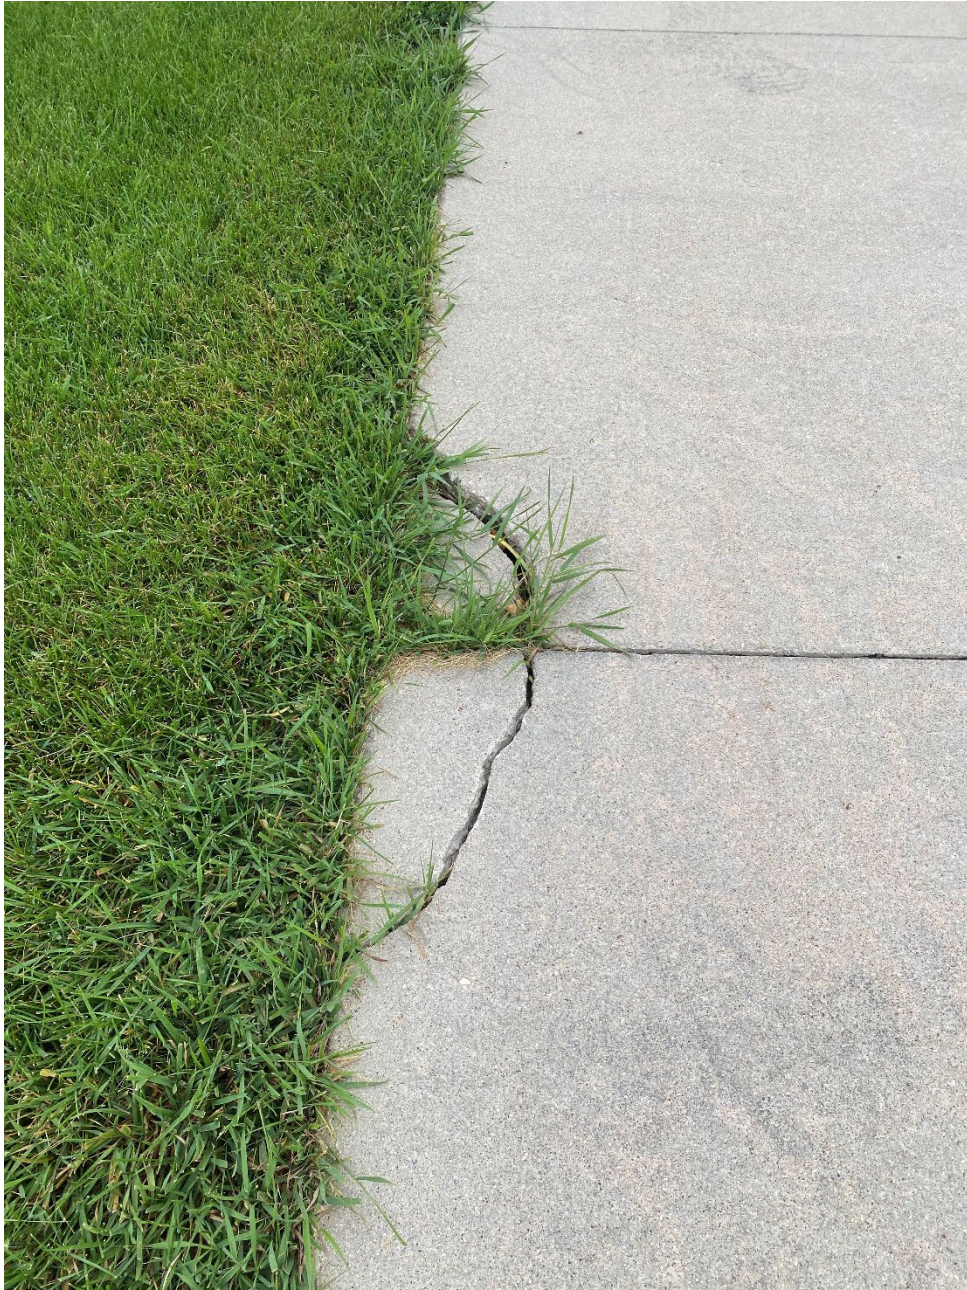
*Figure 17: Corners cracked off front center west concrete sidewalk.*

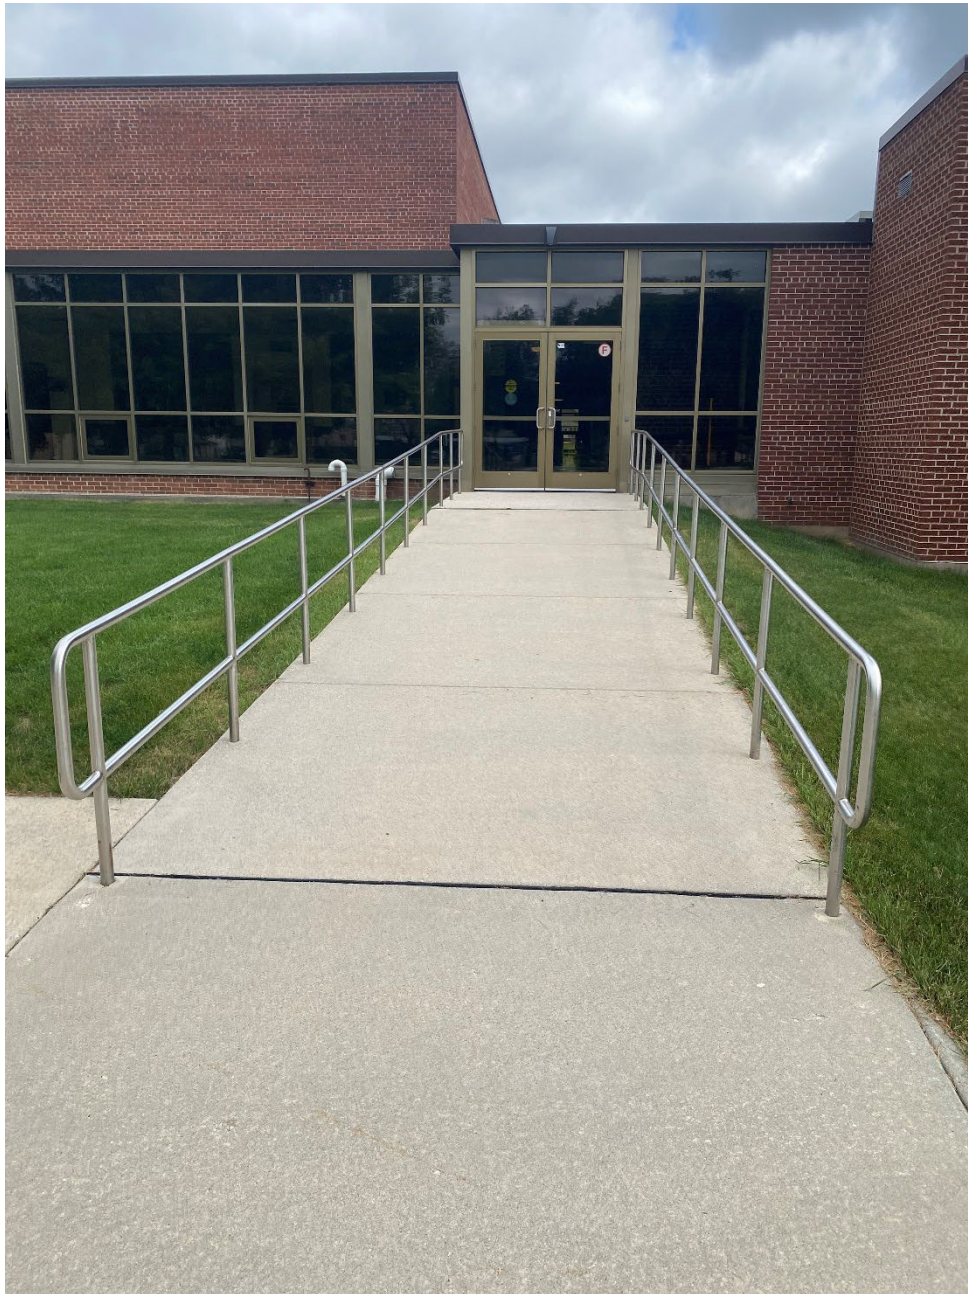
The front concrete ramp is in good to fair condition. The metal railing is in good condition with no rusting (Figure 19). The concrete ramp is in good condition, except for where the railing is attached to the concrete (Figure 20). There is cracked concrete around most of the metal posts, but the cracking is localized to the area around each railing post.

*Figure 19: Front concrete ramp in good to fair condition.*

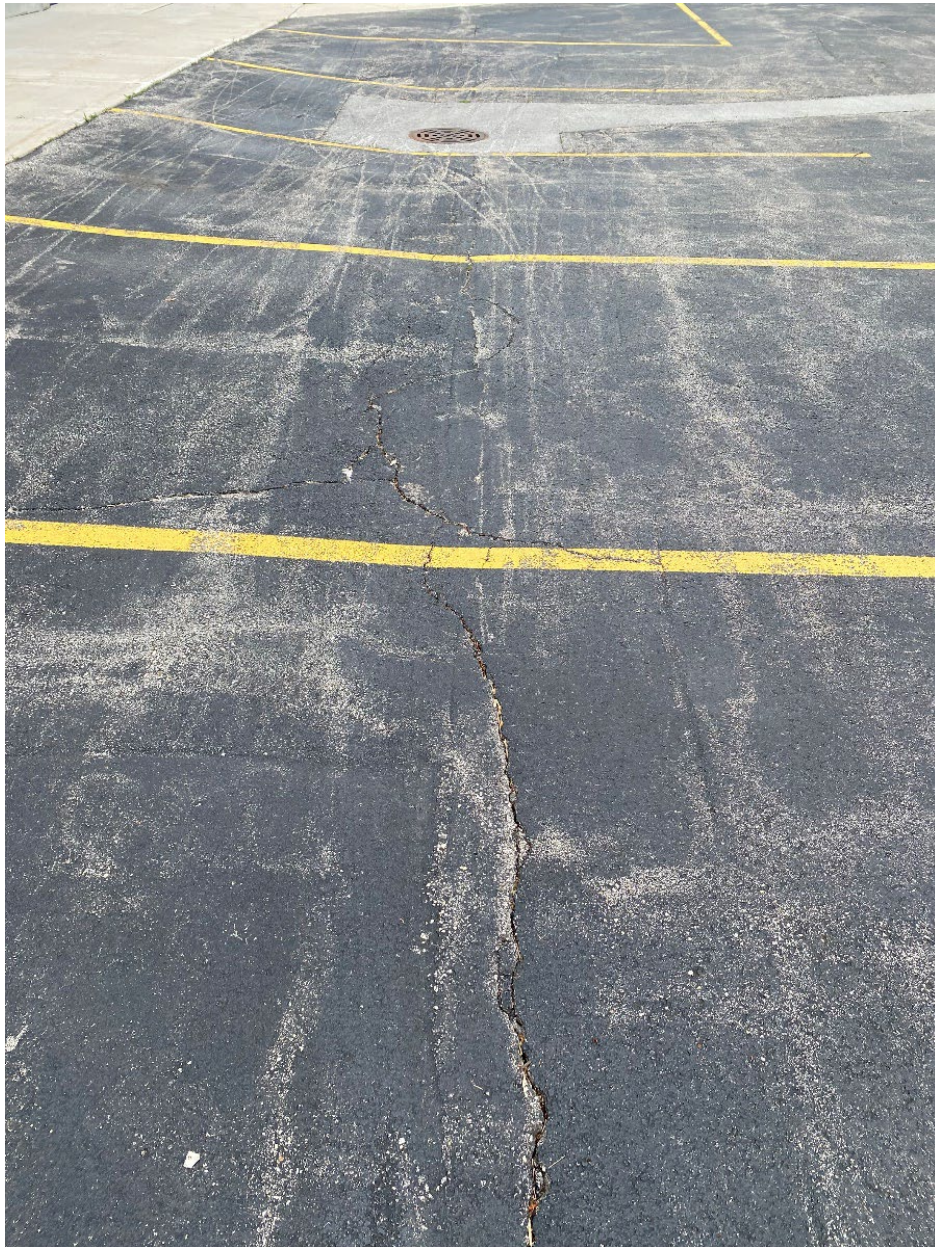
*Figure 75: Longitudinal cracking in northwest parking lot.*

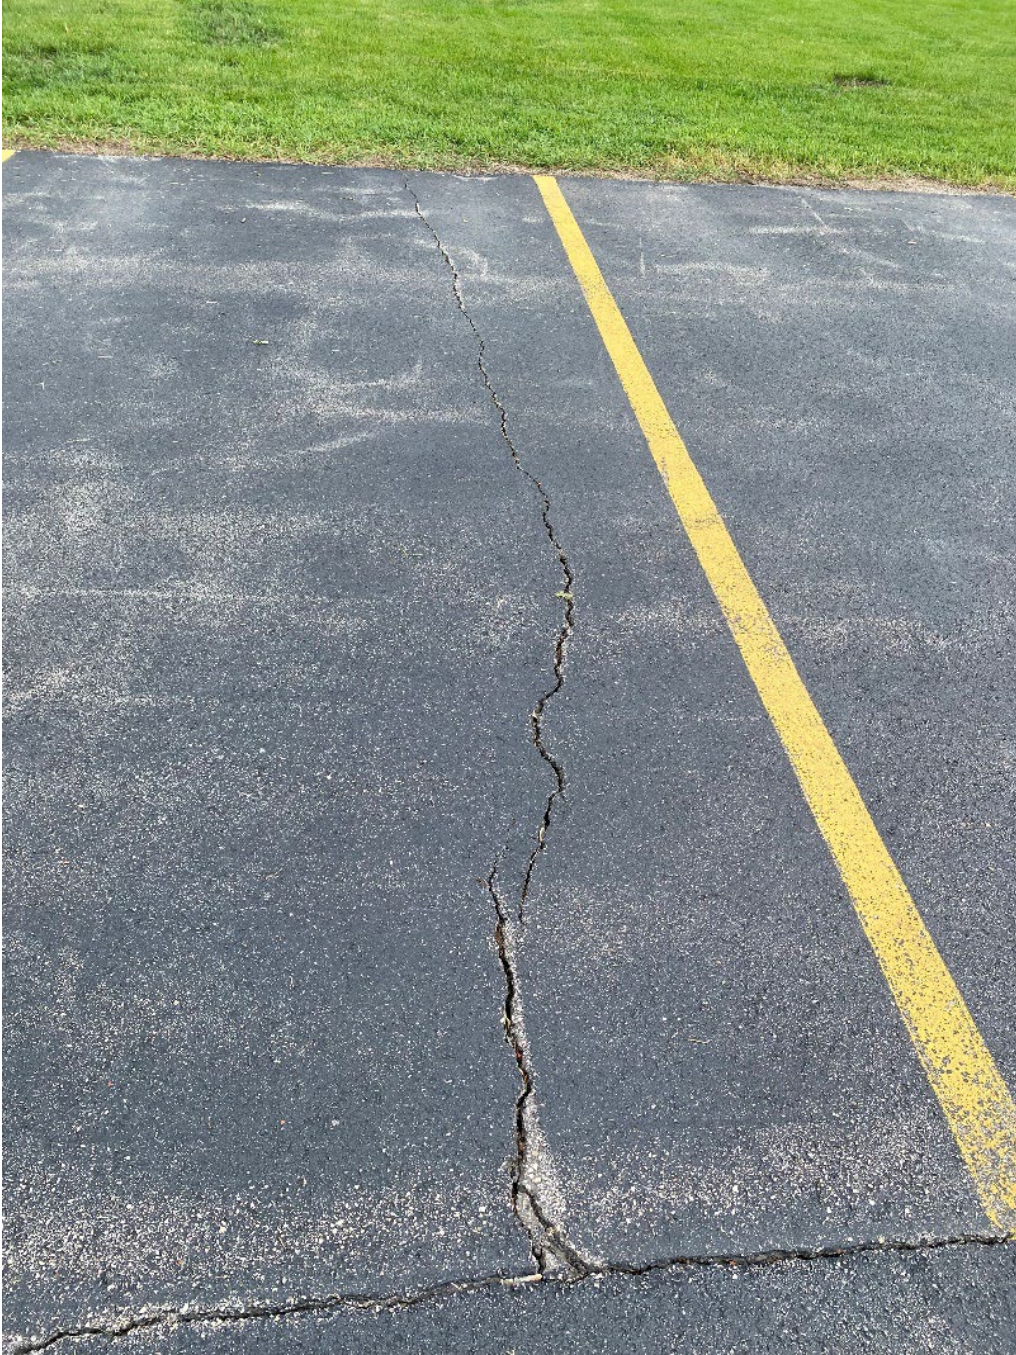
*Figure 86: Longitudinal and transverse cracking in parking stalls in northwest parking lot.*

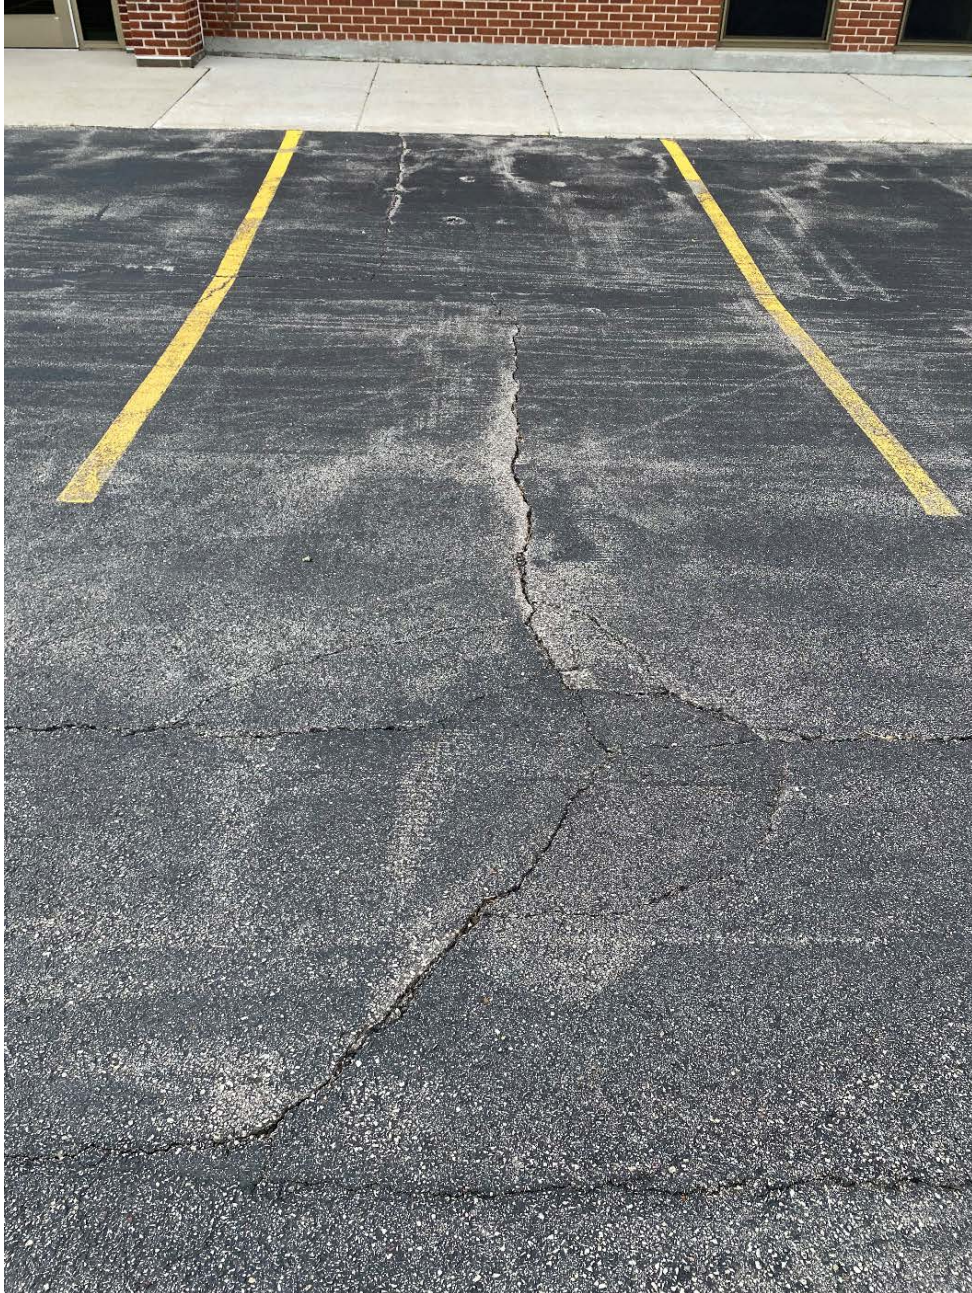
*Figure 37: Cracking and settling in northwest parking lot.*

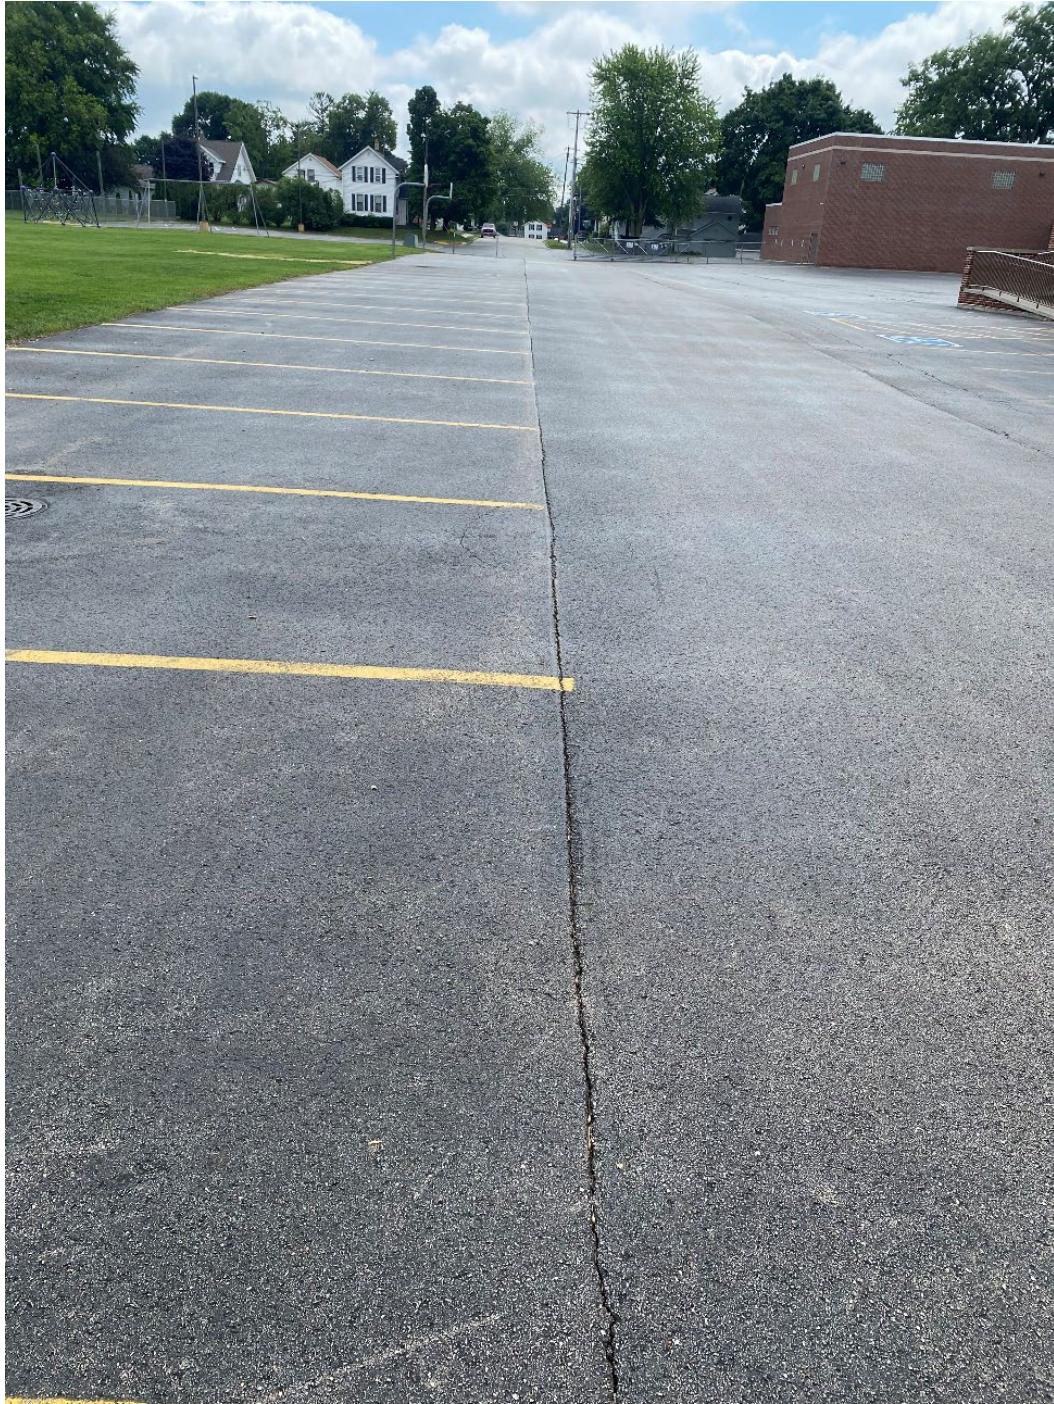
*Figure 38: Newer pavement in drive lane of northwest parking lot in fair condition.*
