# Kiel Area School District

District-wide Facilities Study

# STUDY DOCUMENT

August 2022

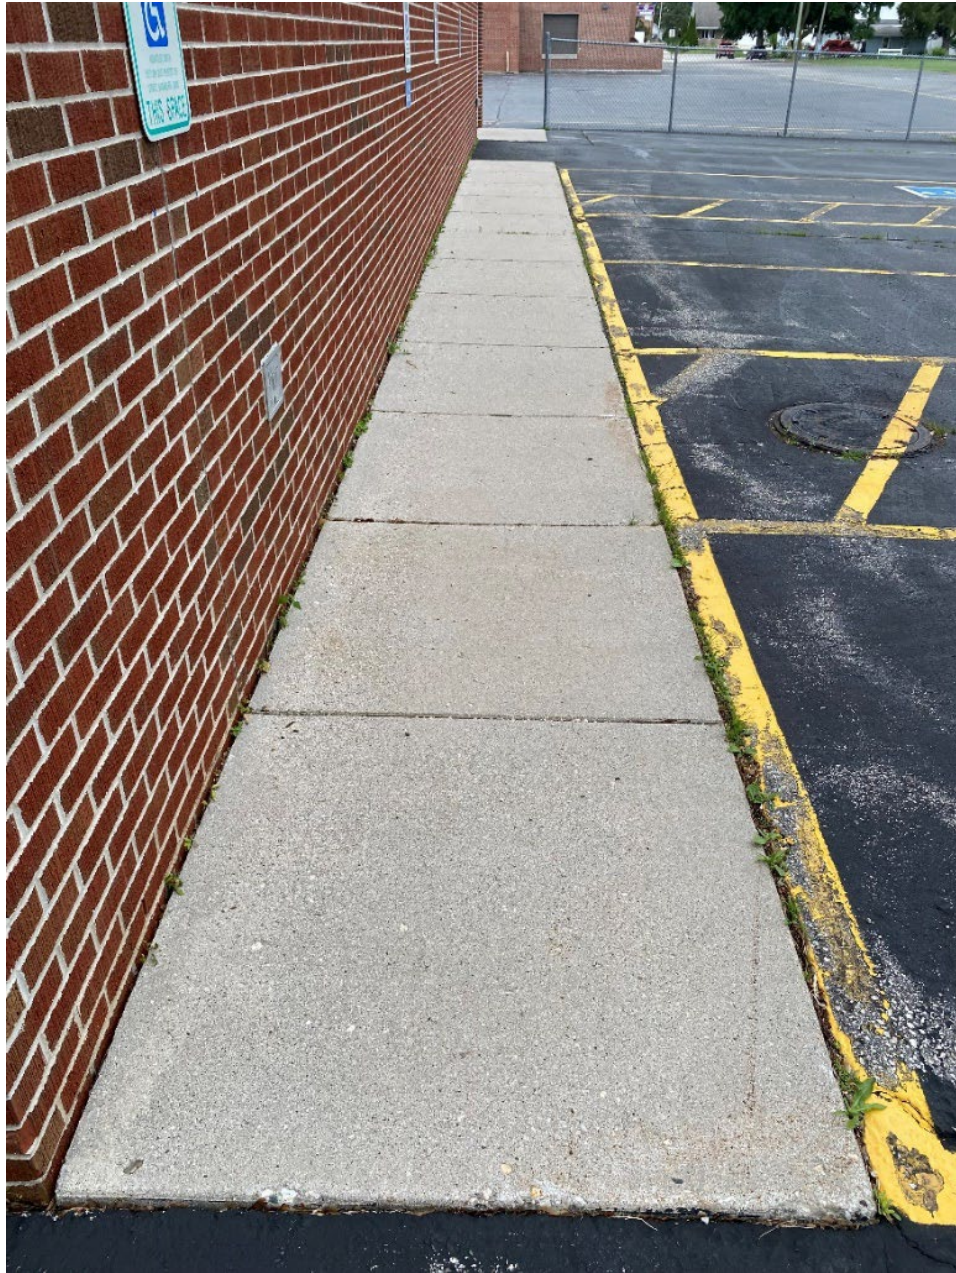
*Figure 51: Concrete sidewalk near back east ADA parking stalls in fair condition.*

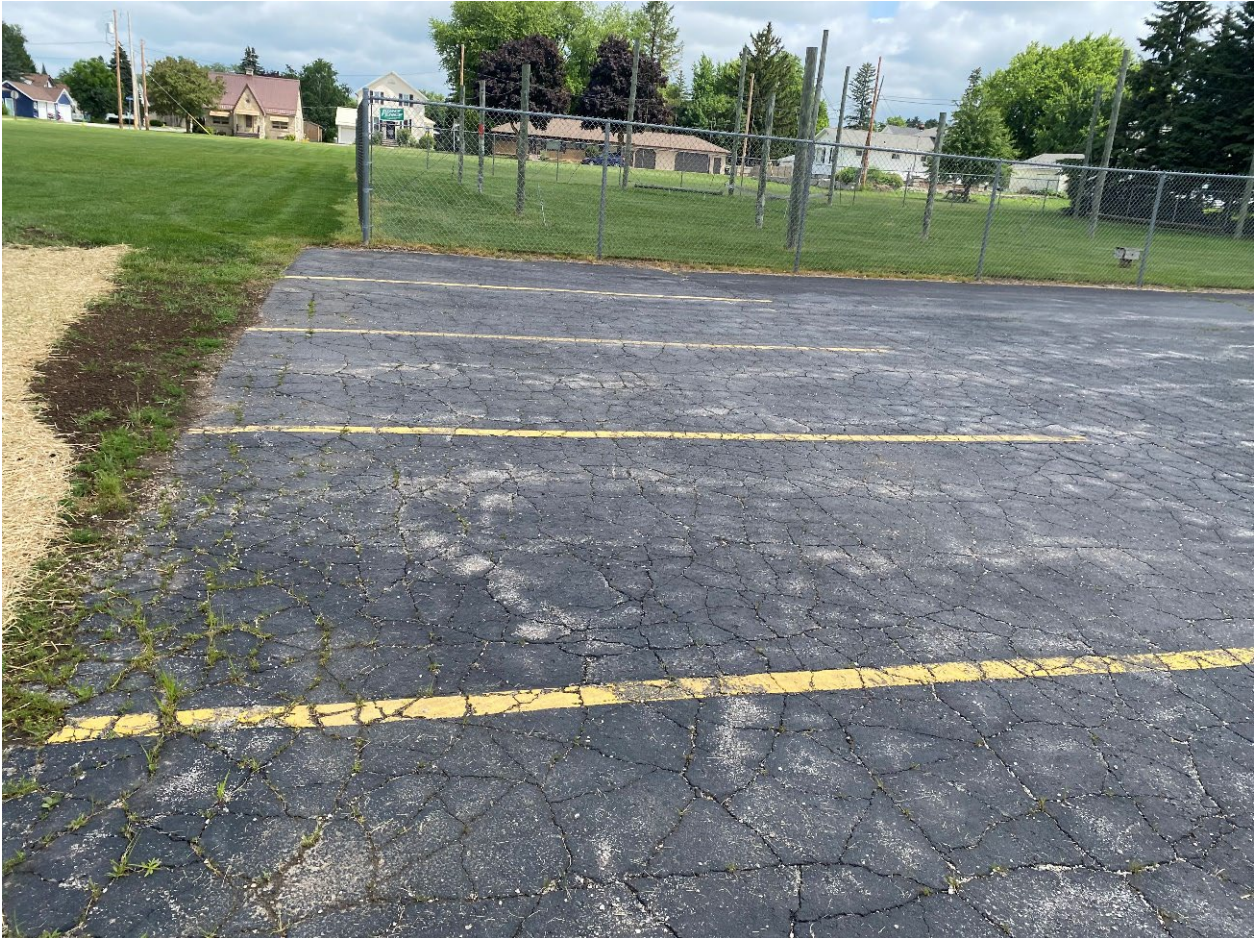
The northeast asphalt parking lot is in very poor condition. The pavement is covered in alligator and block cracks and has grass growing through the cracks (Figure 52&53). The pavement markings are also chipping and fading. There is also settling causing standing water on the pavement in certain spots.

*Figure 52: Northeast parking lot covered in alligator cracking.*

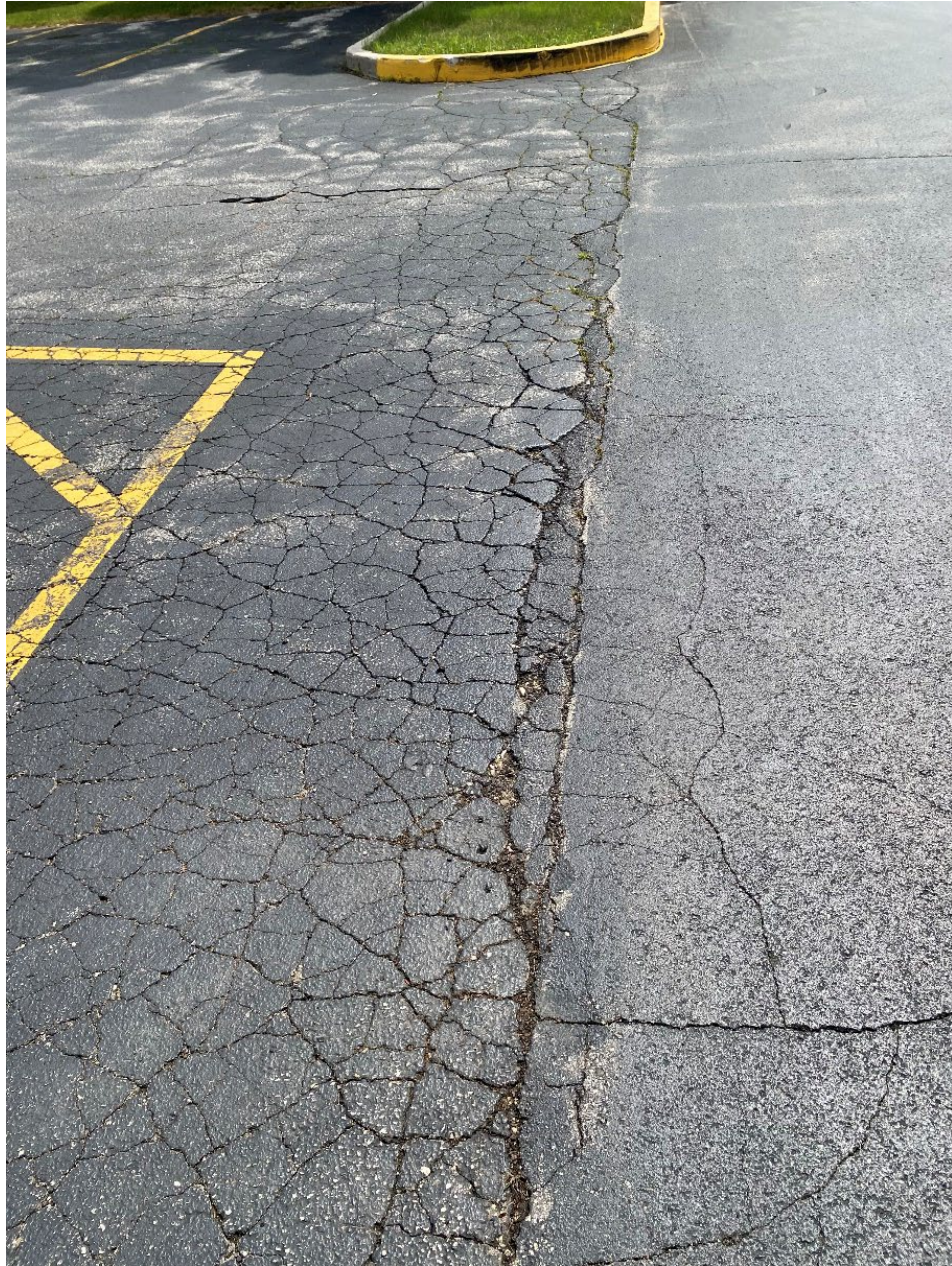
*Figure 53: Alligator cracking near entrance to back northeast parking lot.*

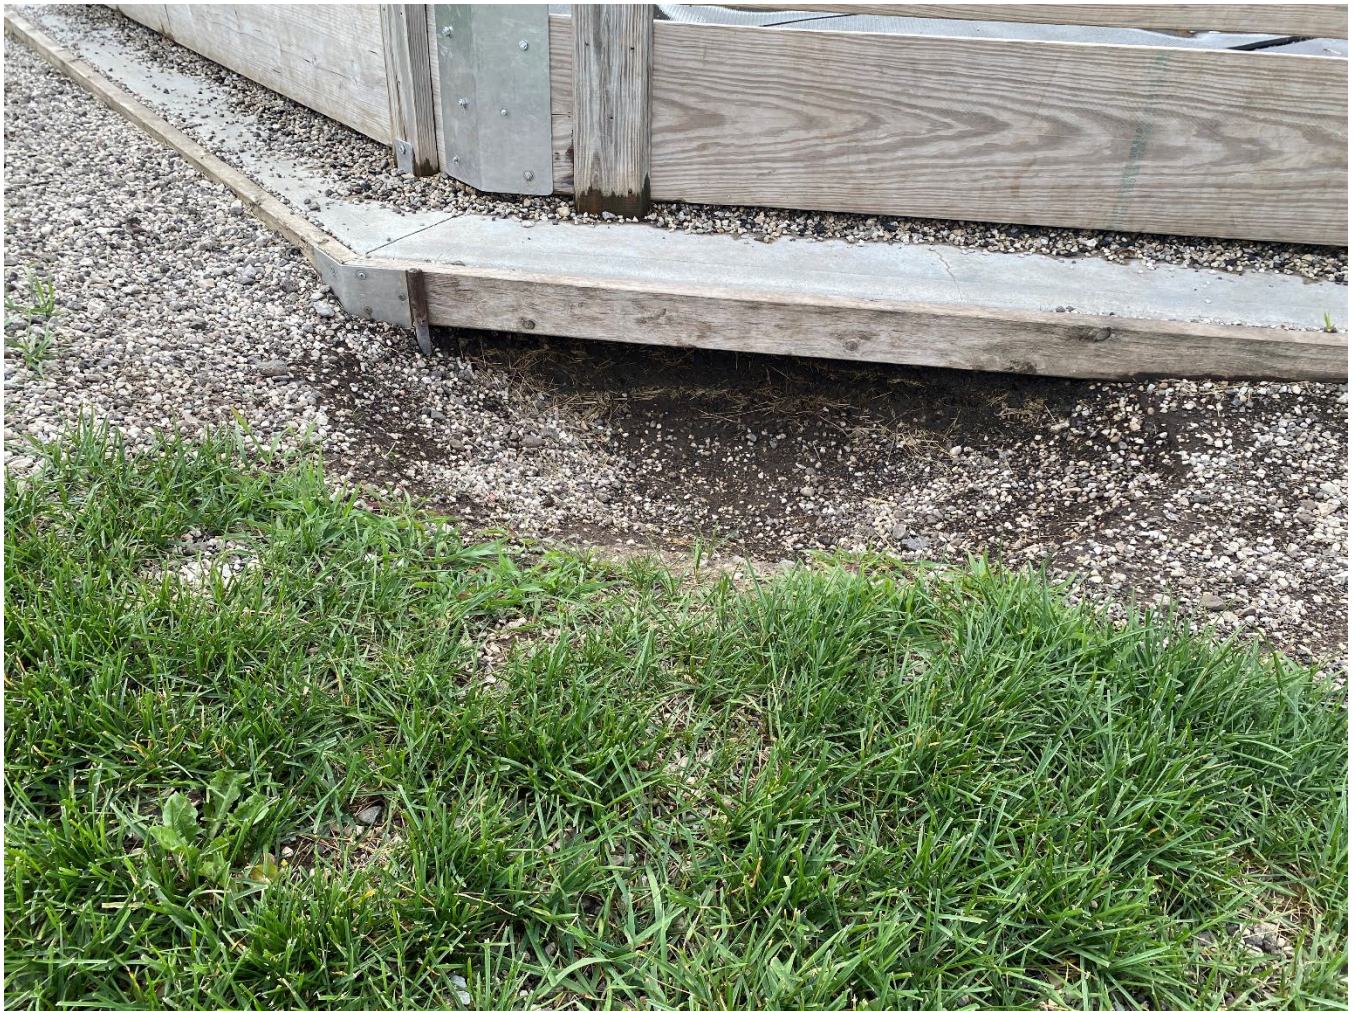
The wooden octagon is in good to fair condition. There was water sitting on the rubber pads inside the enclosure. Some of the gravel base is missing under the concrete pad (Figure 56). There are also some cracks radiating out of the concrete pad (Figure 57). The climbing net is in good condition and looks very new. The swing set is in fair to poor condition due to some of the swings breaking apart (Figure 58).

Figure 56: Missing gravel base under wooden octagon play area.

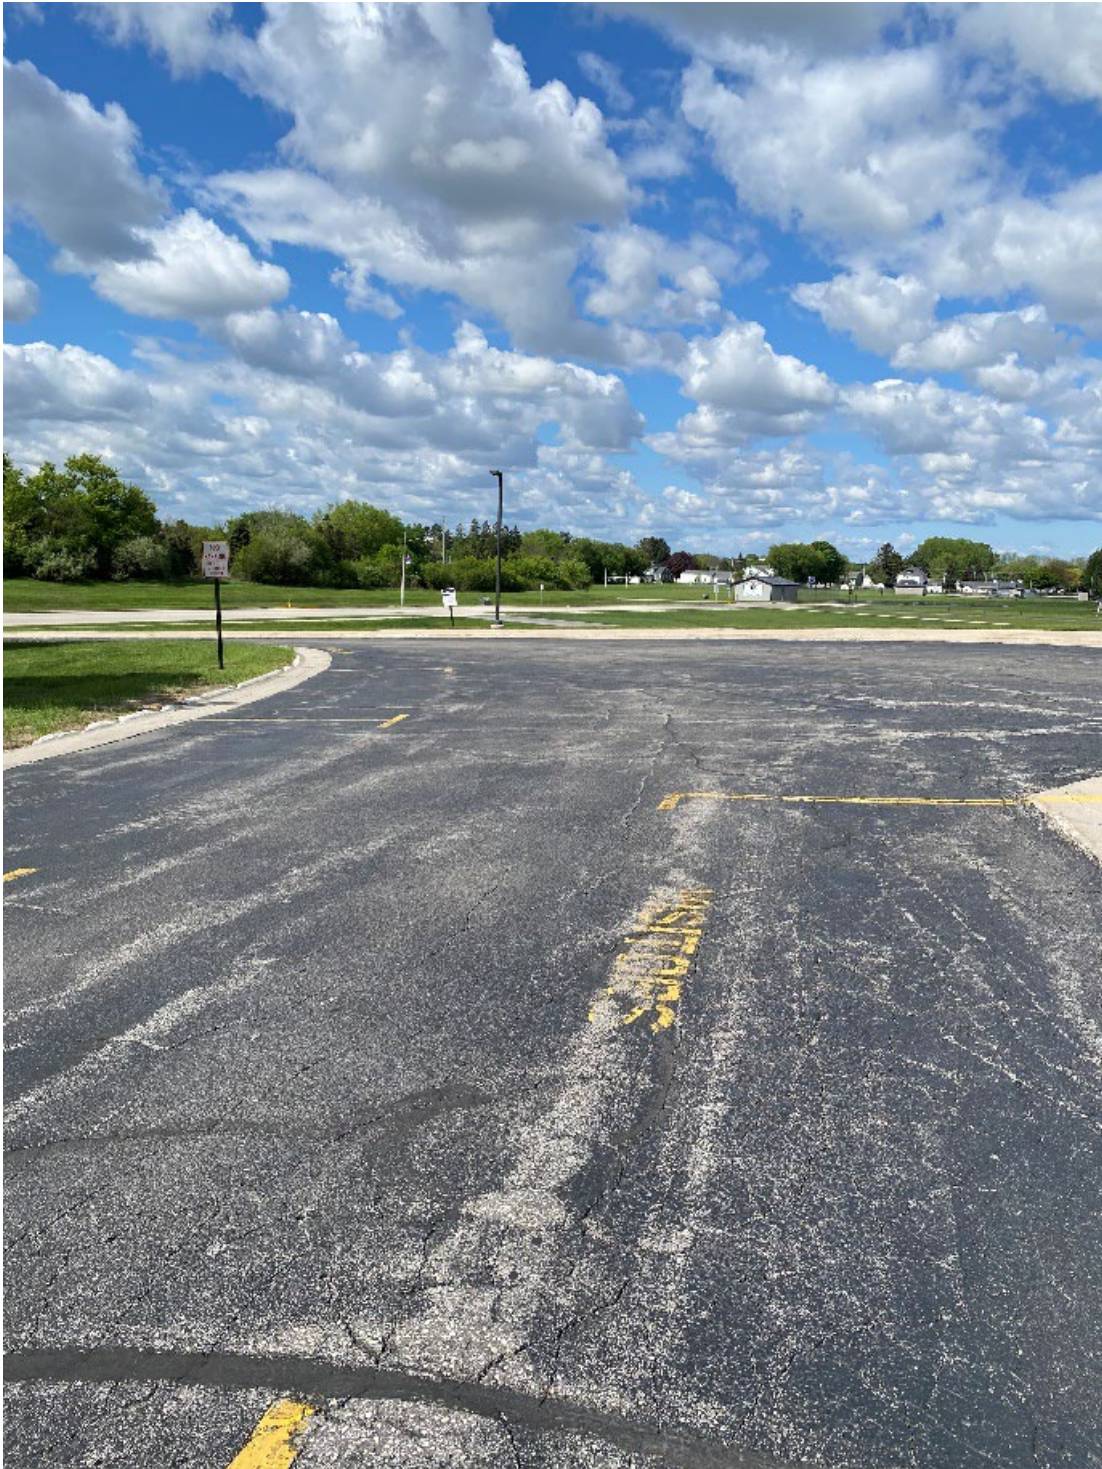
*Figure 3: Faded pavement markings in Bus/Visitor Parking Loop.*

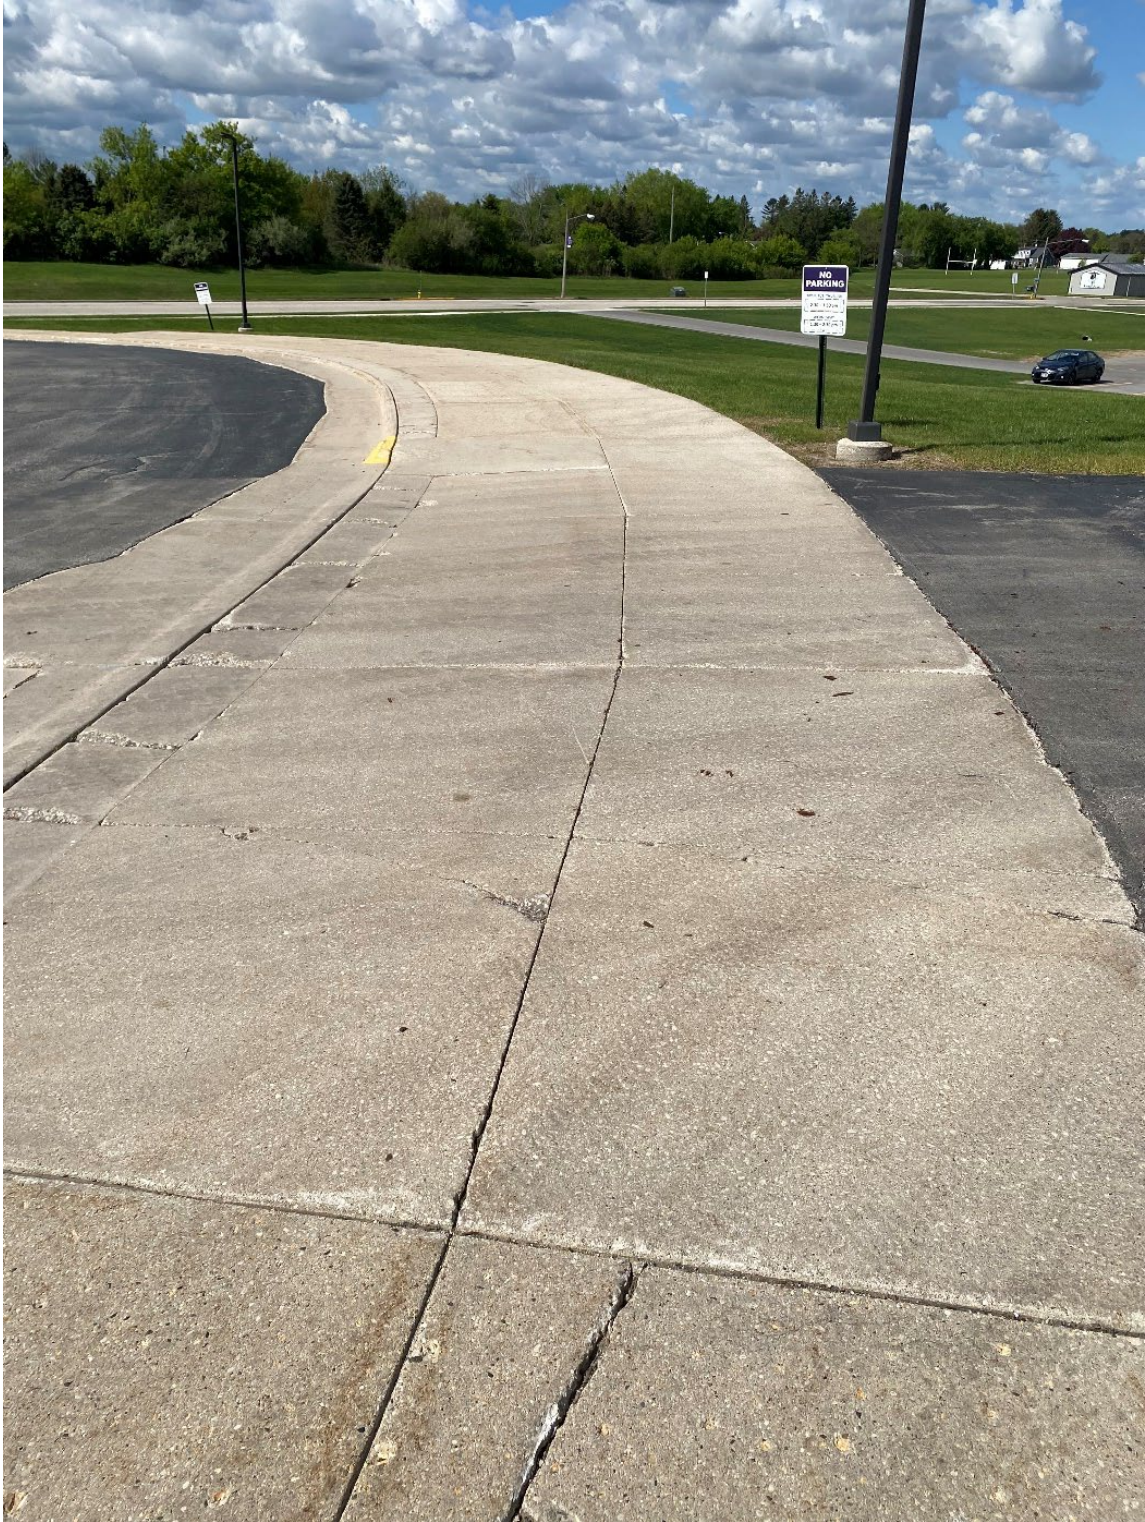
Figure 6: Cracked concrete sidewalk driveway apron into garbage dumpster area along Bus/Visitor Parking Loop.

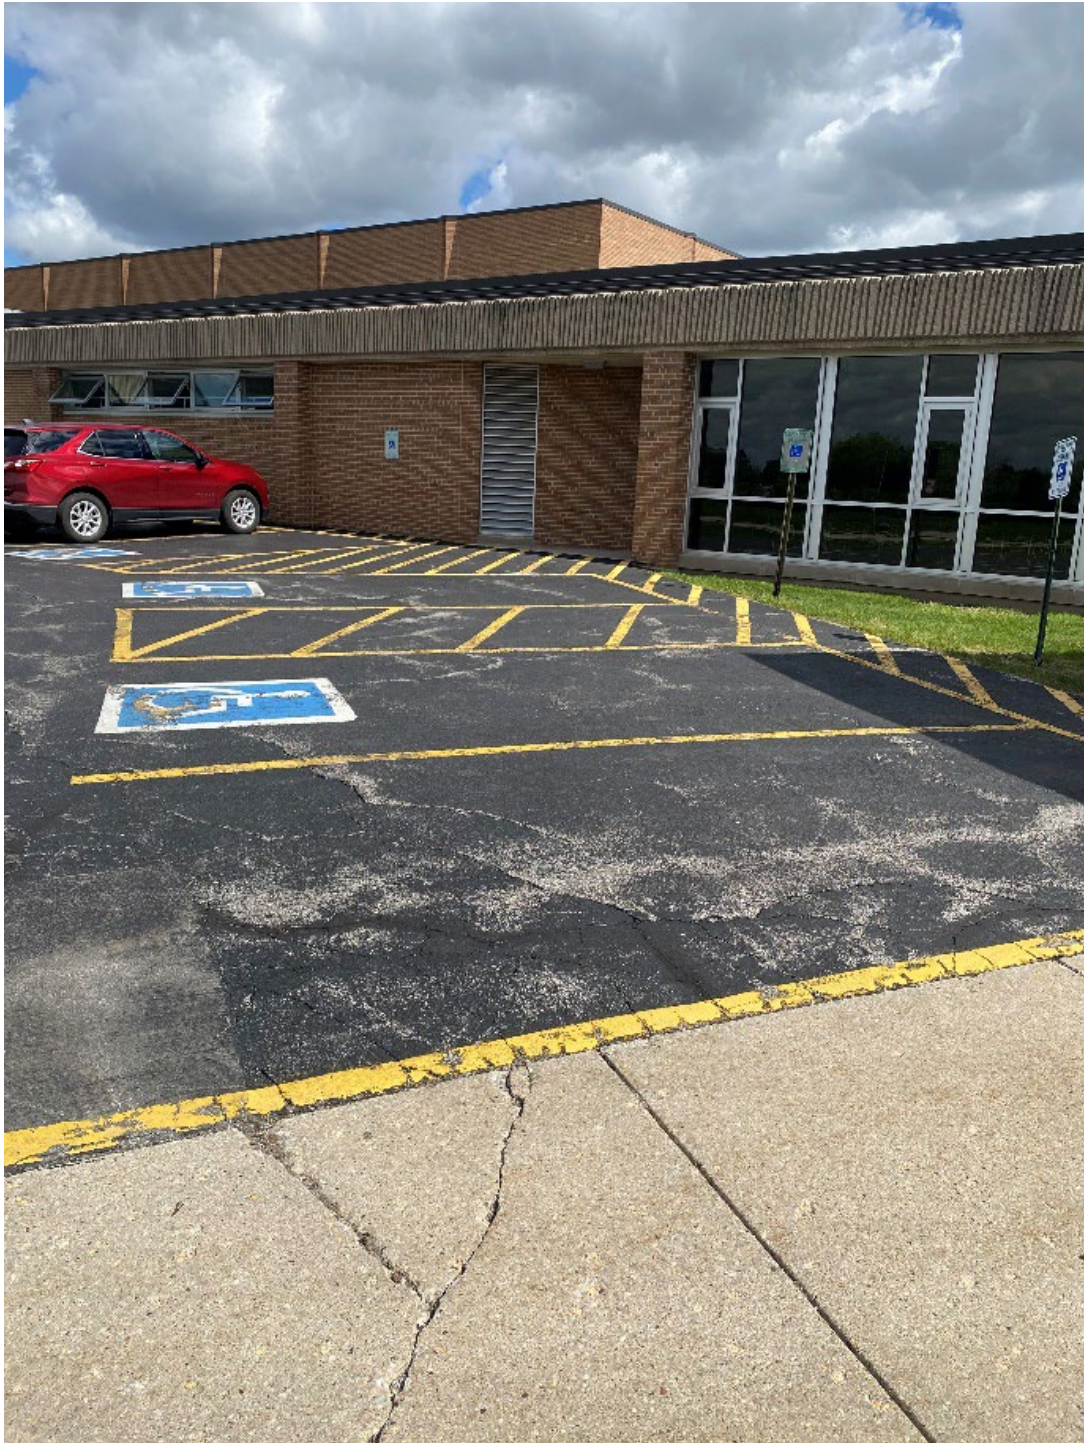
*Figure 8: Pavement markings and signposts in poor condition in the Garbage Dumpster Parking Lot.*

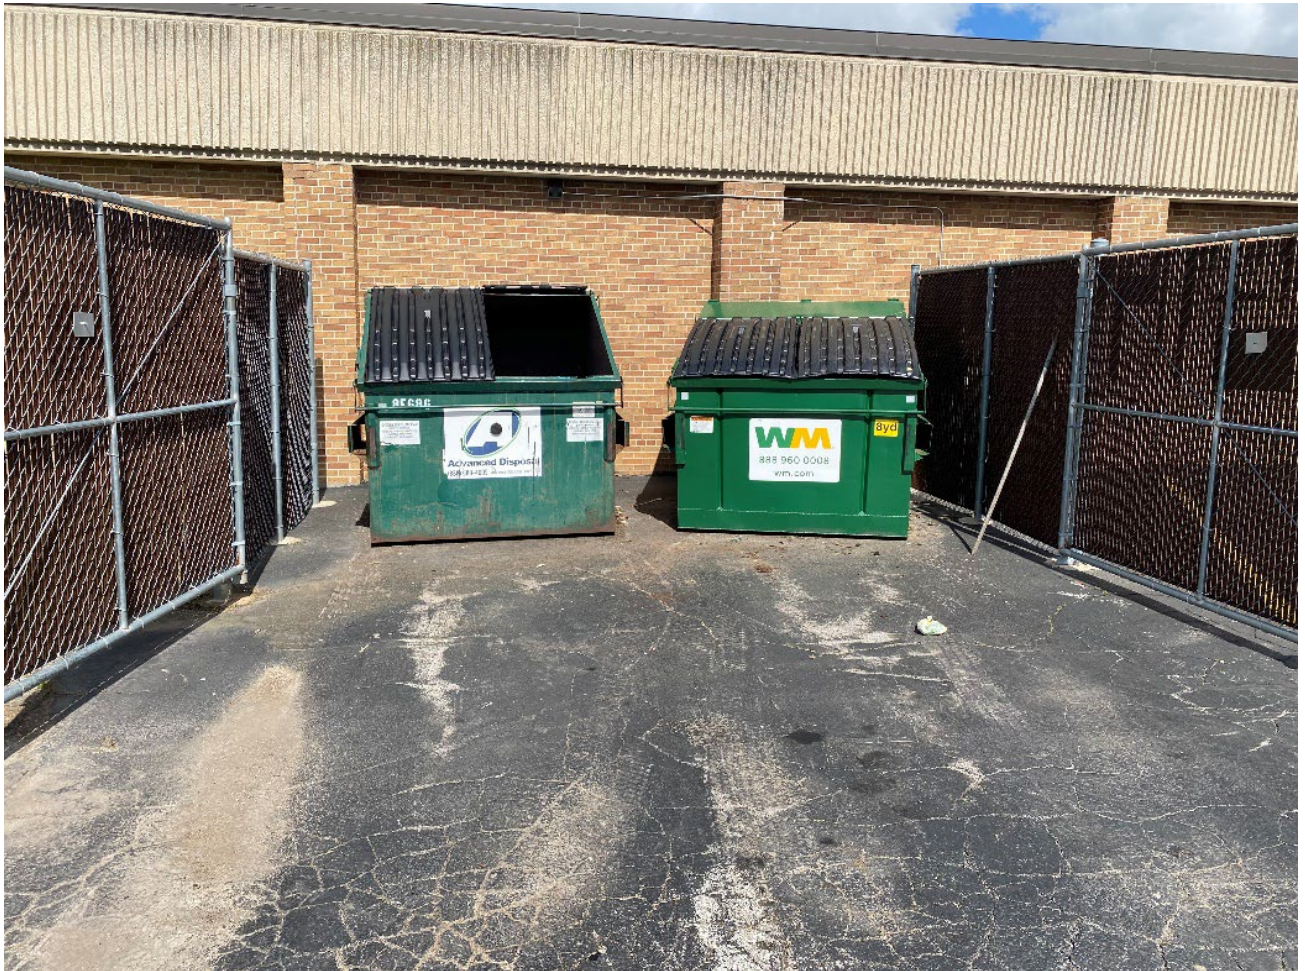
Figure 9: Dumpster enclosure fencing in good condition.

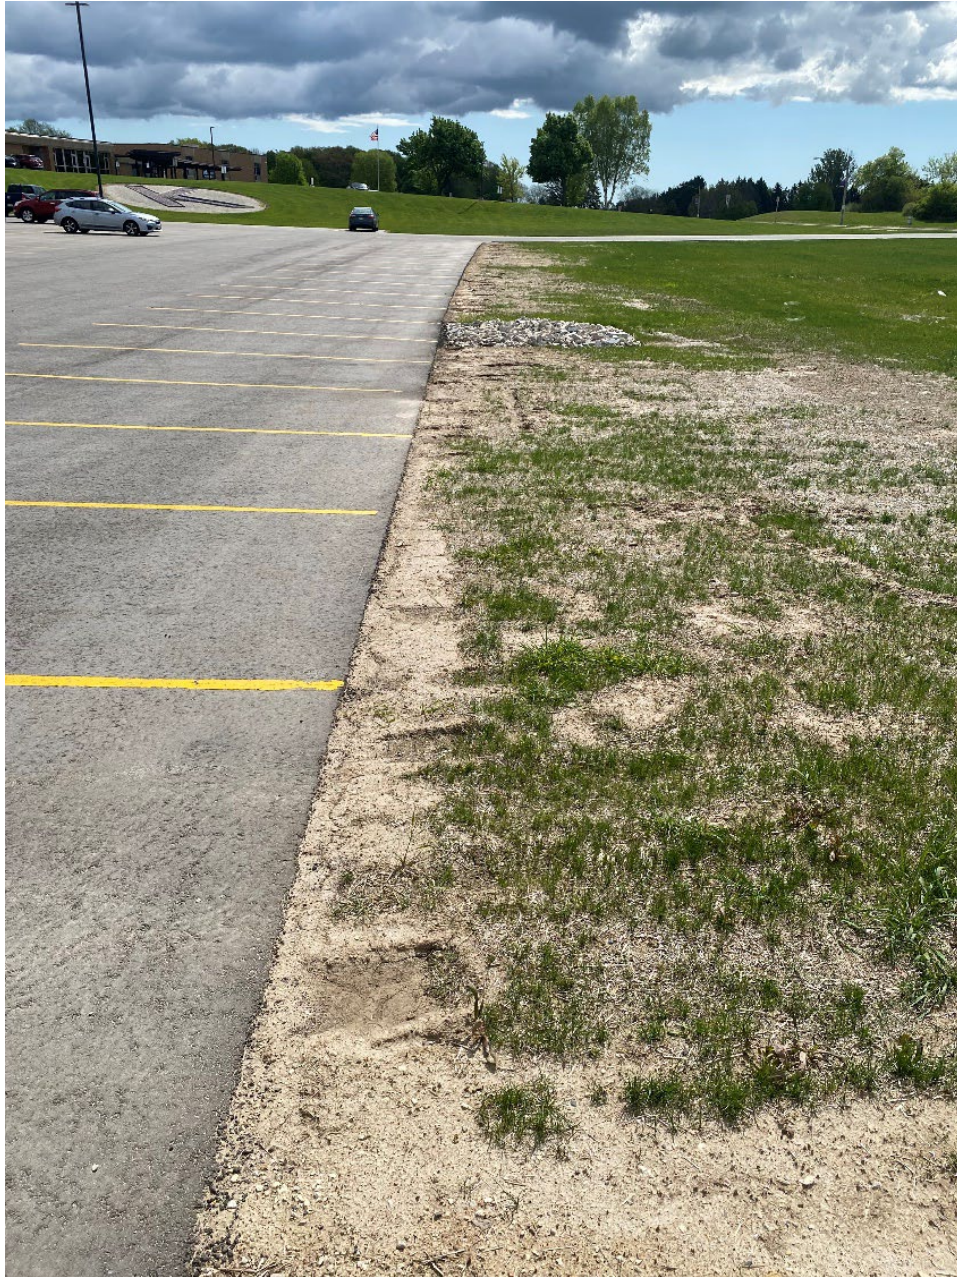
*Figure 10: Erosion and dead grass on south end of PAC Parking*

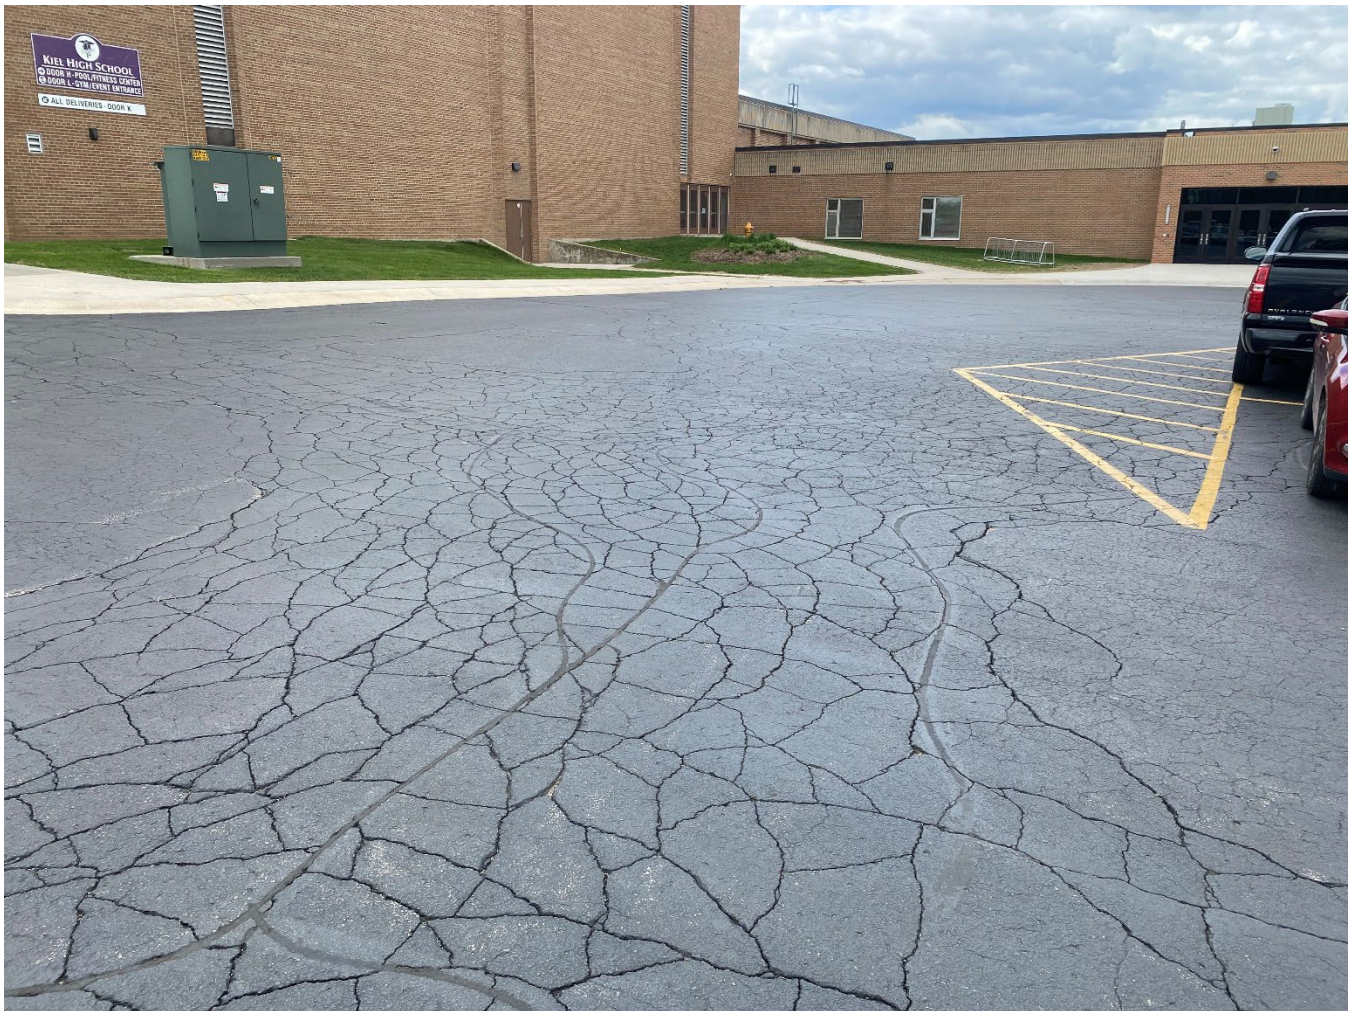
The Student Parking Lot consists of asphalt pavement and concrete sidewalk and curb and gutter. The asphalt pavement in the south drive lane and accessible stalls appears to have been replaced during the 2020 school addition and is in excellent condition. The bus parking stalls along the west side of the lot appear newer and are in good to fair condition. The remainder of the asphalt pavement in the lot is older and in poor condition. There is alligator and block cracking occurring in throughout the whole parking lot (Figure 14). There are also longitudinal and transverse cracks. The pavement around the shed is in fair condition (Figure 15). The concrete sidewalk and curb and gutter that was added in 2020 along the north and west sides of the PAC addition is in excellent condition. The concrete sidewalk and curb along the stadium are also in excellent condition. The older concrete sidewalks along the parking lot are in good to fair condition (Figure 16). There is minimal cracking, but there is some settlement and separation in slabs causing some slabs to be higher than others. However, the concrete sidewalk and curb around the greenhouse is in poor condition due to cracking, chipping, and settling in slabs (Figure 17). The pavement markings are in fair to poor condition due to fading and chipping paint.

Figure 14: Alligator cracking in Student Parking Lot

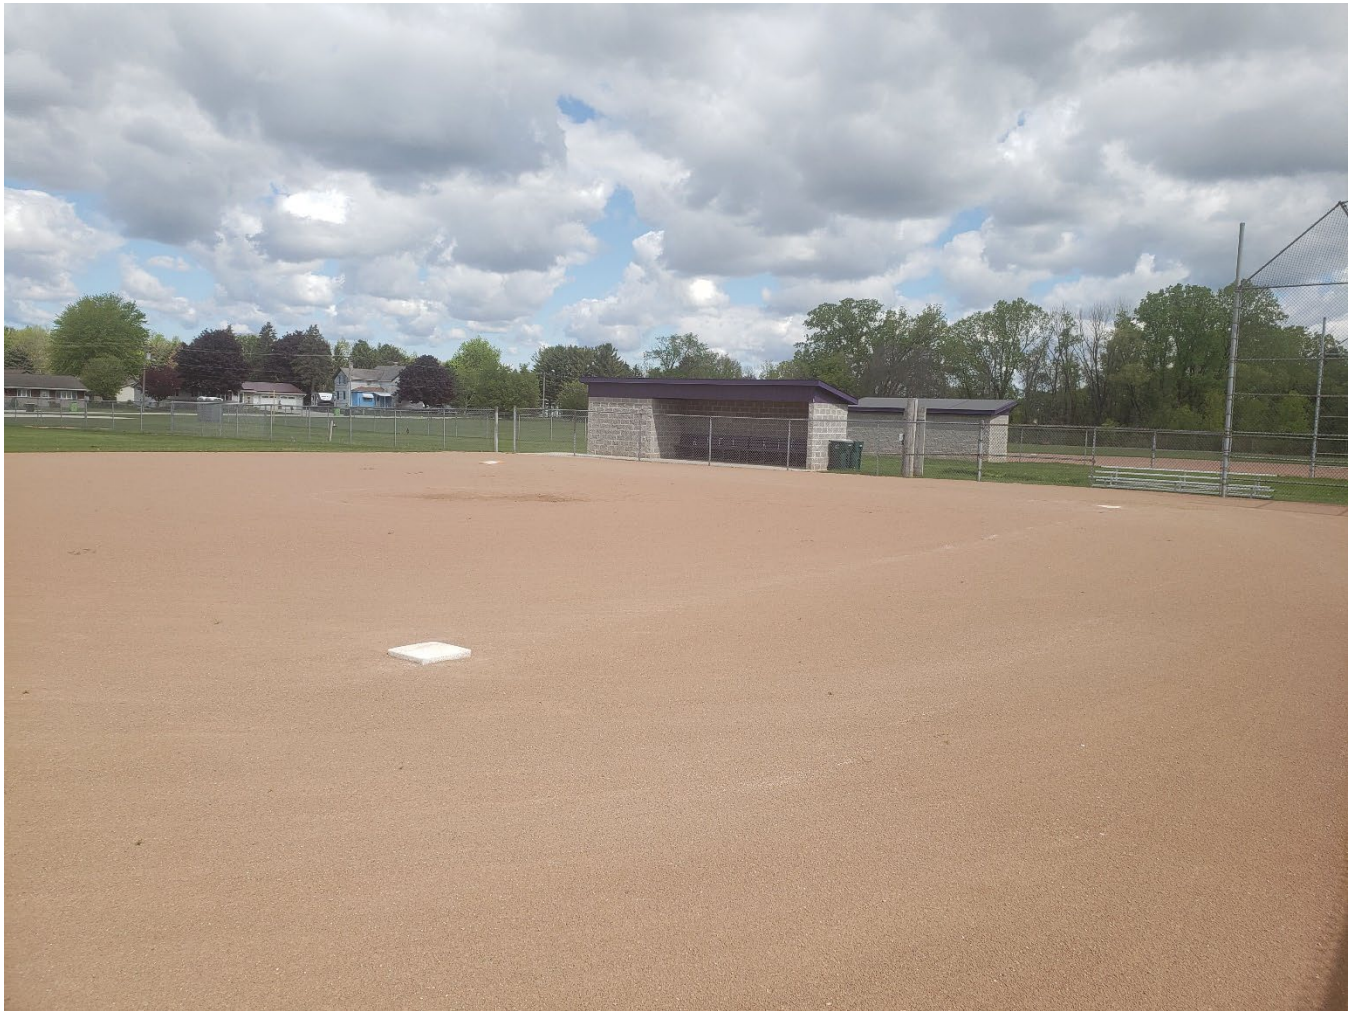
The two practice baseball fields consist of fields, fencing, dugouts and standalone metal bleachers. The fields are in good condition and appear well groomed (Figure 26). The dugouts appear to be newer, and the concrete pads are in good condition. There is a water fountain between the two fields that is in poor condition, due to it being anchored to a tilted board (Figure 27). The fencing requires some maintenance due to rusting posts, unravelling at the bottom, and tilting (Figure 28).

*Figure 26: Practice baseball field in good condition.*

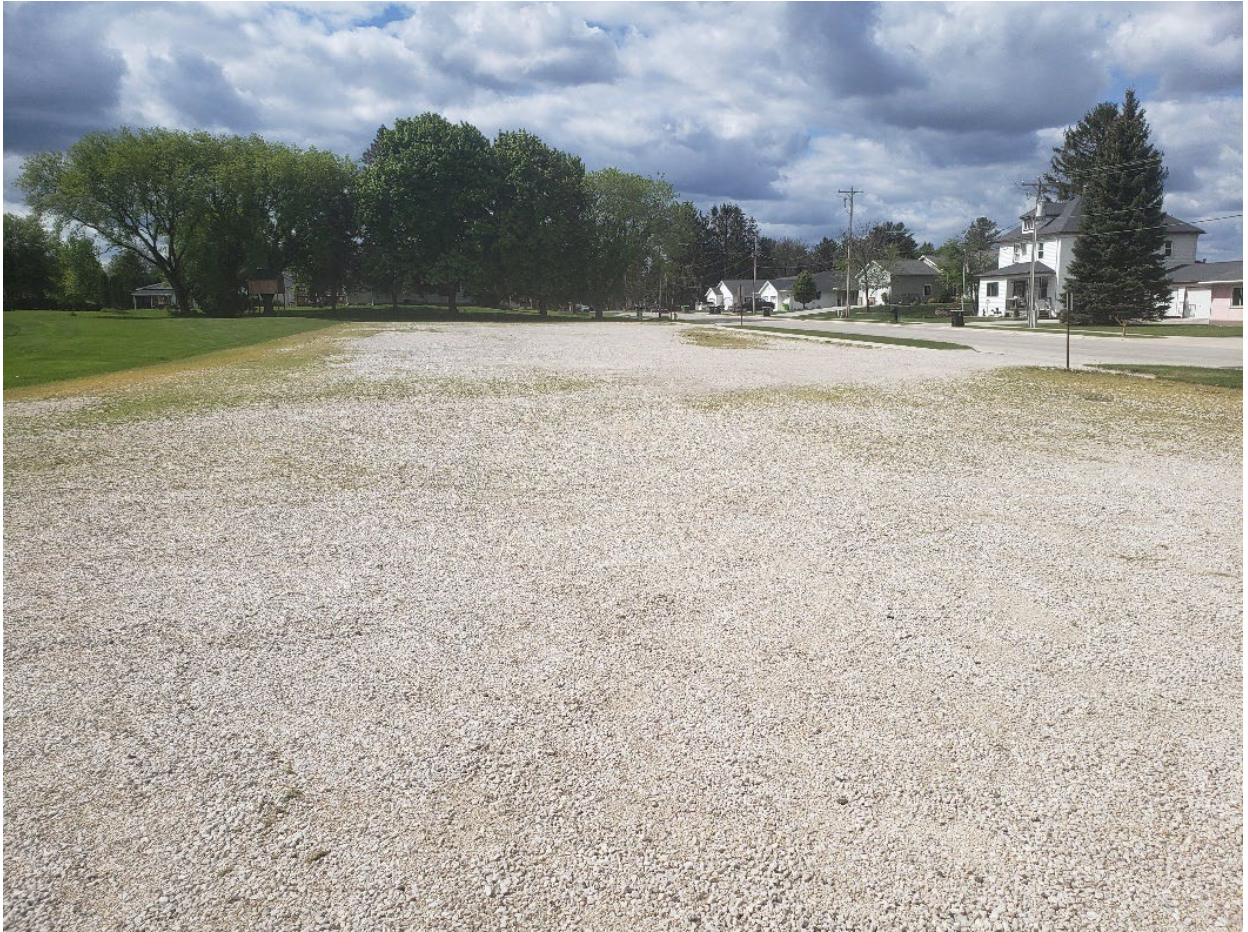
*Figure 30: Gravel parking lot on South in good condition despite green growth.*

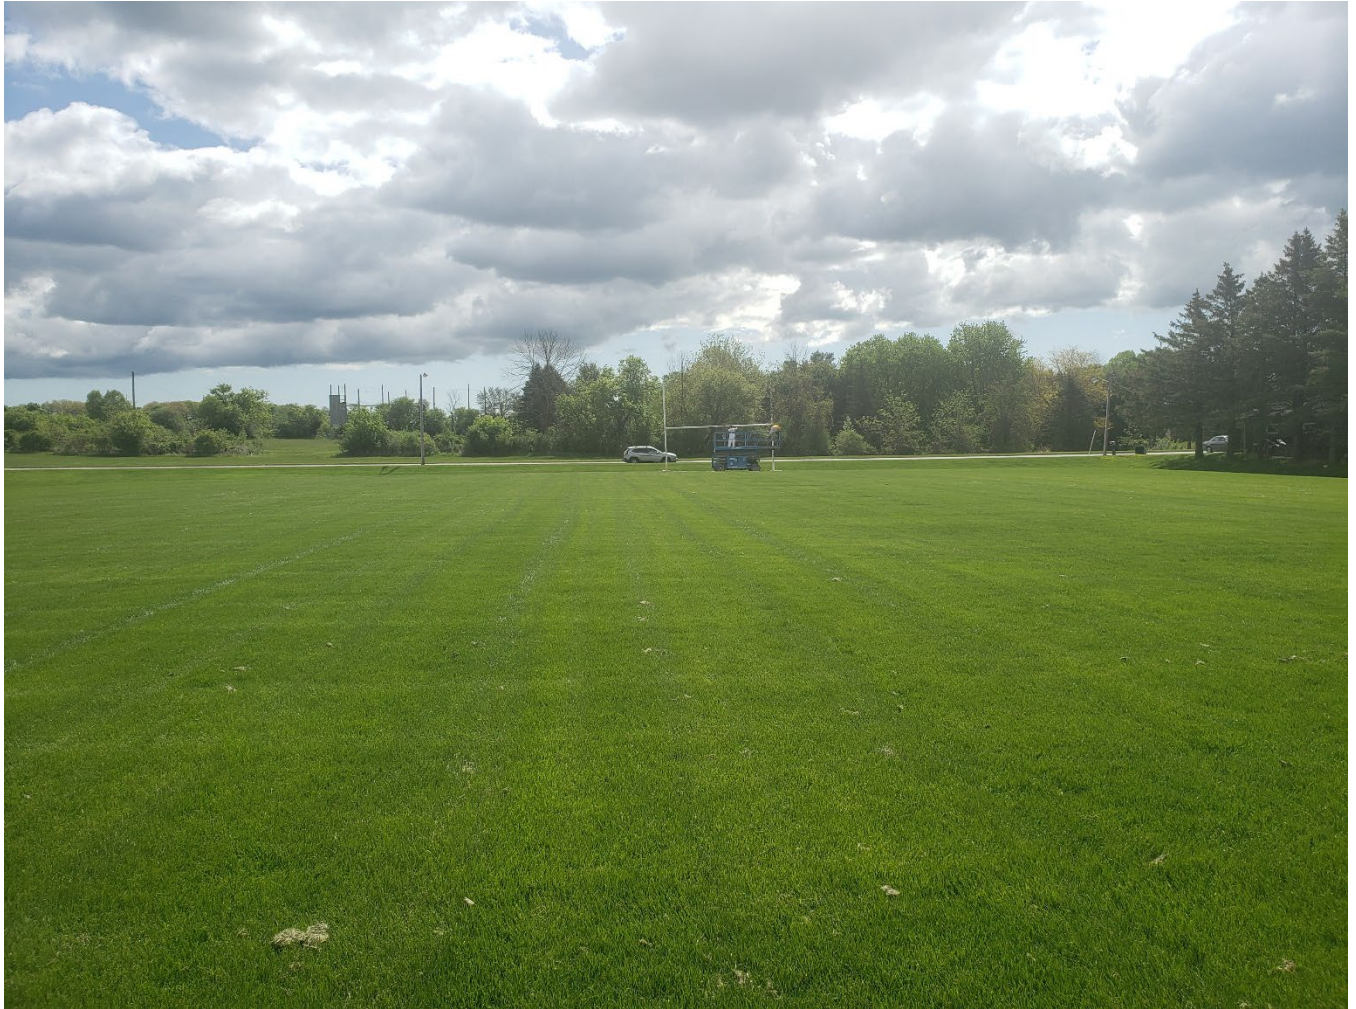
The grass football field is in excellent condition. The grass is well maintained and there were no dead areas (Figure 35). The field appeared flat with no bumps or ruts. The goal posts looked older and had some paint missing, but there was maintenance work being completed on them the day of the site visit.

*Figure 35: Practice Football Field in good condition*

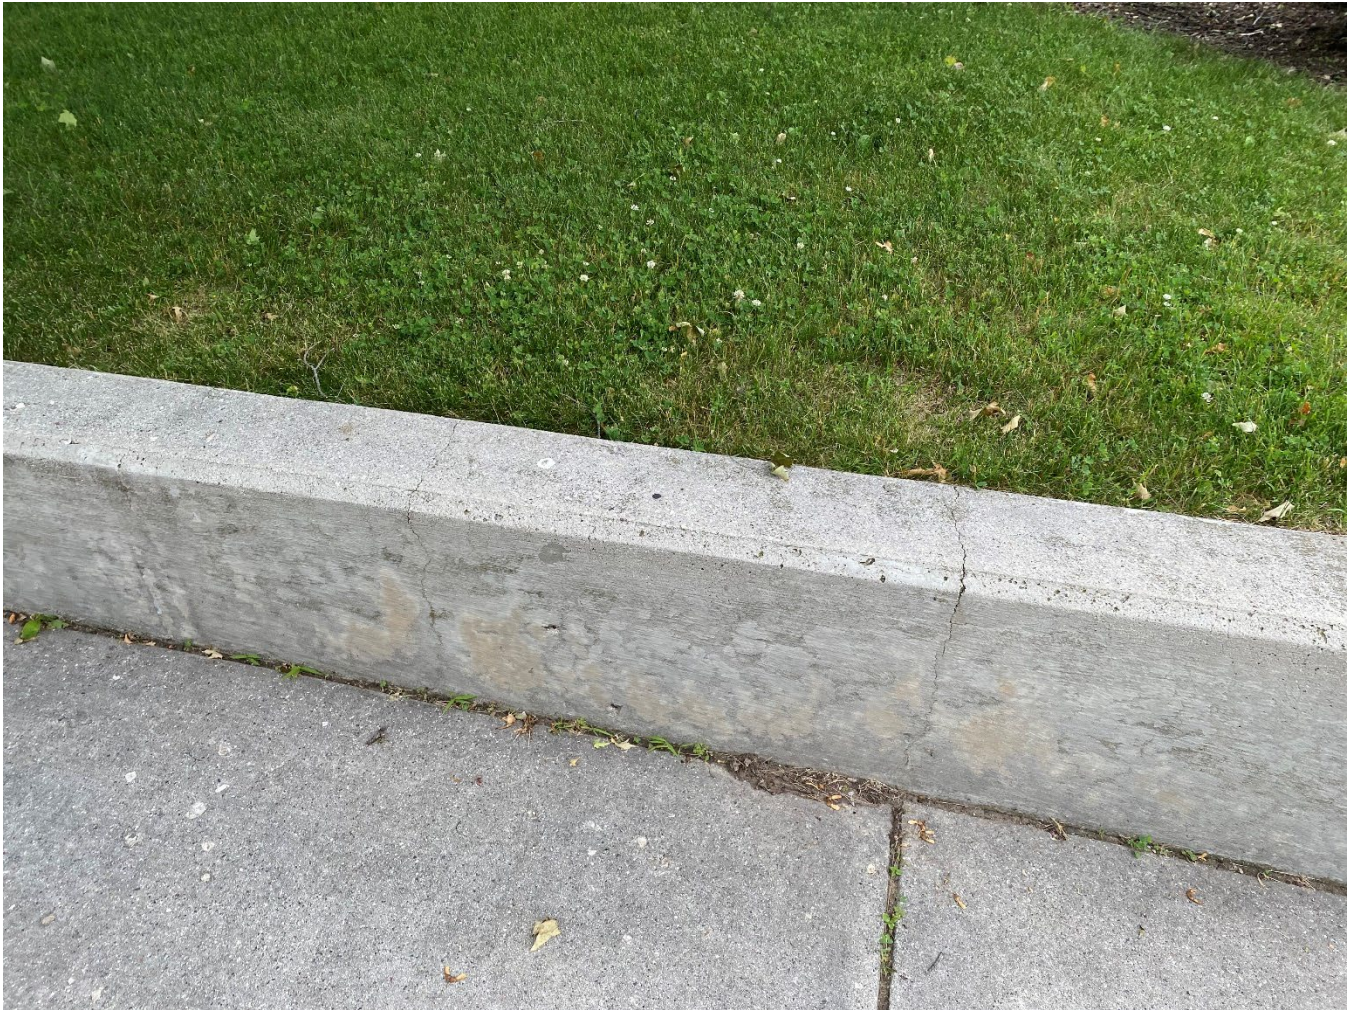
*Figure 40: Cracking in concrete retaining wall in courtyard.*

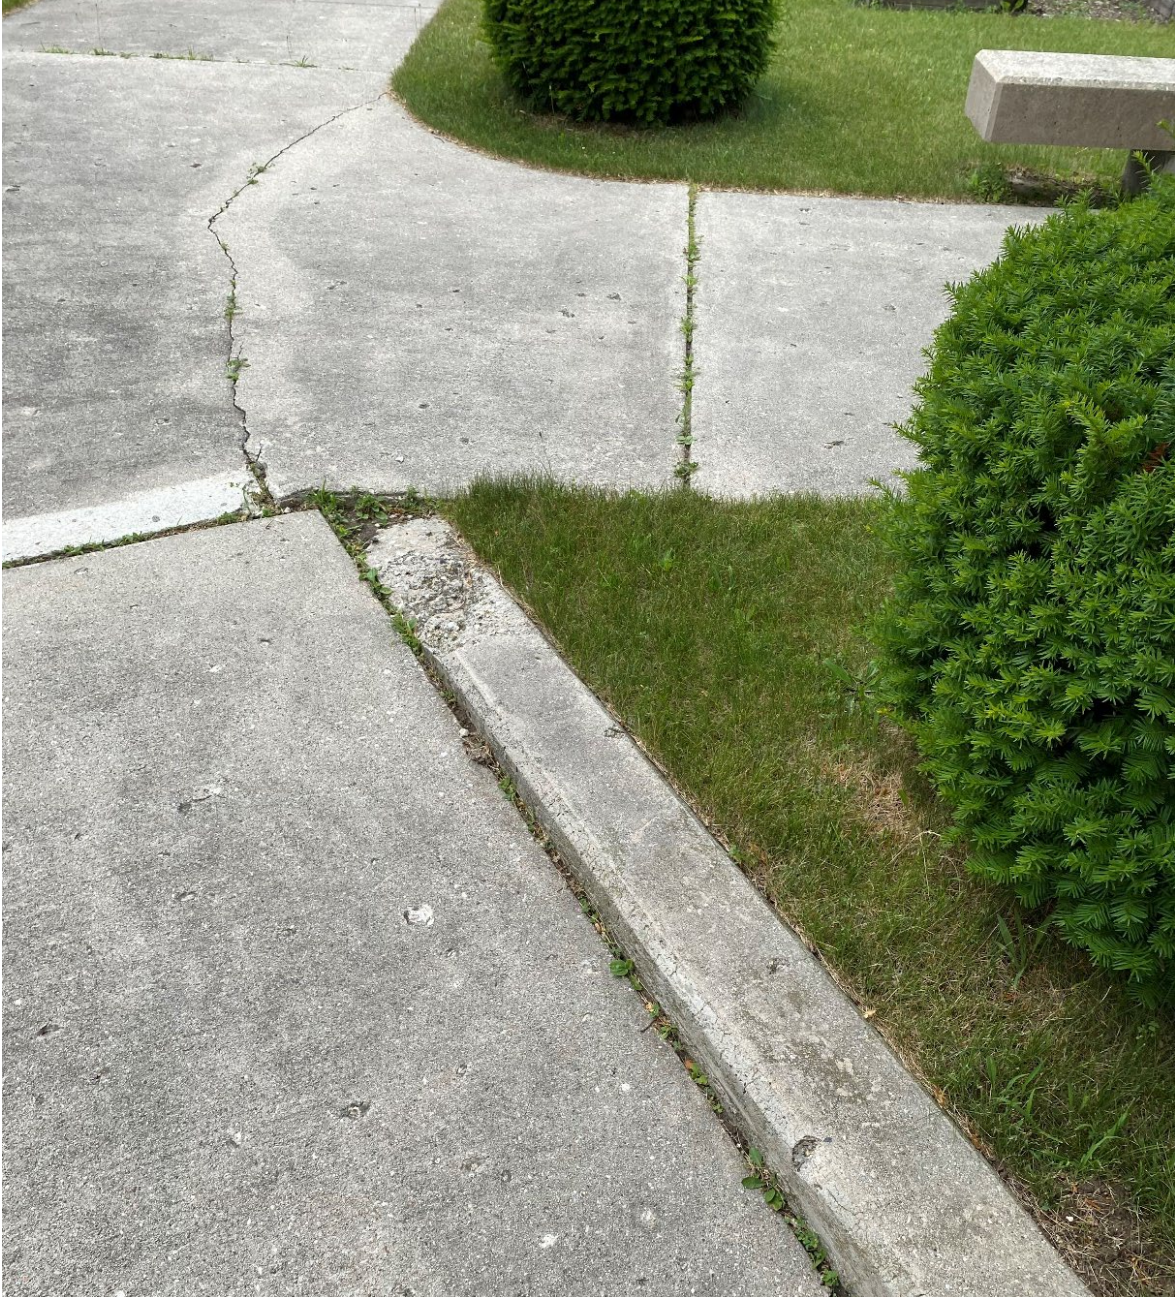
*Figure 41: Cracking in sidewalk and deteriorating concrete retaining wall in courtyard.*

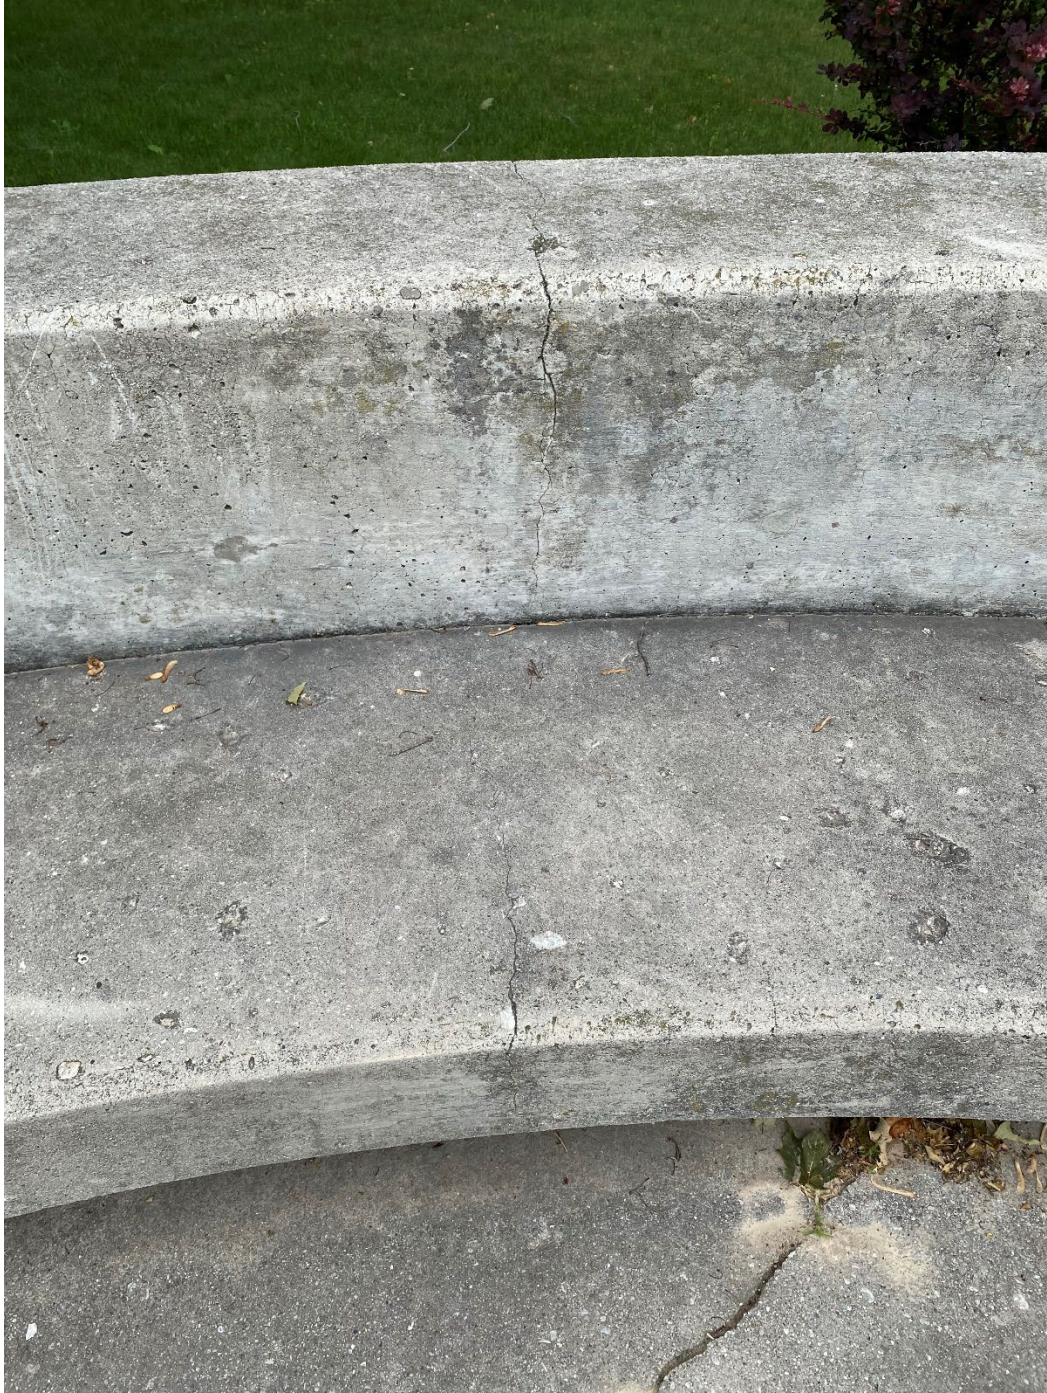
*Figure 42: Cracking in circular concrete bench in center of courtyard.*
