# Kiel Area School District

District-wide Facilities Study

# STUDY DOCUMENT

August 2022

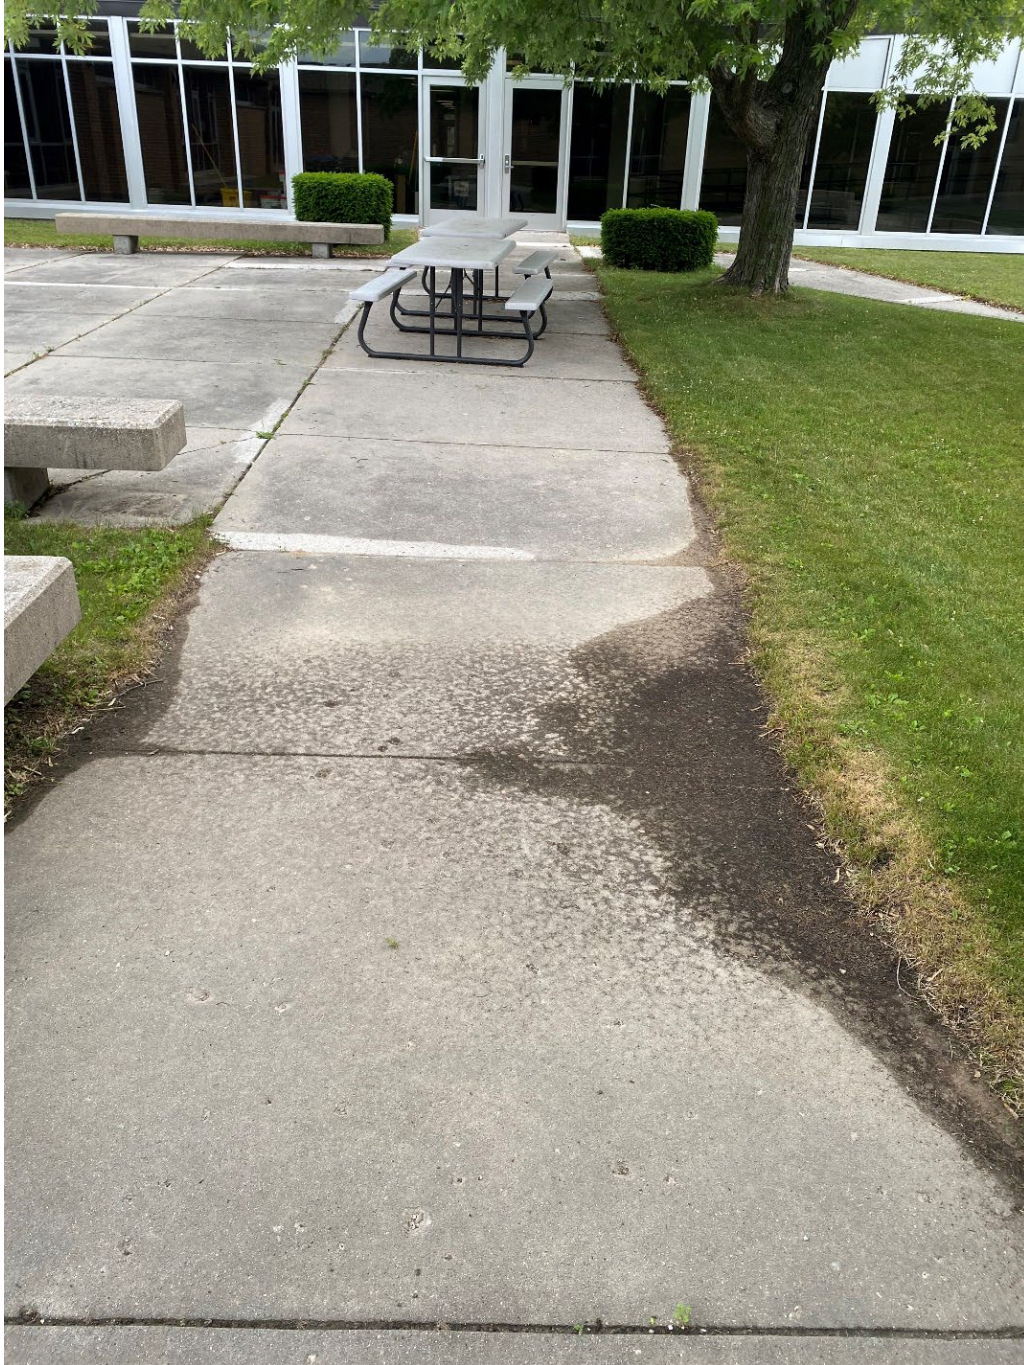
*Figure 43: Accumulation of soil due to settling pavement in courtyard.*
