kiel high school

SUMMARY

kiel high school building systems summary

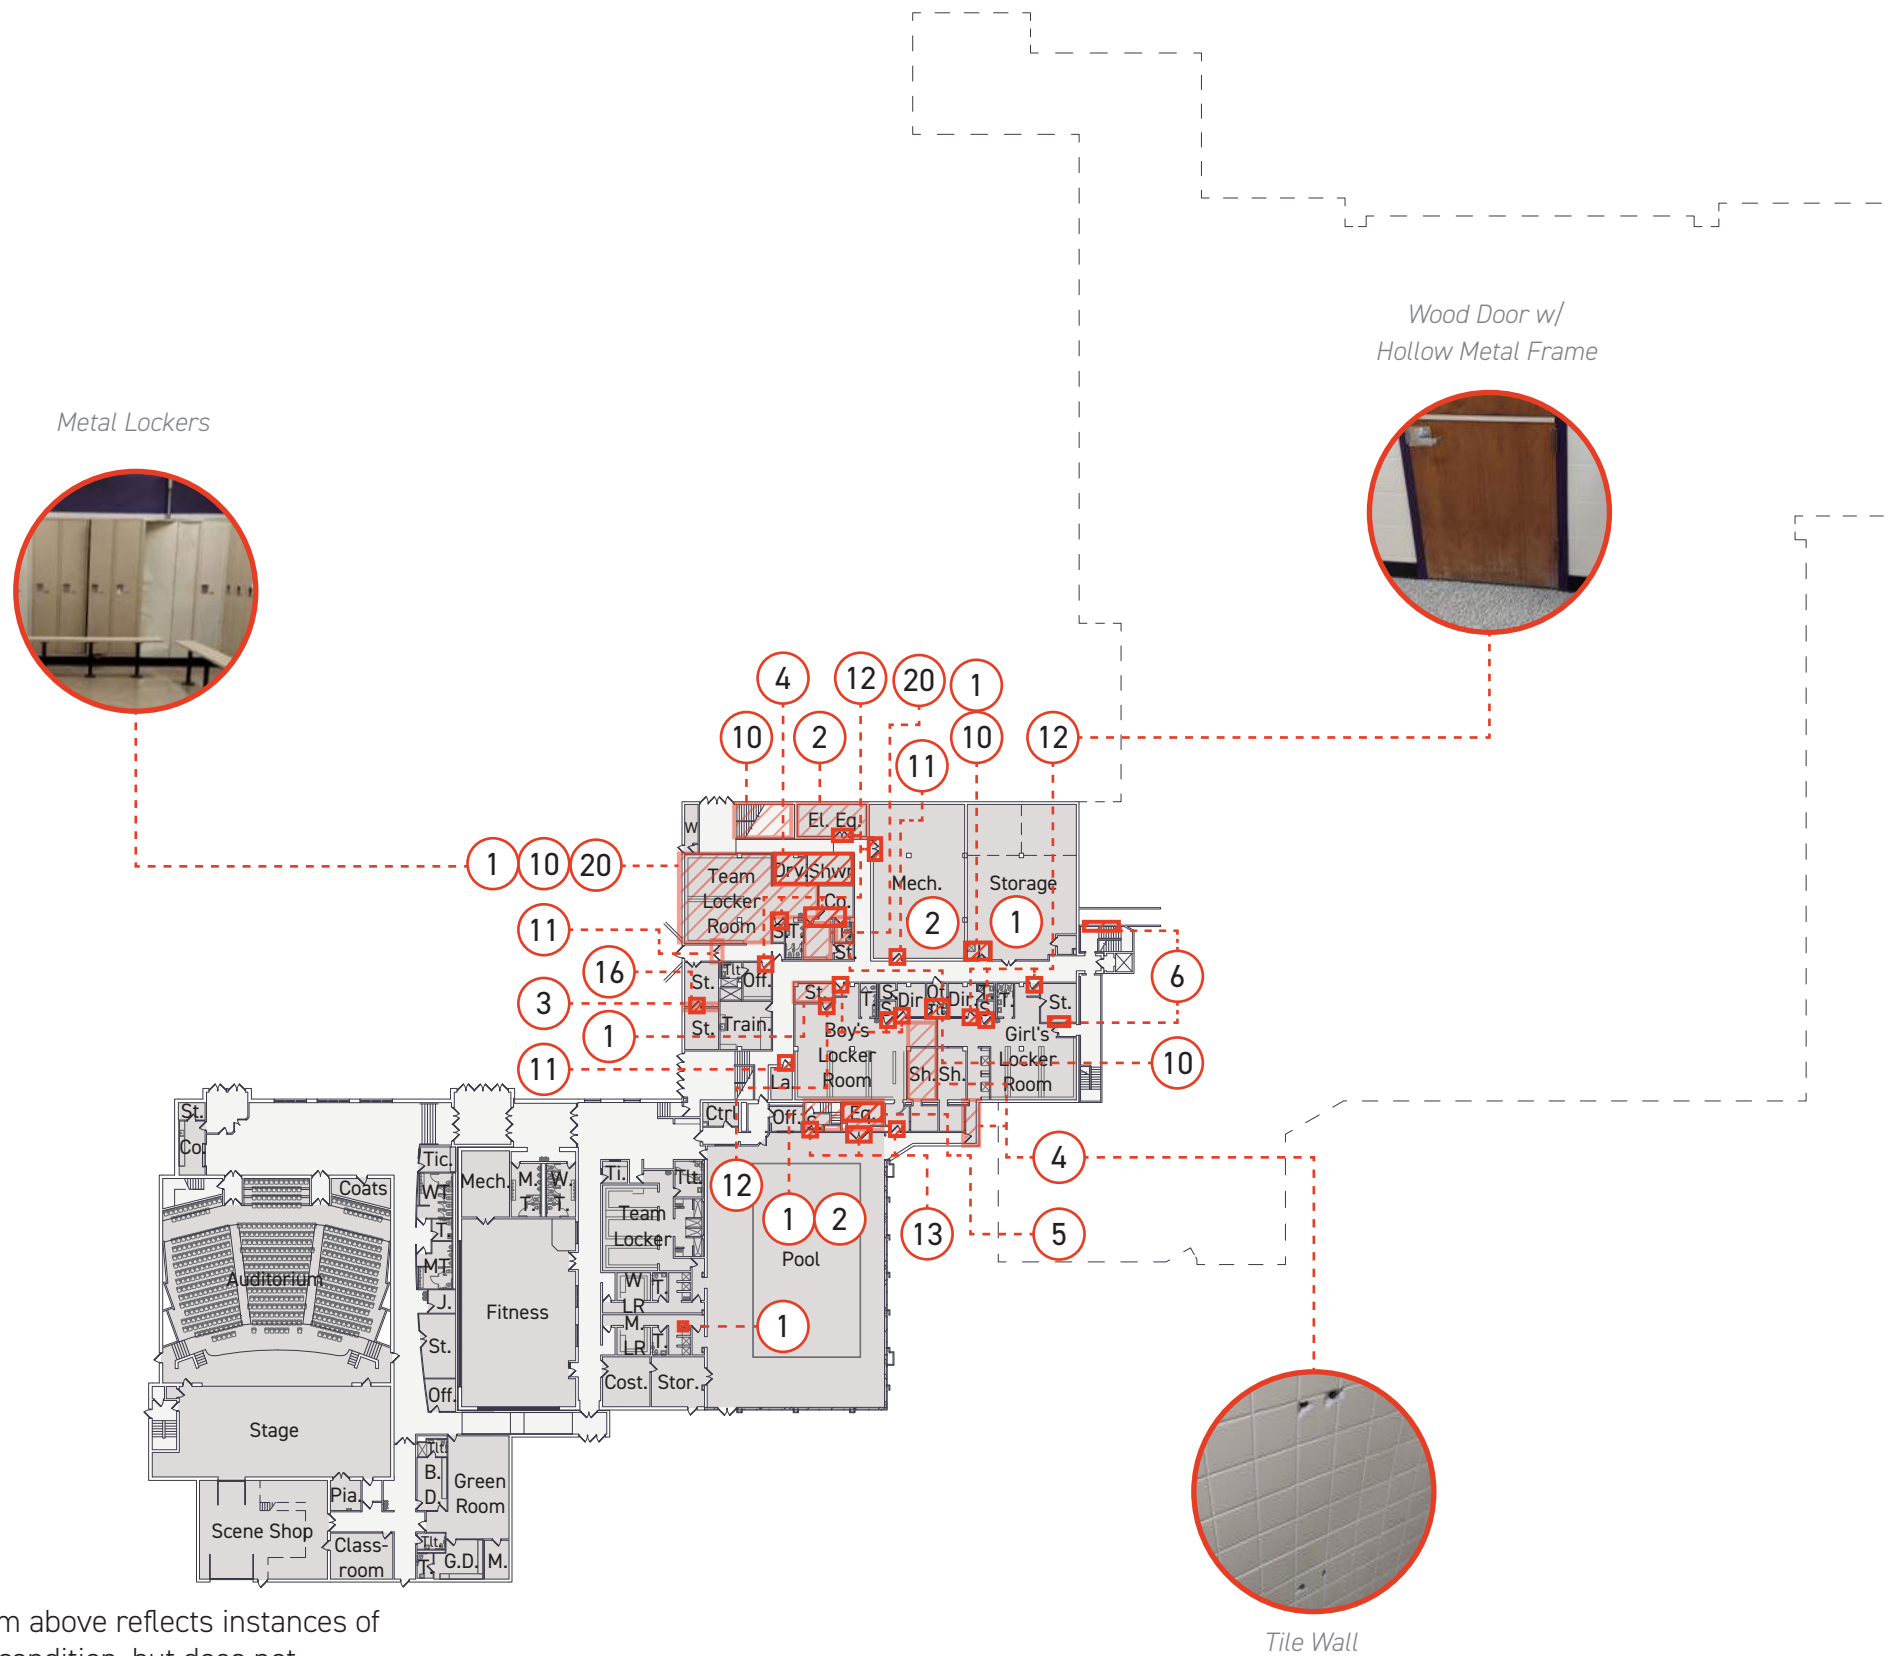
kiel high school interior identifications + analysis | lower level

- Majority of wood doors with hollow metal frames in the lower level are in poor condition due to surface scratching, denting, staining, and paint peeling off.
- Concrete block base in the south-east area of the school is in poor condition due to cracking, chipping, and staining.
- There are instances of concrete block walls that are in poor condition due to crumbling and cracking.
- Majority of interior brick walls throughout the building are in good condition.

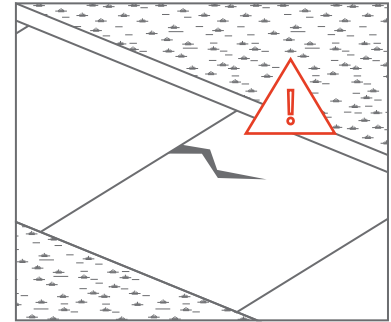
Site Concrete Repairs

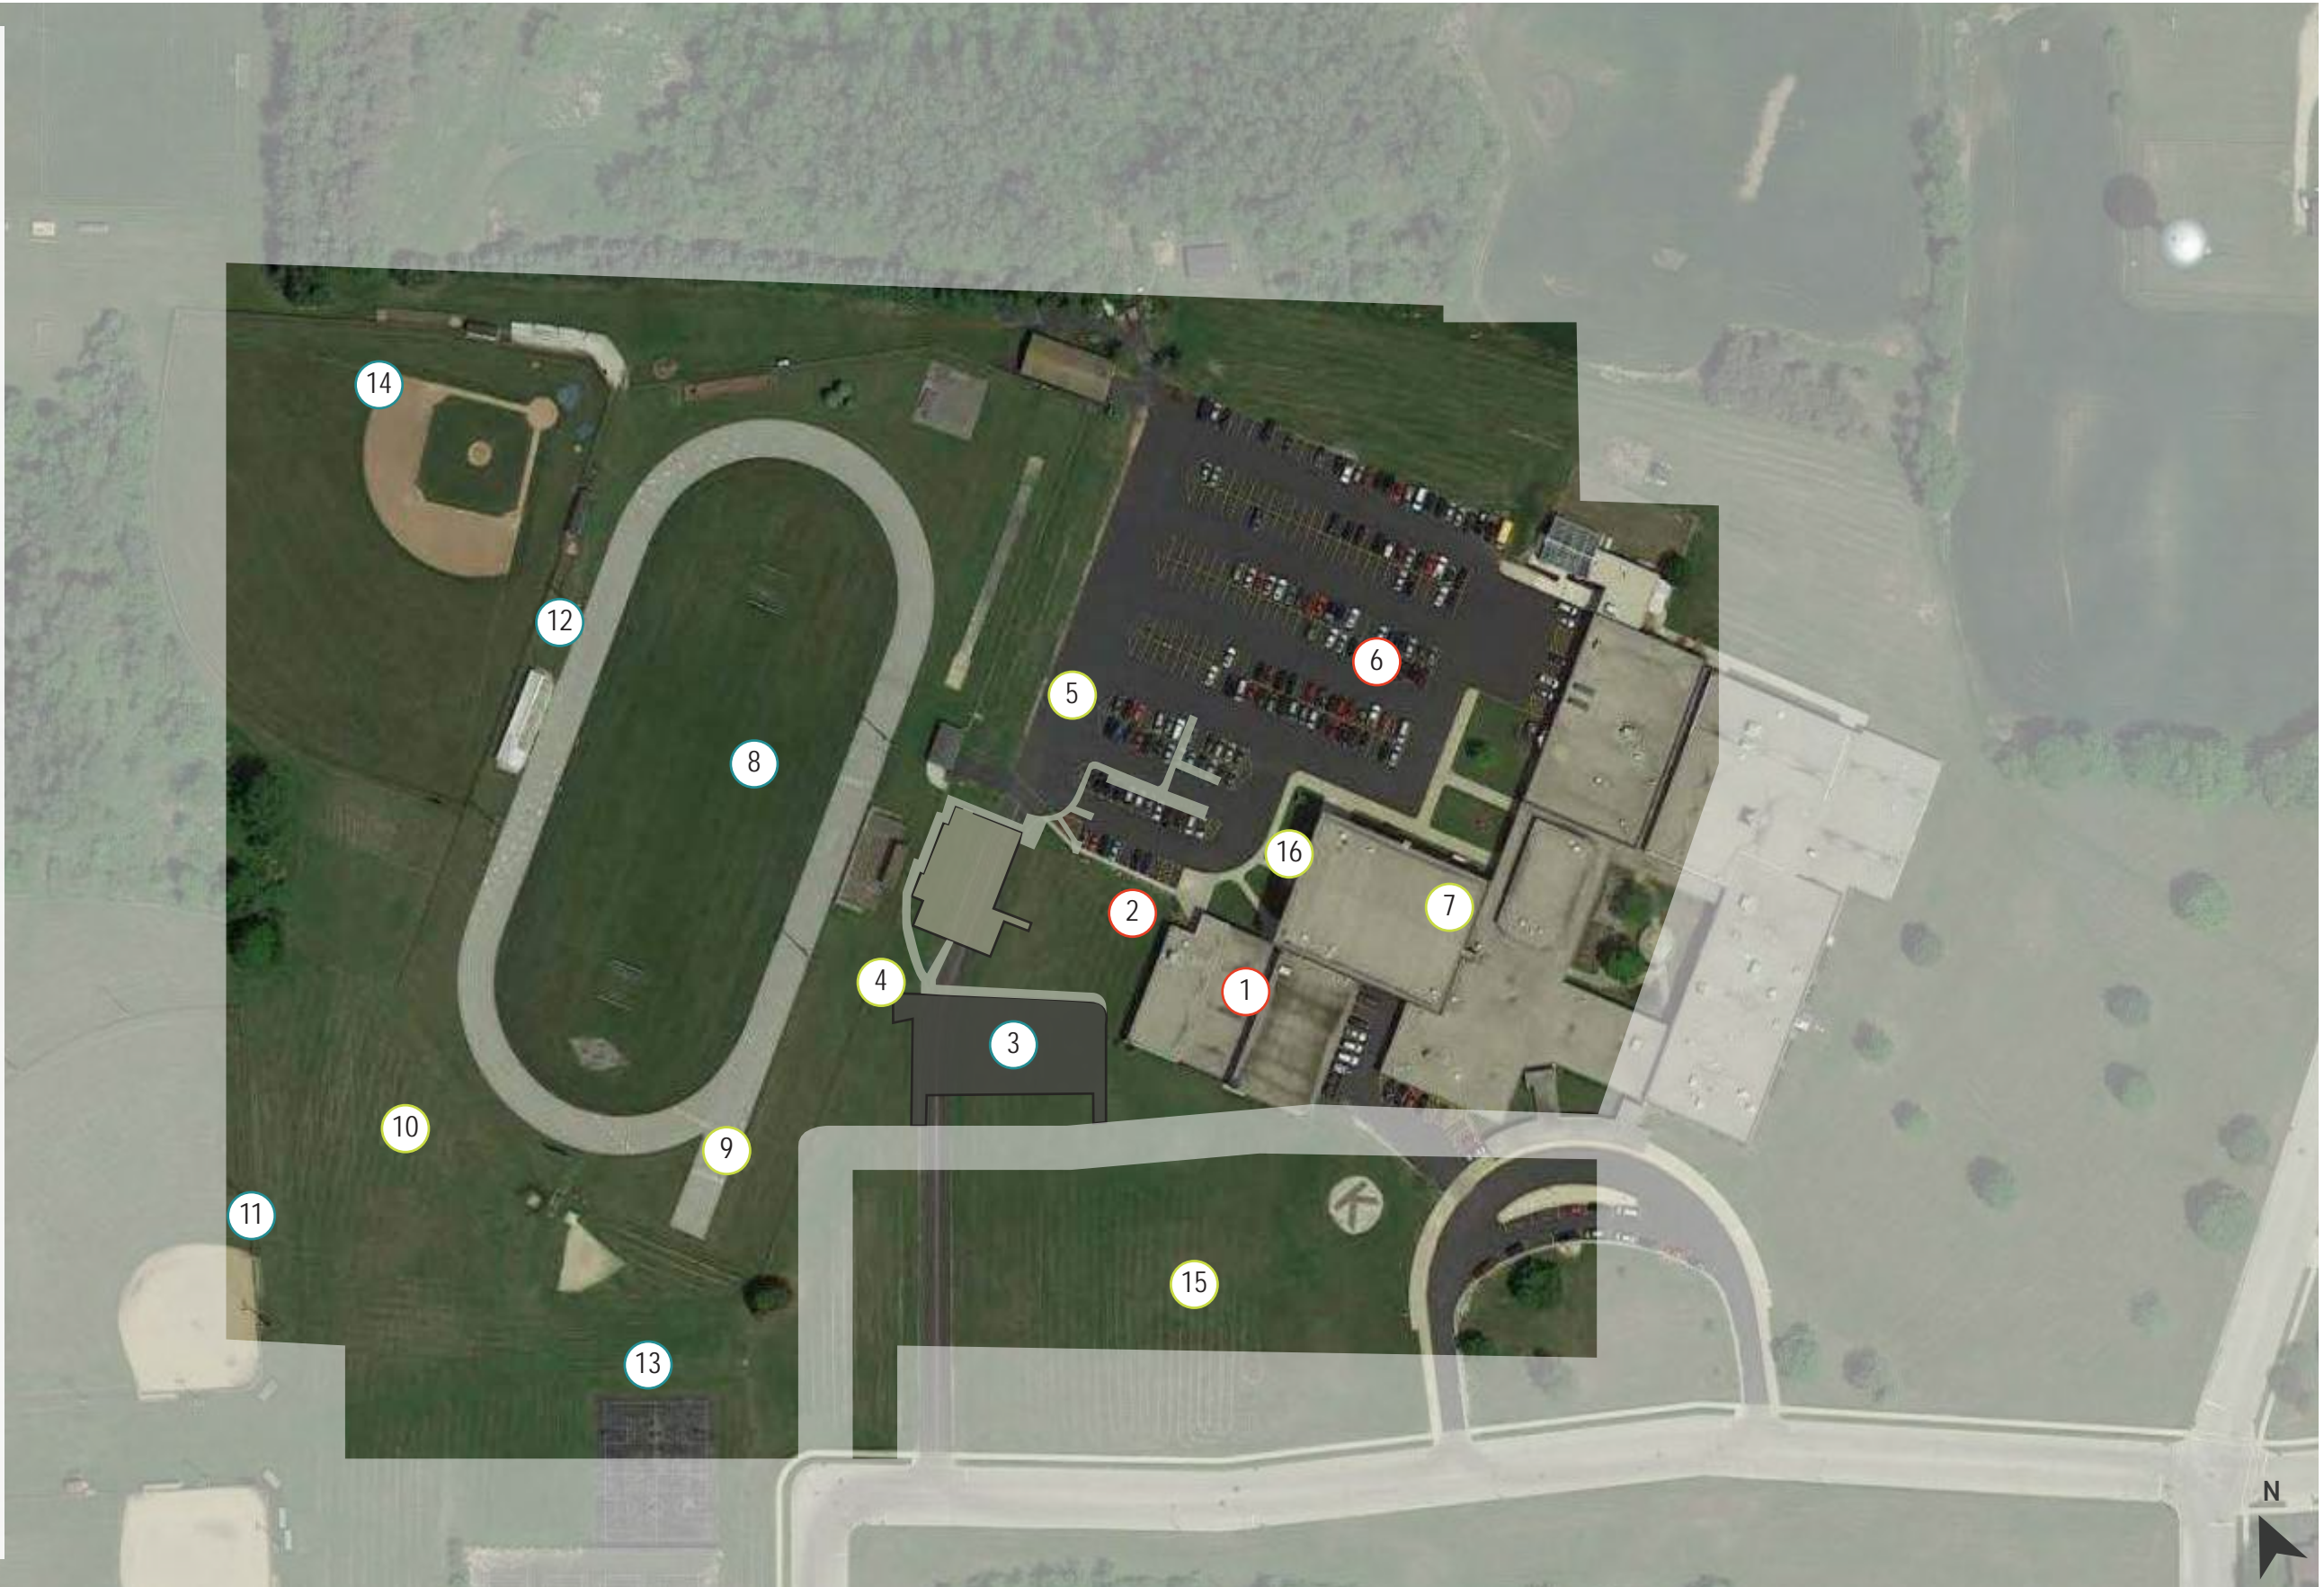
IDENTIFICATION + OVERALL ASSESSMENT

Asphalt Pavement	●	Many large areas of block and alligator cracking.
Pavement Markings	●	Significant fading and missing paint.
Curb + Gutter	●	Shows typical wear, pieces broken and missing.
Concrete Sidewalk	●	Few areas of significant cracking.
Concrete Sidewalk	●	Significant cracking due to vehicles driving over it.
Concrete Parking Island	●	Large amount of cracking.

Asphalt Pavement	●	Significant block and alligator cracking. Pieces breaking off into the grass. Rutting in front of the dumpsters.
Pavement Markings	●	Fading and chipping.
Signage	●	Many signs posts are leaning to the side or bent.
Fencing	●	Gate staked into an open position.

Asphalt Pavement	●	
Asphalt Pavement	●	Block and alligator cracking. Many longitudinal and transverse cracks.
Concrete Driveway	●	Typical wear, with few cracks.
Pavement Markings	●	Some fading.
Curb + Gutter	●	Excellent condition due to being recently installed.

Asphalt Pavement	●	Excellent condition.
Asphalt Pavement	●	Alligator and block cracking occurring throughout the whole parking lot, including longitudinal and transverse cracks.
Asphalt Pavement	●	
Concrete Sidewalk	●	Excellent condition.
Concrete Sidewalk	●	Minimal cracking, but some settlement and separation in the slabs.
Concrete Sidewalk	●	Cracking, chipping, and settling in slabs.
Pavement Markings	●	Fading and chipping paint.

Asphalt Basketball Court	●	Large transverse and longitudinal cracking. Some cracks have been filled with crack sealant.
Basketball Hoop Posts	●	Shows some cracking.
Shed Area	●	Newer.
Pavement Markings	●	Some flakes of paint missing.

Fields	●	Appear well groomed.
Dugouts	●	Appear to be newer.
Concrete Pads	●	
Water Fountain	●	Anchored to a tilted board.
Fencing	●	Requires maintenance due to rusting posts, unraveling at the bottom, and tilting.

Fields	●	Some areas outside of the fenced in field have no grass growing.
Concession Stand	●	
Dugouts	●	Rubber on the concrete floors is peeling away and ripping.
Wood Benches	●	Old and have paint worn off them.
Bleachers	●	
Fencing	●

Concrete Sidewalk	●	Many slabs have cracked. Pavement looks very old and has weeds growing through the cracks.
Concrete Benches	●	Some chipped edges and vertical cracks.
Concrete Retaining Wall	●	Vertical cracks.
Picnic Tables	●

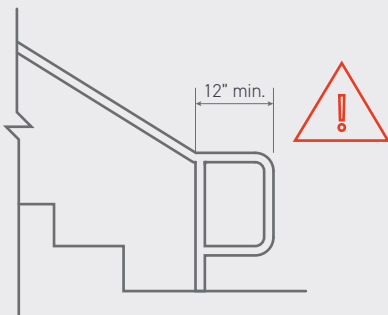
*Not providing ADA compliant
railings at stairs*
