kiel middle school

SUMMARY

Kiel Middle School provides a comprehensive program for 5th grade - 8th grade students.

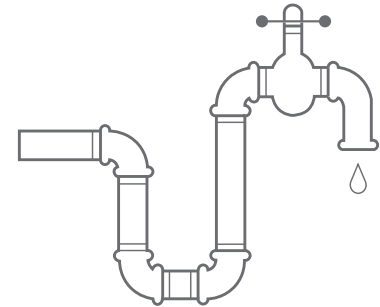
Plumbing Condition Overview

Water Service	●	4" Ductile Iron with 3" water meter with bypass. 2" Ductile Iron with 2" water meter without bypass.
Water Distribution Piping	●	Original addition piping is poor, newer addition piping is fair.
Water Softening System	●	Supplies main water heater and building mixing valve. The Gymnasium area water is not softened.
Fire Sprinkler System	○

Sanitary Waste System	●	Cast iron and PVC piping. Underground piping likely in poor condition. Visible cast iron piping appears to be in poor condition.
Sanitary Waste + Vent Piping	●	
Acid Waste + Vent Piping	●	Sinks appear to have Polypropylene pipe material.
Interceptors	●	Exterior grease interceptor.
Sump Pump	●	Lower levels rely on sump systems.

Storm System	●	Cats Iron and PVC piping.
Storm Waste Piping	●	
Sump Pump	●	Lower levels rely on sump systems.

Replace original sanitary and storm piping in lower level.

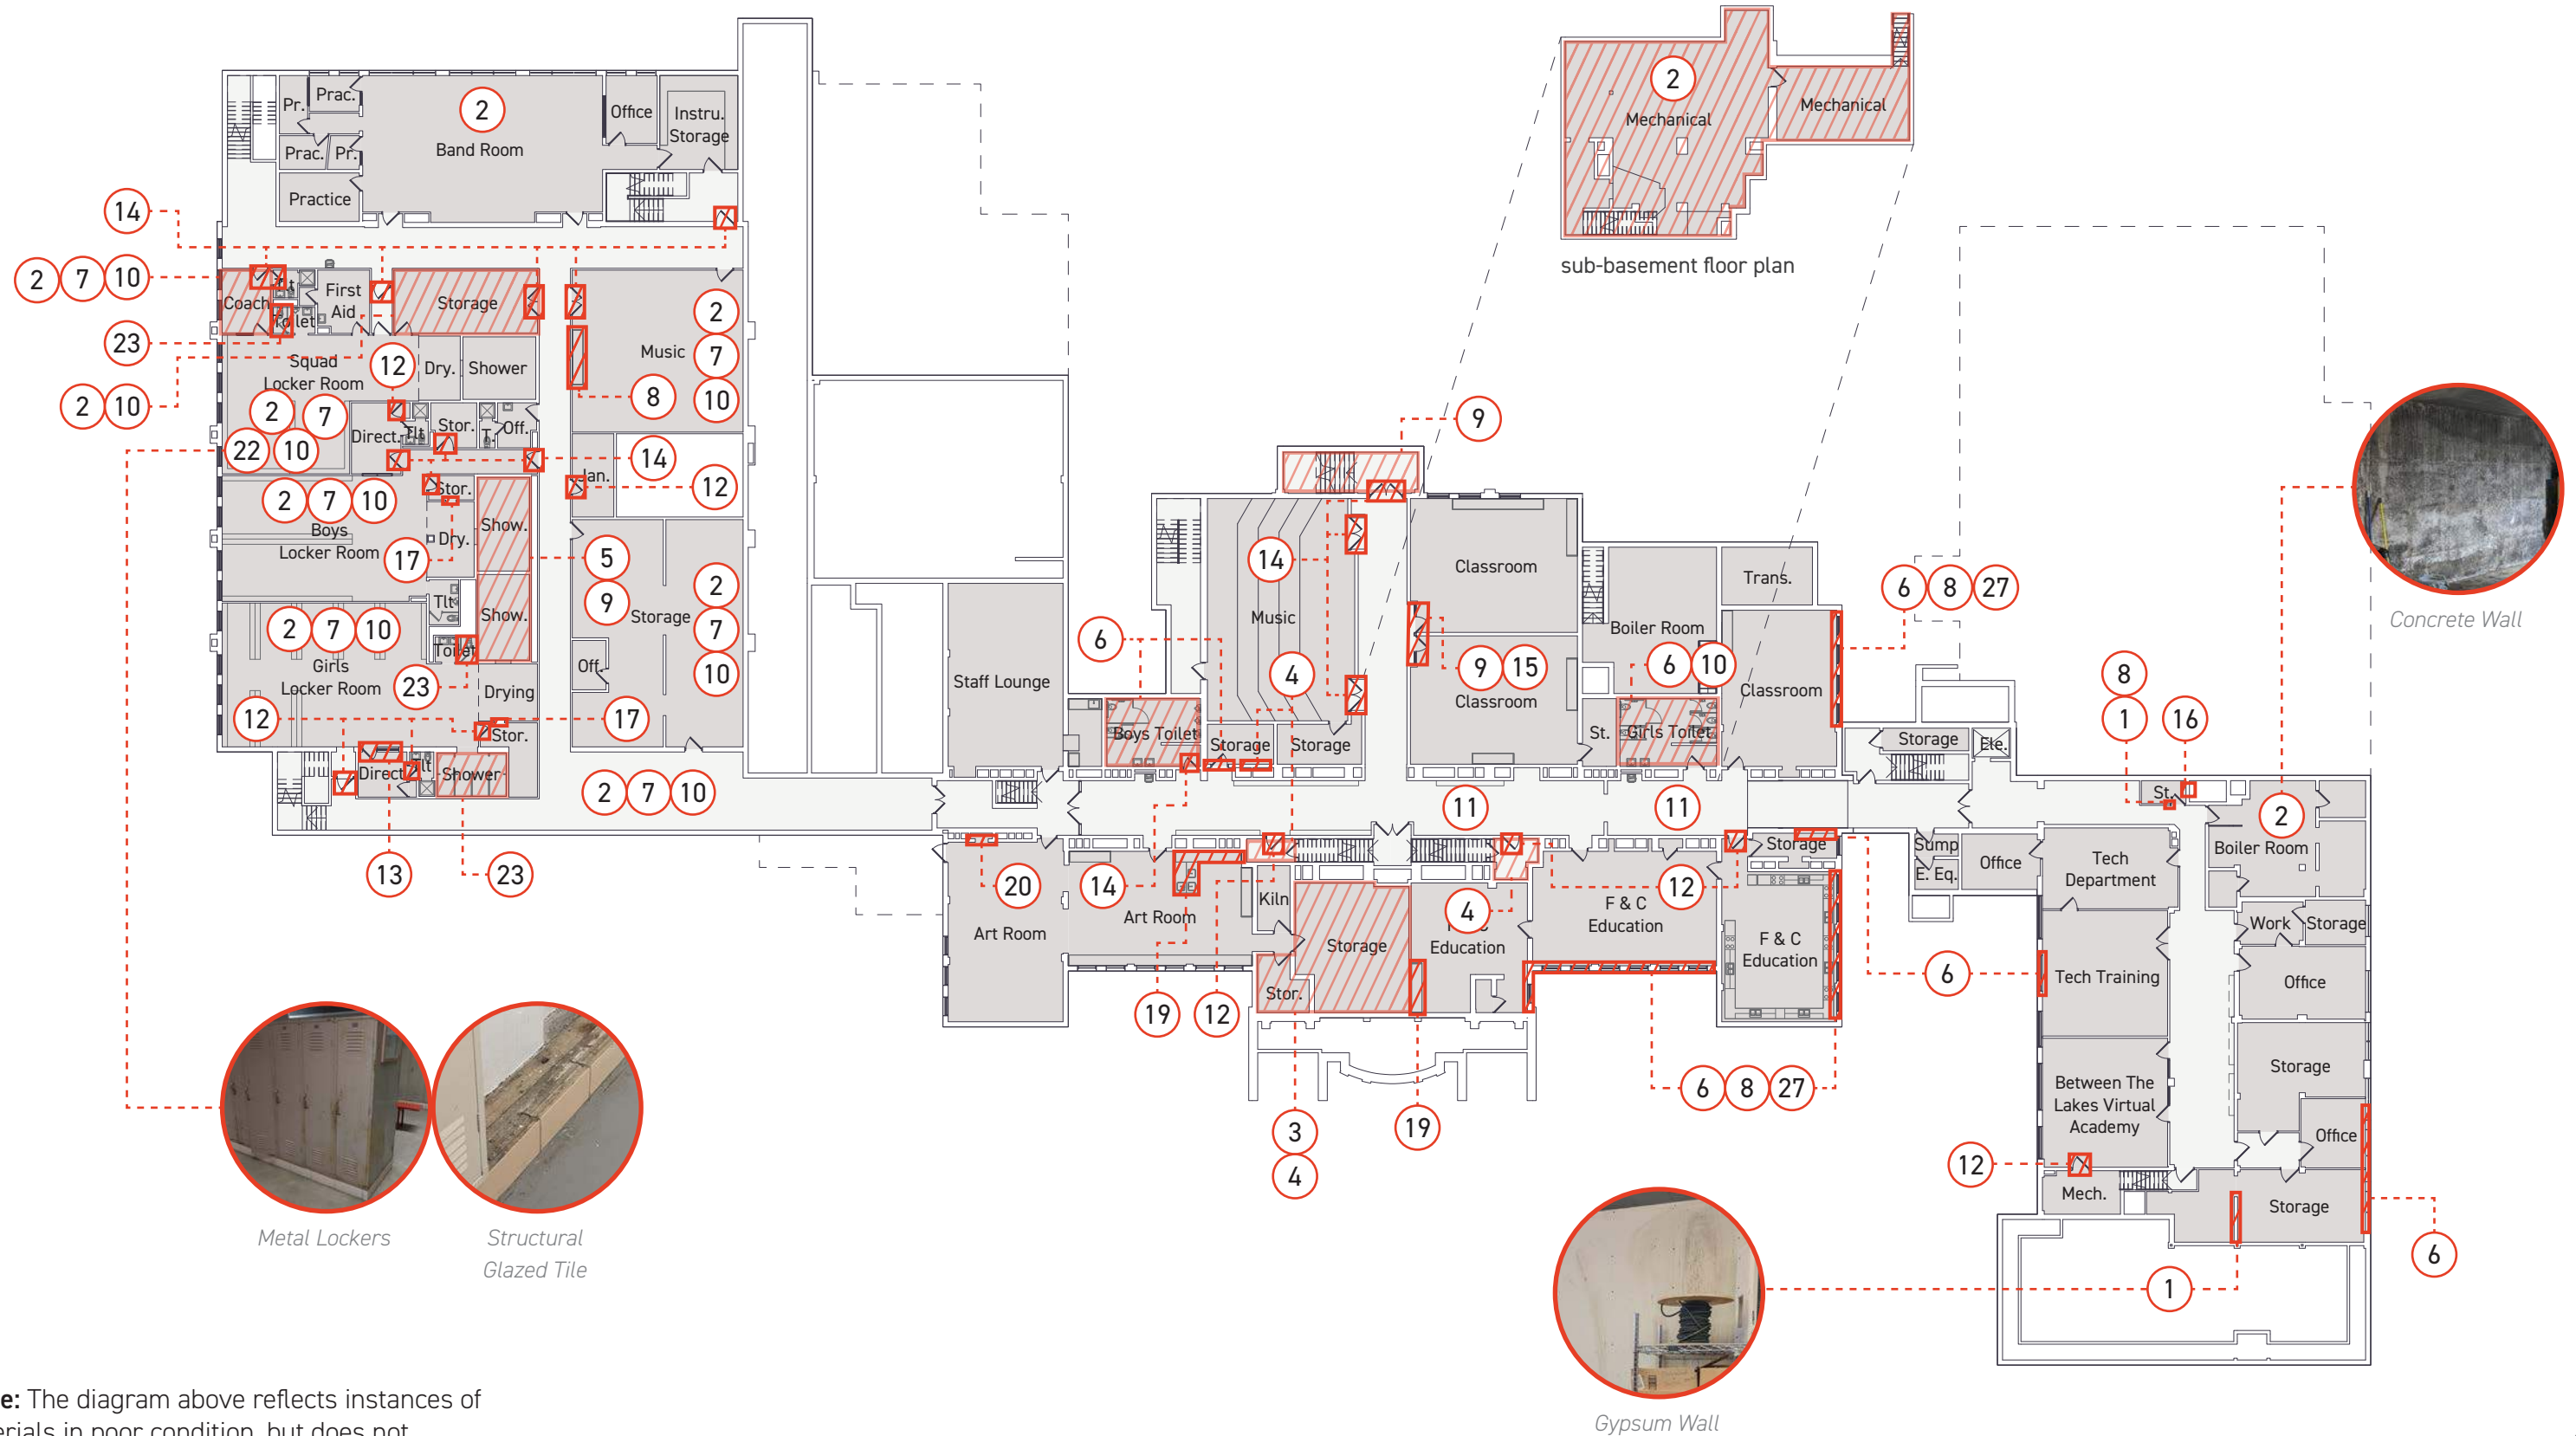
kiel middle school interior identifications + analysis | lower level

- Majority of concrete walls in the lower level are in poor condition due to cracking and staining.
- Terrazzo base throughout the building is in poor condition due to cracking and crumbling.
- Majority of wood doors throughout the building are in poor condition due to denting and surface scratches.
- There are some instances where metal lockers are dented and have surface scratches.

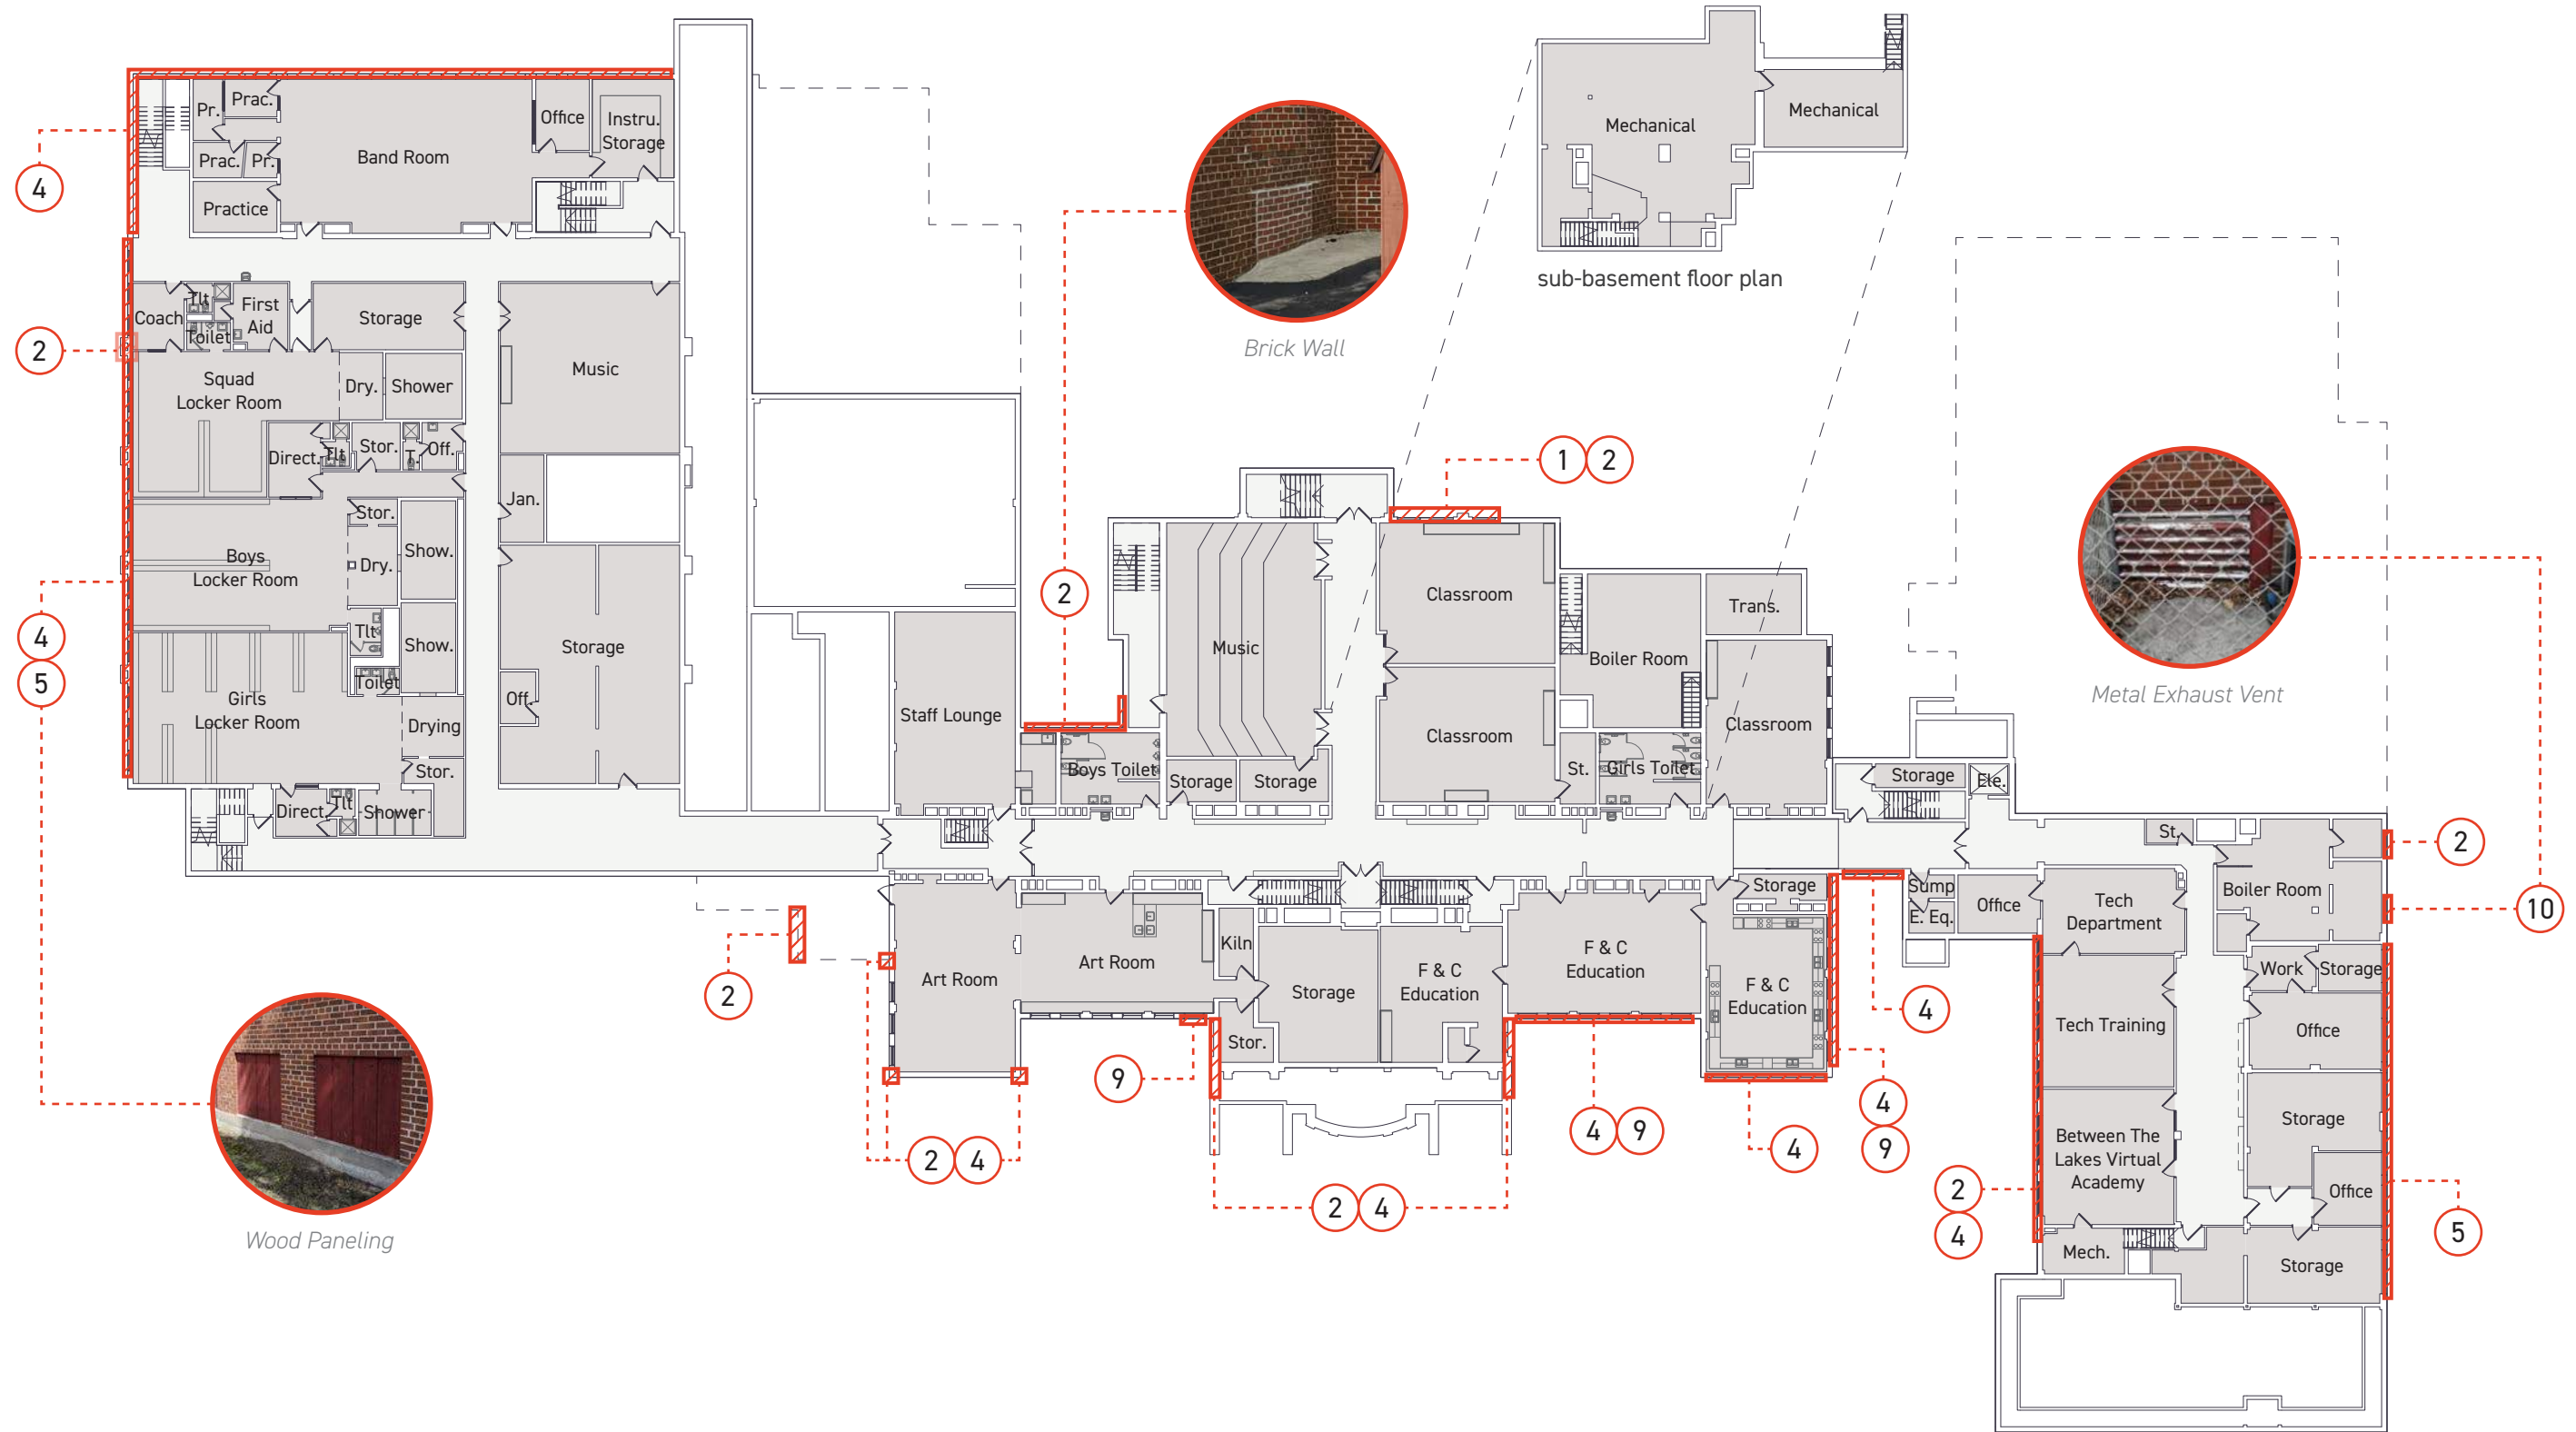
kiel middle school exterior identifications + analysis | lower level

- Wood paneling in the lower level is in poor condition due to staining, wearing, and paint peeling off.
- There are instances where metal railings are in poor condition due to rusting.
- Concrete foundation walls are in poor condition due to cracking and crumbling.
- Majority of brick walls are in fair condition due to instances of crackling and crumbling.

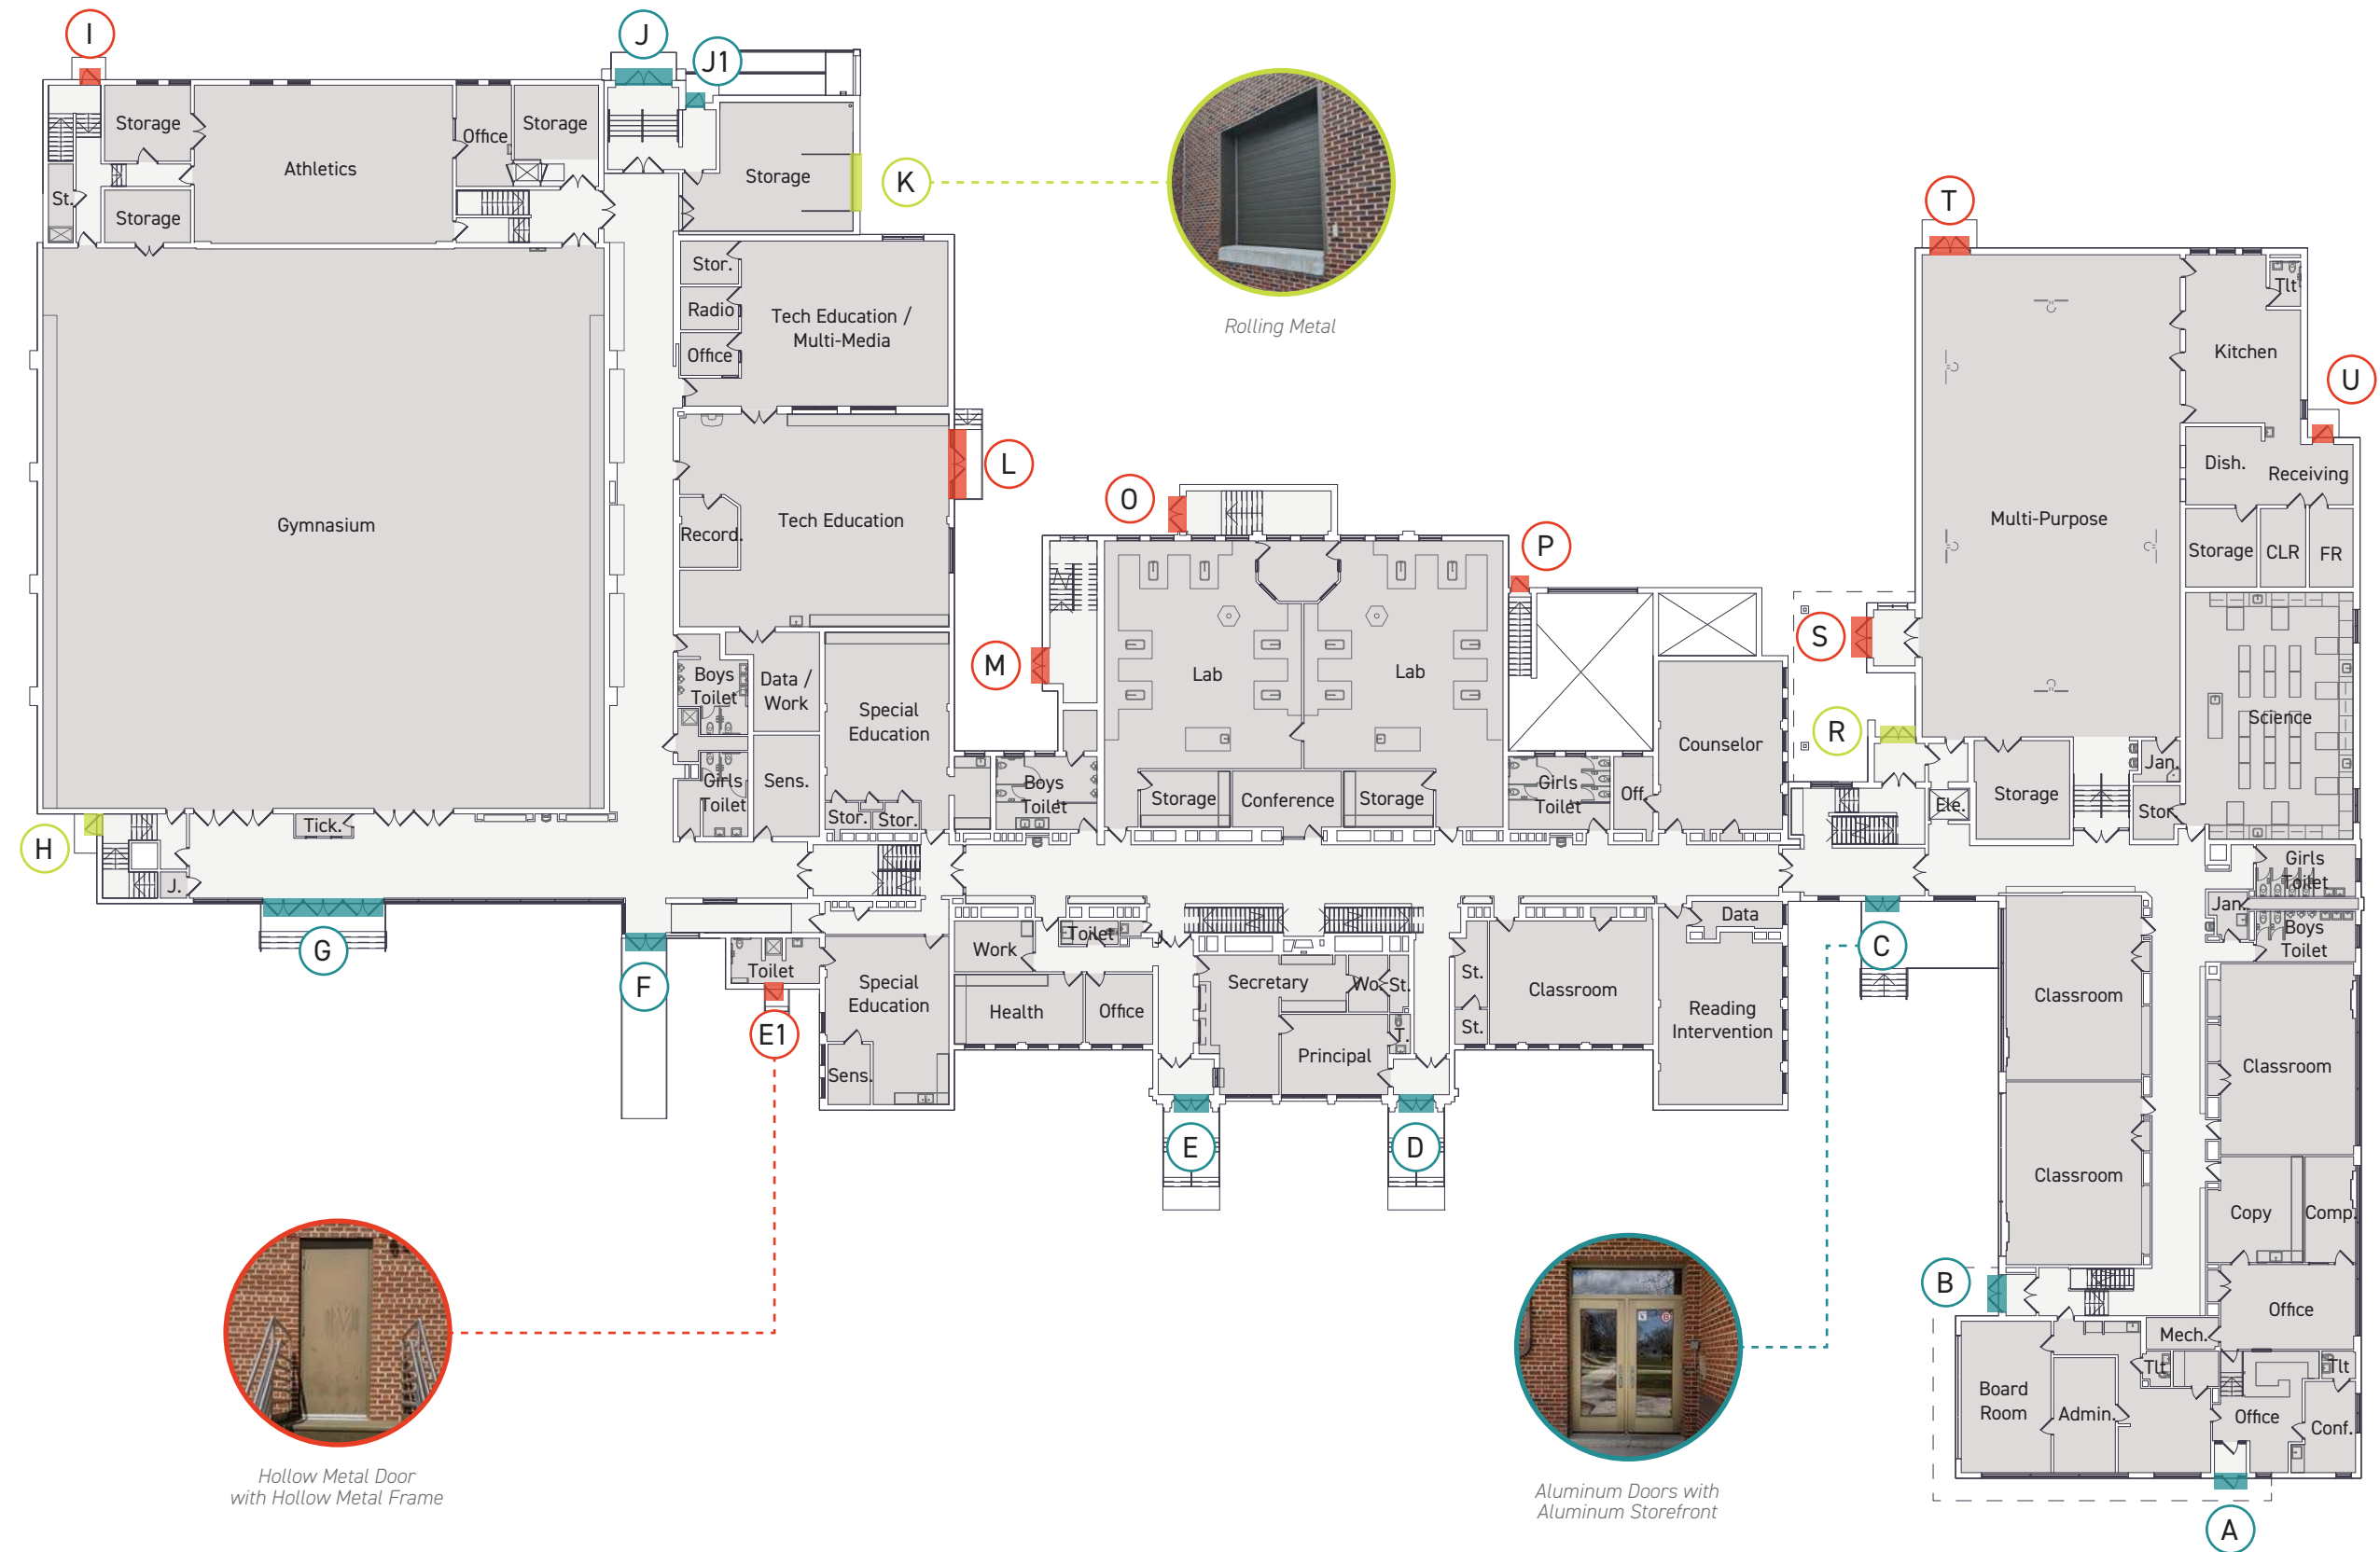
kiel middle school exterior door identification + analysis | first floor

- Majority of aluminum doors with aluminum storefront framing are in good condition.
- All hollow metal doors are in poor condition due to rusting, staining, denting, and surface scratches.
- Door K is in fair condition due to instances of denting.

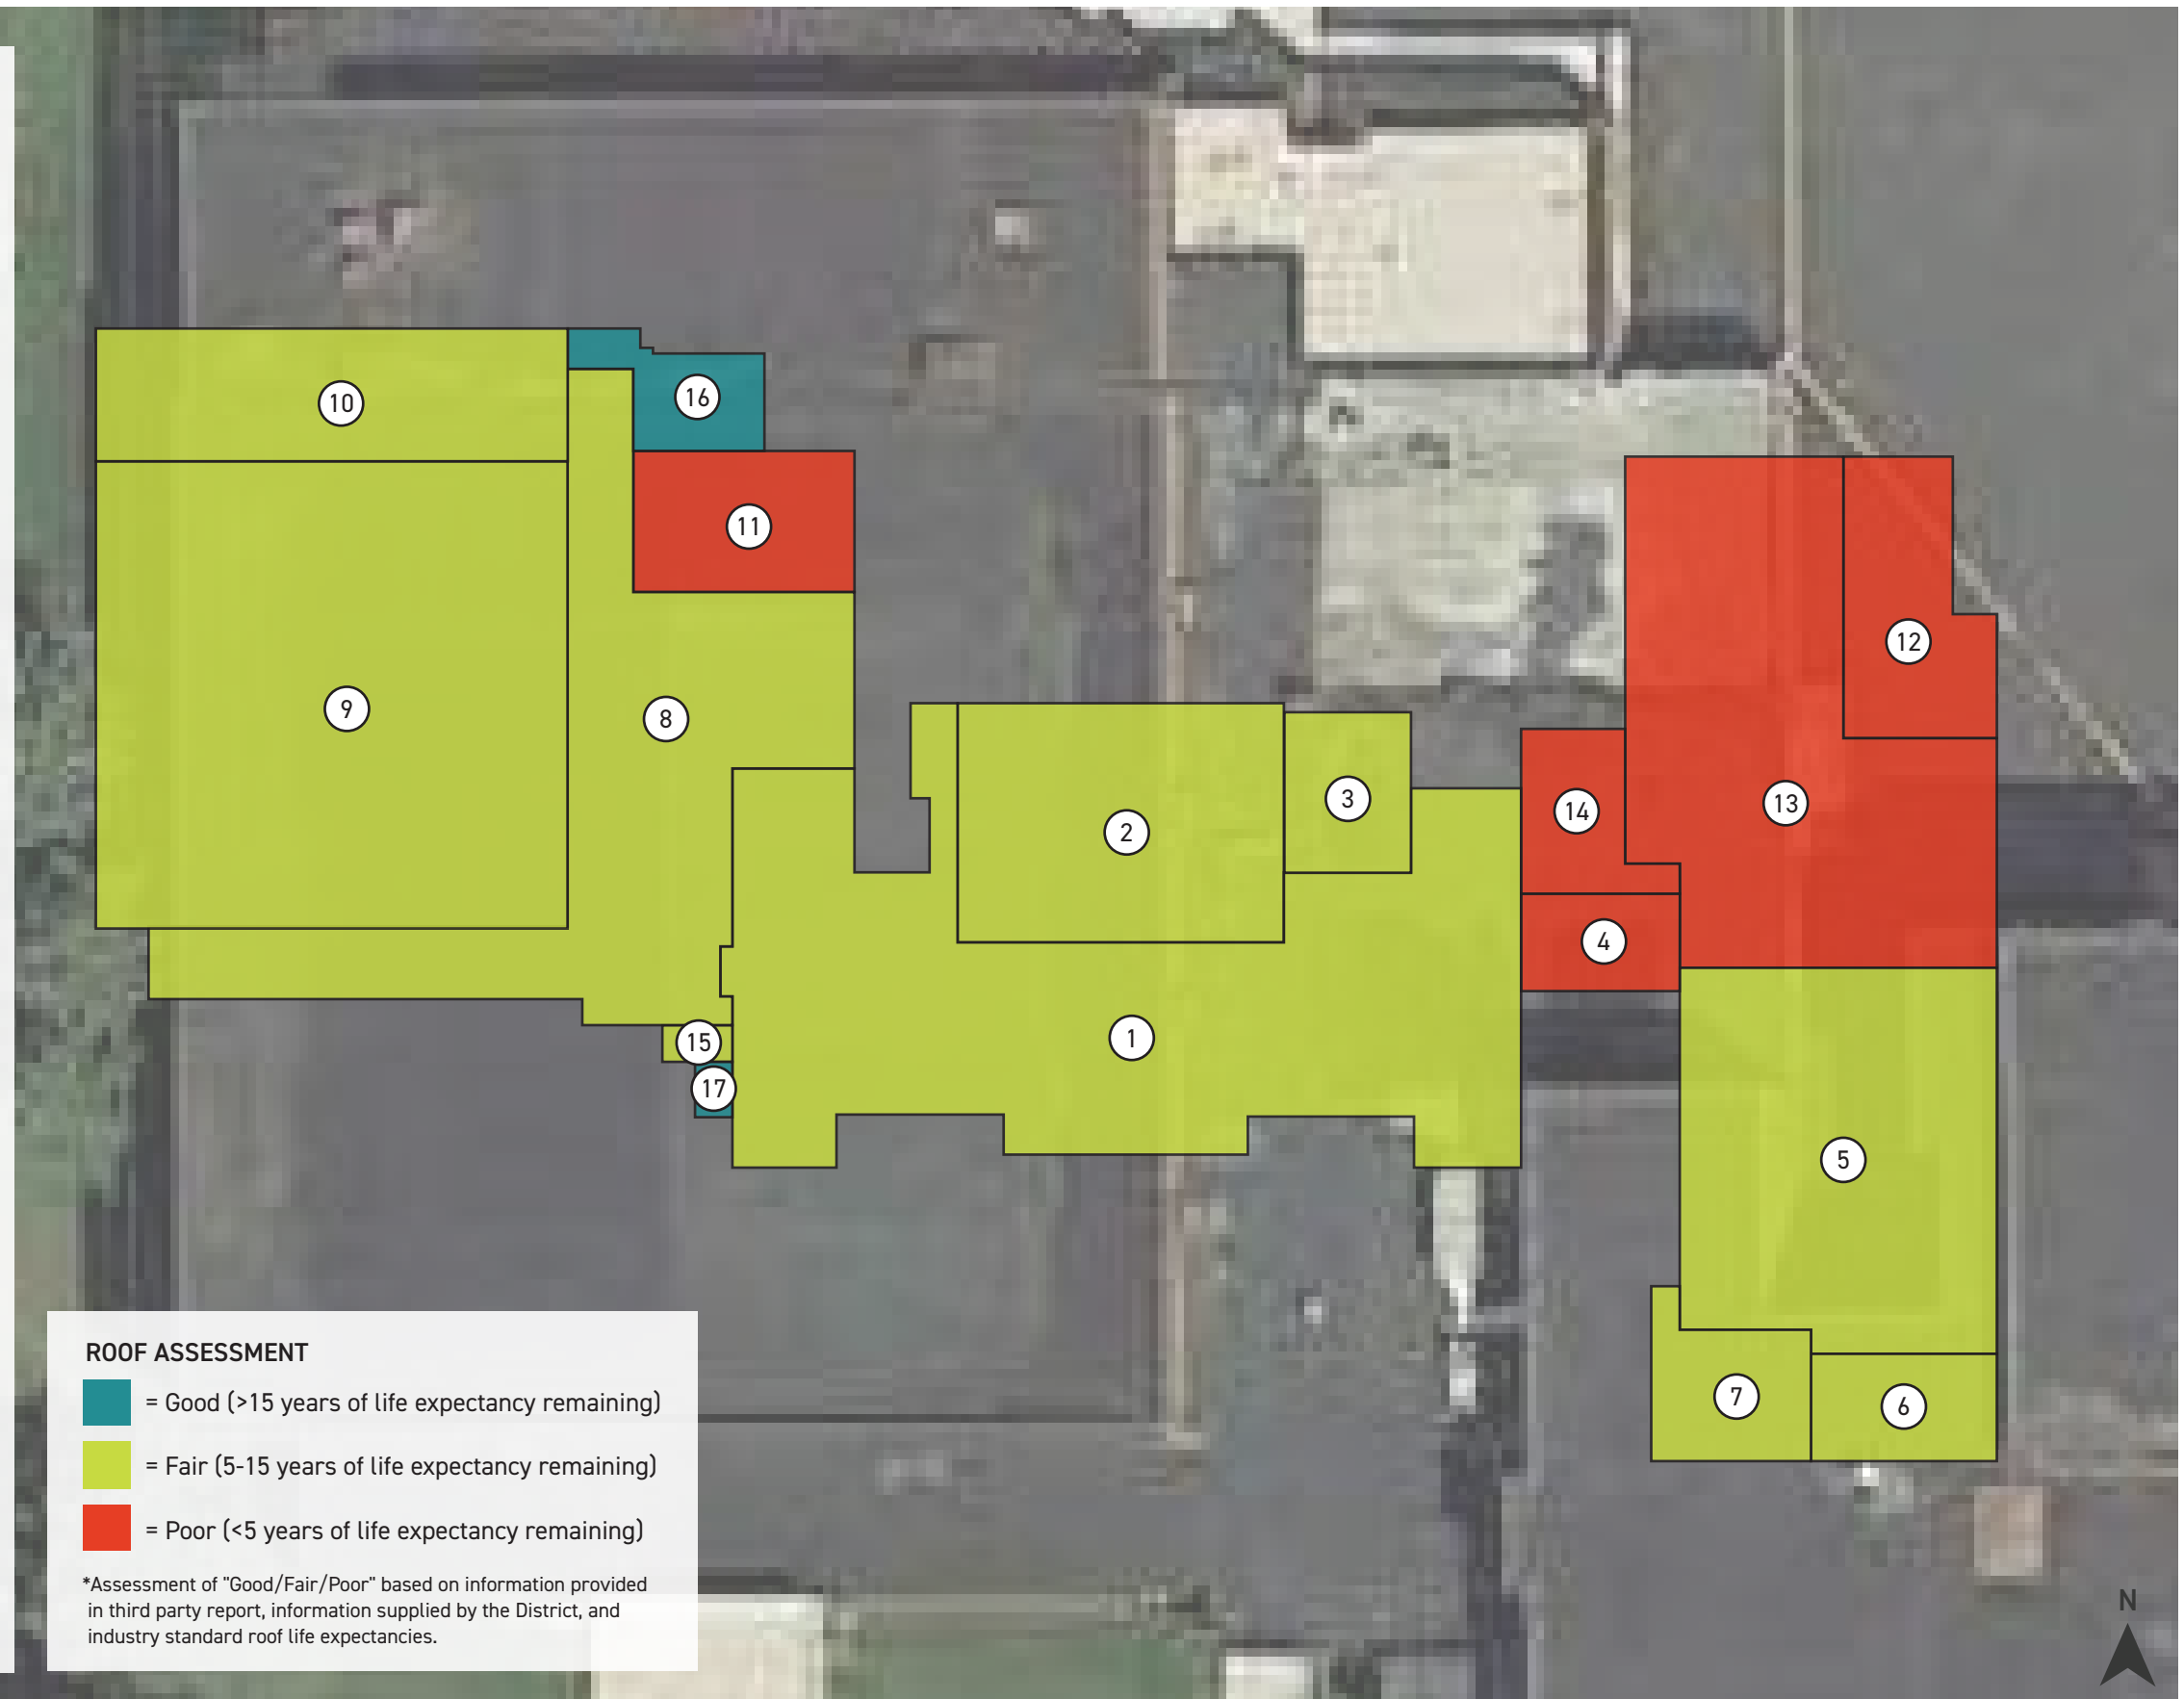
kiel middle school roof identification

- 1 = Fully Adhered EPDM, 2001 Installation
- 2 = Fully Adhered EPDM, 2001 Installation
- 3 = Fully Adhered EPDM, 2001 Installation
- 4 = Ballasted EPDM, 1999 Installation
- 5 = Fully Adhered EPDM, Unknown Installation
- 6 = Fully Adhered EPDM, Unknown Installation
- 7 = Fully Adhered EPDM, Unknown Installation
- 8 = Fully Adhered EPDM, 2001 Installation
some replacement/work completed in the past few years
- 9 = Fully Adhered EPDM, 2001 Installation
- 10 = Fully Adhered EPDM, 2001 Installation
- 11 = Ballasted EPDM, 1993 Installation
- 12 = Ballasted EPDM, 1999 Installation
- 13 = Ballasted EPDM, 1999 Installation
- 14 = Ballasted EPDM, 1999 Installation
- 15 = Tapered Polyiso Insulation, 2010 Installation
- 16 = Tapered Polyiso Insulation, 2014 Installation
- 17 = Unknown Roof Type, Unknown Installation

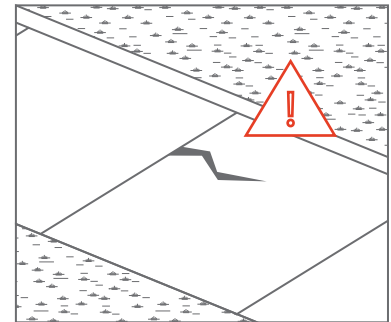
Civil / Site Analysis Overview

Area 3: North Side of Site

Northwest Parking Lot	●	Significant longitudinal and transverse cracks throughout. Appears to be some settling near the catch basins.
Northwest Parking Sidewalk	●	One slab with a large crack through it.
Back Concrete Ramp	●	Minimal cracking. Railing is rusted especially at the base.
Back Play Yard	●	Majority of the pavement has alligator cracking, as well as longitudinal, transverse, and block cracks.
Back Concrete Stairway	●	Cinder block base is disintegrating in areas and the concrete steps are cracking and chipping. Metal railing is very rusted.
Back Mechanical Fence	●	Appears to be damage on the top portion of the fencing.
Back ADA Parking Area	●	Majority of the pavement is covered in alligator cracking. Pavement marking is also wearing off.
Northeast Parking Lot	●	Pavement covered in alligator and block cracks. Pavement markings are chipping and fading.
Climbing Area Fencing	●	Tipping over in some areas and the bottom is coming unraveled.

Playground Equipment	●	Some gravel base is missing. Some cracks in concrete pad.

Asphalt Pavement	●	Many longitudinal and transverse cracks.
Concrete Sidewalk	●	Cracks in the pavement and some settlement.
Concrete Sidewalk	●	Minimal cracking.
Fencing	●	Overgrown with trees and tipping over in areas.

Site Concrete Repairs

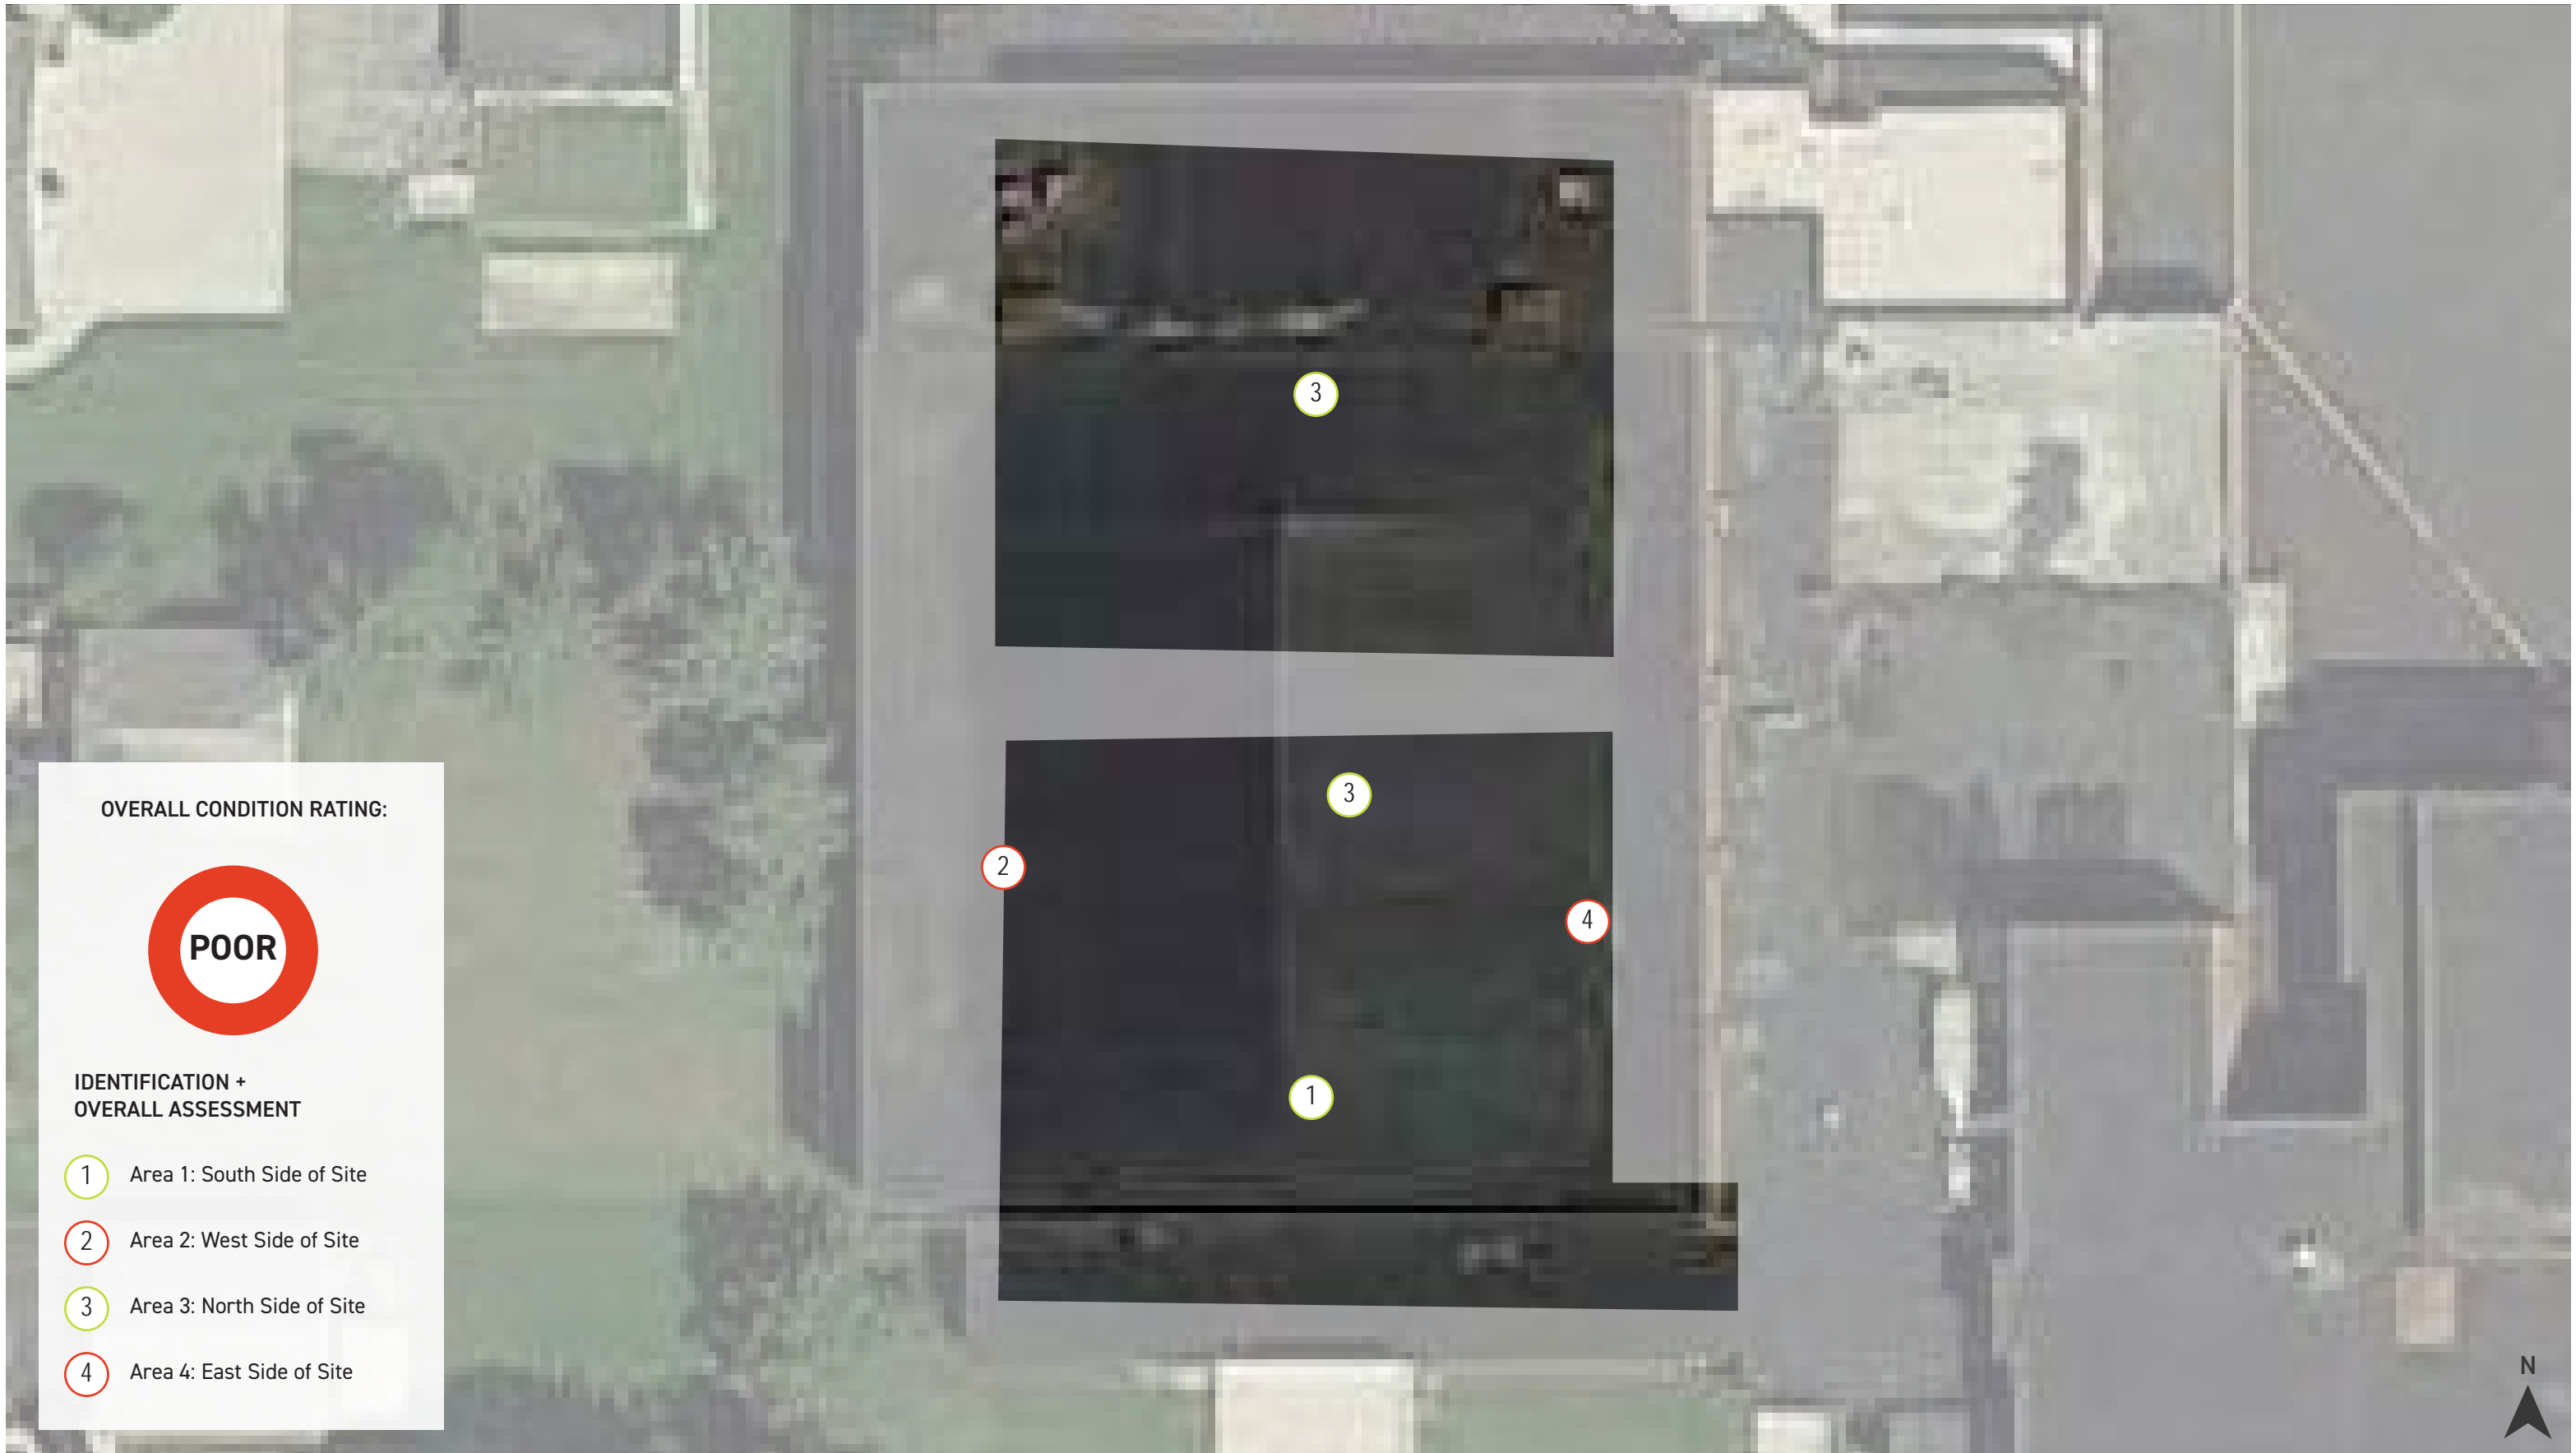
kiel middle school site assessment

Southeast Parking Lot	●	Transverse and longitudinal cracks. Areas of block cracking that have not been sealed. Some settling occurring. Pavement markings are beginning to rub off in certain areas.
Front East Sidewalks	●	Few cracks.
Front East Staircase	●	Extremely worn. Chipped concrete and rusted railings.
Front East to West Sidewalk	●	Some areas of settling and cracking.
Front Center East Sidewalk	●	Large horizontal cracks.
Front Center East Staircase	●	Many cracks and missing concrete.
Front Center West Sidewalk	●	Large cracks.
Front Center West Staircase	●	Many cracks and missing concrete.
Front Metal Stair	●	No visible rusting.
Front Concrete Ramp	●	Cracked concrete around most of the metal posts.
Front West Concrete Stair	●	Large vertical crack in foundation.
Front West Concrete Plaza	●	Concrete appears very new.
Front West Sidewalk	●	Appears old and worn with cracks throughout.

West Door	●	Appears worn and one corner has broken off.
West Fence	●	Many of the pieces are missing and the wood appears rotted and tipsy.
