kiel middle school

SUMMARY

Kiel Middle School provides a comprehensive program for 5th grade - 8th grade students.

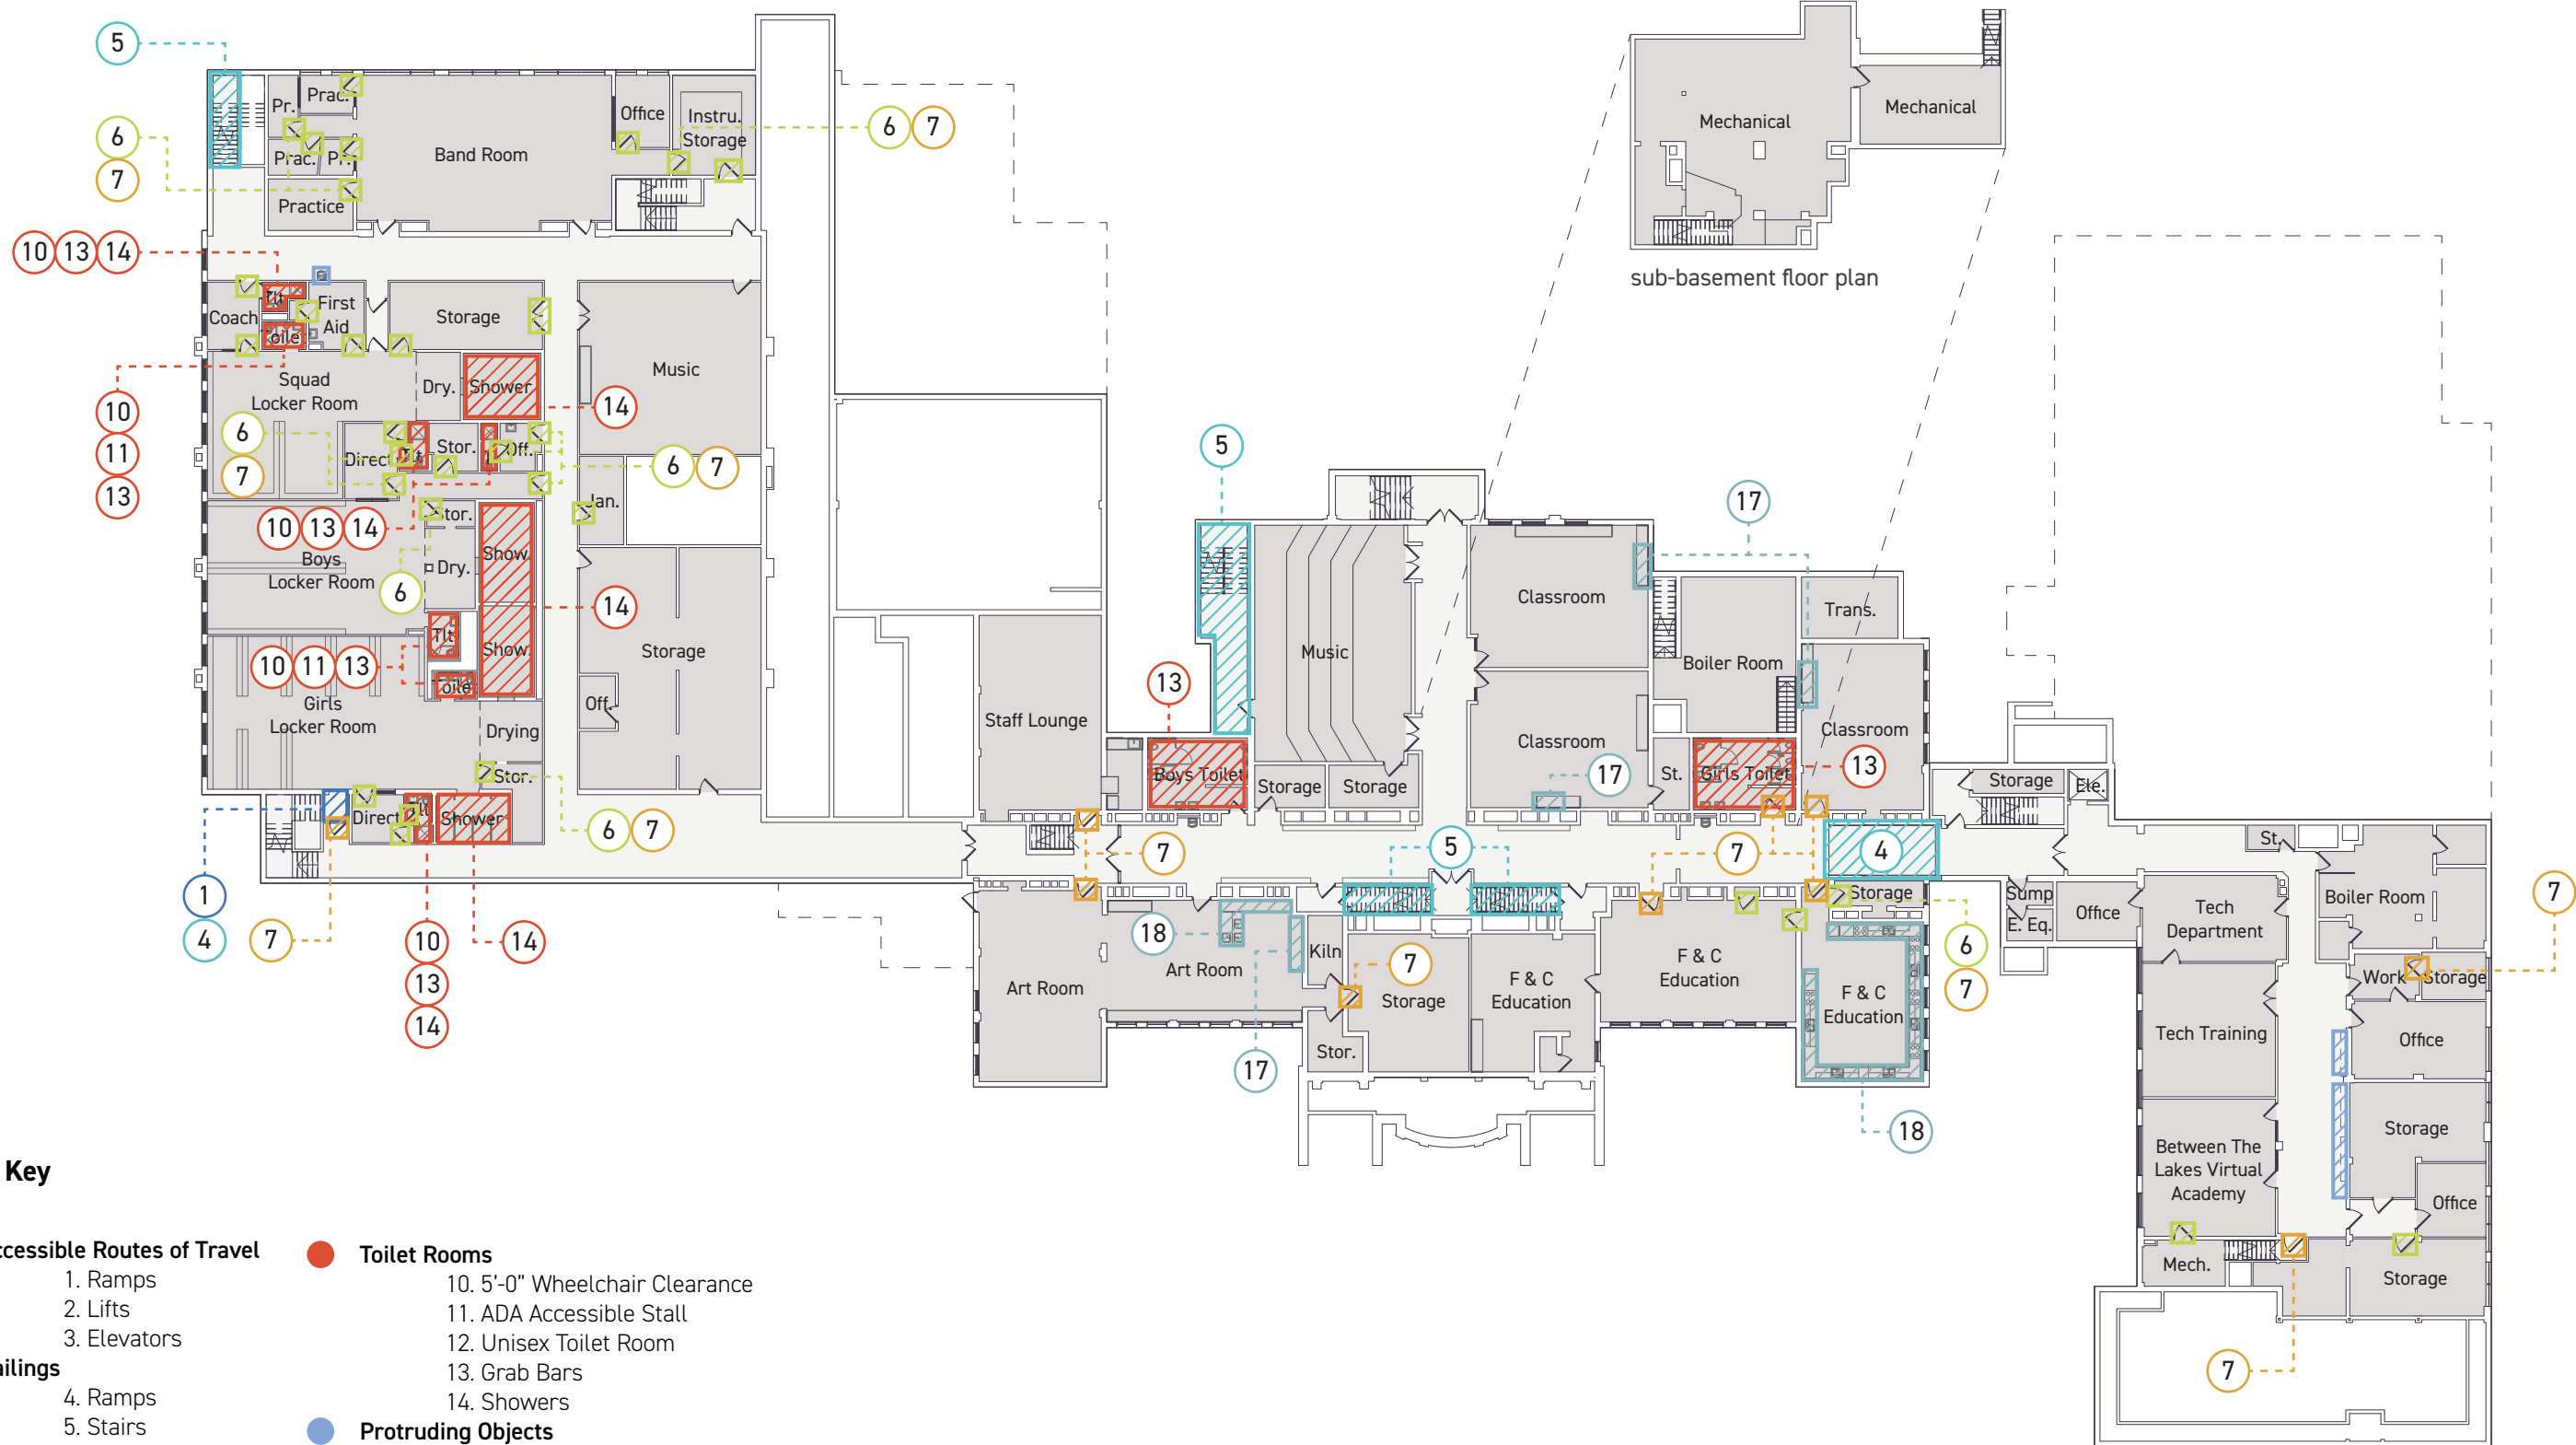
kiel middle school ada conditions + assessment | lower level

*Toilet rooms do not contain
ADA compliant stall*

*Door hardware is not
ADA compliant*
