zielanis elementary

SUMMARY

zielanis elementary building systems summary

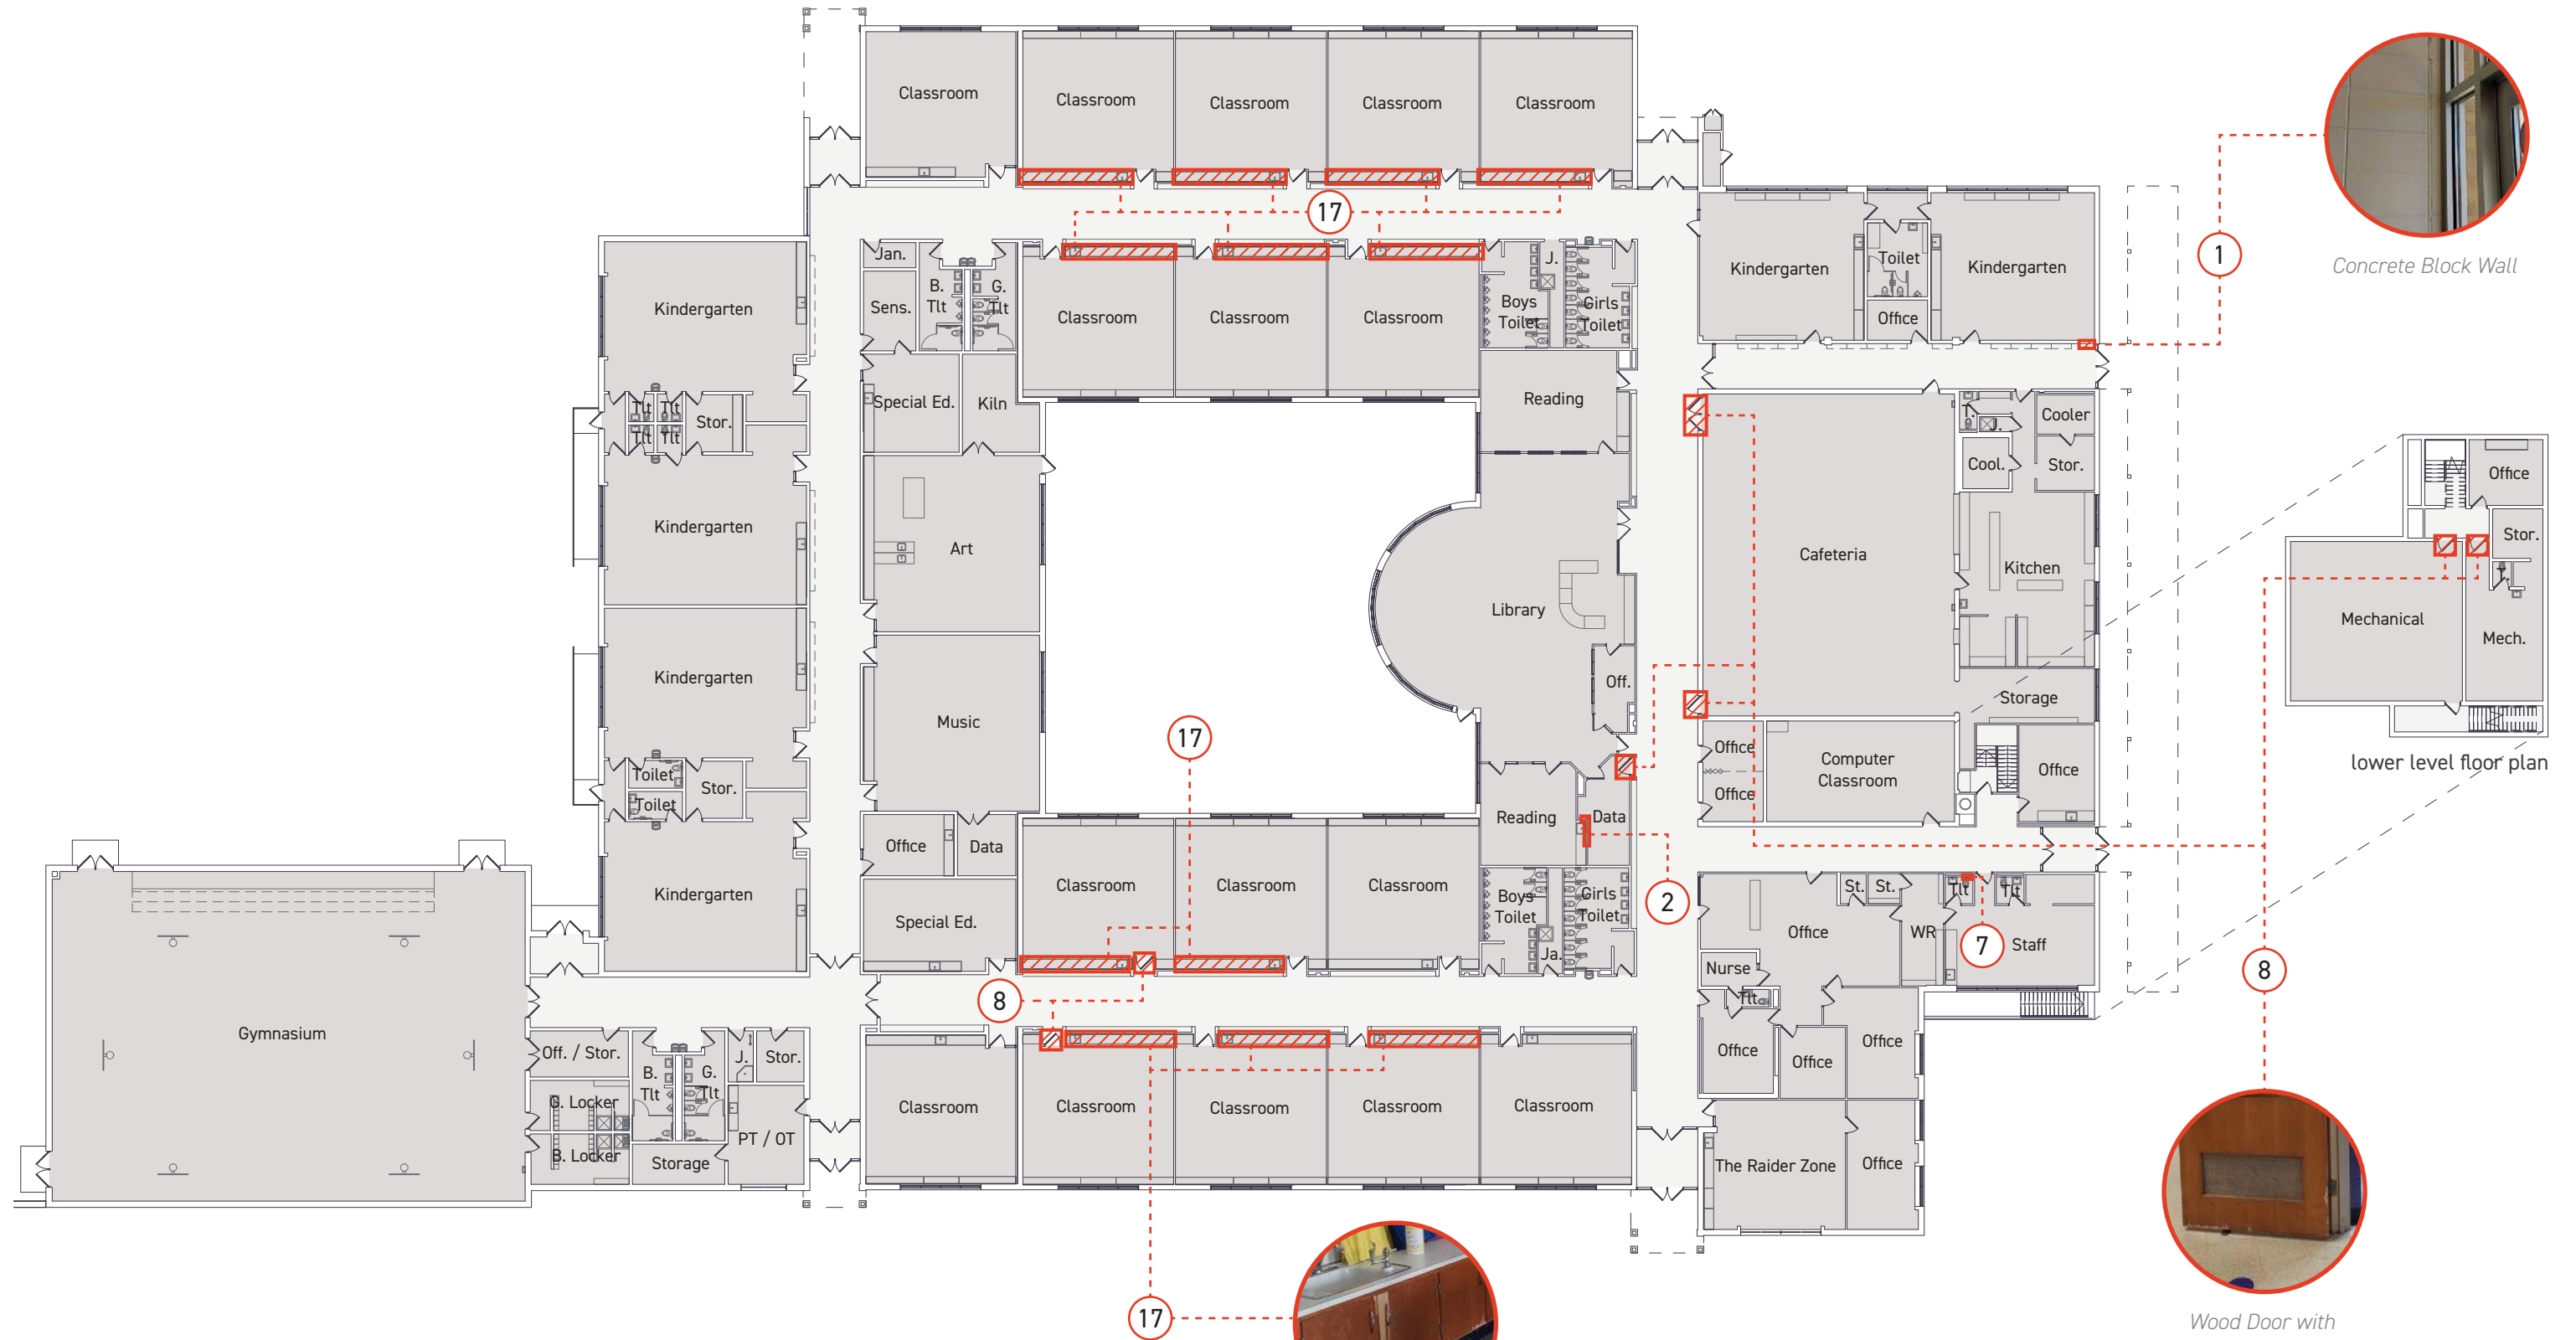
zielanis elementary interior identifications + analysis | first floor

- Majority of laminate casework located within classrooms appears to be newer and in good condition.
- Wood and laminate casework located within classrooms is in poor condition to due to surface scratches and finish peeling off.
- Majority of the wood doors located throughout the building are in fair condition.
- There are few instances of concrete block walls cracking and crumbling.

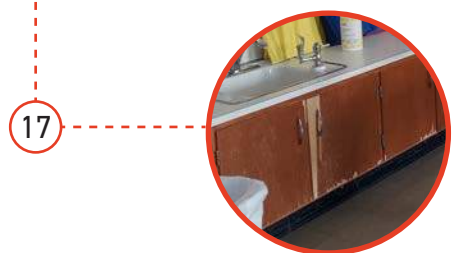
Wood and Laminate Casework

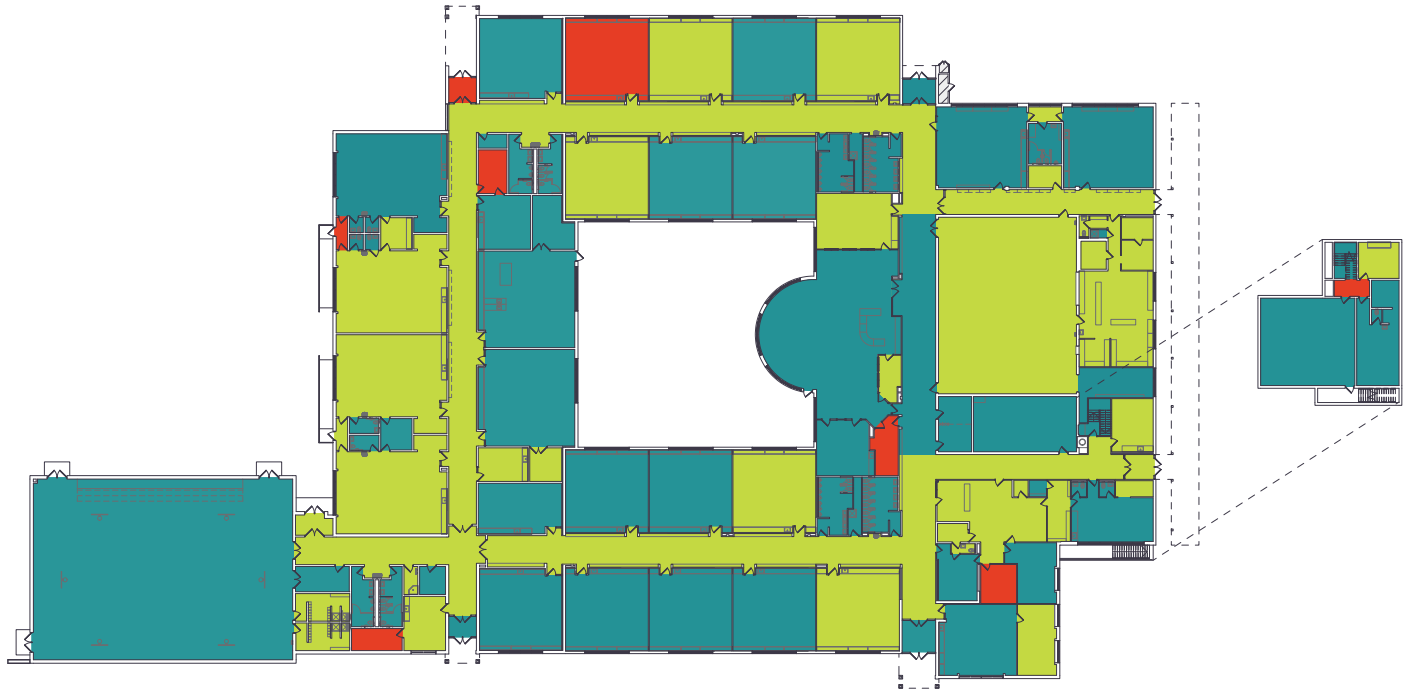
First Floor

- Acoustical tile ceilings in the corridors and some classrooms are in fair condition due to having instances of stained or cracked tiles.
- Insulation board ceiling in the cafeteria is in fair condition due to having instances of staining.
- There are instances of acoustical tile ceilings in poor condition due to stained tracks.

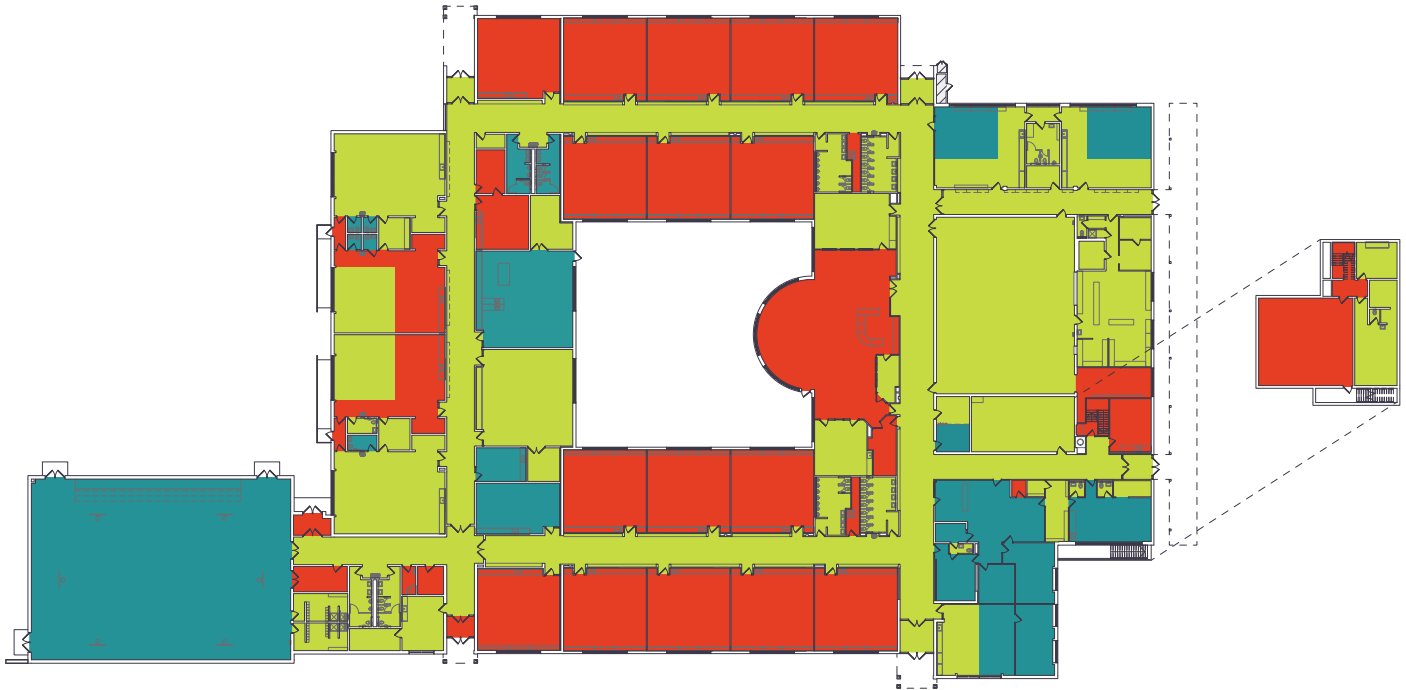
First Floor

- Carpeting in the library is in poor condition due to staining and zippering.
- Concrete flooring and stairs in mechanical and storage areas are in poor condition due to cracking, staining, and paint peeling off.
- 9" x 9" vinyl tile is identified as a material potentially containing asbestos.
- Materials identified as potentially containing asbestos are considered to be in poor condition.

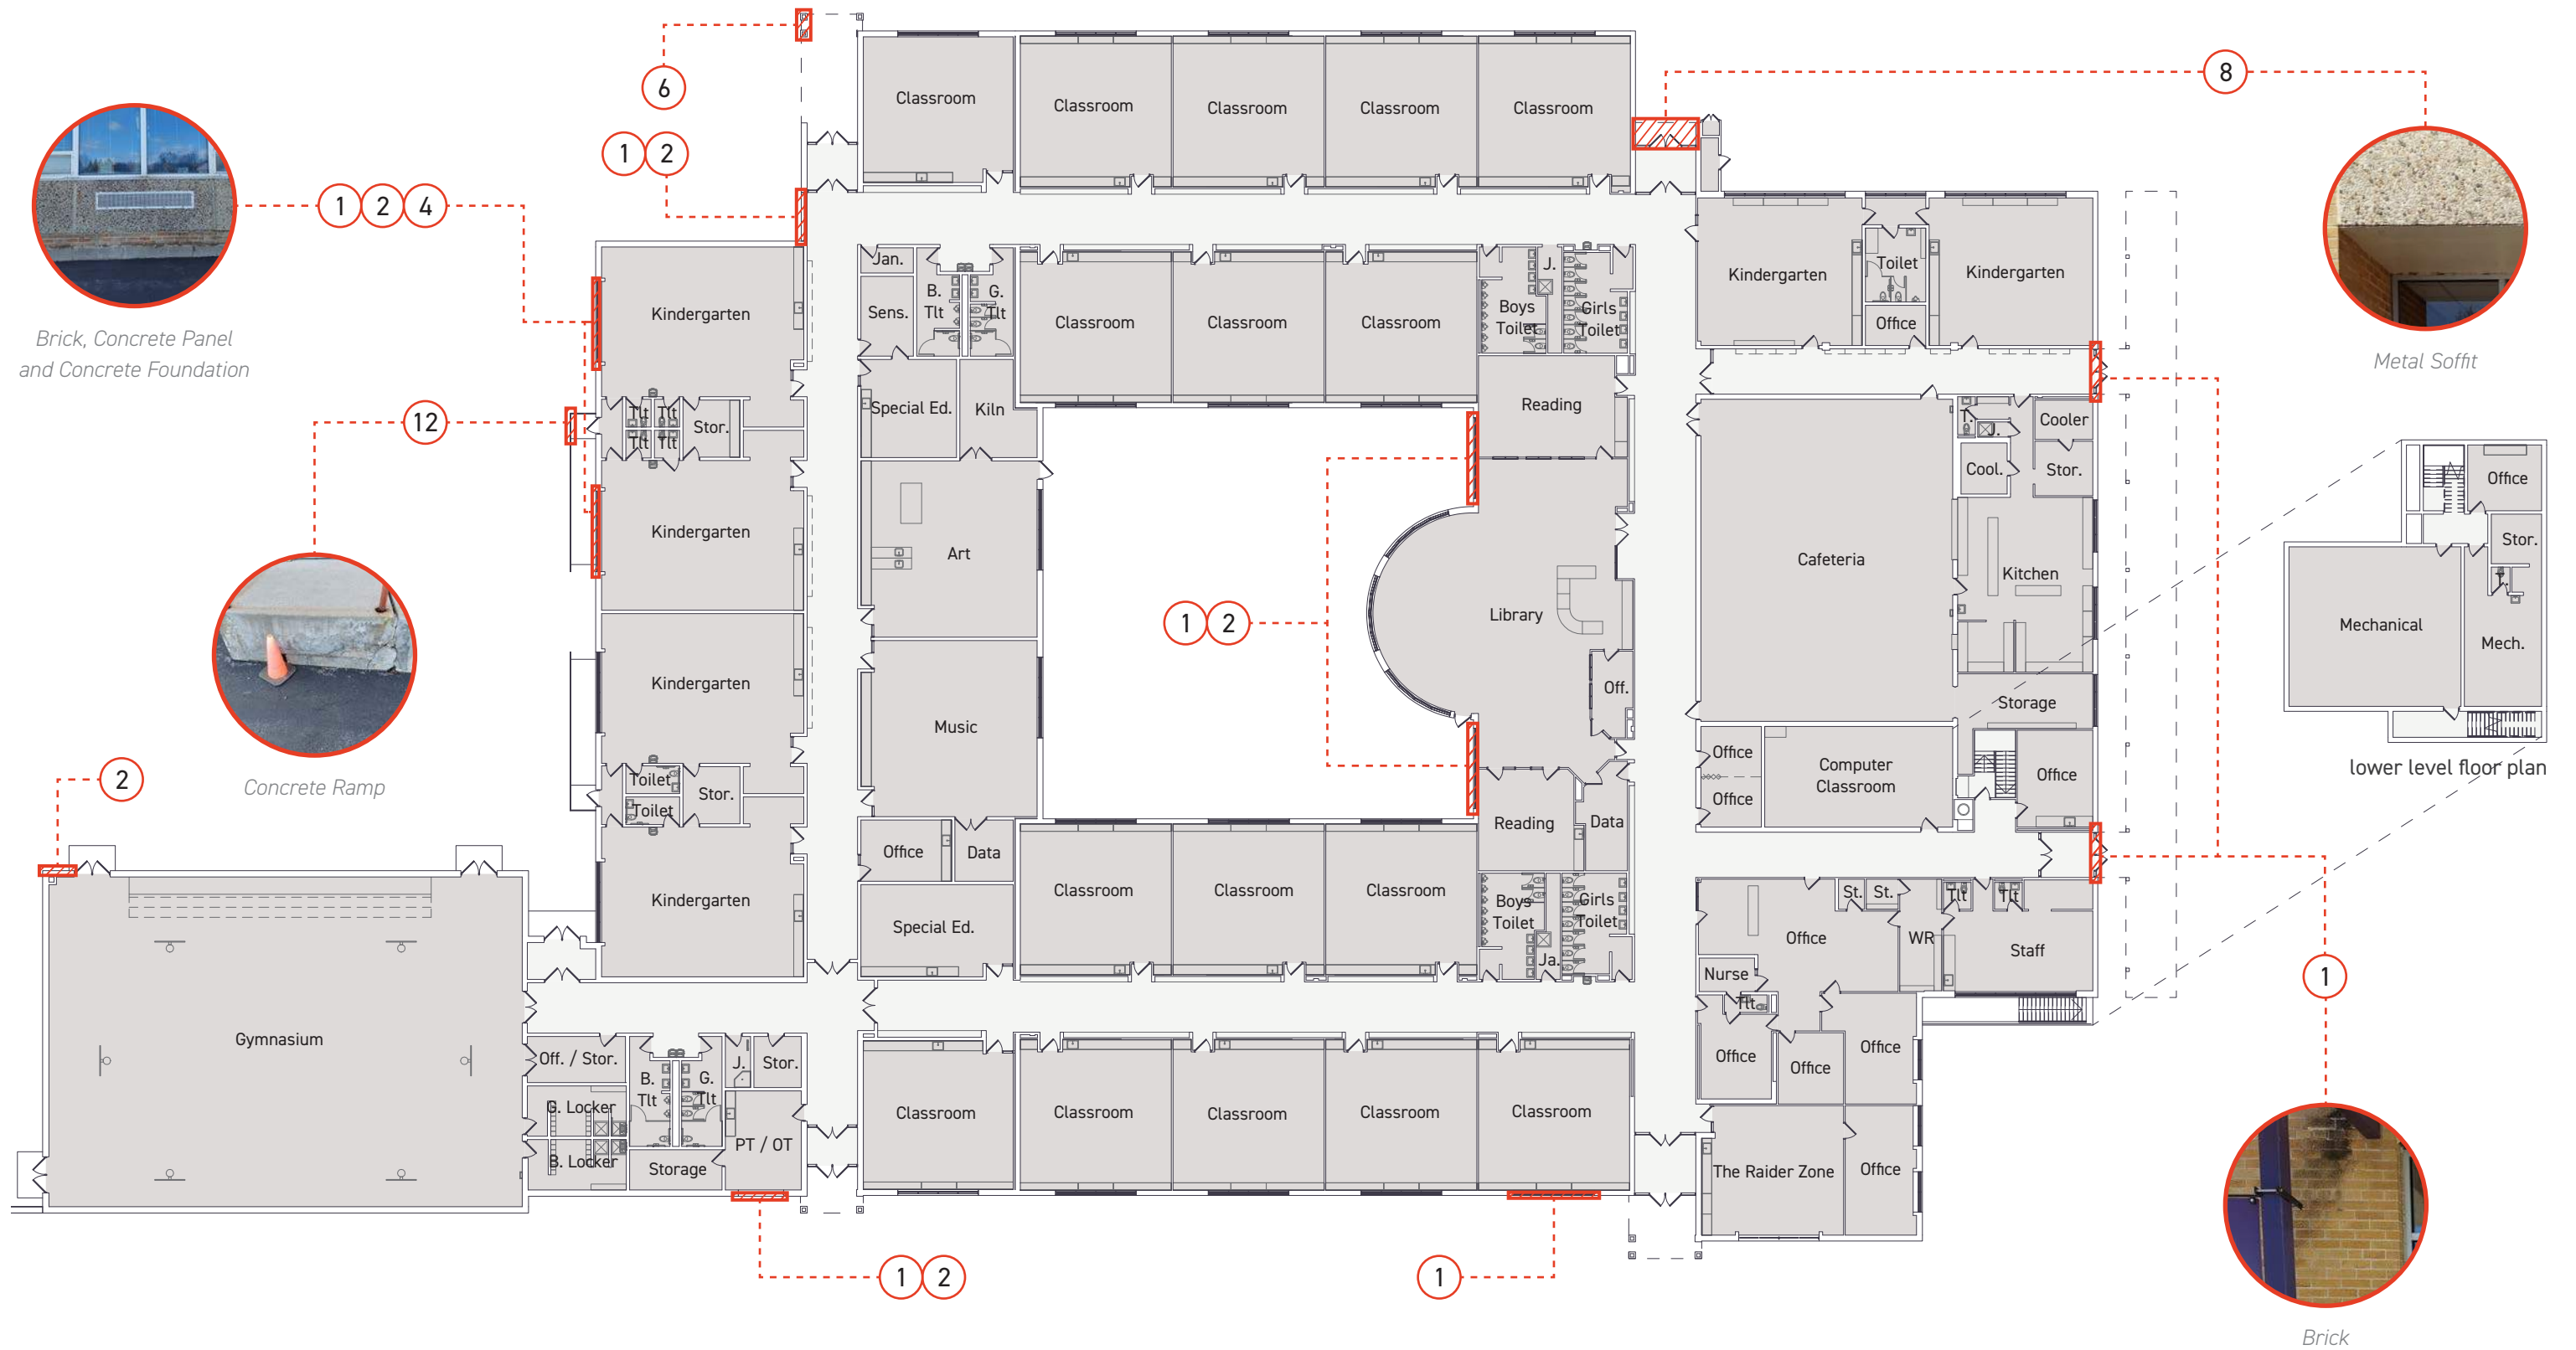
zielanis elementary exterior identifications + analysis

- Majority of the exterior concrete wall panels are in fair condition due to staining.
- The metal soffit is in poor condition due to rusting.
- The concrete ramp is in poor condition due to cracking and crumbling.
- Majority of bricks are in fair condition due to instances of staining, especially near windows and openings.

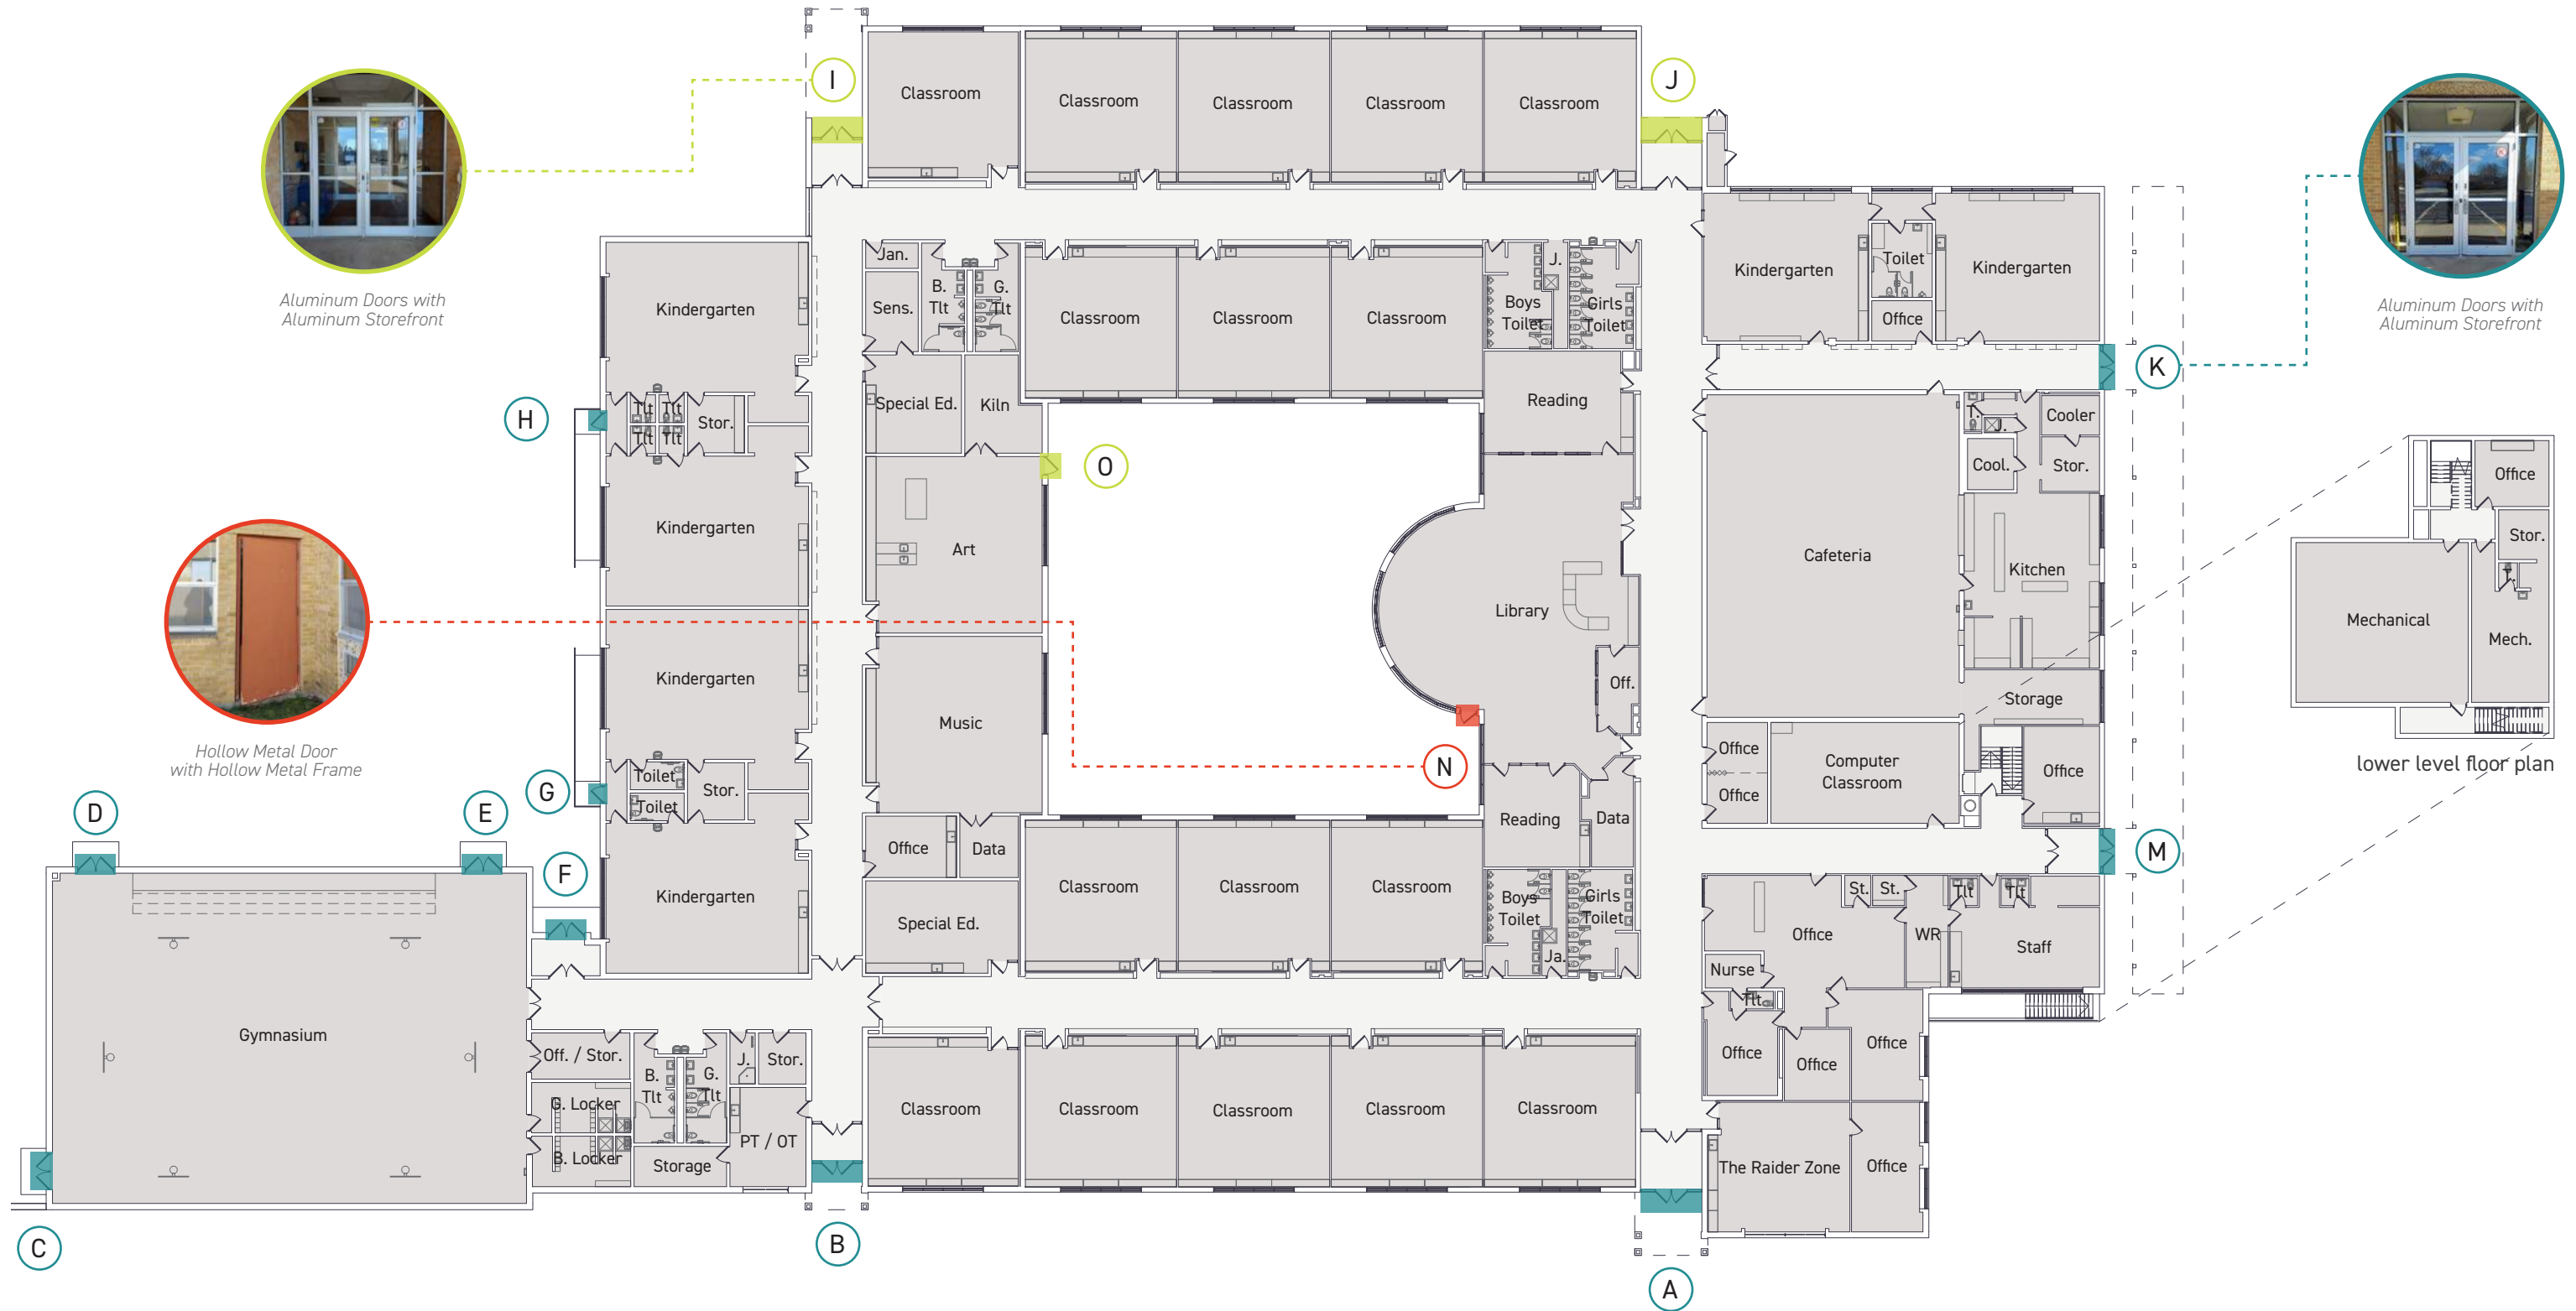
zielanis elementary exterior door identification + analysis

- Majority of aluminum doors with aluminum storefront framing are in good condition.
- Door N is in poor condition due to rusting, denting, and paint peeling off.
- Doors I and J are in fair condition due to denting and surface scratches.

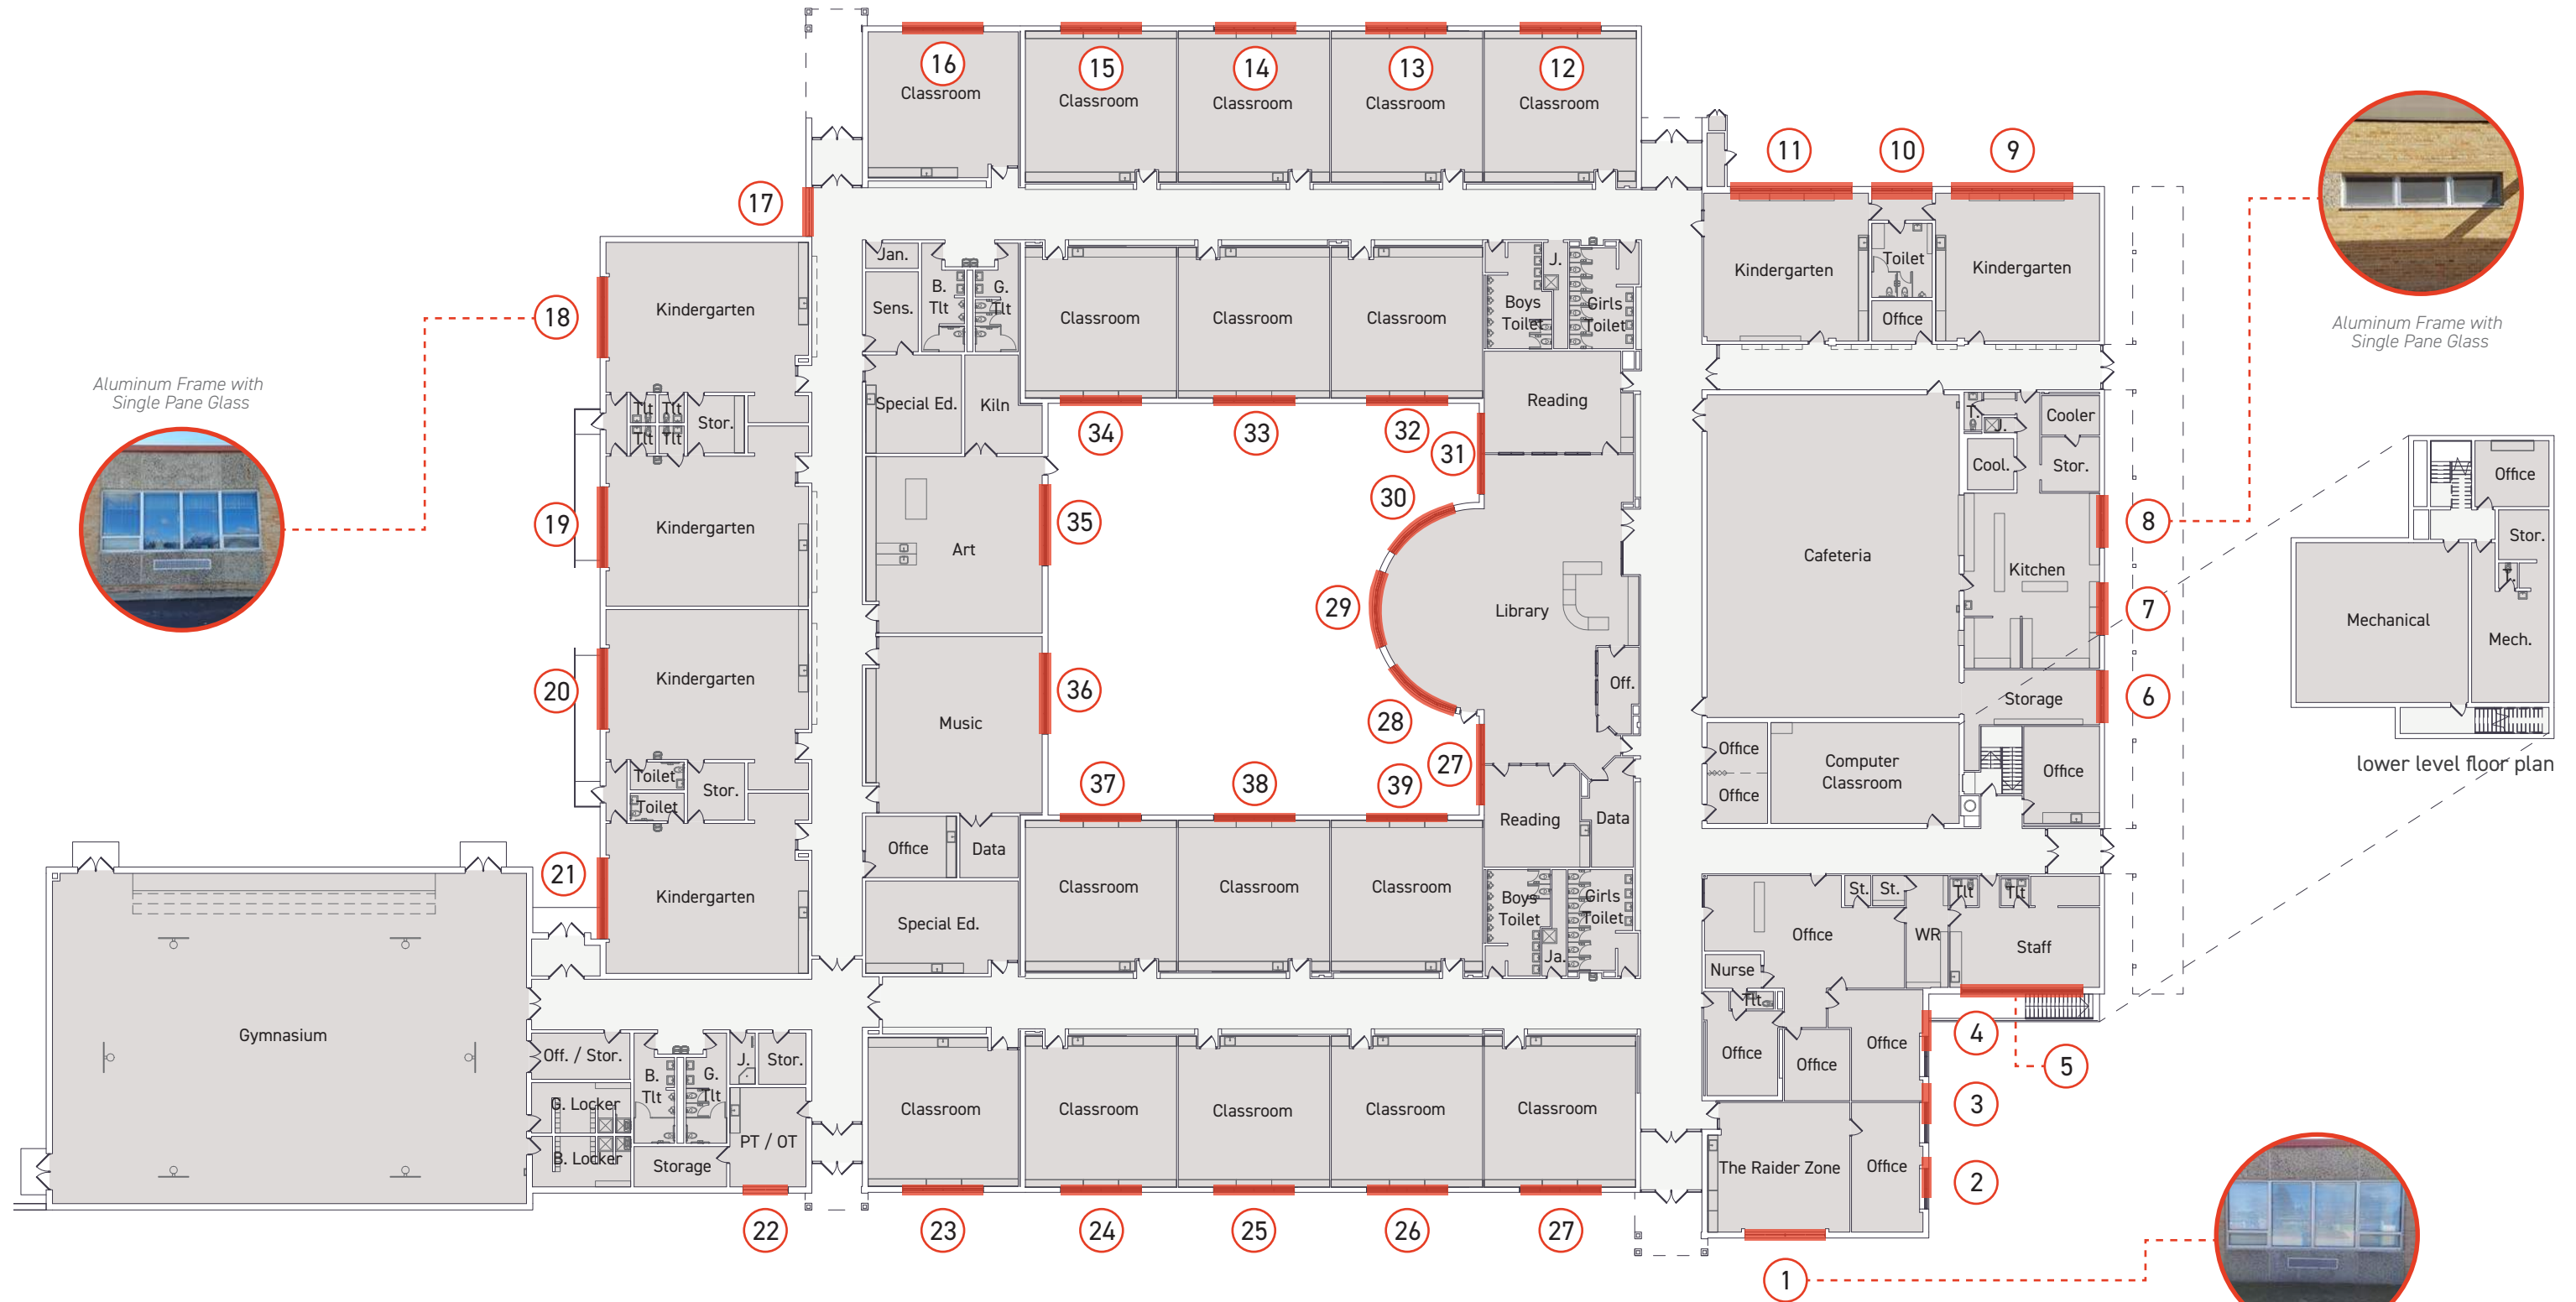
zielanis elementary exterior window identification + analysis

- Some windows have additional sliding windows and/or tackboards on the interior side of the window. Any glass within these sliders is single pane.
- There is an instance of staining at window 36.
- Windows containing single pane glass are considered as in poor condition.

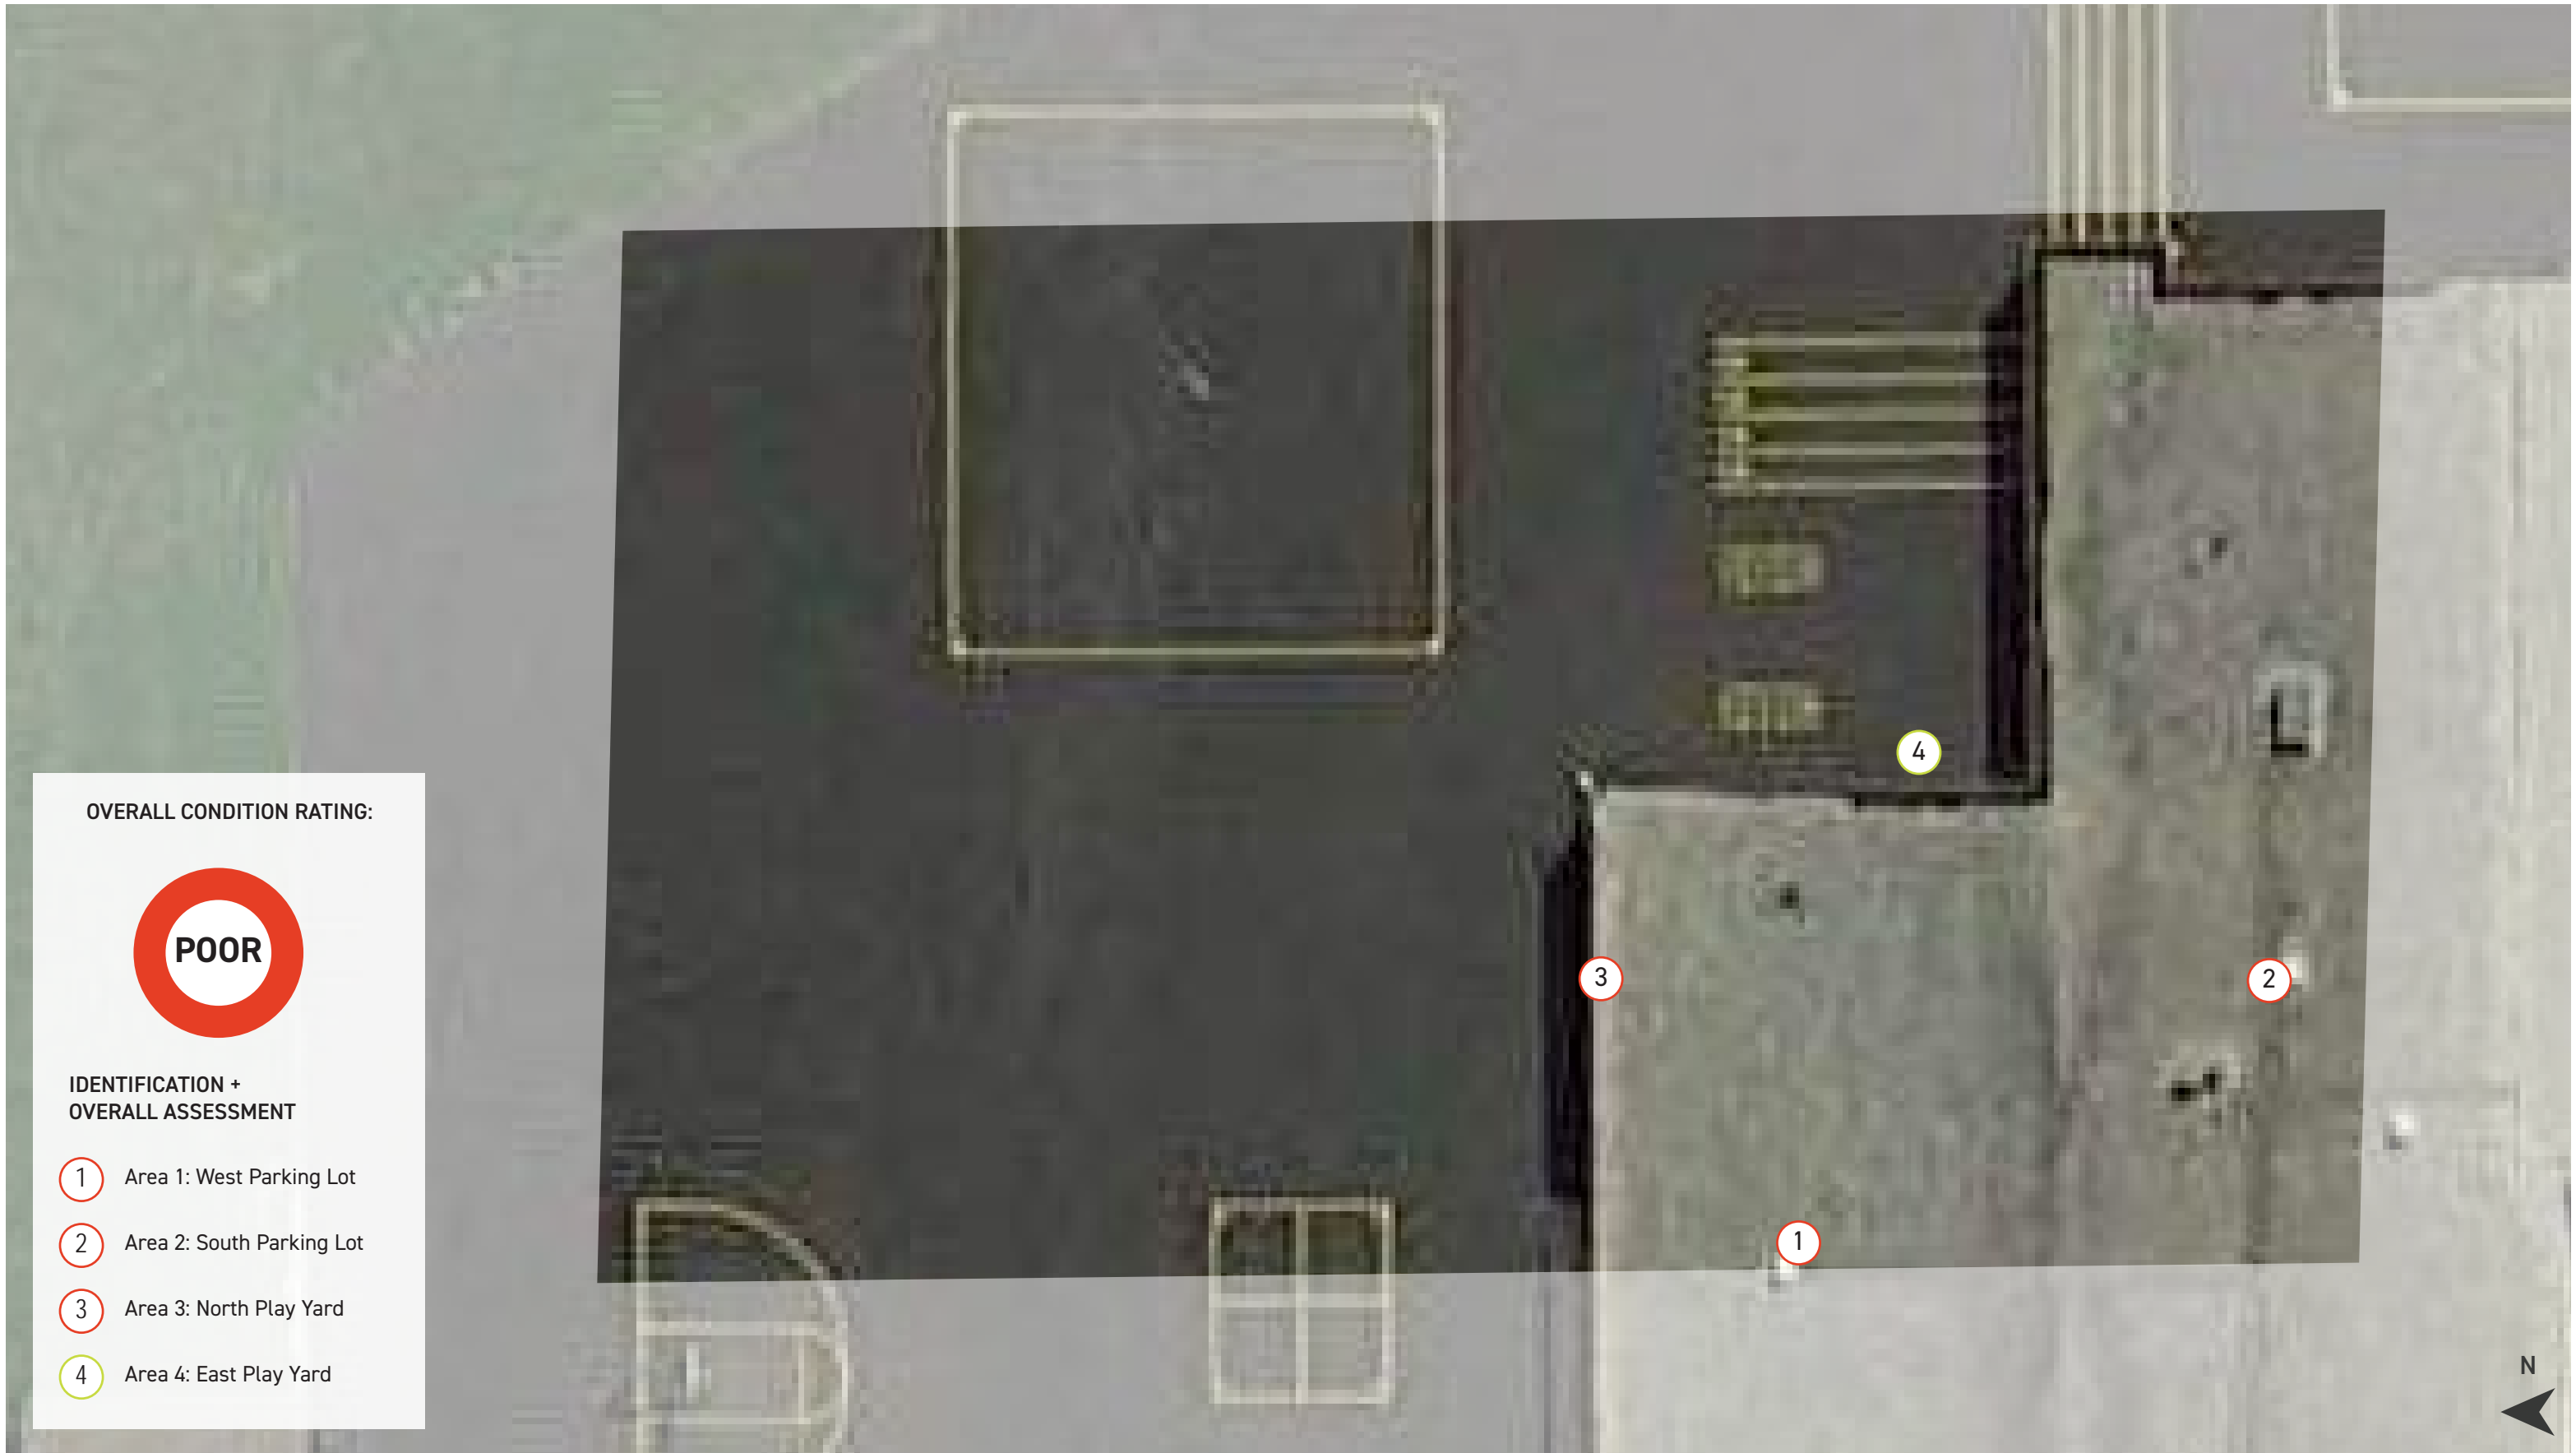
zielanis elementary site assessment

| Asphalt Driveway | ● | Driveway aprons have edge cracking on all edges and cracking in the concrete gutter. |
| Asphalt Parking Lot | ● | North end has alligator and block cracking. There are large areas covered in crack sealant, and many of the sealed cracks are expanding. |
| Concrete Sidewalk | ● | Severely cracking and uneven in multiple areas. |
| Curb + Gutter | ● | Extremely worn and many pieces of concrete are breaking off. |

| Asphalt Parking Lot | ● | Several areas of severe alligator cracking. Settlement is causing additional cracking, such as longitudinal, transverse, and block. |
| Concrete Sidewalk | ● | Appears very worn with some areas of cracking concrete. |
| Curb | ● | Gaps between sections and pieces of concrete broken off. |

| Asphalt Play Area | ● | Longitudinal cracking and settling towards the middle. Fading pavement markings. |
| Concrete Ramps | ● | Severe cracking and rusting metal railings. |

| Asphalt Play Yard | ● | Several cracks and settling in the pavement. Many of the cracks that are sealed are opening again. Fading pavement markings. |
| Fencing | ● | Several broken links. |

Parking Lot Repair
