zielanis elementary

SUMMARY

zielanis elementary building systems summary

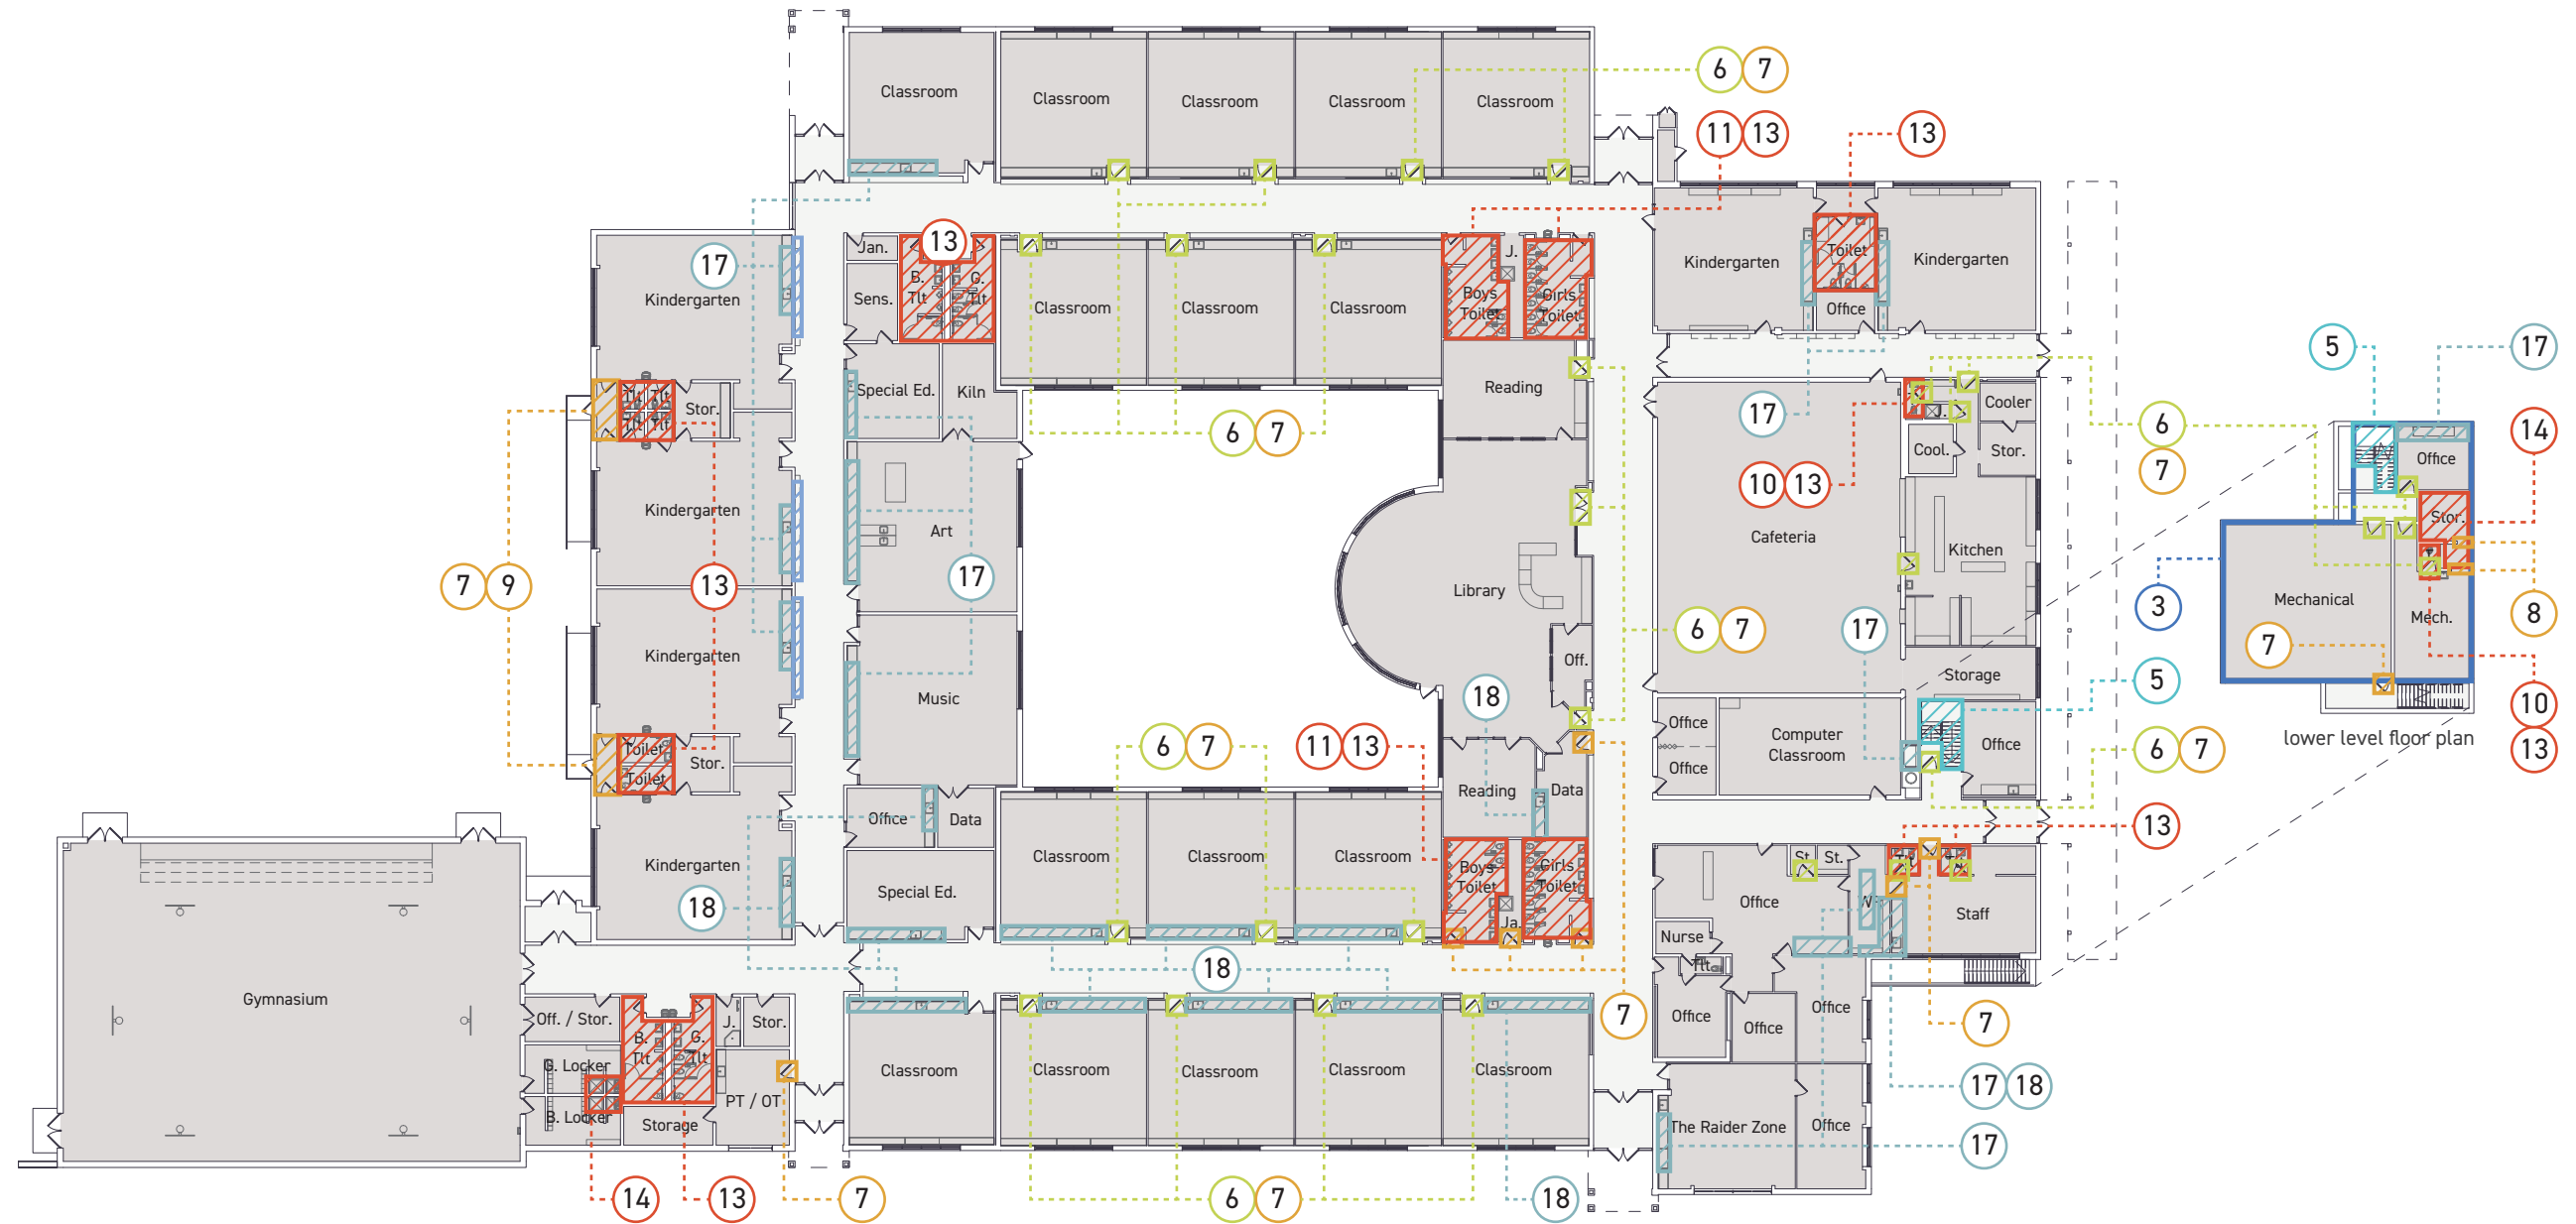
zielanis elementary ada conditions + assessment | first floor

*There is an inaccessible route of
travel between floor levels*

*Door hardware is not
ADA compliant*
