# Kiel Area School District

District-wide Facilities Study

# STUDY DOCUMENT

August 2022

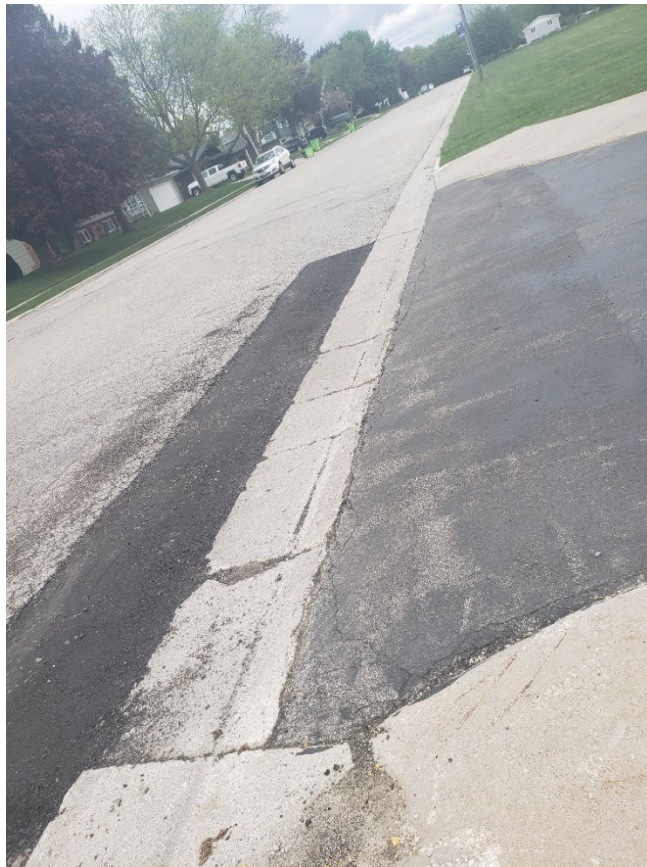
The West Parking Lot consists of two asphalt driveways, an asphalt parking lot and concrete sidewalk. The asphalt is in poor condition. Both asphalt driveway aprons have edge cracking on all edges (*Figure 2*), as well as cracking in the concrete gutter. The north end of the parking lot has an area that is settling causing alligator and block cracking (*Figure 3*). The pavement has longitudinal and transverse cracking in several areas and some edge cracking. The surface has large areas covered in crack sealant, and many of the sealed cracks are expanding (*Figure 4*). The sidewalk is severely cracked and uneven in multiple areas and is in poor condition (*Figure 5*). The concrete curb and gutter throughout the lot is extremely worn and many pieces of concrete are breaking off (*Figure 6*). It is in poor condition. The pavement markings are also in poor condition and are chipped and fading.

*Figure 2: NW Driveway apron in fair condition.*

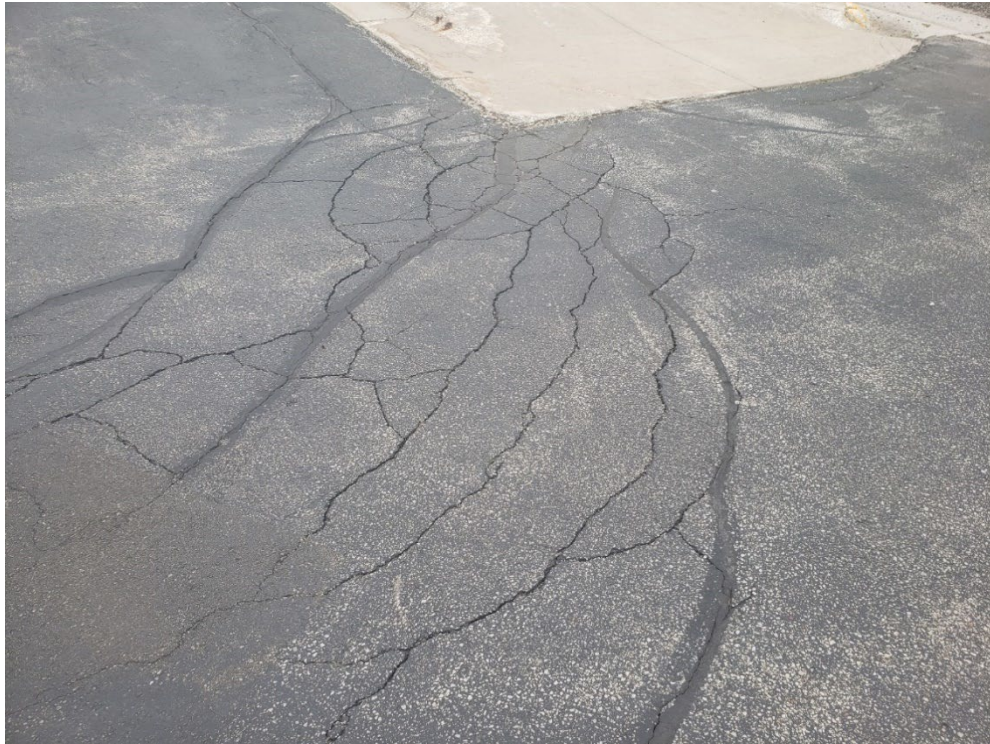
*Figure 3: Cracked pavement on the North portion of West parking lot.*

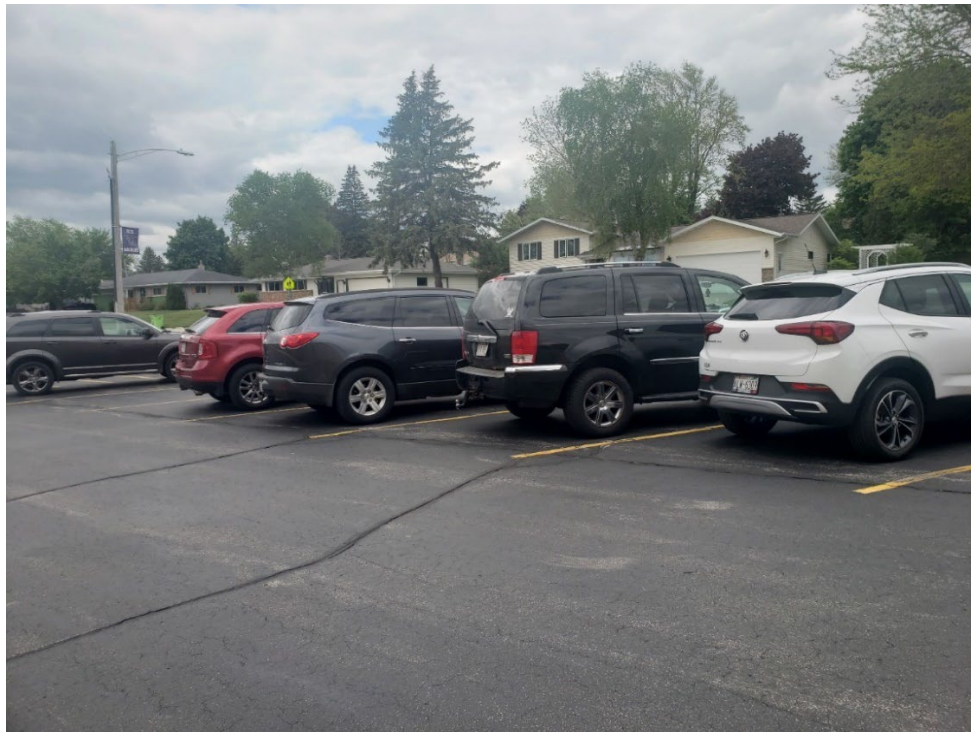
*Figure 4: Transverse crack in West parking lot.*

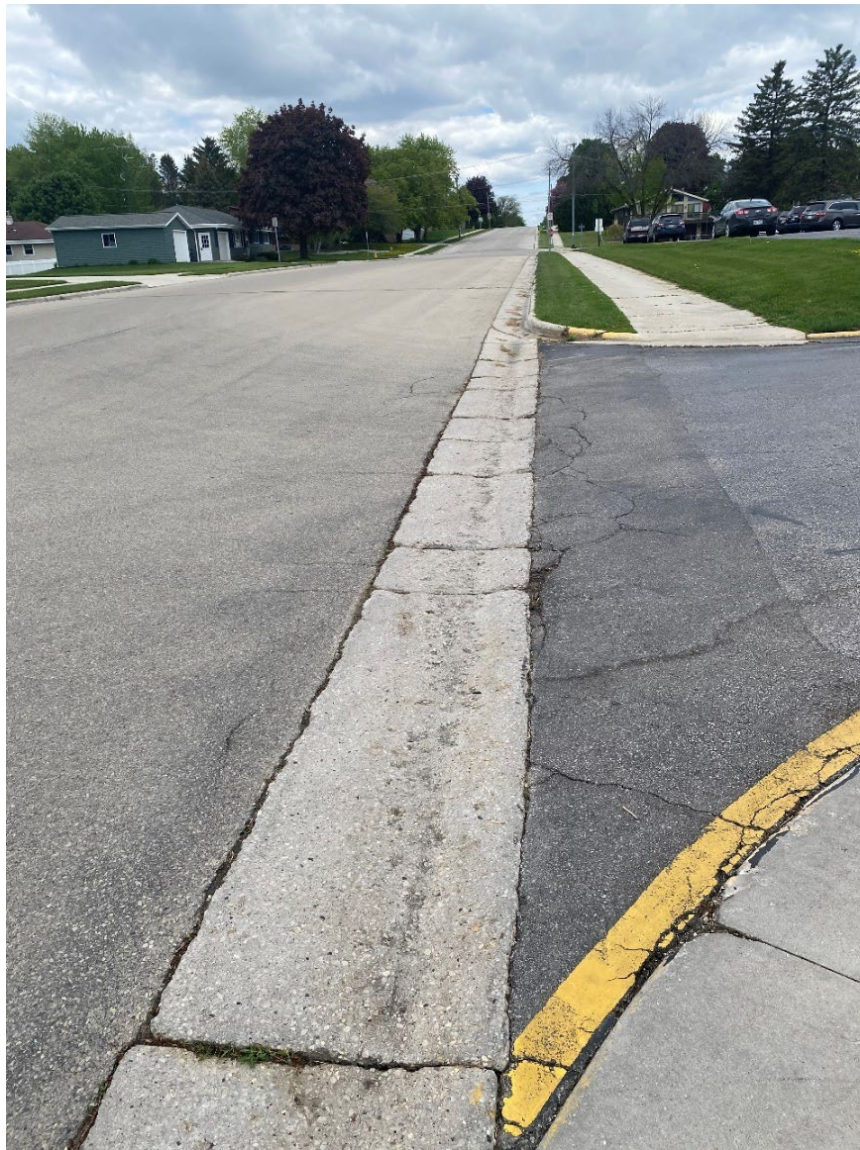
The South Parking Lot consists of an asphalt parking lot and drive loop, and sidewalk on the north, east and west sides. The asphalt driveway aprons at entry and exit, and the concrete driveway gutters are in poor condition (*Figure 7*). There are several areas of severe alligator cracking throughout the lot (*Figure 8*). There appears to be settlement in many areas causing additional cracking such as longitudinal, transverse and block (*Figure 9*). The sidewalks appear very worn but are in fair condition with some areas of cracking concrete (*Figure 10*). The concrete curb is in poor condition throughout due to gaps between sections and pieces of concrete broken off (*Figure 11*). The trash enclosure gate on the north-east portion of the south parking lot is uneven (*Figure 12*).

*Figure 7: South driveway apron*

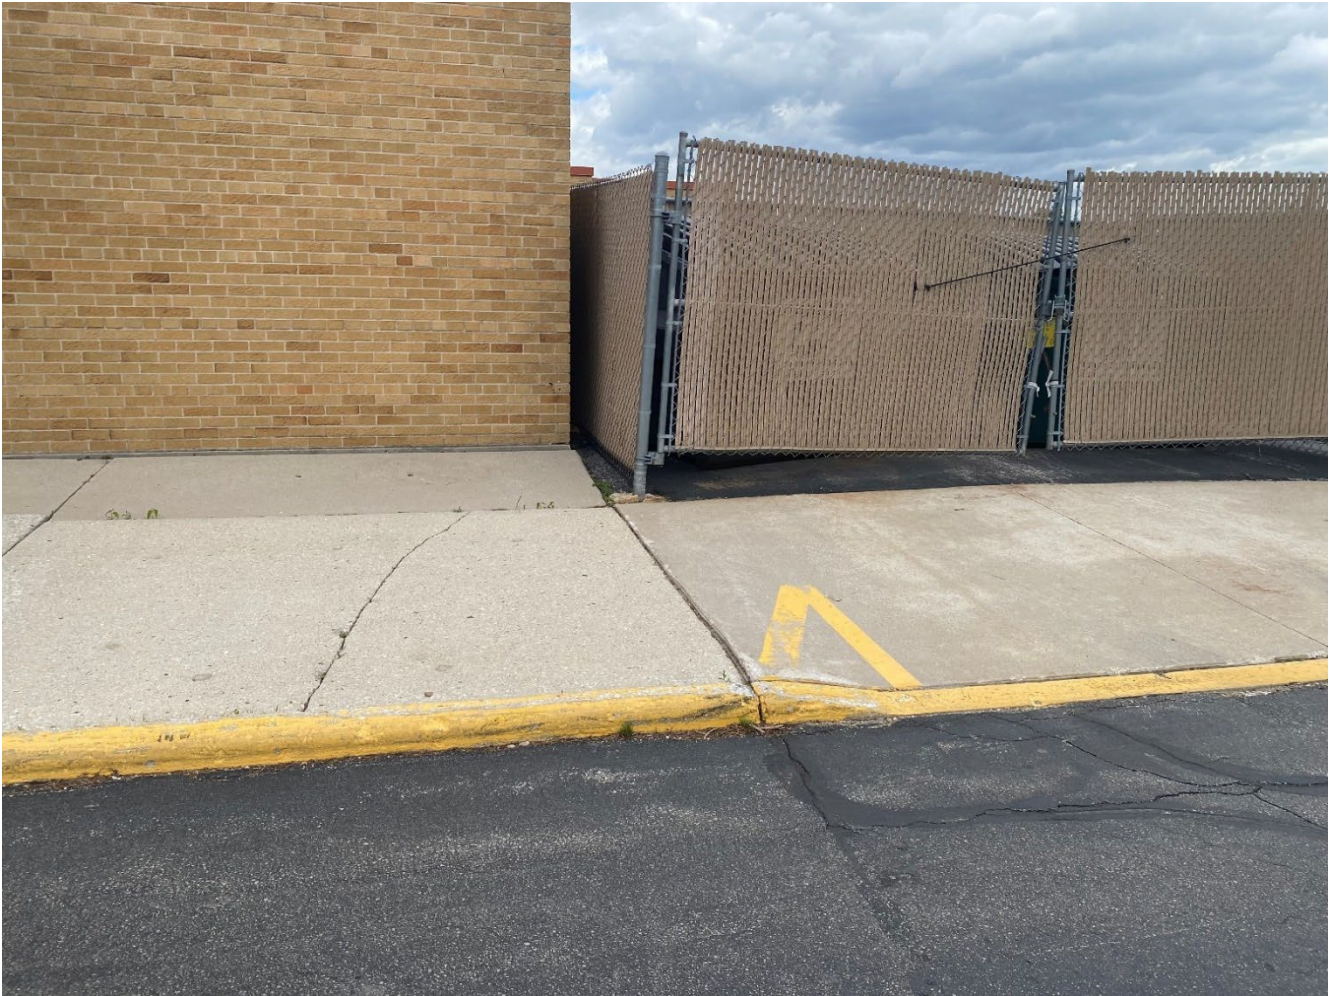
*Figure 12: Trash enclosure near north-east corner of south parking lot*

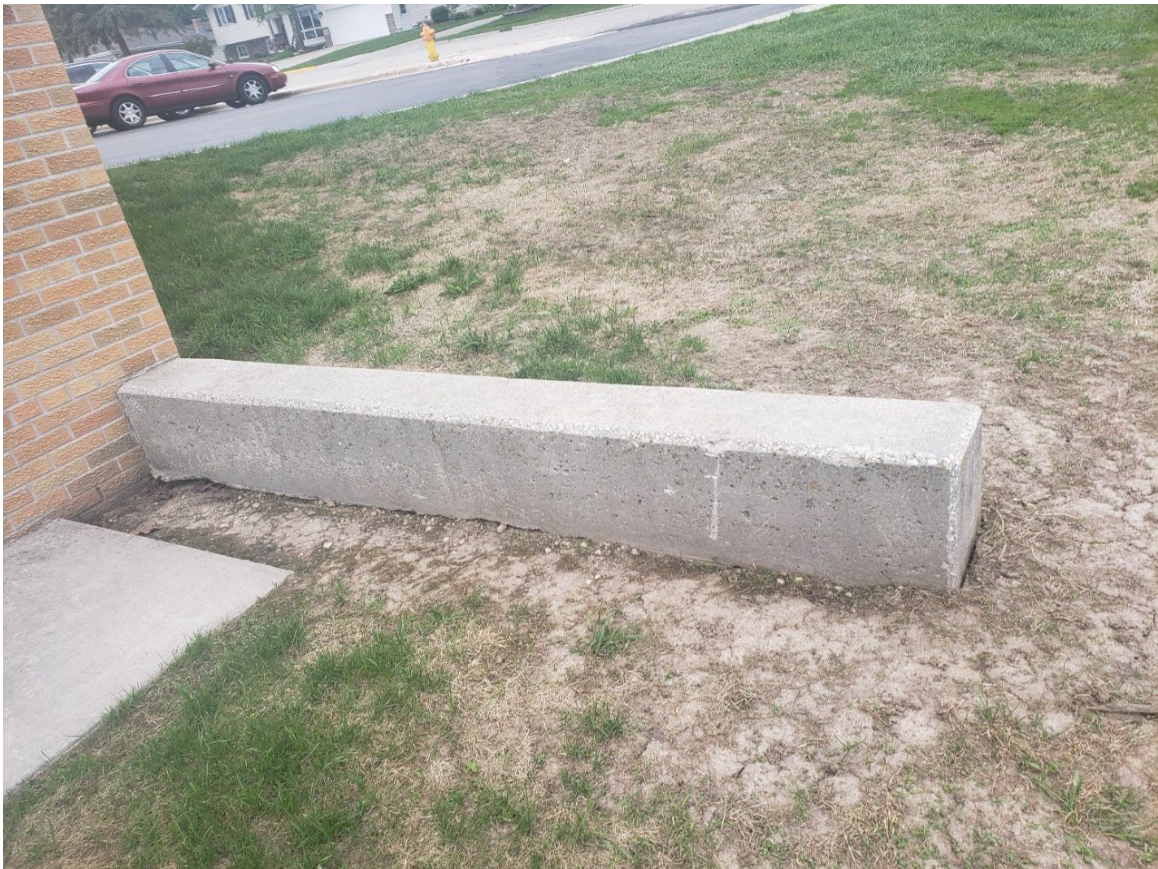
The North Play Yard consists of an asphalt play area, ball field with fencing and a covered picnic table pad. The concrete seating area extending off the north-west corner of the building has some chipped edges (*Figure 13*). The ball field is poorly maintained and covered with weeds (*Figure 14*). The ball field fencing needs to be repaired/replaced due to a wire hanging off the bottom (*Figure 15*). The existing asphalt swale on the north-east portion of the yard is deteriorated and in very poor condition (*Figure 16*). The picnic table pad is in good condition with no cracking present (*Figure 17*). The north portion of the asphalt play yard is in poor condition with longitudinal cracking and settling towards the middle (*Figure 18*). The pavement markings are fading in the asphalt play yard (*Figure 19*). The concrete ramps on the north portion of the building are in very poor condition with severe cracking (*Figure 20*). The metal railings on the ramp are rusting and becoming completely separated from the concrete ramp. This is causing sharp edges to be exposed near the base (*Figure 21*).

*Figure 13: Concrete seating area*

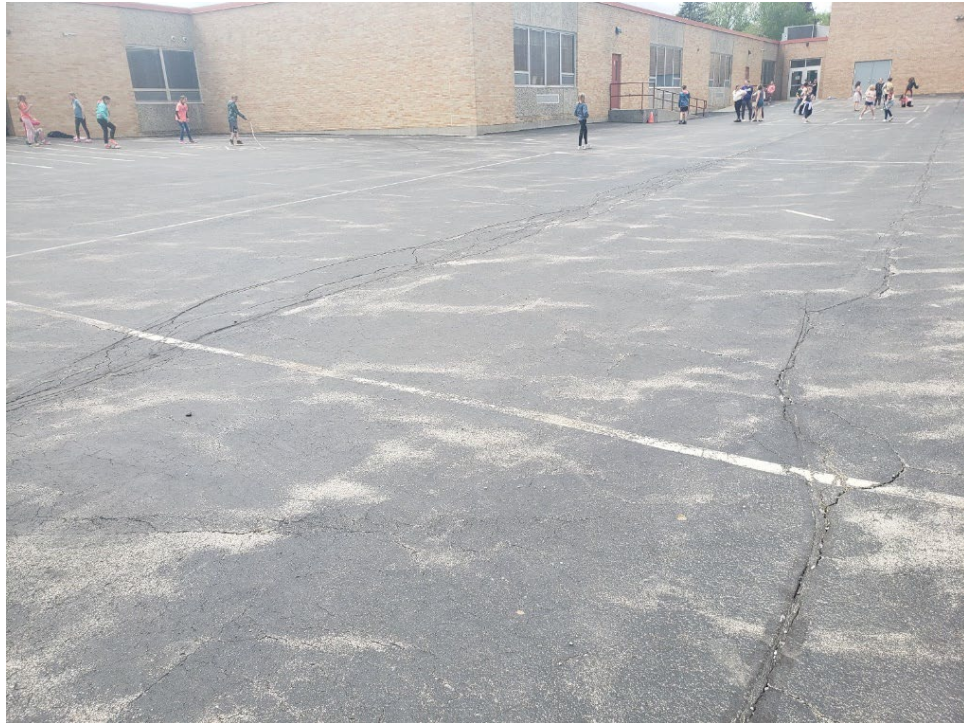
*Figure 18: Longitudinal cracking and settling in the north play area*

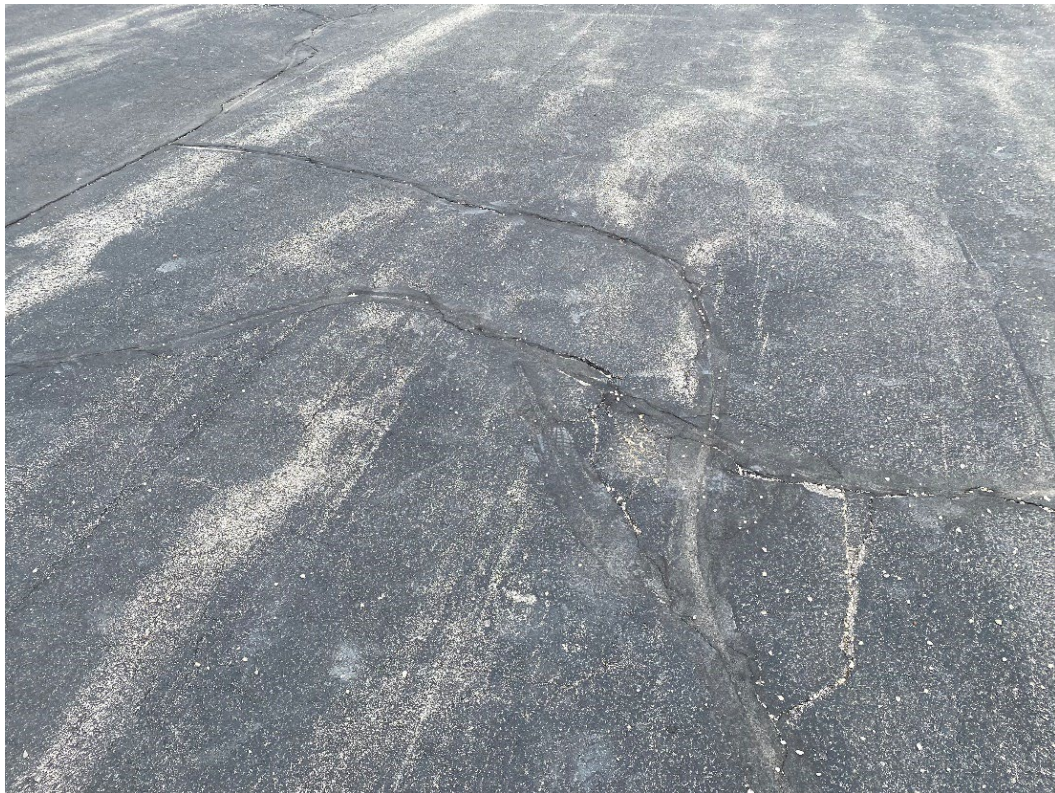
*Figure 24: Cracks in play area surface*

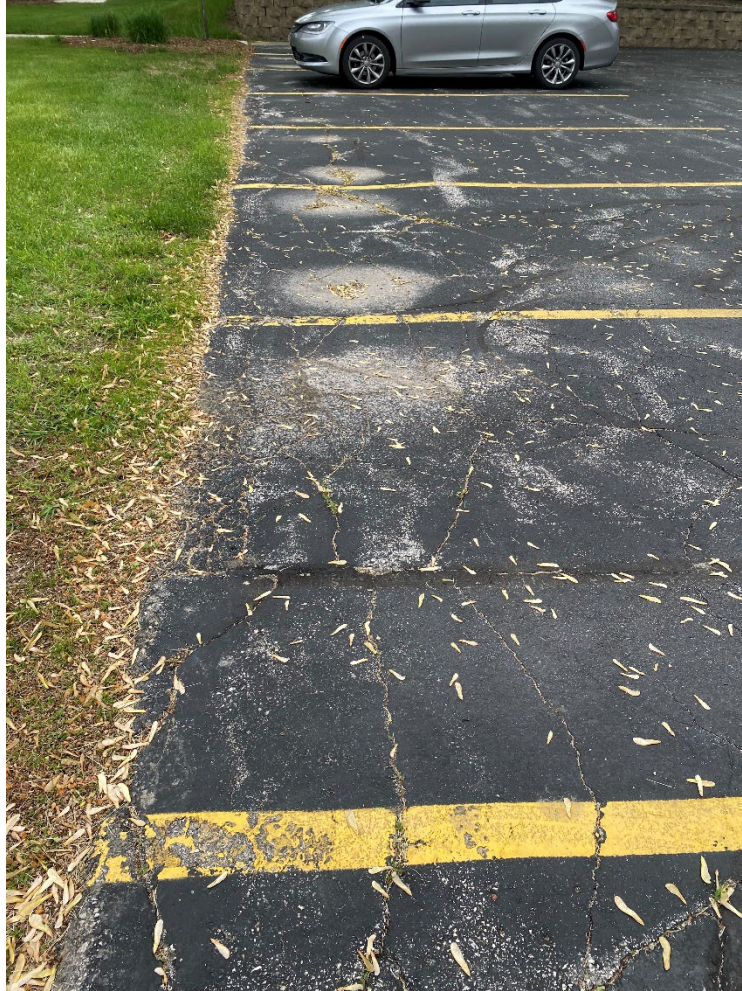
*Figure 3: Pavement settling occurring in southeast parking lot.*

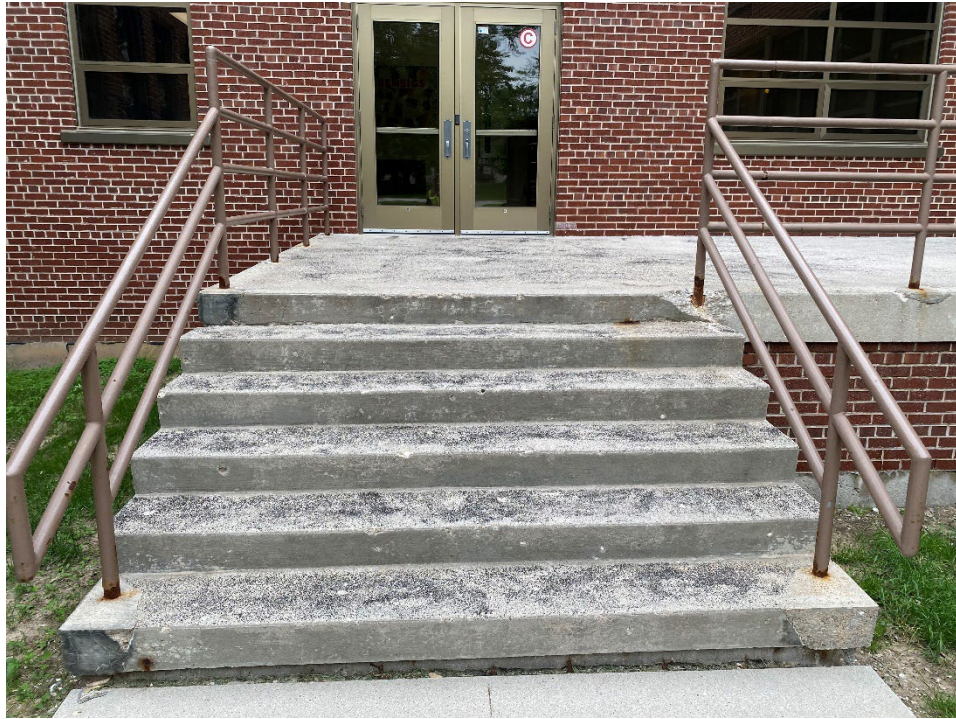
The concrete sidewalk from the bottom of the staircase to Paine Street appears to be in good condition with few cracks. Many of the slabs appear new. The concrete staircase and landing are extremely worn and in poor condition (Figure 4). There is a lot of chipped concrete, and the railings are rusted (Figure 5). The grass in this area has areas of exposed soil where no grass is growing.

Figure 4: Front east stairs in poor condition.

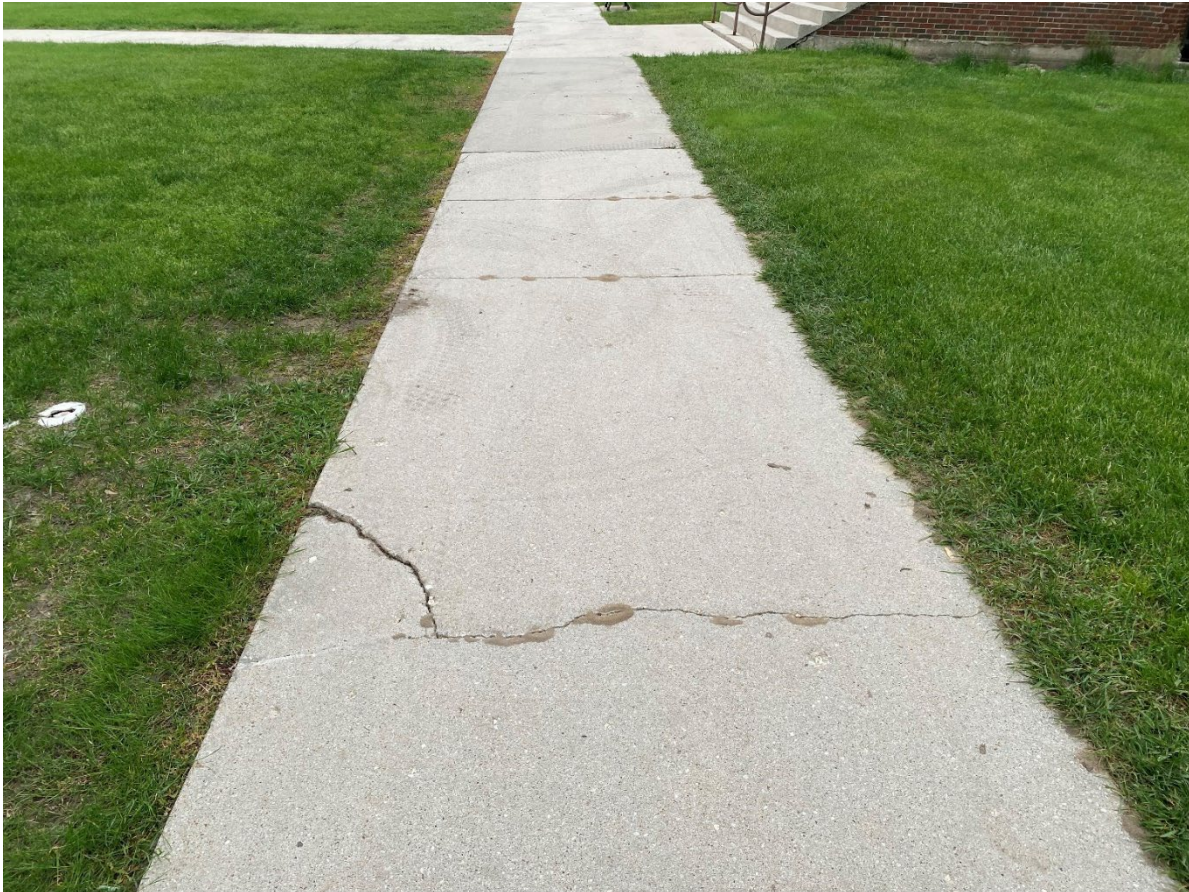
The front east to west sidewalk is in fair to poor condition. There are some areas of settling and cracking occurring, but most of the sidewalk just has common signs of aging such as chipped edges (Figure 6).

*Figure 6: Cracking in east to west sidewalk.*

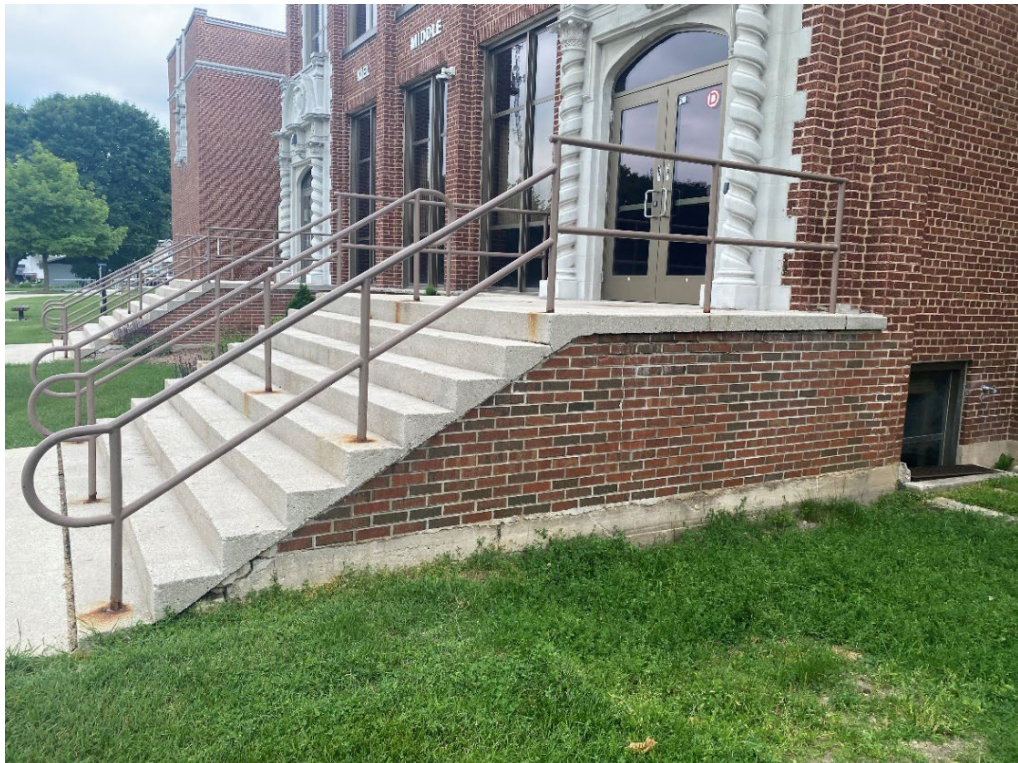
The center east concrete staircase is in poor condition. There are many cracks on the concrete slab, as well as cracking and missing concrete on the stair's foundation (Figures 7&8). The bottom of the railings are rusting. The large slab at the base of the center east stairway also has a large vertical crack running through it (Figure 9). The center east sidewalk from the school to Paine Street is in fair to poor condition. Two slabs on the north end have large horizontal cracks all the way through them (Figure 10). The farthest south slab near the city sidewalk has a large corner completely cracked off (Figure 11). Overall, the concrete sidewalk is in fair condition, except for the four cracked slabs which are in poor condition.

Figure 8: Side of center east concrete stairs.

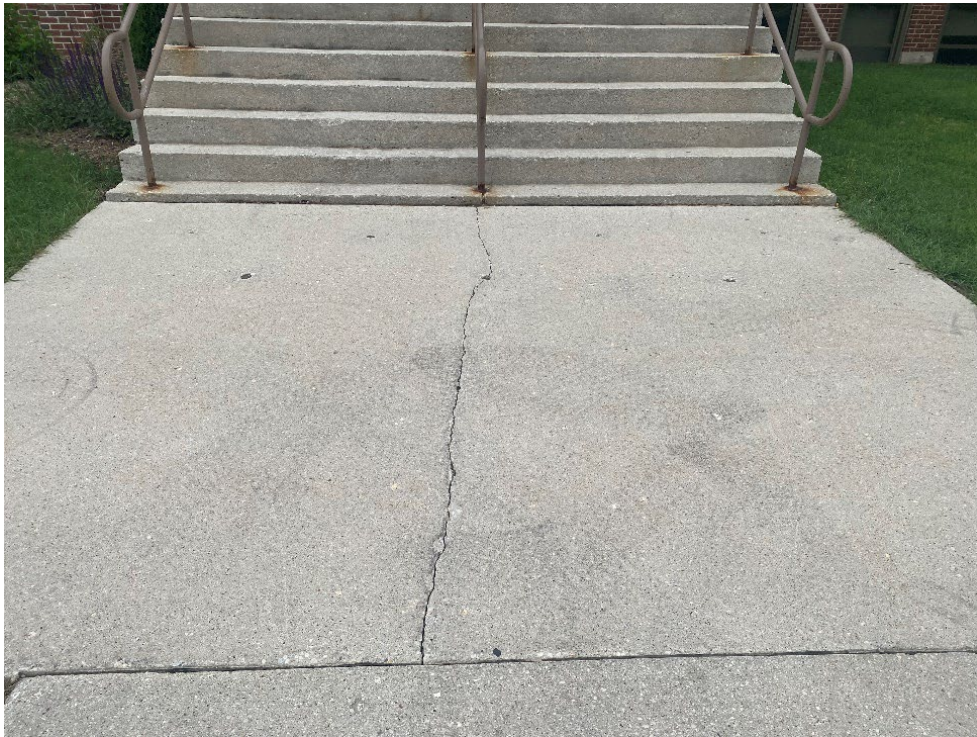
*Figure 9: Vertical crack in concrete slab at bottom of front center east stairs.*

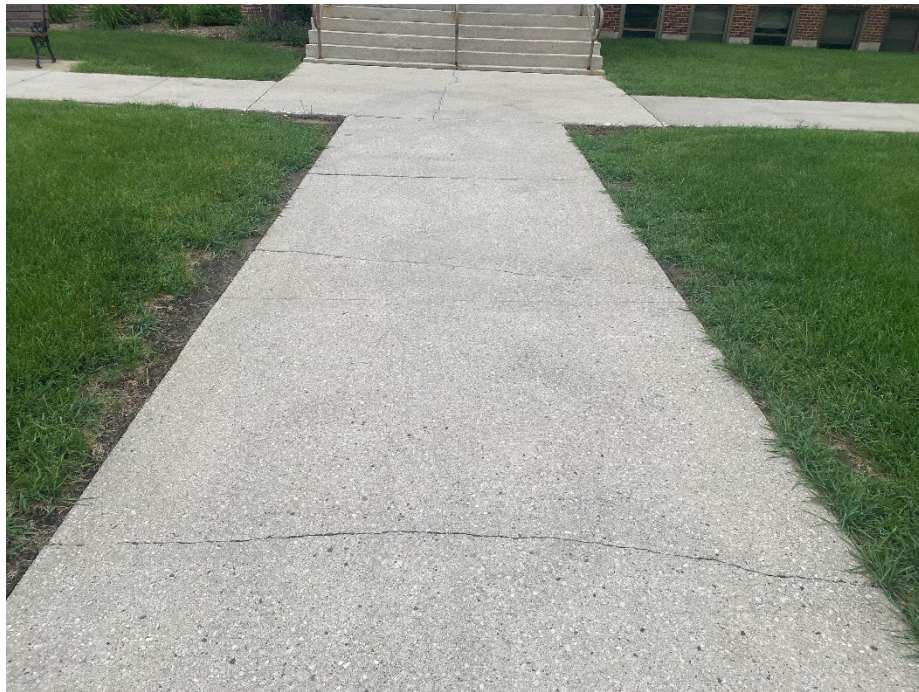
*Figure 10: Horizontal cracking in front center east Sidewalk.*

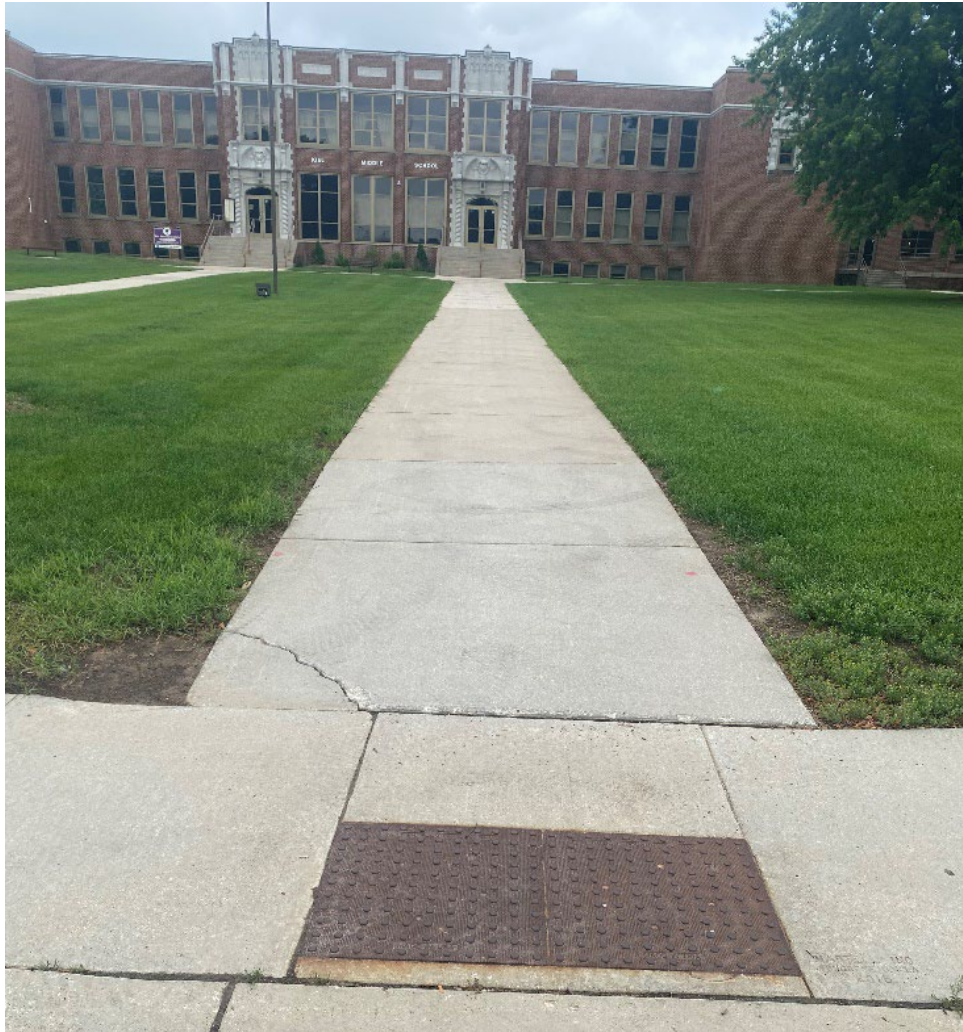
*Figure 11: Corner of concrete sidewalk slab cracked off at south slab of center east sidewalk.*

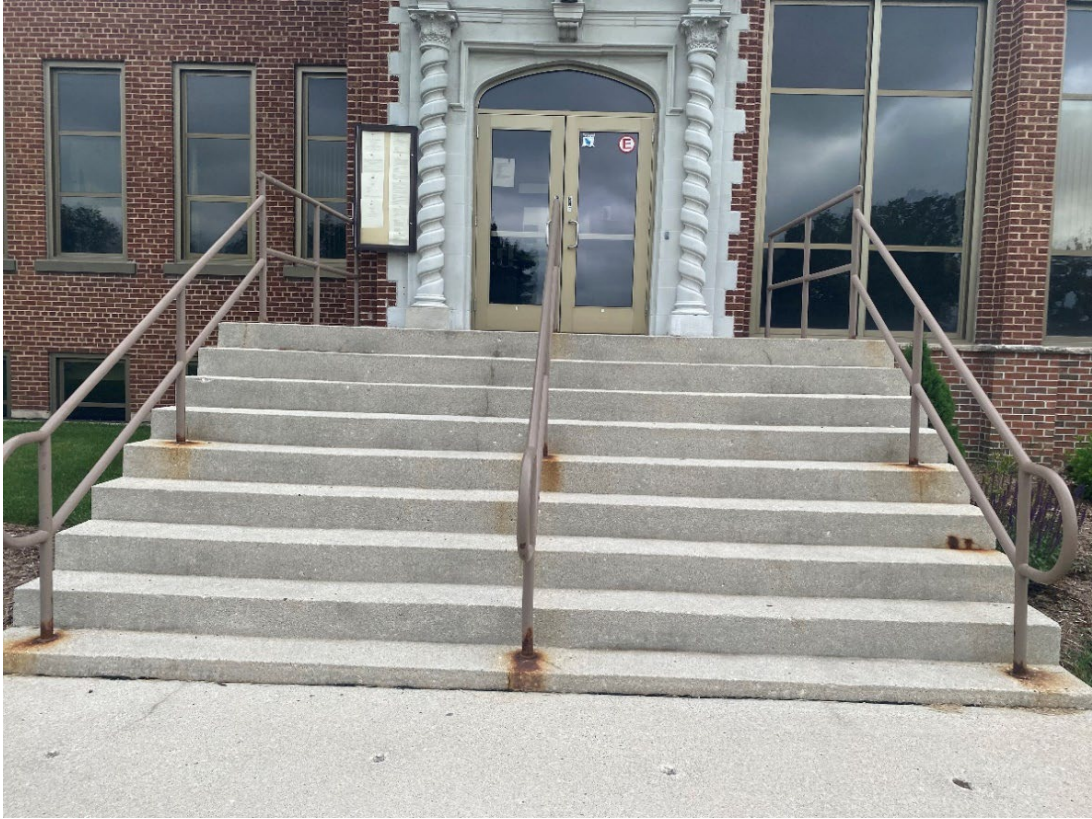
The center west sidewalk concrete staircase is in poor condition (Figure 12). There are many cracks on the concrete slab (Figure 14), as well as cracking and missing concrete on the stair's foundation (Figure 13). The bottoms of the railings are rusting. The concrete sidewalk that connects the stairs to Paine Street has some slabs that have large cracks in it. There is one slab towards the north end that has a large horizontal crack all the way across it (Figure 15). The same slab also has an angled crack further north (Figure 16). This area of concrete appears older than the concrete on the south half of the sidewalk. There are two slabs in the newer portion that have the corners completely broken off from the slab (Figure 17). All these cracked slabs could be replaced while keeping the other slabs that have no cracking.

Figure 12: Front center west stairs.

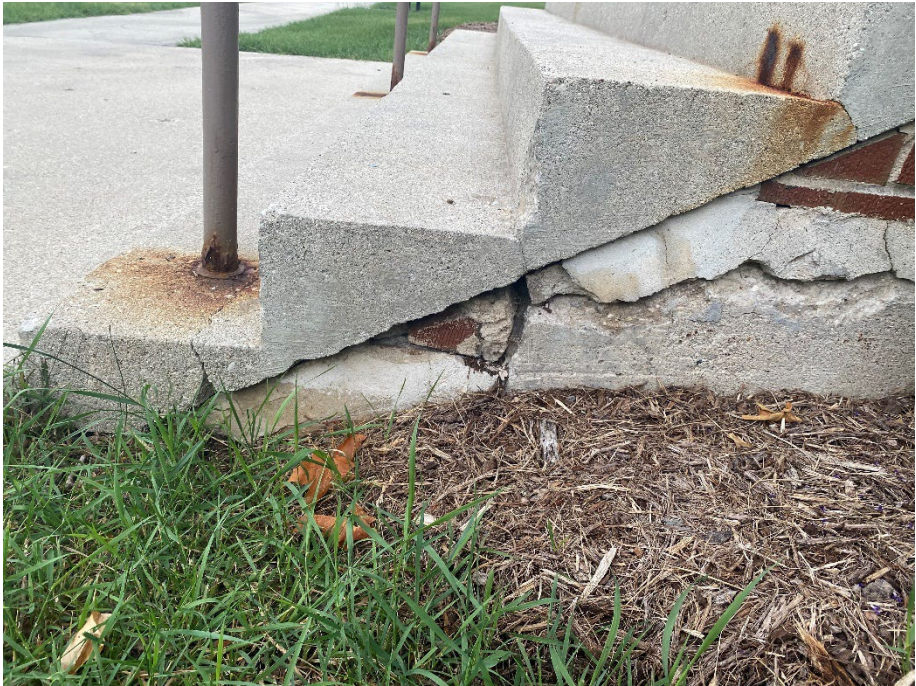
Figure 13: Foundation deterioration of front center west concrete stair.

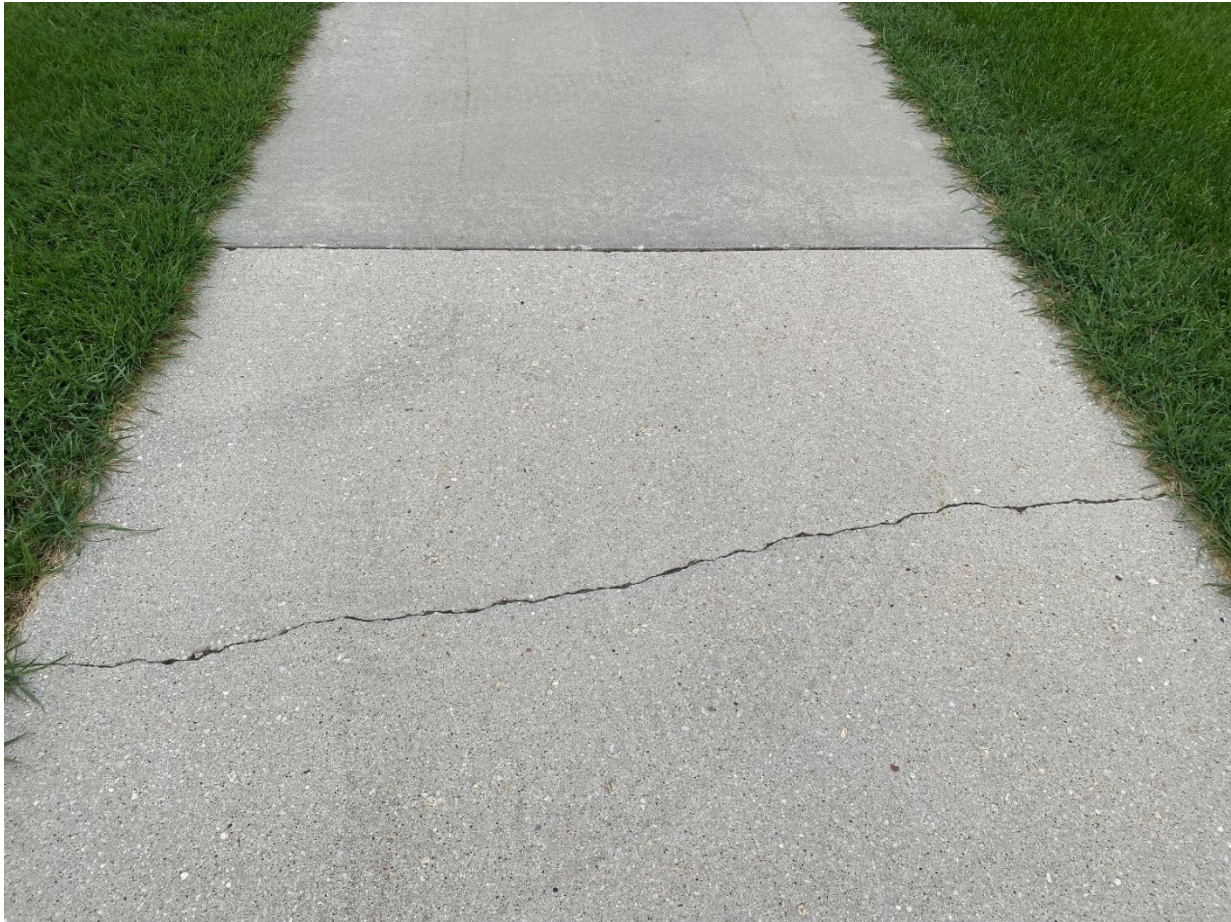
Figure 16: Diagonal crack in front center west sidewalk.

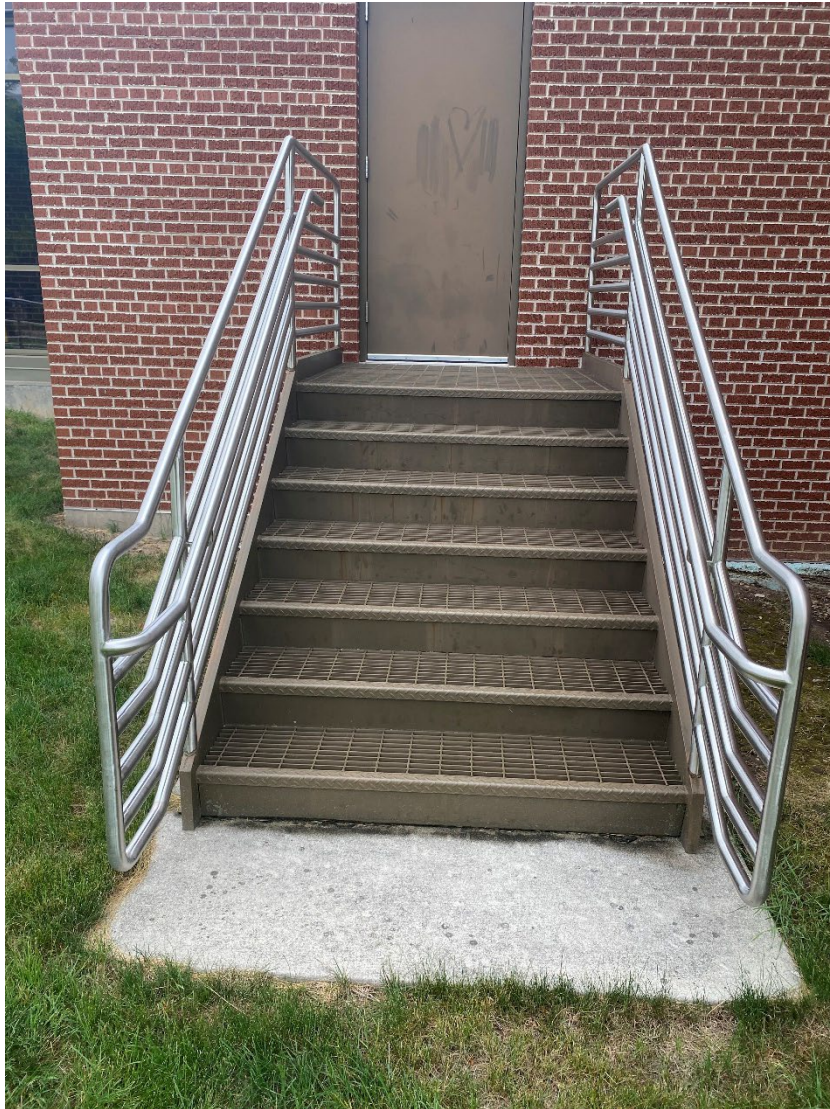
The metal stairway is in good condition and there is no visible rusting (Figure 18). The concrete pad it sits on is also in good condition with no visible cracks.

Figure 18: Front metal stair in good condition.

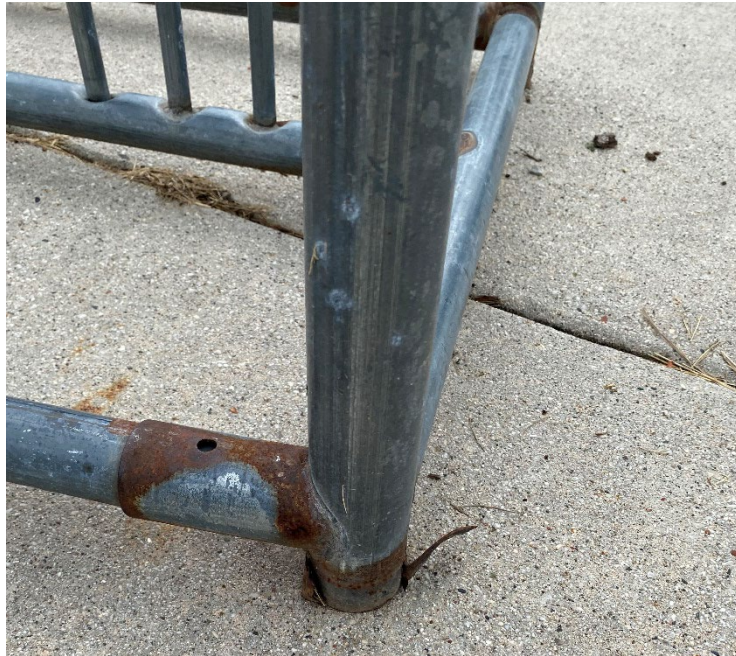
*Figure 21: Sharp edges exposed on metal bike rack.*

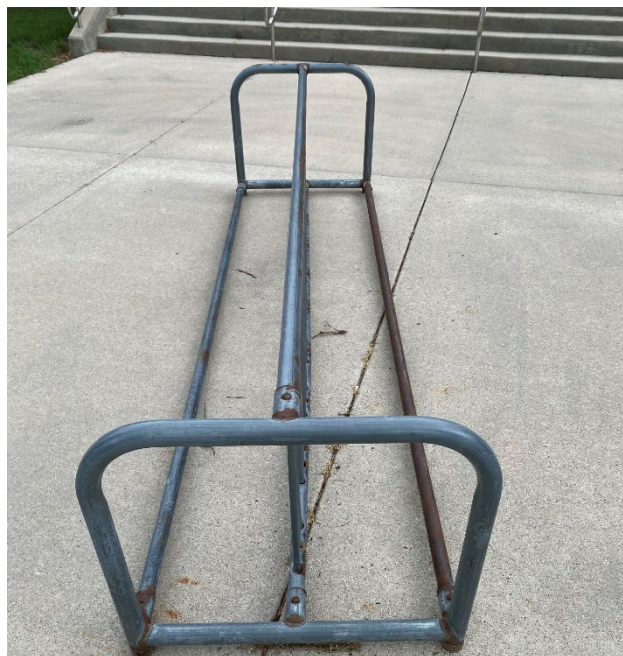
*Figure 22: Metal bike racks in fair to poor condition.*

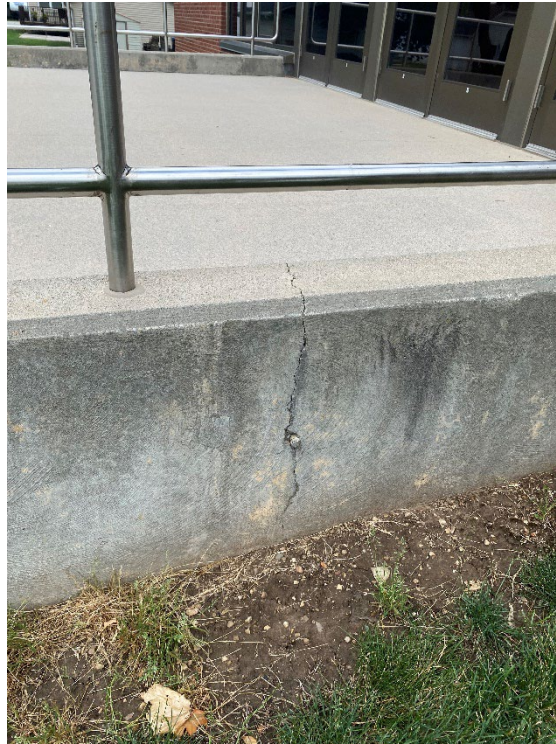
*Figure 23: Crack in foundation of front west stairway.*

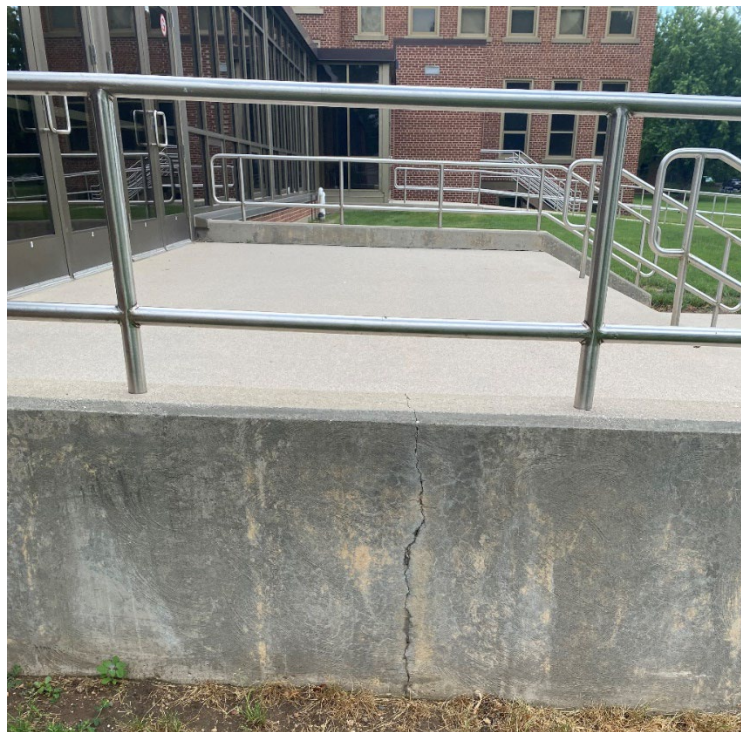
*Figure 24: Another foundation crack on front west stairs.*

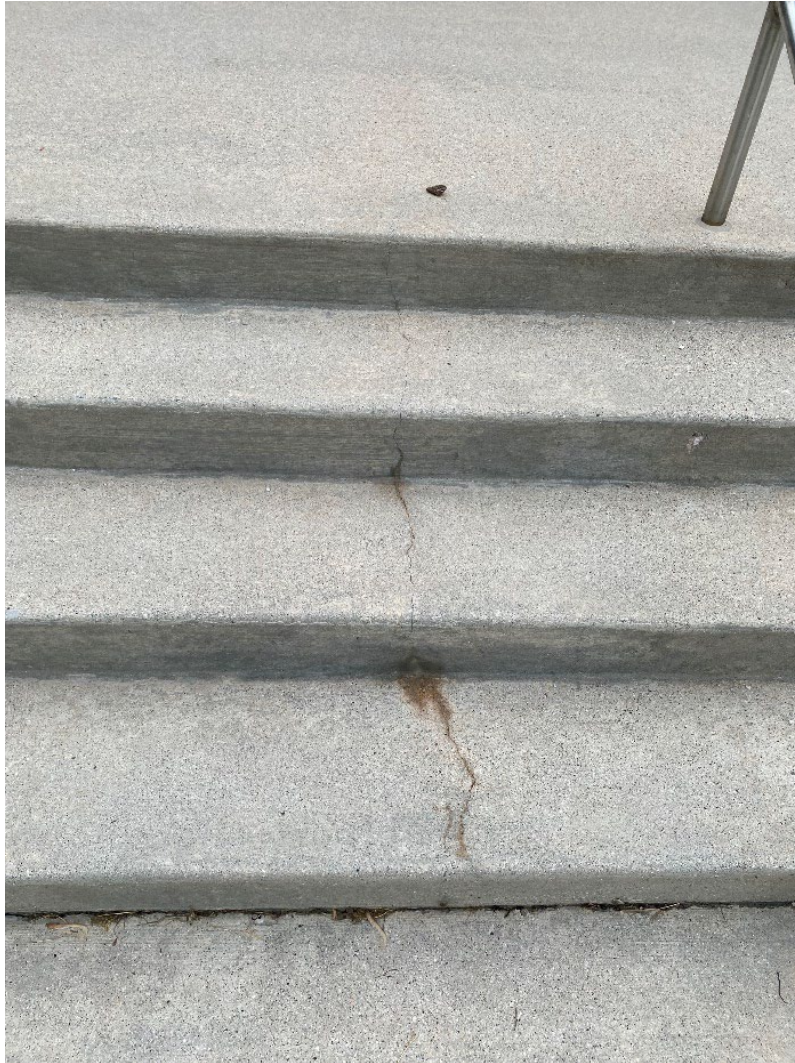
*Figure 25: Crack on stairs of front west stairway.*

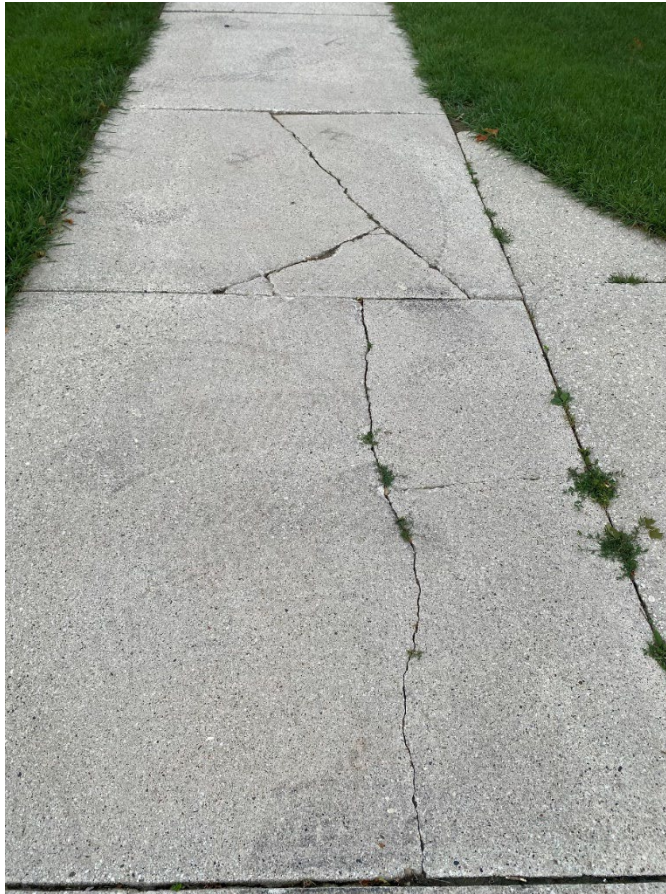
*Figure 26: Severe cracking in front west sidewalk.*

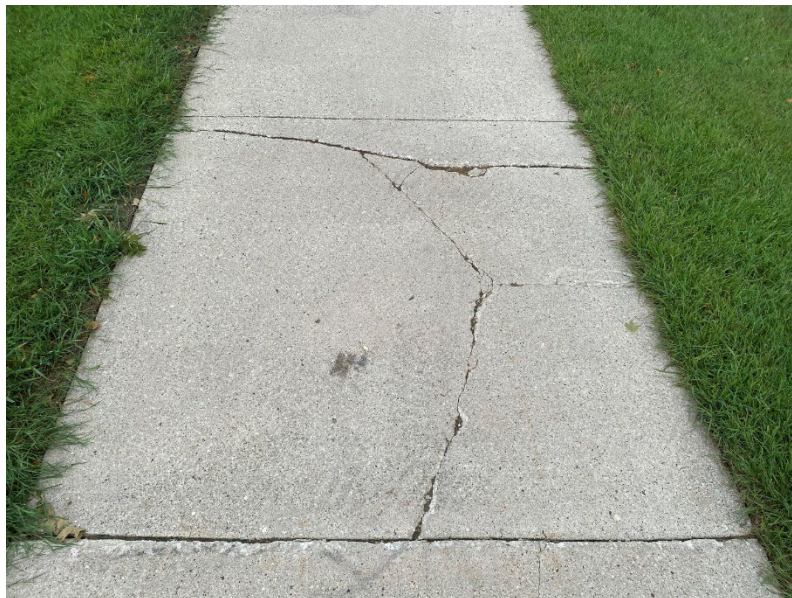
*Figure 27: Additional cracking in front west sidewalk.*

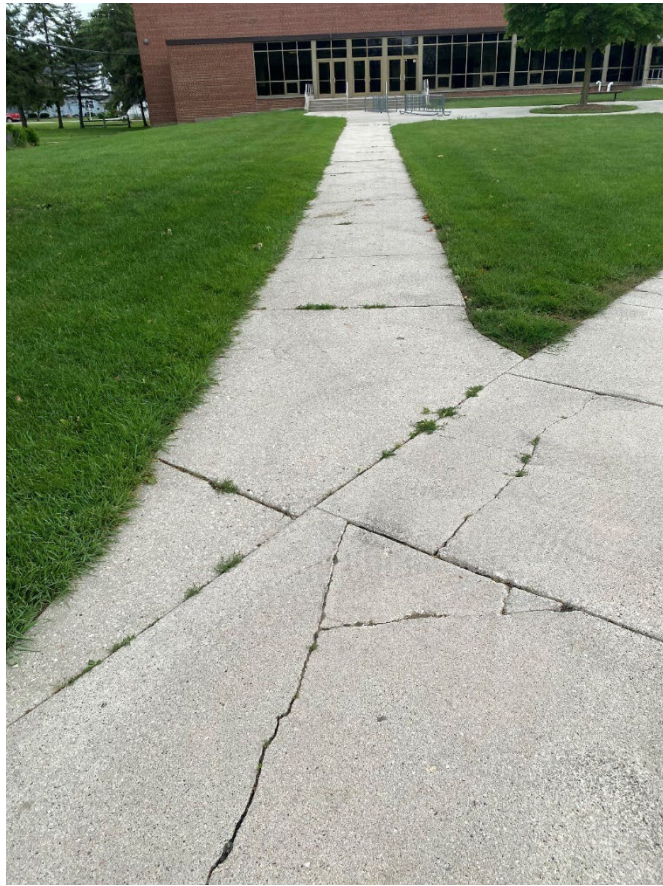
*Figure 28: Cracking in front west sidewalk.*

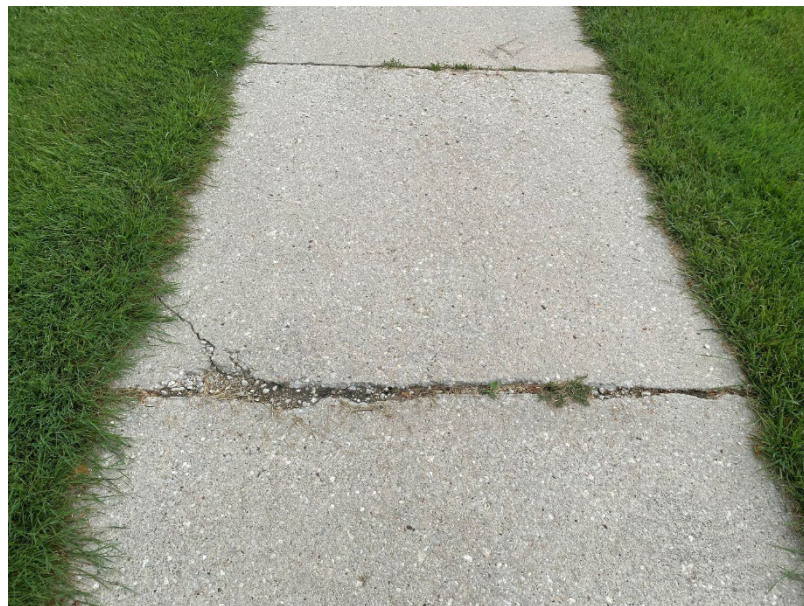
*Figure 29: Deteriorating concrete on front west sidewalk.*

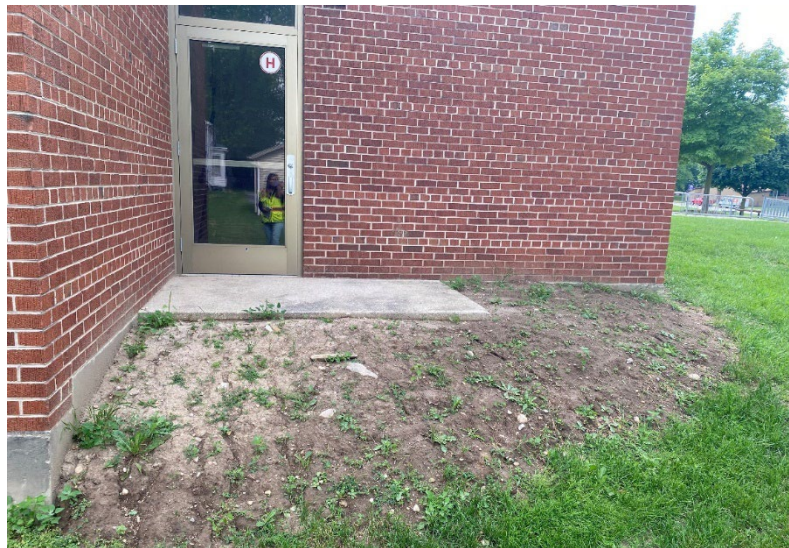
*Figure 31: Concrete slab and surrounding grass in good to fair condition on west side of school.*
