# Kiel Area School District

District-wide Facilities Study

# STUDY DOCUMENT

August 2022

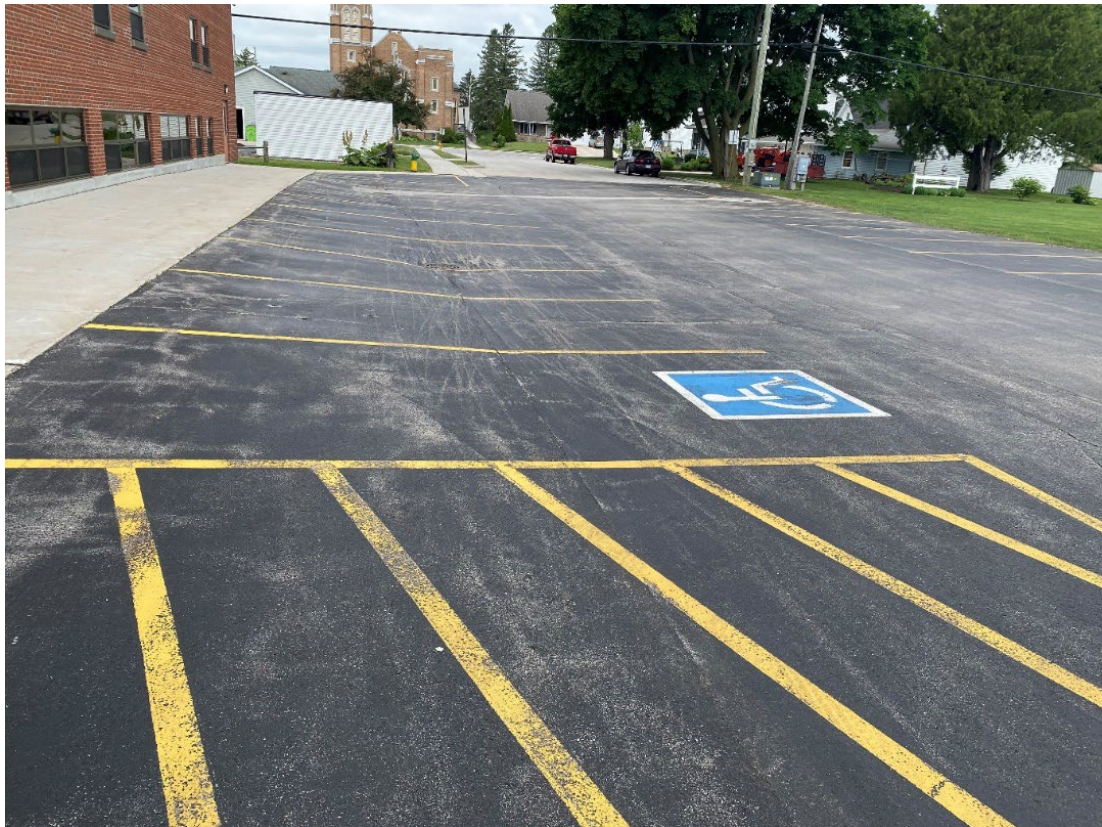
*Figure 34: Longitudinal cracking in parking stalls in northwest parking lot.*

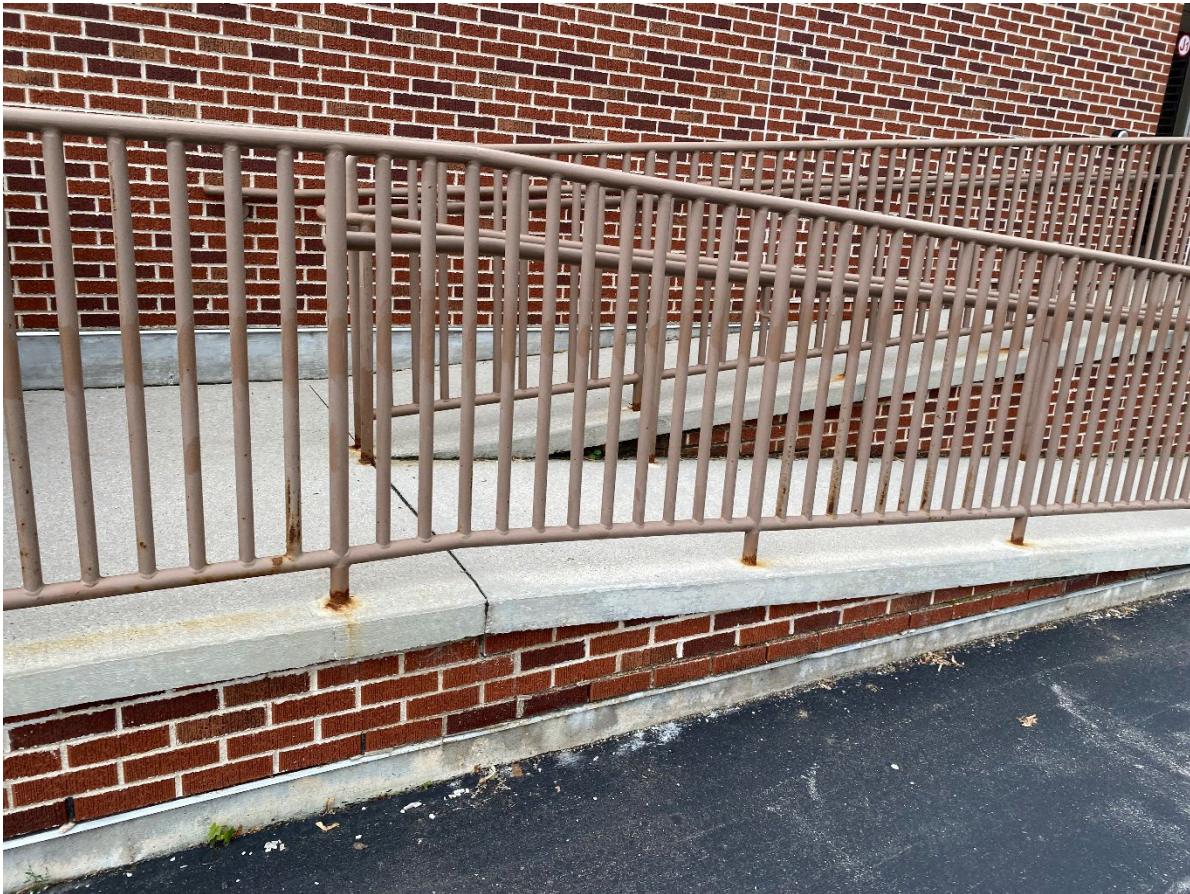
*Figure 39: Back concrete ramp in fair condition.*

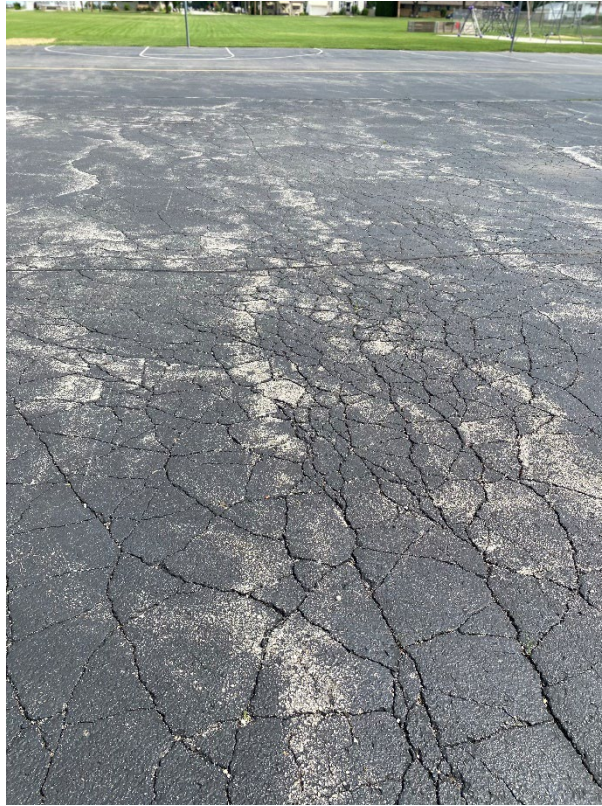
*Figure 41: Severe alligator cracking in back play yard.*

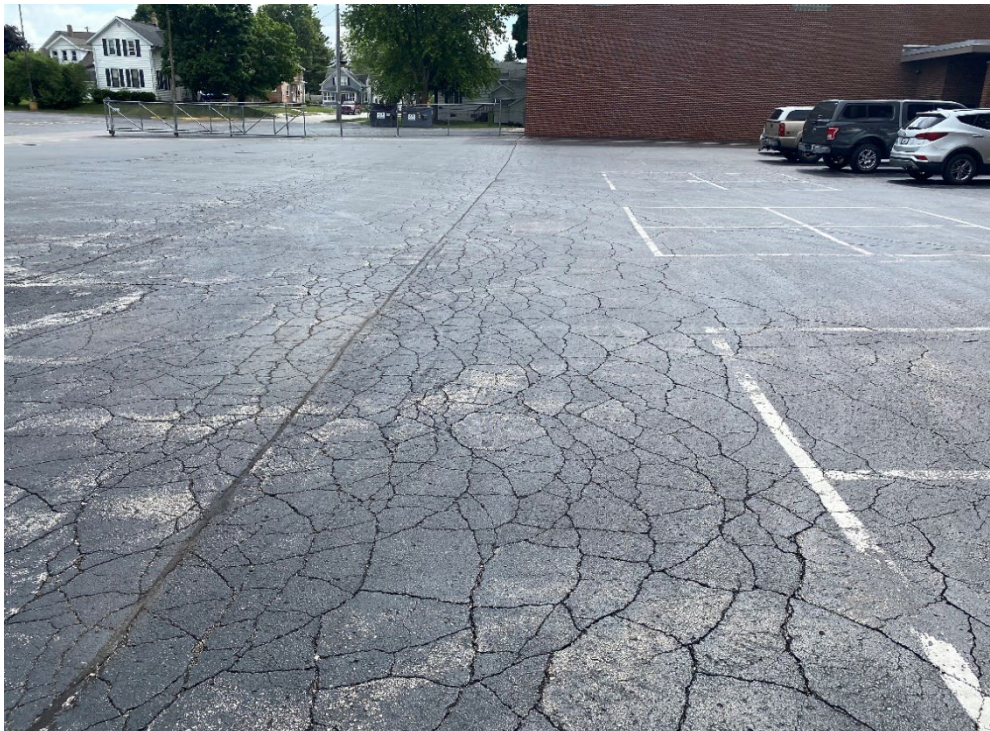
*Figure 42: Alligator cracking throughout back play yard.*

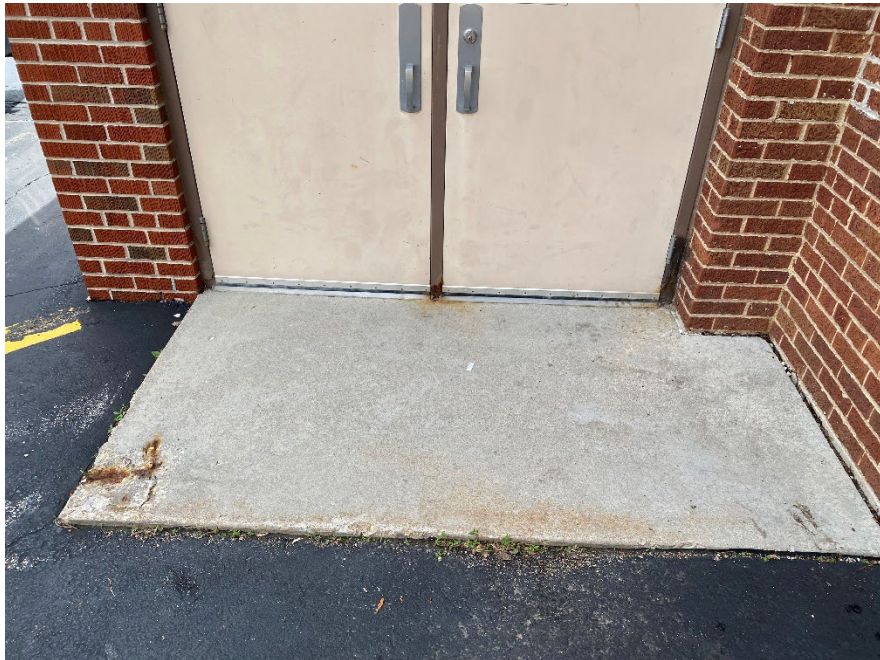
*Figure 43: Deteriorating concrete stoop in back play yard.*

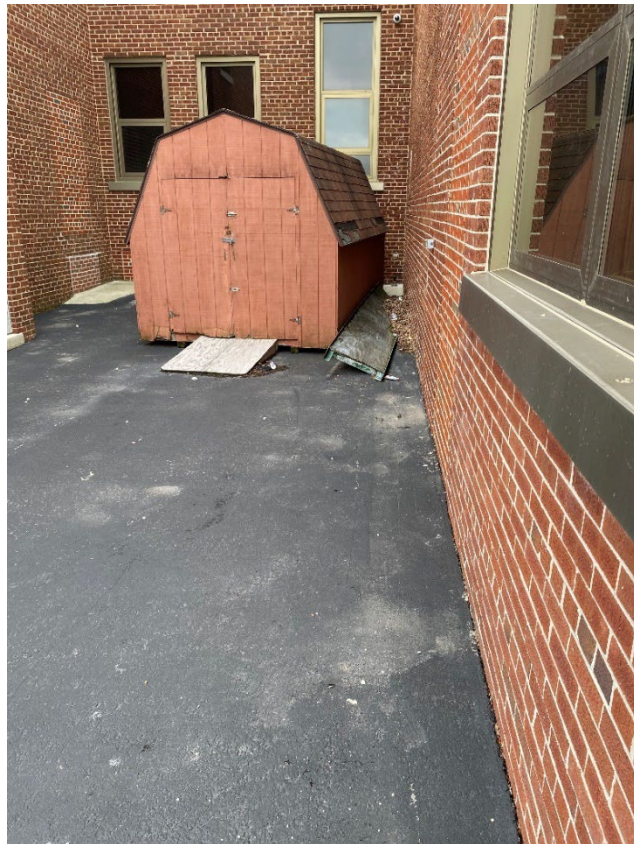
*Figure 44: Deteriorating shed in back play yard.*

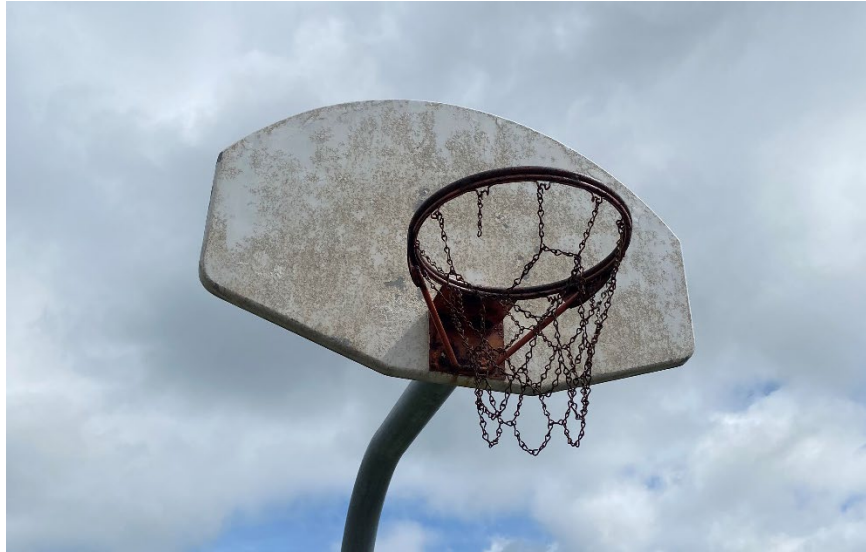
*Figure 45: Basketball hoops in poor condition in back play yard.*

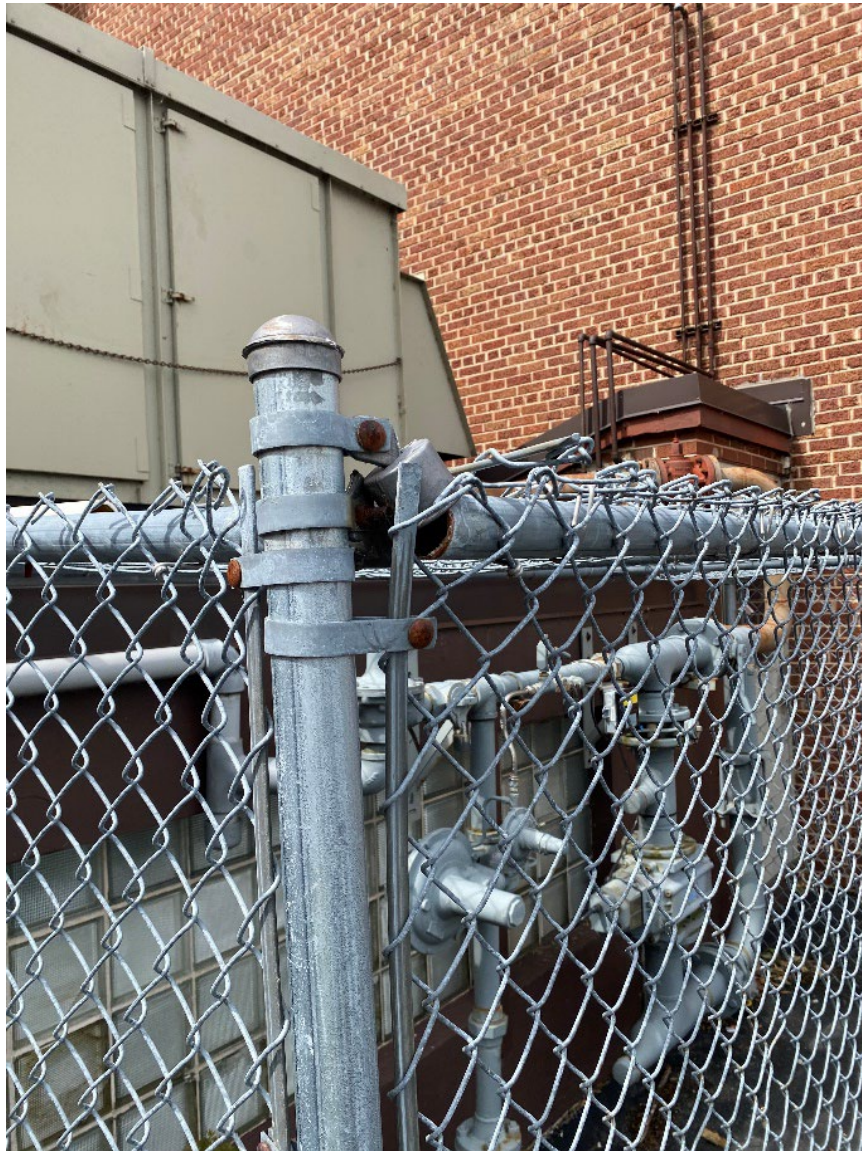
The metal fence enclosing the mechanical equipment on the back side of the school is in fair condition. There appears to be damage to the top portion of fencing (Figure 47). There is also rusting beginning.

*Figure 47: Damaged fencing surrounding mechanical equipment on back side of school.*

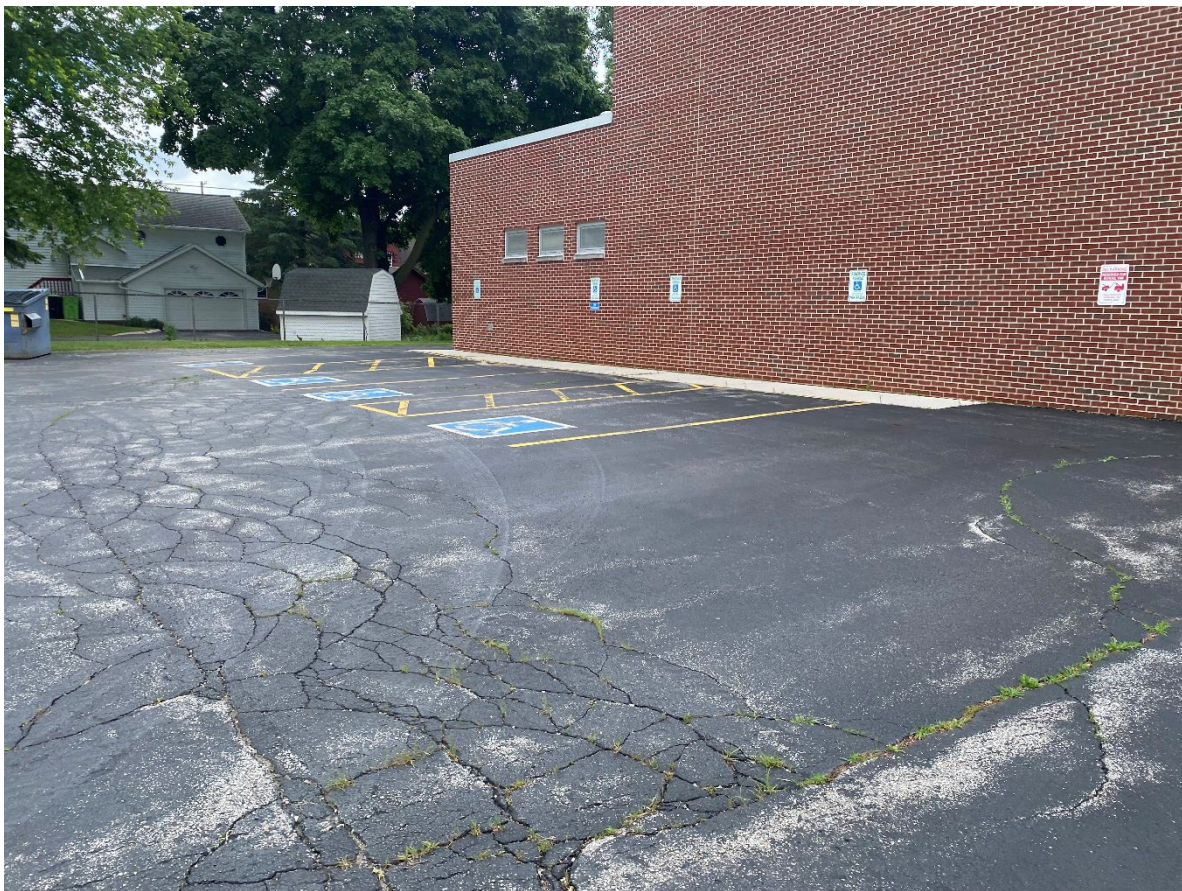
Figure 48: ADA parking area in poor condition due to alligator cracking.

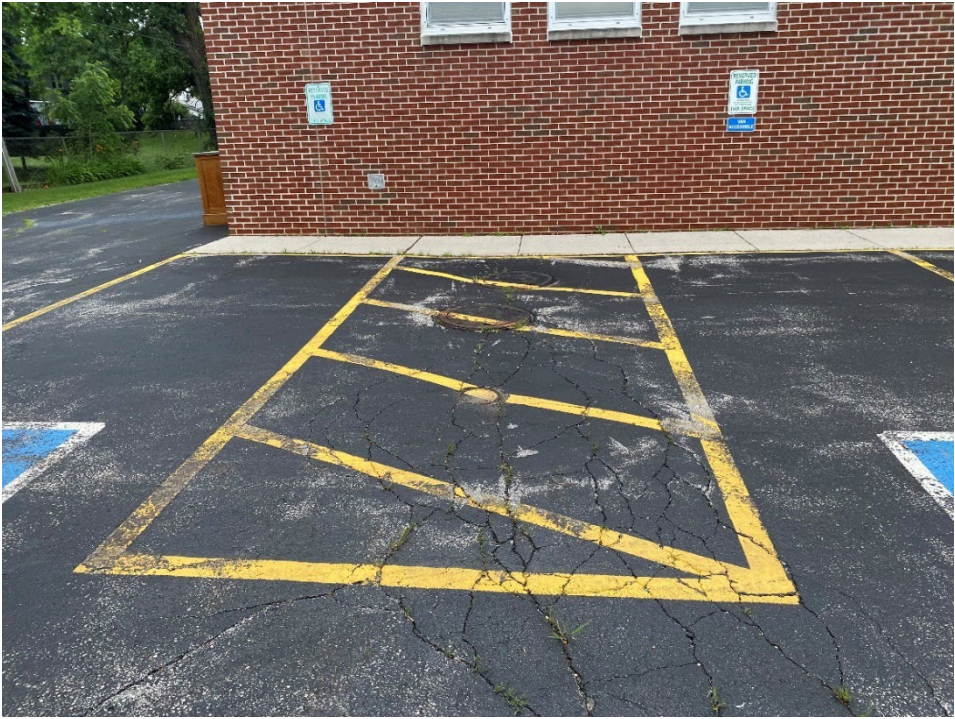
Figure 50: Alligator cracking and worn pavement markings in back east ADA stalls.

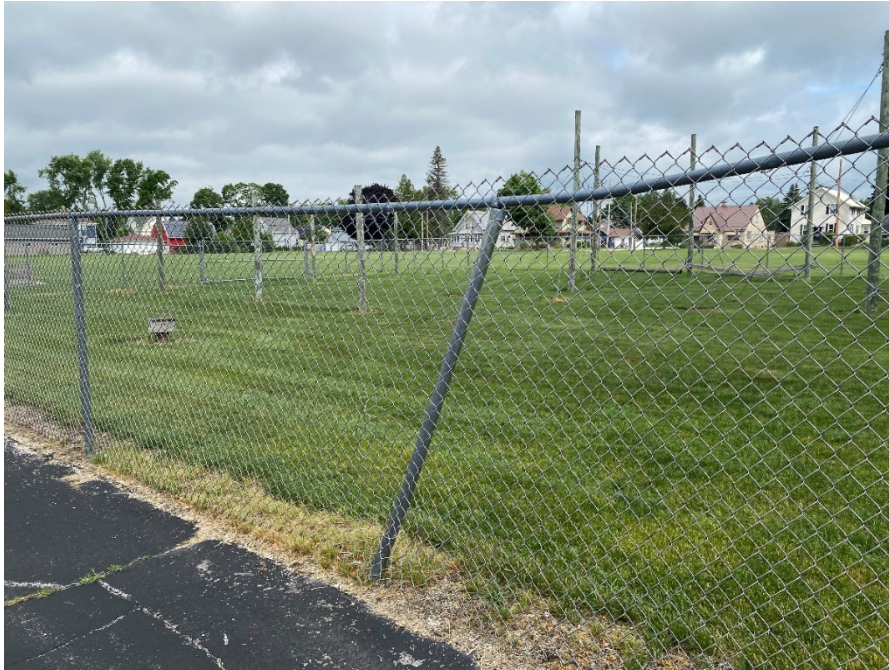
The fencing surrounding the climbing area is in fair condition. It is tipping over in some areas and the bottom is coming unraveled causing sharp wires to stick out (Figure 54&55).

*Figure 54: Fence surrounding climbing area falling over.*

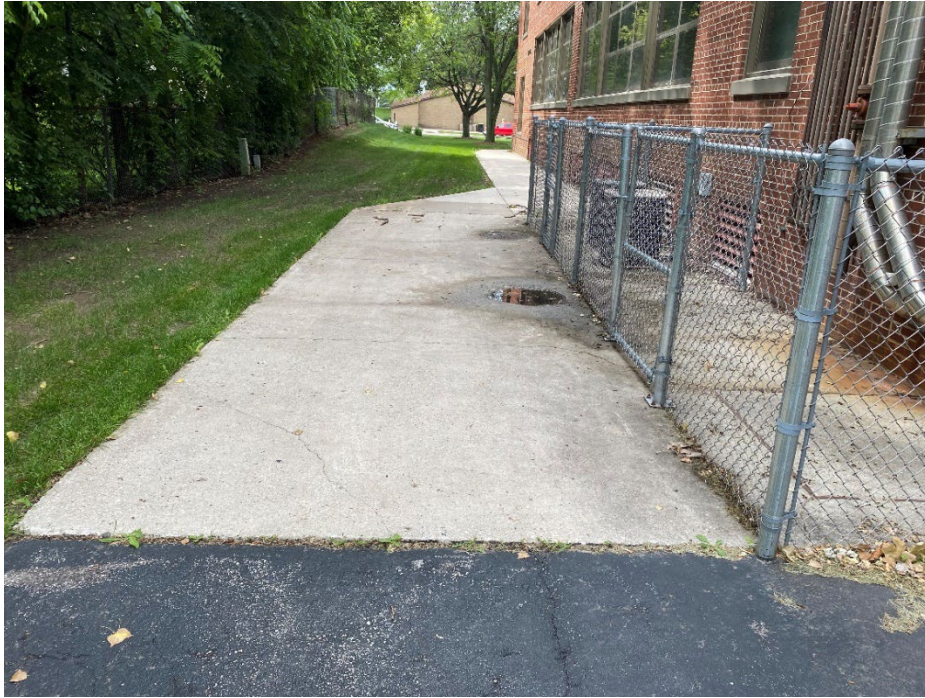
*Figure 60: Cracking and settling in concrete slab on east side of school causing water to pool.*

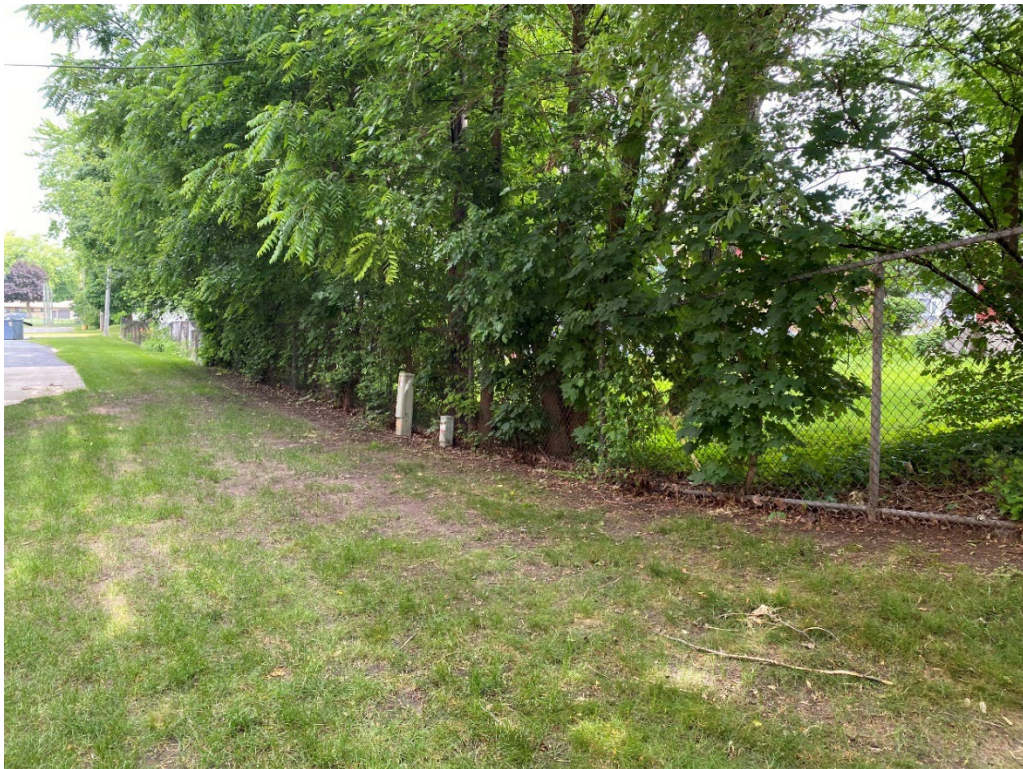
The asphalt on the east side of the school is in poor condition. There are many longitudinal and transverse cracks with weeds growing up through them (Figure 59). The older concrete sidewalk near the fenced in mechanical equipment is in poor condition. There are cracks in the pavement and some settlement causing standing water (Figure 60). There is also newer concrete sidewalk to the south of the mechanical equipment that is in good condition with minimal cracking. The grass on the east side of the school is patchy and having trouble growing in the shade. The metal fencing enclosing the mechanical equipment is in good condition. The metal fence on the property line is in poor condition (Figure 61). It is overgrown with trees and tipping over in areas.

*Figure 61: Metal fence on east property line falling over and overgrown with trees.*

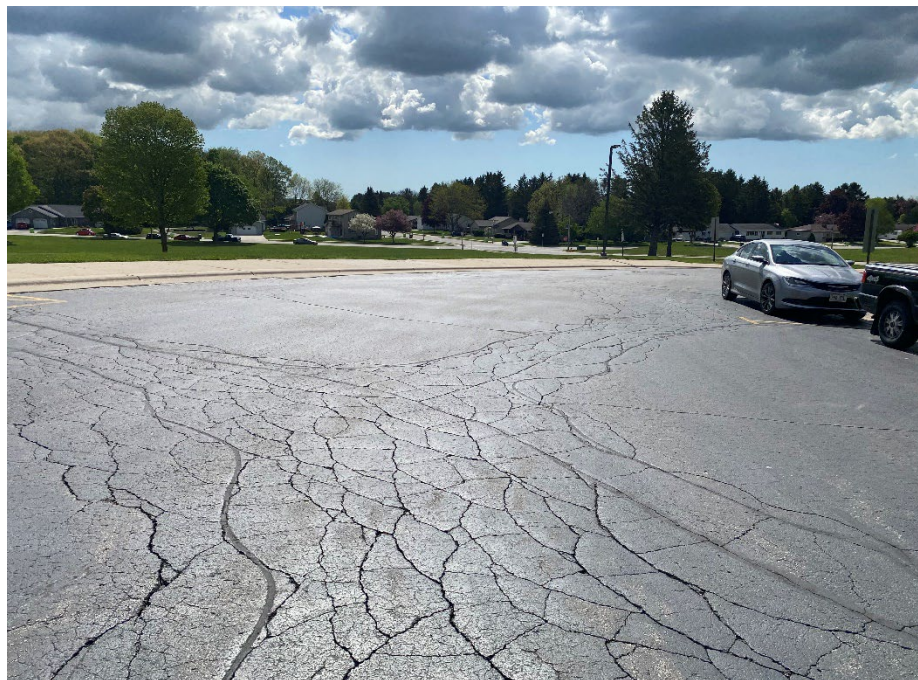
*Figure 2: Alligator and block cracking in asphalt pavement in Bus/Visitor Parking Loop.*

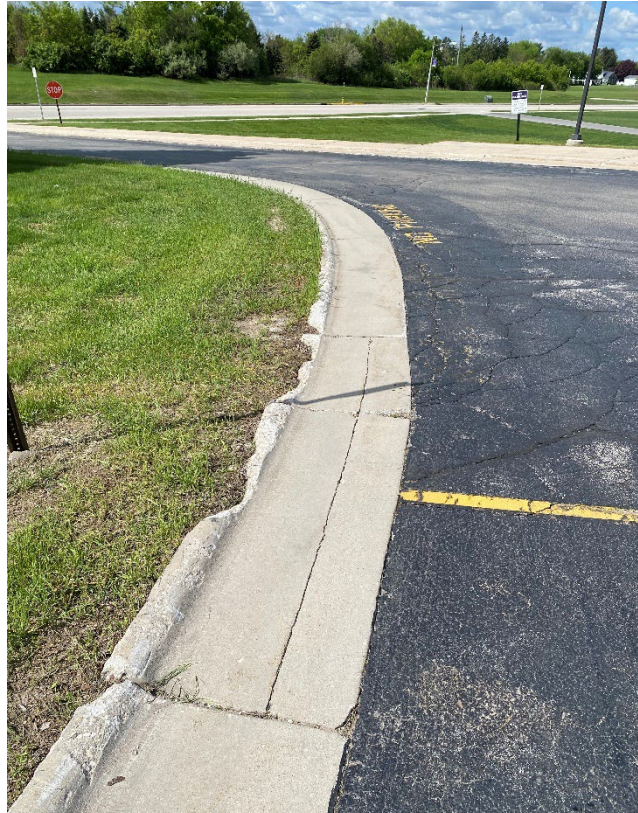
*Figure 4: Curb head broken off in Bus/Visitor Parking Loop.*

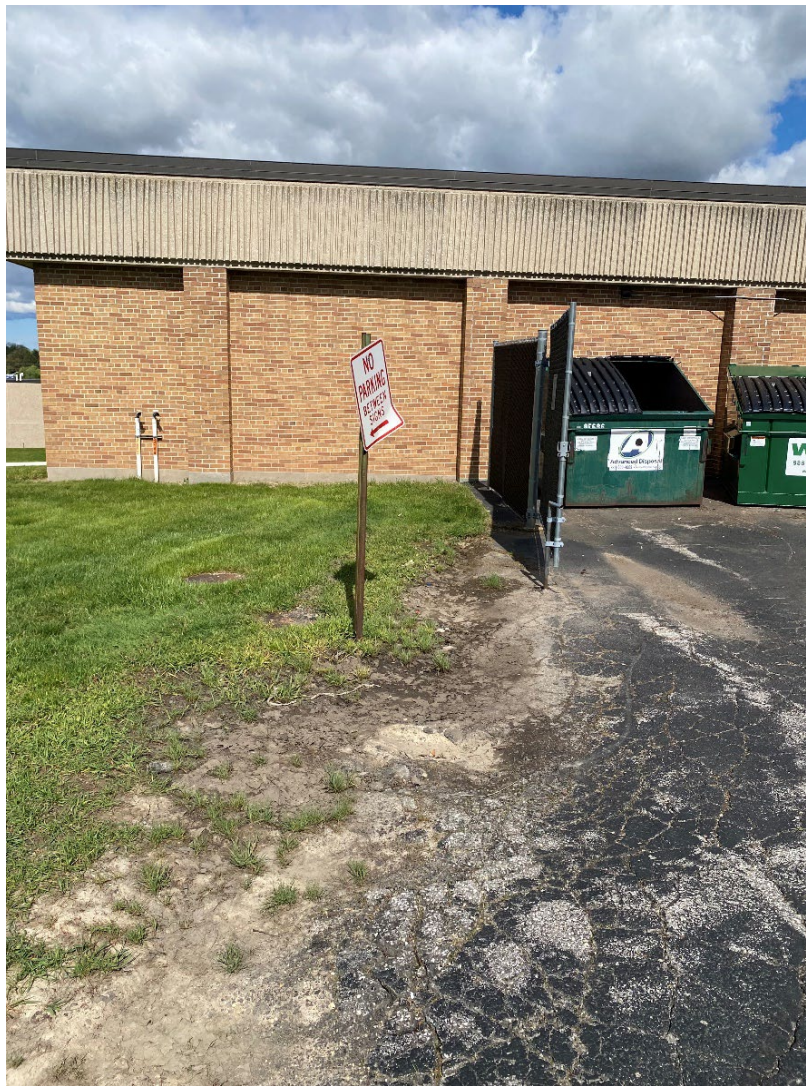
*Figure 7: Significant edge cracking in Garbage Dumpster Parking Lot.*

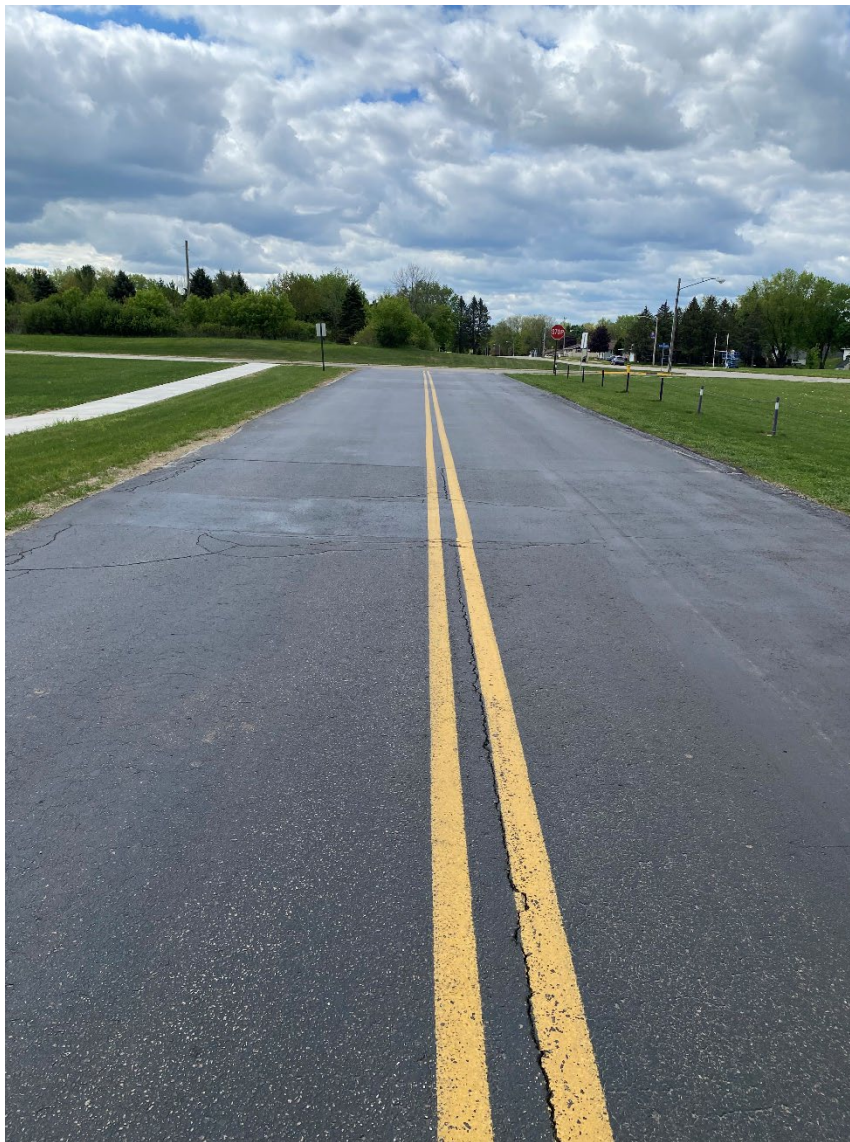
building and extends north. The condition of the asphalt drive is fair from the southwest corner of the school building to the south (Figure 11). The portion of the roadway that borders the west side of the school is in poor condition due to block and alligator cracking (Figure 12). There are many longitudinal and transverse cracks throughout the entire drive (Figure 13). There are multiple patches on the roadway, but some of the patches are cracking. There is edge cracking along the edges of the drive where there is no curb and gutter. The concrete driveway is in good to fair condition. It shows signs of typical wear and tear, but few cracks in the concrete except for the curb and gutter portion and flares. Pavement markings are in good to fair condition with some fading beginning. The curb and gutter near the north portion of the roadway is in excellent condition, as it was recently installed.

*Figure 11: South portion of Access Drive in fair condition.*

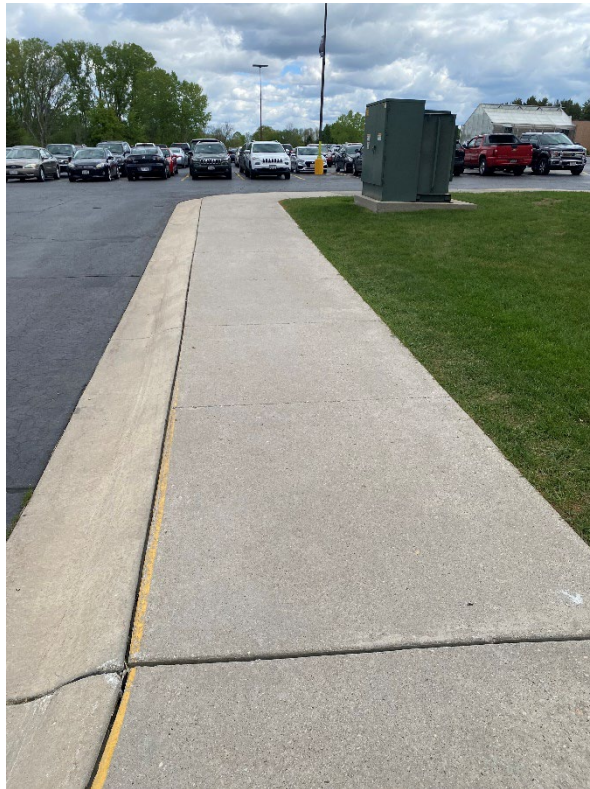
Figure 16: Sidewalk in Student Parking Lot

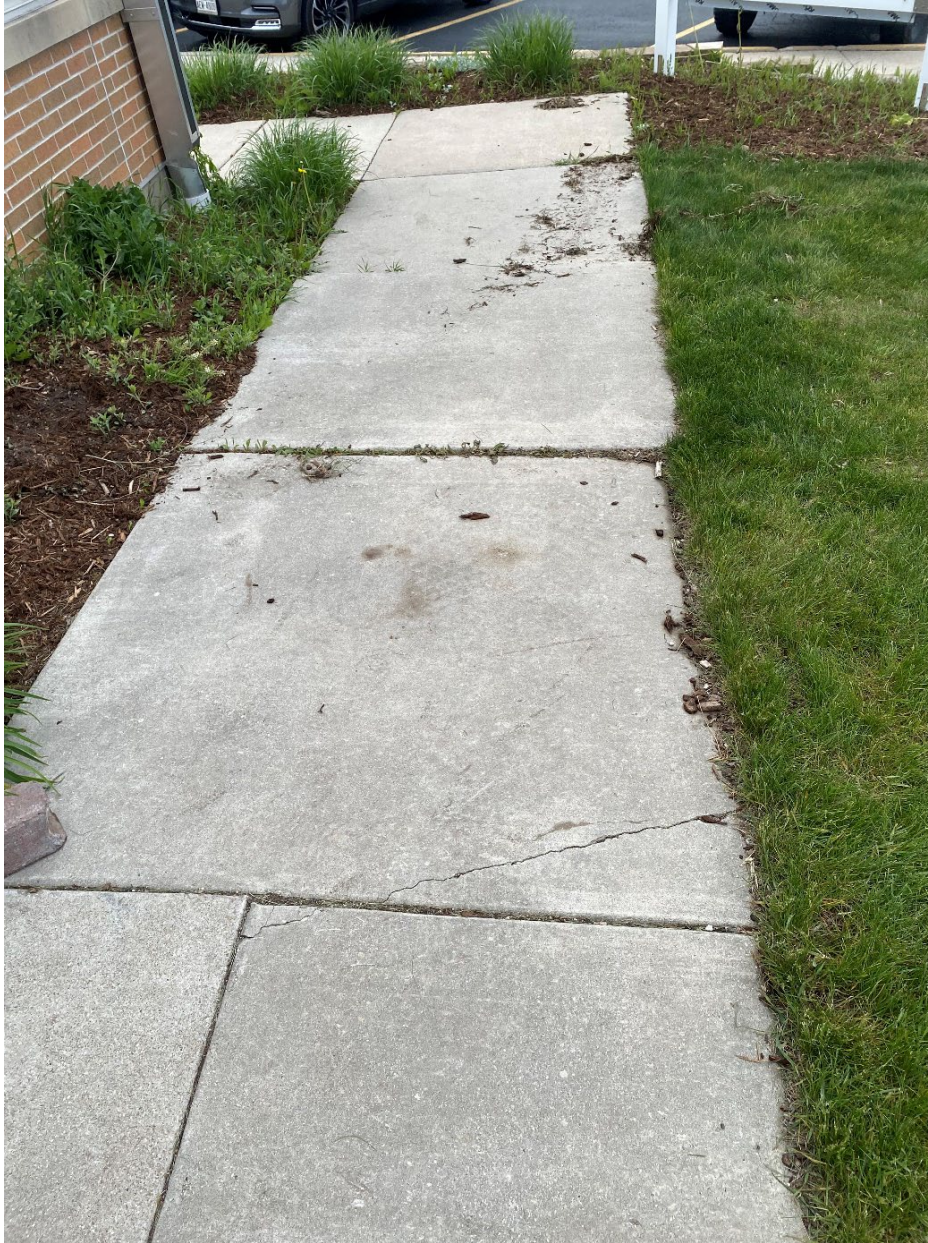
The Student Parking Lot consists of asphalt pavement and concrete sidewalk and curb and gutter. The asphalt pavement in the south drive lane and accessible stalls appears to have been replaced during the 2020 school addition and is in excellent condition. The bus parking stalls along the west side of the lot appear newer and are in good to fair condition. The remainder of the asphalt pavement in the lot is older and in poor condition. There is alligator and block cracking occurring in throughout the whole parking lot (Figure 14). There are also longitudinal and transverse cracks. The pavement around the shed is in fair condition (Figure 15). The concrete sidewalk and curb and gutter that was added in 2020 along the north and west sides of the PAC addition is in excellent condition. The concrete sidewalk and curb along the stadium are also in excellent condition. The older concrete sidewalks along the parking lot are in good to fair condition (Figure 16). There is minimal cracking, but there is some settlement and separation in slabs causing some slabs to be higher than others. However, the concrete sidewalk and curb around the greenhouse is in poor condition due to cracking, chipping, and settling in slabs (Figure 17). The pavement markings are in fair to poor condition due to fading and chipping paint.

*Figure 17: Cracked and uneven sidewalk around greenhouse*

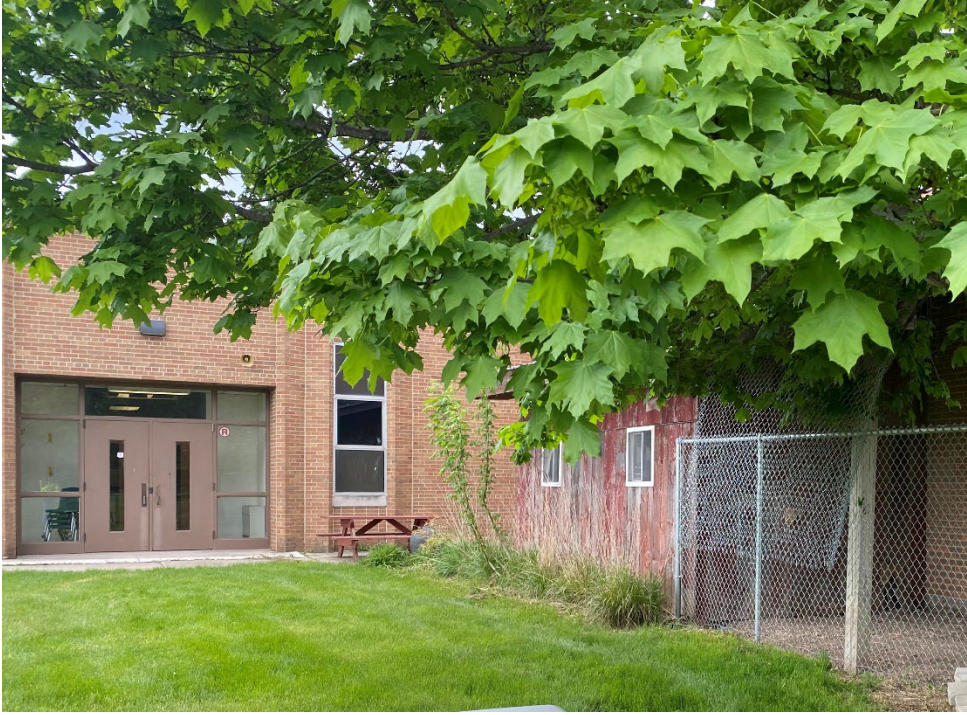
*Figure 18: Extra fence lattice extending above top of fence for goat pen on north side of school*

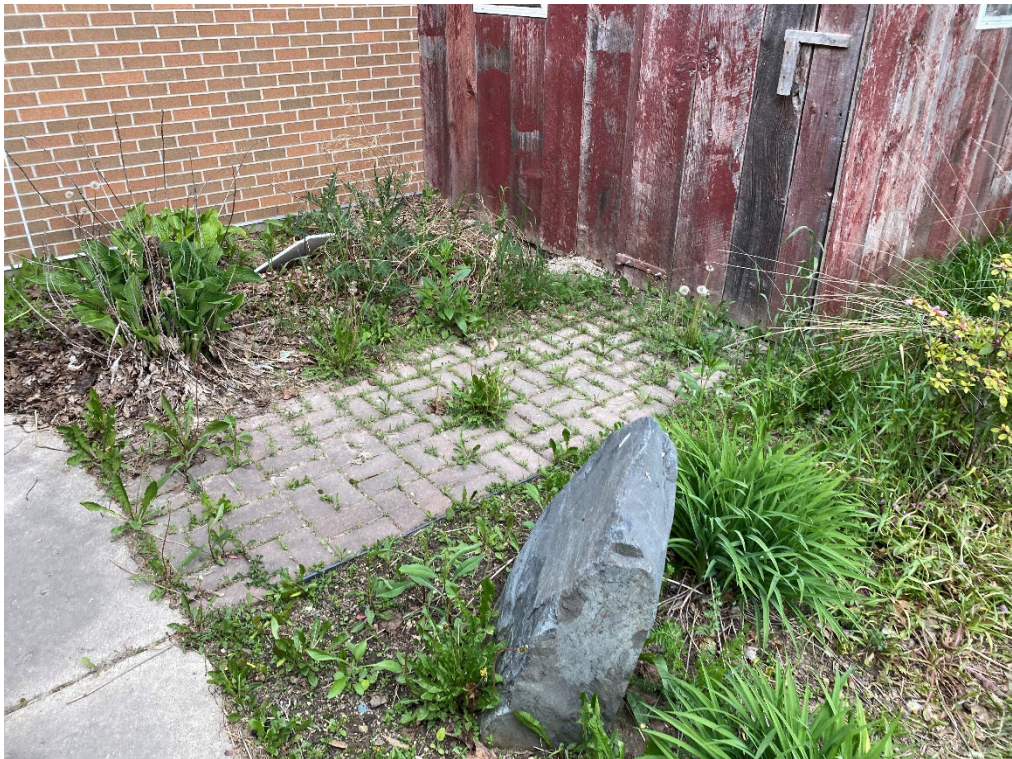
*Figure 19: Overgrown pavers in front of small shed near goat pen on north side of school*

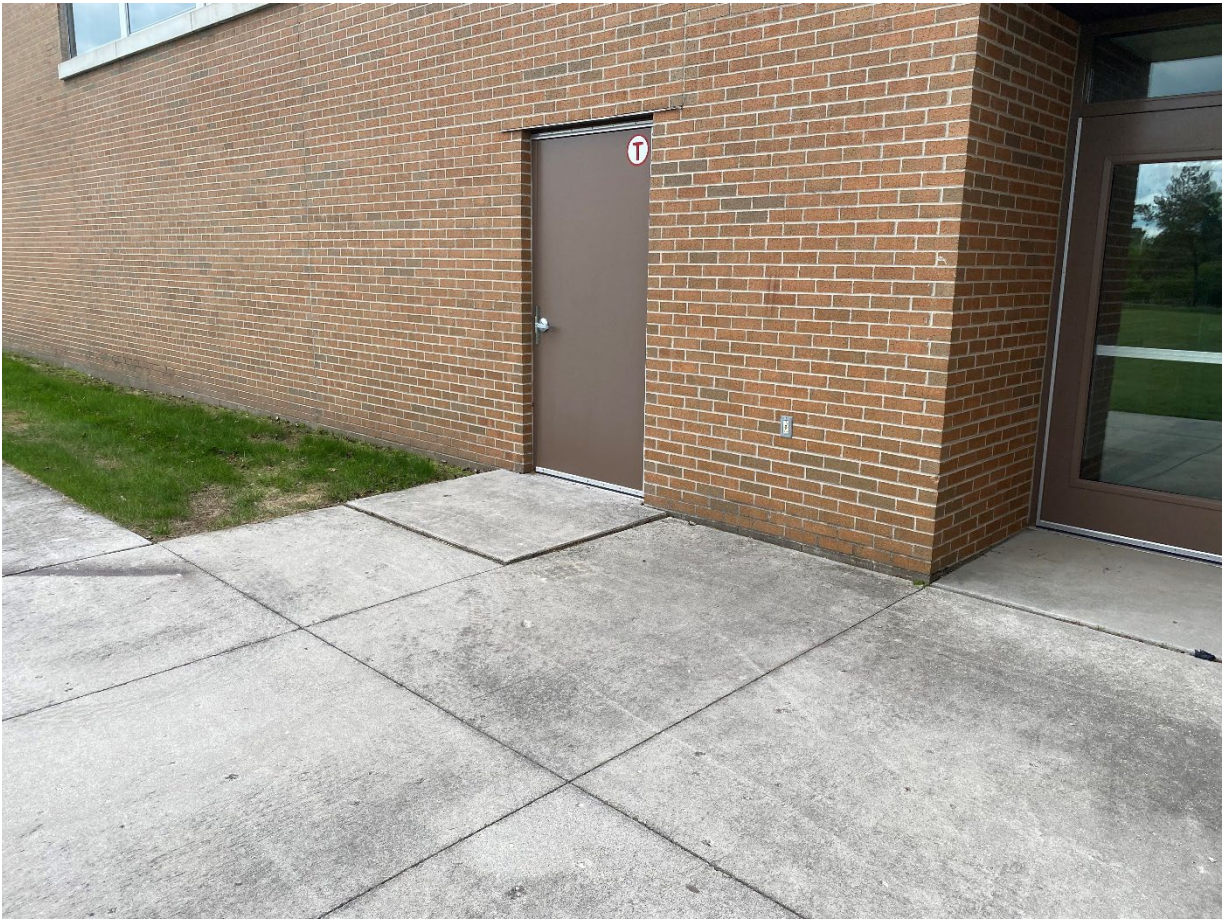
The north side of the school consists of a fenced in goat play area, two small sheds and concrete sidewalk connecting the doors. The goat fence is in good to fair condition. There is a section of extra fencing lattice that is attached to a portion of the fence and extends up over the top of the fence that is anchored into the ground (Figure 18). The small shed touching the school building is surrounded by planting beds with weeds and overgrown brick pavers (Figure 19). The concrete sidewalk is in fair condition, due to wear and tear and settlement of slabs (Figure 20).

*Figure 20: Worn sidewalk and stoop height higher than surrounding pavement on north side of school*

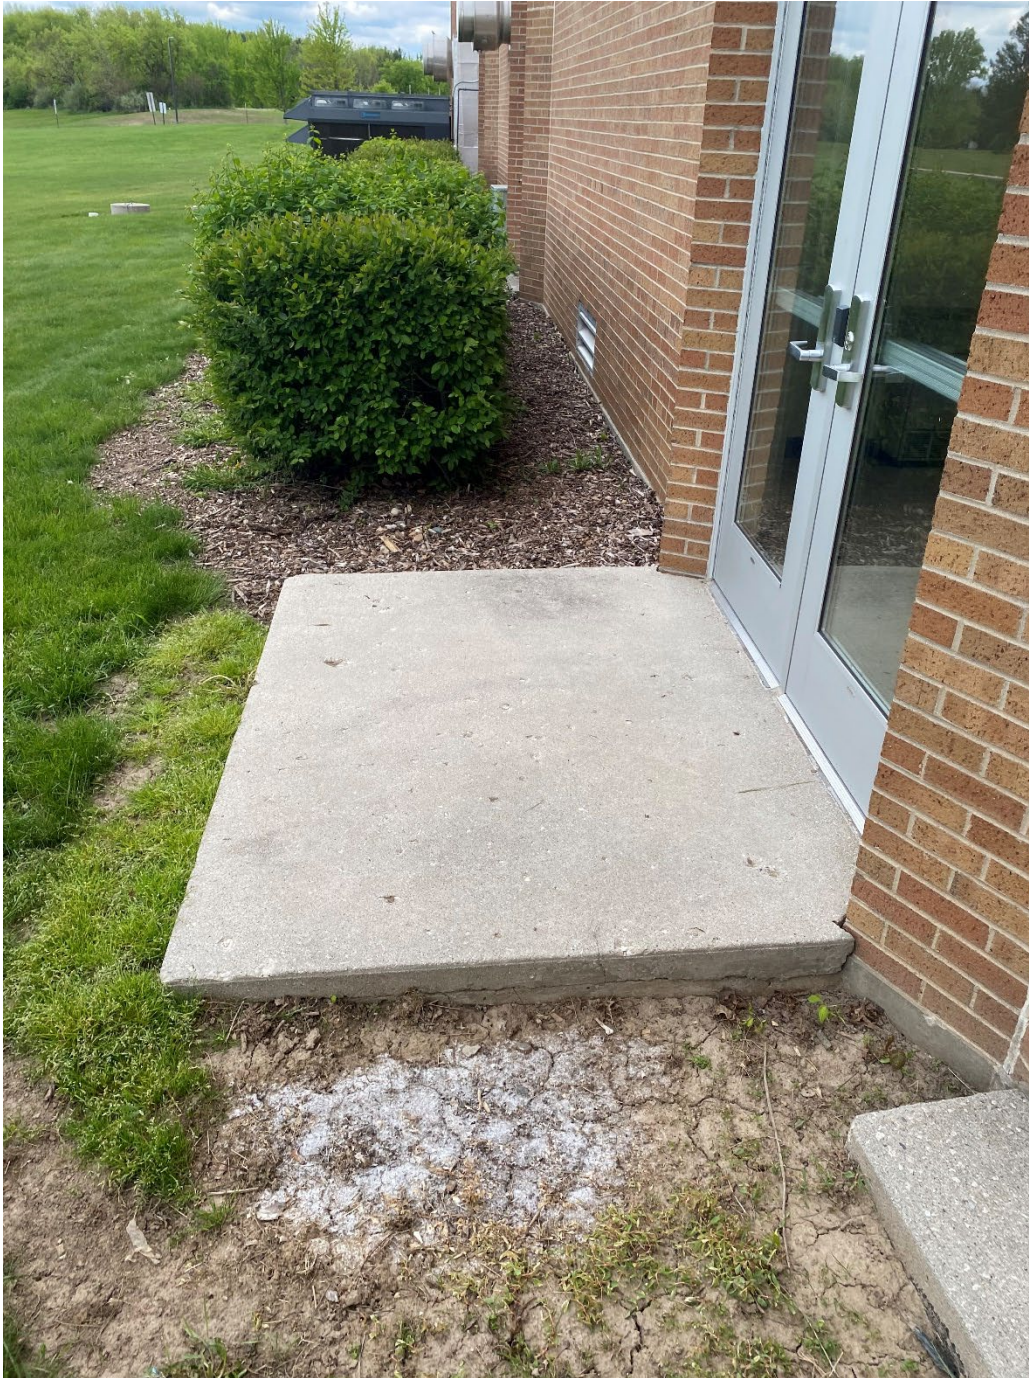
Figure 21: Door landings on east side of building

The east side of the school consists of two doors with concrete pads, as well as a concrete pad with mechanical equipment on it. There is one-foot-high concrete wall attached to the school between the two doors. It is unknown what purpose this serves. The concrete pads all in good to fair condition, due to some chipping. The door pads are also not even with the ground surface and require a step down (Figure 21).

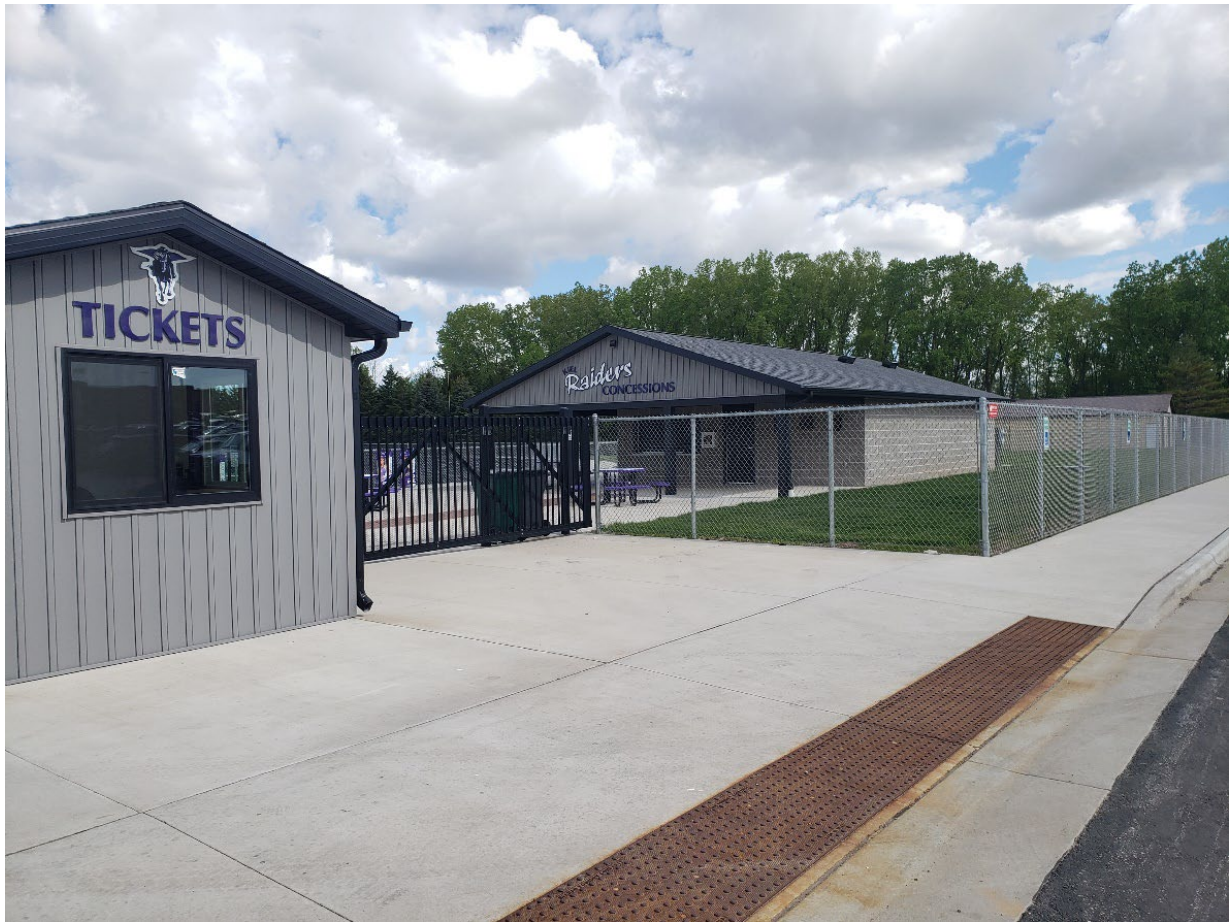
The running track, football field, adjoining fencing, bleachers and concrete sidewalk areas are in excellent condition due to being built in 2019 (Figure 23 & 24). The truncated dome near the entrance is rusted (Figure 22).

*Figure 22: Rusted truncated dome in entrance to running track.*

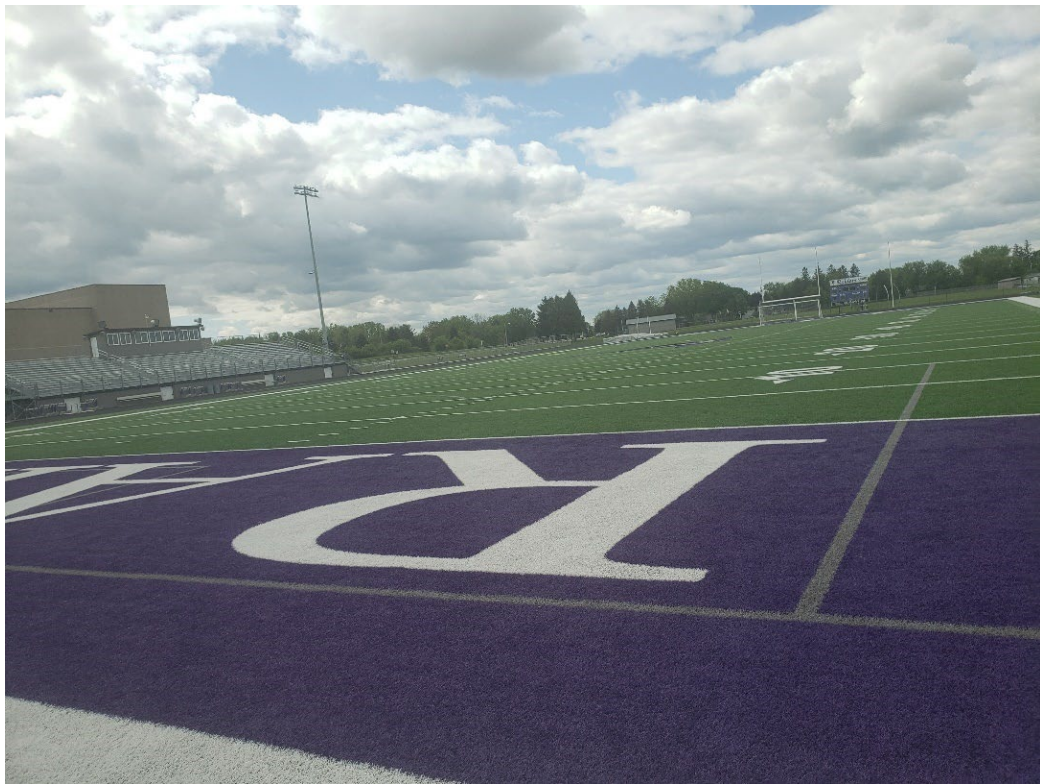
Figure 24: Artificial turf football field in excellent condition.

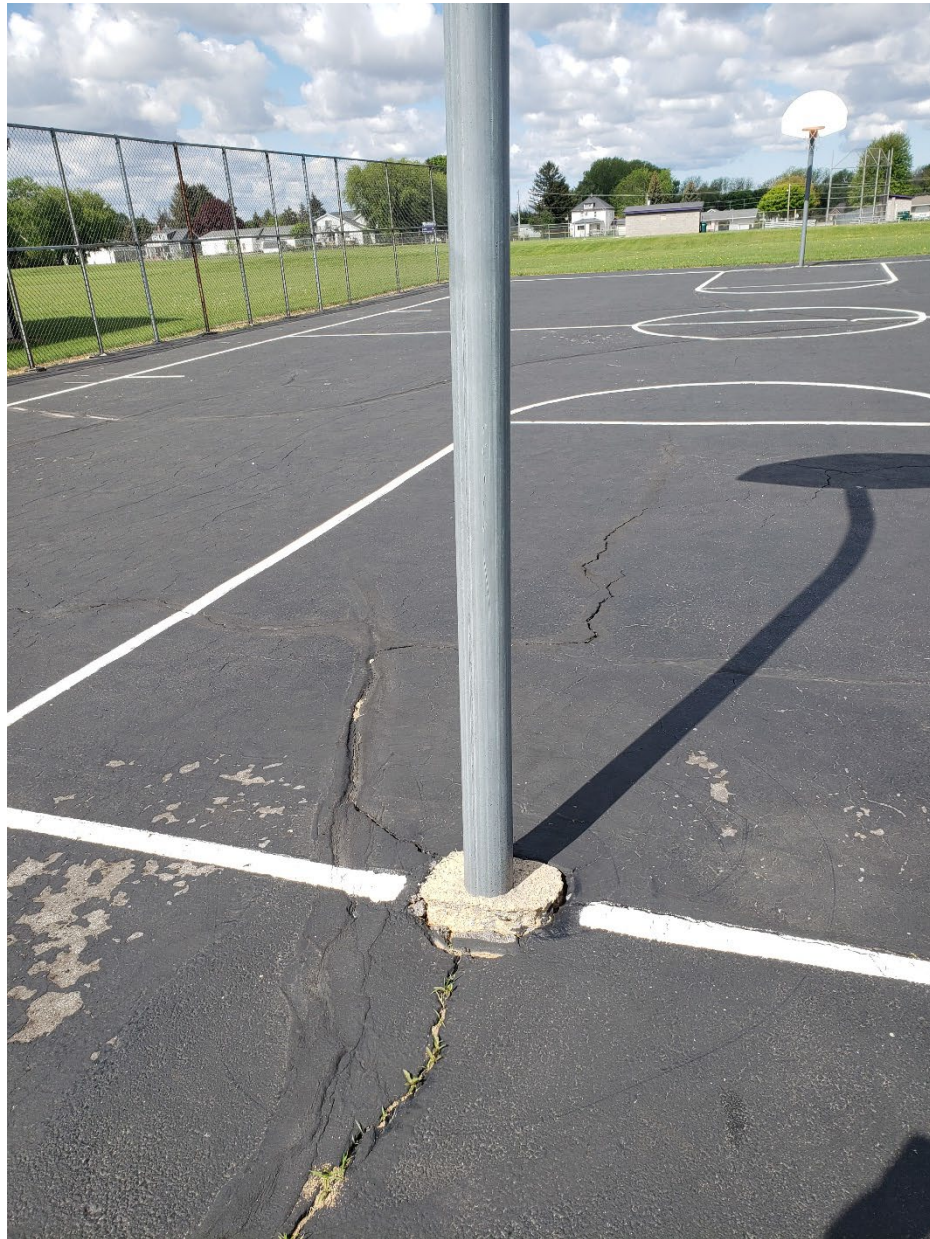
The two asphalt basketball courts are in fair condition. The pavement has large transverse and longitudinal cracking. Some of those cracks have been filled with crack sealant. The whole court is seal coated, but there are areas where the sealant is missing and cracking (Figure 25). The base of all basketball hoop posts shows some cracking. The shed area is newer and in good condition. The pavement markings are in fair condition and have some flakes of paint missing. However, the paint that is there is not very faded (Figure 25).

*Figure 25: Basketball court with alligator and transverse cracking*
