# Kiel Area School District

District-wide Facilities Study

# STUDY DOCUMENT

August 2022

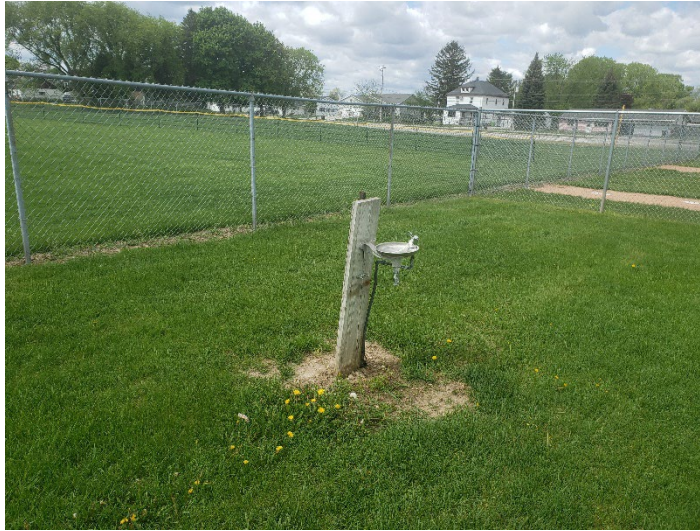
*Figure 27: Water fountain in between practice baseball fields in poor condition*

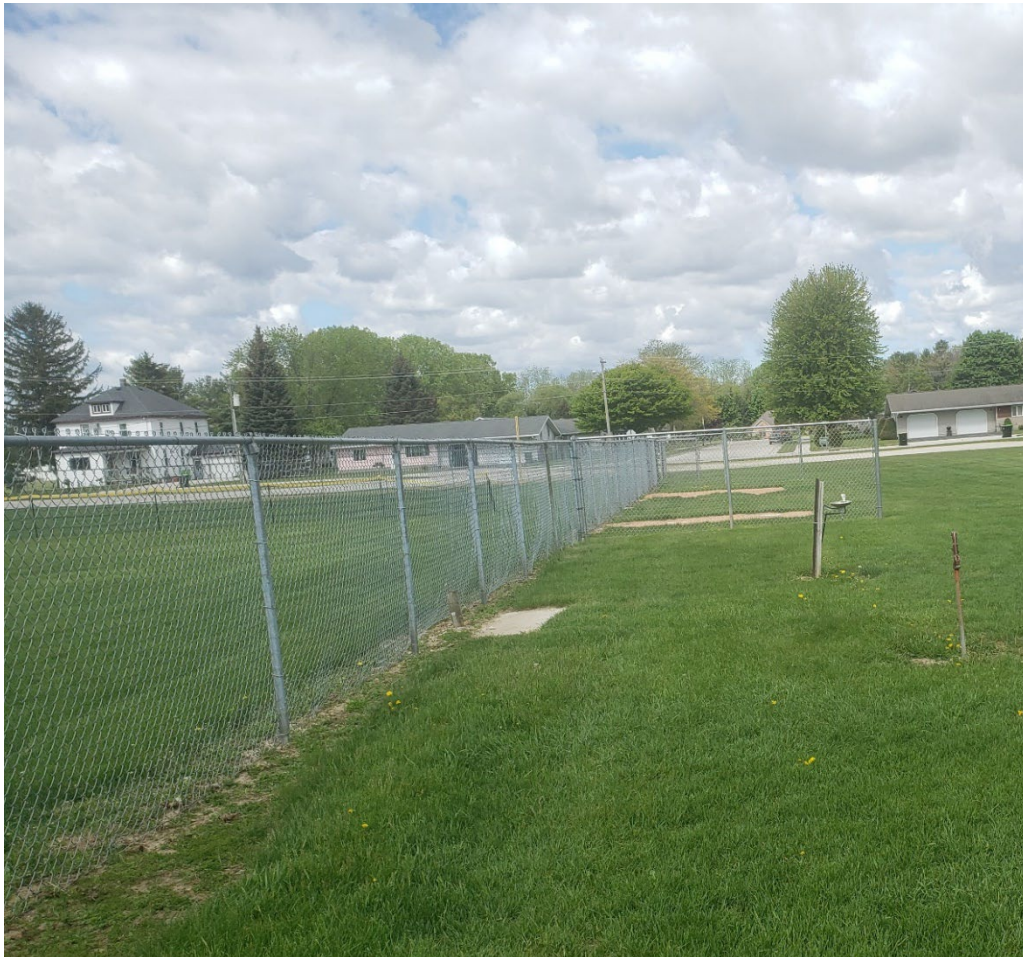
The two practice baseball fields consist of fields, fencing, dugouts and standalone metal bleachers. The fields are in good condition and appear well groomed (Figure 26). The dugouts appear to be newer, and the concrete pads are in good condition. There is a water fountain between the two fields that is in poor condition, due to it being anchored to a tilted board (Figure 27). The fencing requires some maintenance due to rusting posts, unravelling at the bottom, and tilting (Figure 28).

*Figure 28: Fencing unraveling at bottom and unattached from posts.*

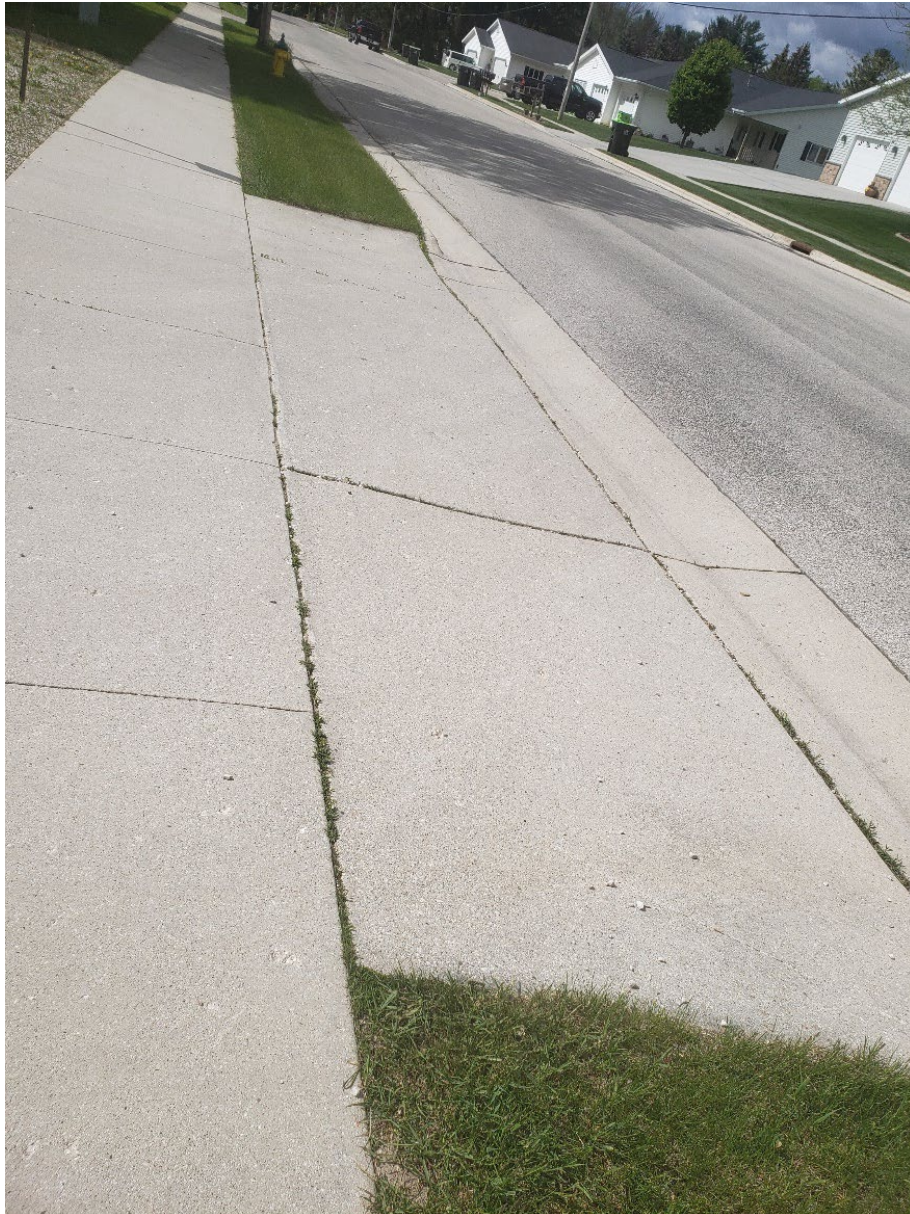
The gravel parking lot, sidewalks off 6<sup>th</sup> street and driveway apron are in good condition. There does not appear to be any rutting or depressions in the gravel lot (Figure 30). However, there is some green growth creeping into the lot. The concrete driveway and sidewalk are in good condition with some small pieces chipped off on the surface (Figure 29). There are no cracks.

*Figure 29: Driveway apron in good condition.*

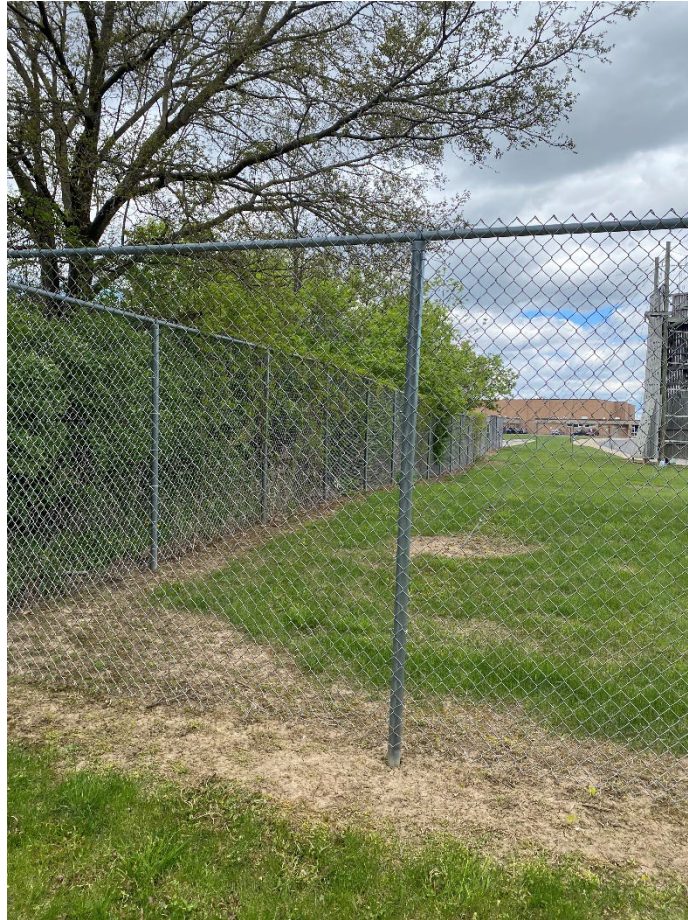
The Outdoor Climbing Area consists of a fenced in area with climbing walls and posts. The fence was in fair condition due to some unraveling at the bottom. There was some trees and brush growing into the west fence line (Figure 37). The grass area between the road and the north fence had a lot of patches of dead grass (Figure 38).

*Figure 37: Trees and brush growing into fence on west side of climbing area*

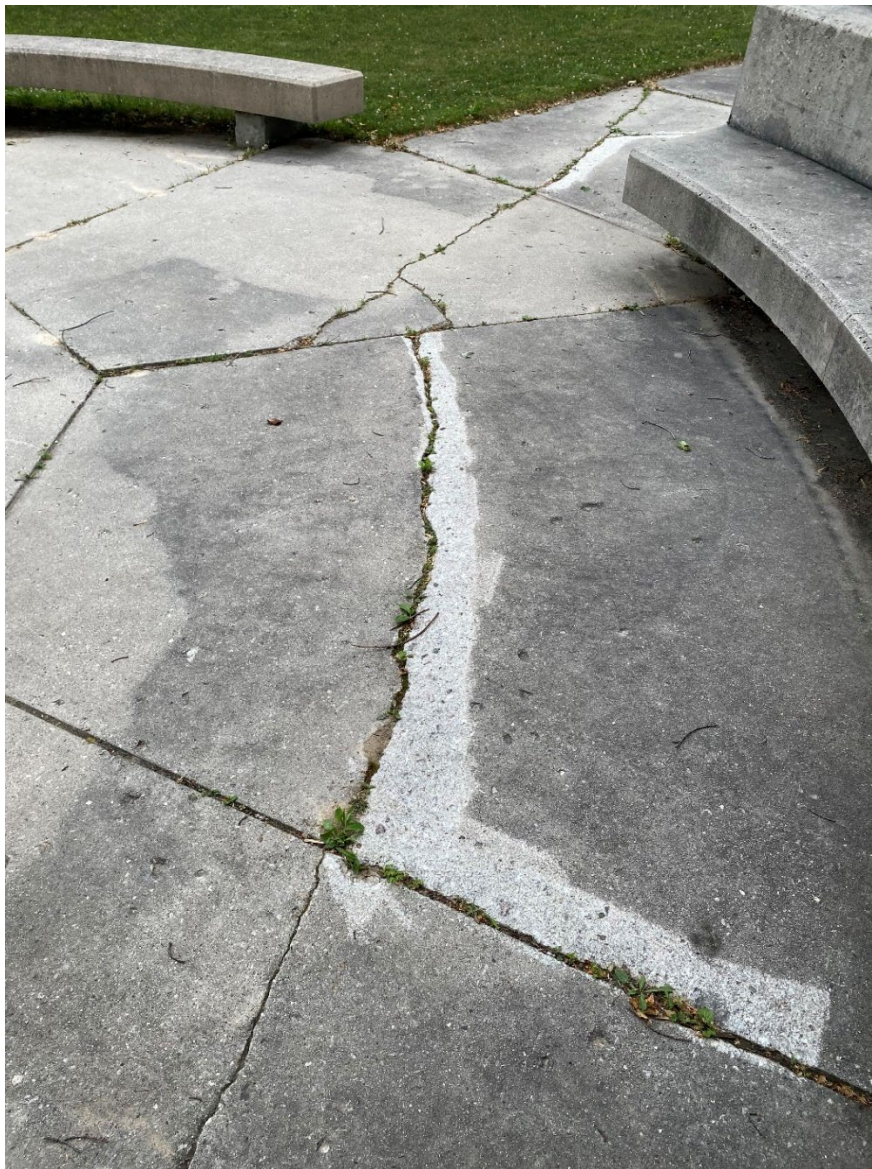
The interior courtyard consists of multiple concrete sidewalks, concrete benches, a concrete retaining wall and movable picnic tables. There are also some wooden planters. The concrete sidewalk throughout the courtyard is in poor condition and many slabs have cracked. The pavement looks very old and has weeds growing through the cracks (Figure 39). Many of the concrete slabs have settled causing uneven surfaces (Figure 43). Some of the edges have been ground down to reduce tripping hazards. The retaining walls have vertical cracks along them and are in fair condition (Figure 40 &41). The standalone concrete benches have some chipped edges and are in fair condition. The large center rounded seating bench has vertical cracks throughout it and is in fair to poor condition (Figure 42). The wooden planters have some rotting wood pieces. The picnic tables are in good condition.

*Figure 39: Cracking and settling concrete in courtyard.*
