kiel high school

SUMMARY

kiel high school building systems summary

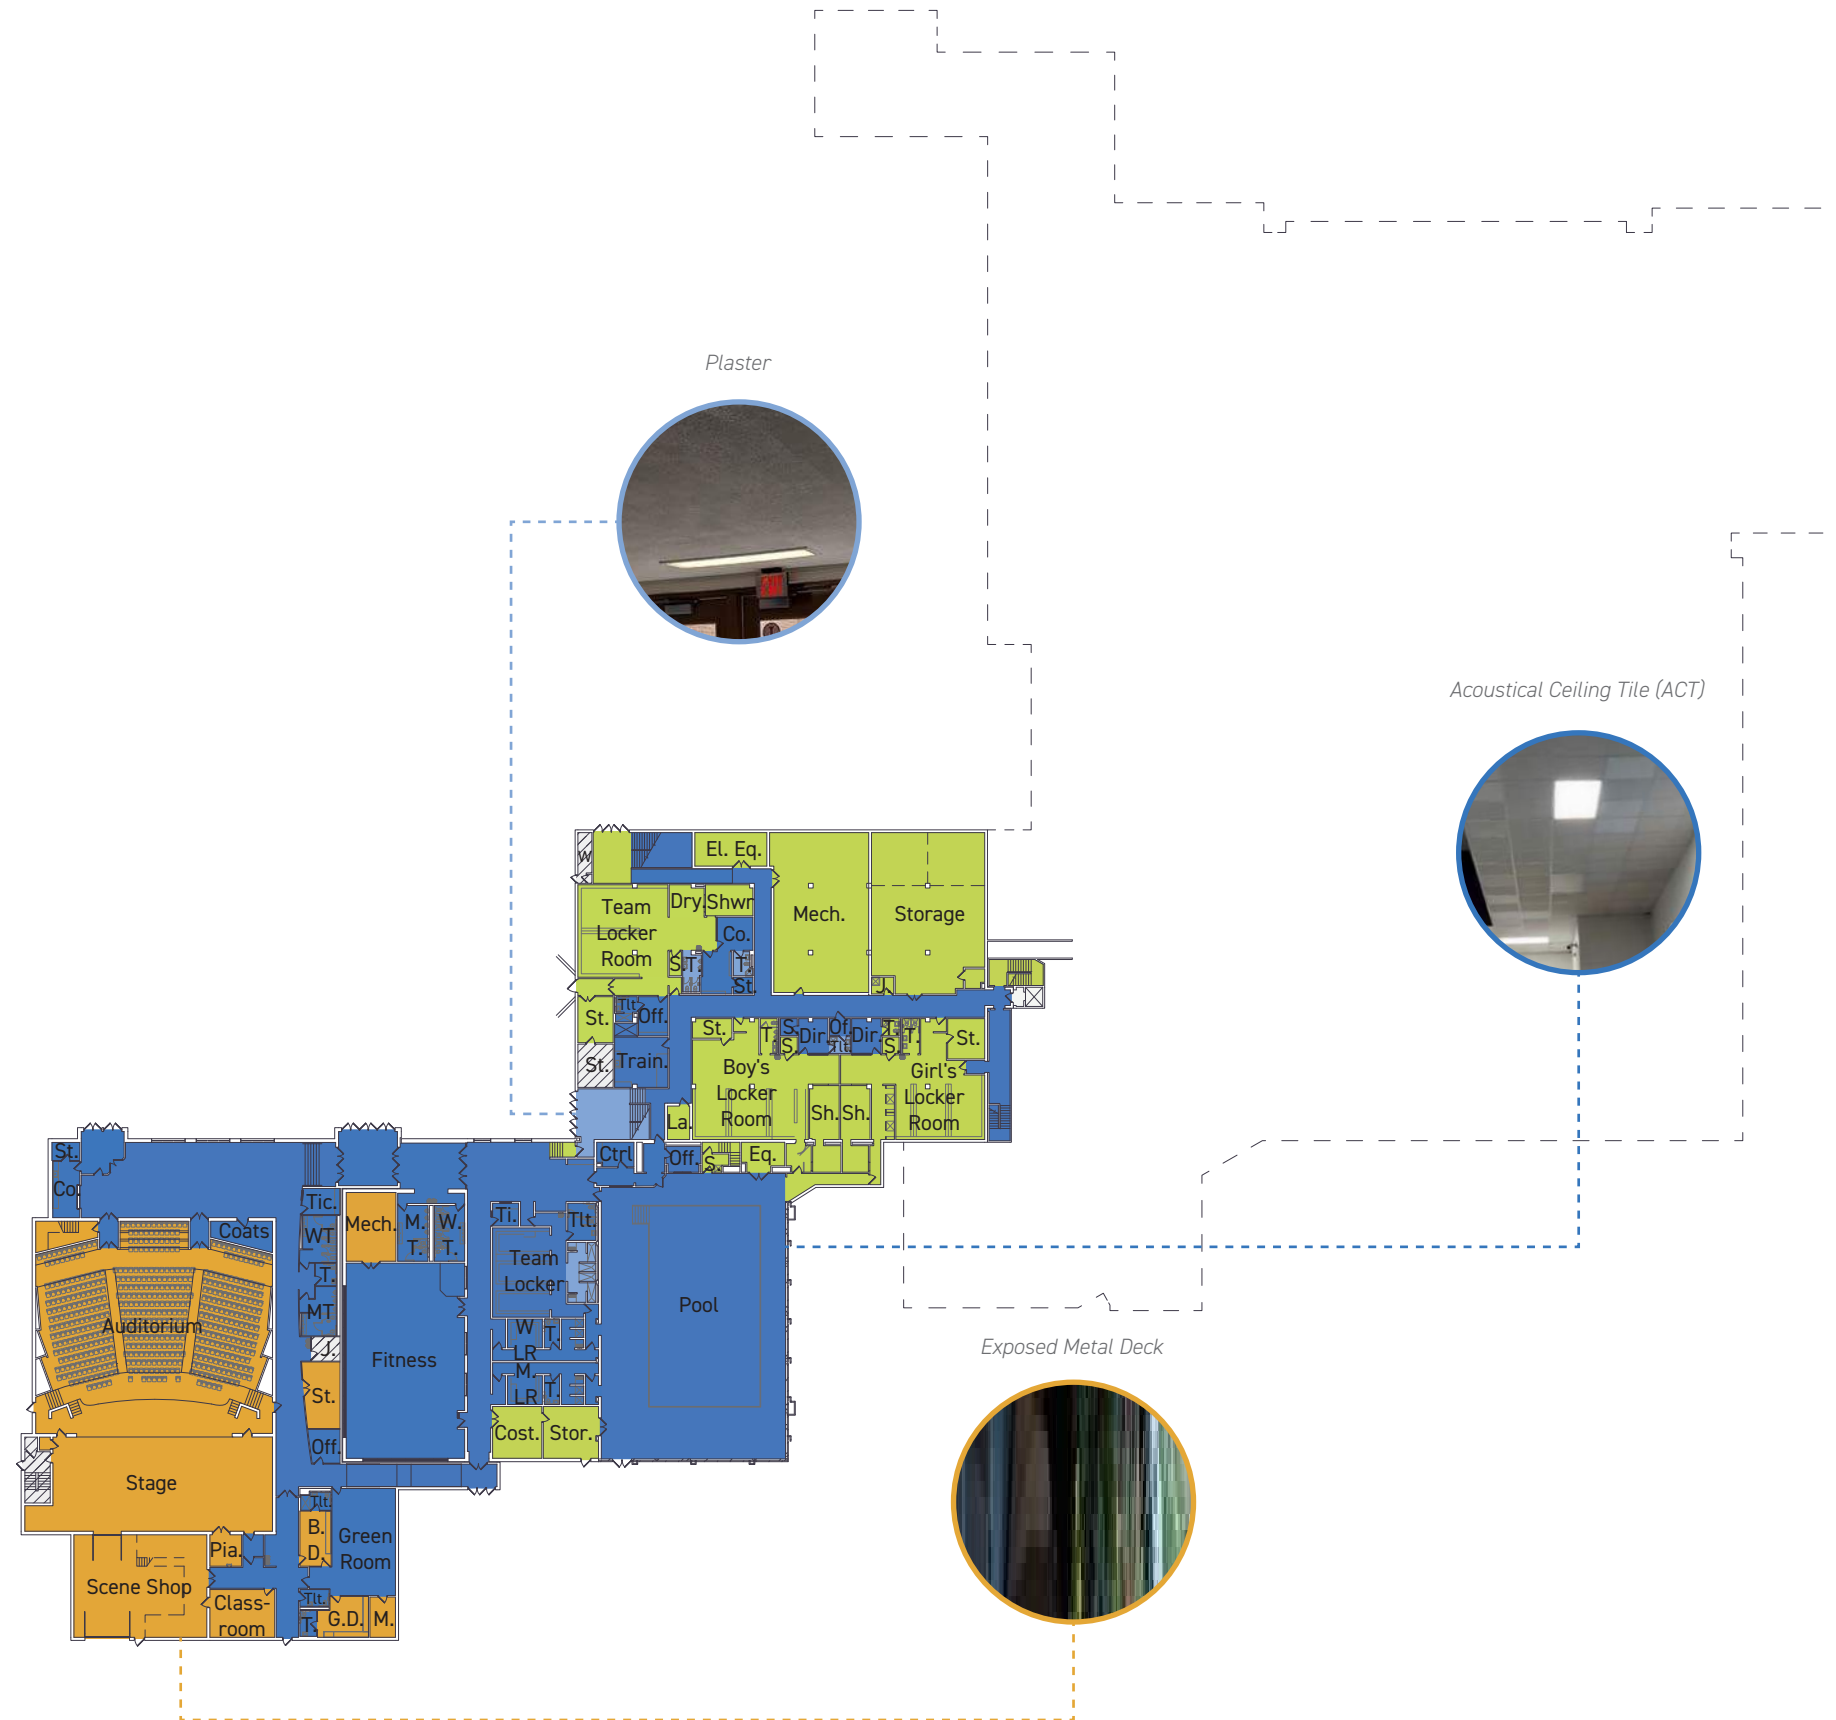
- Acoustical tile ceiling in the pool is in poor condition due to having instances of stained and missing tiles.
- There are instances of concrete ceilings in the lower level that are in poor condition due to staining and cracking.
- Materials identified as potentially containing asbestos are considered to be in poor condition.
- Spline ceilings are identified as potentially containing asbestos.

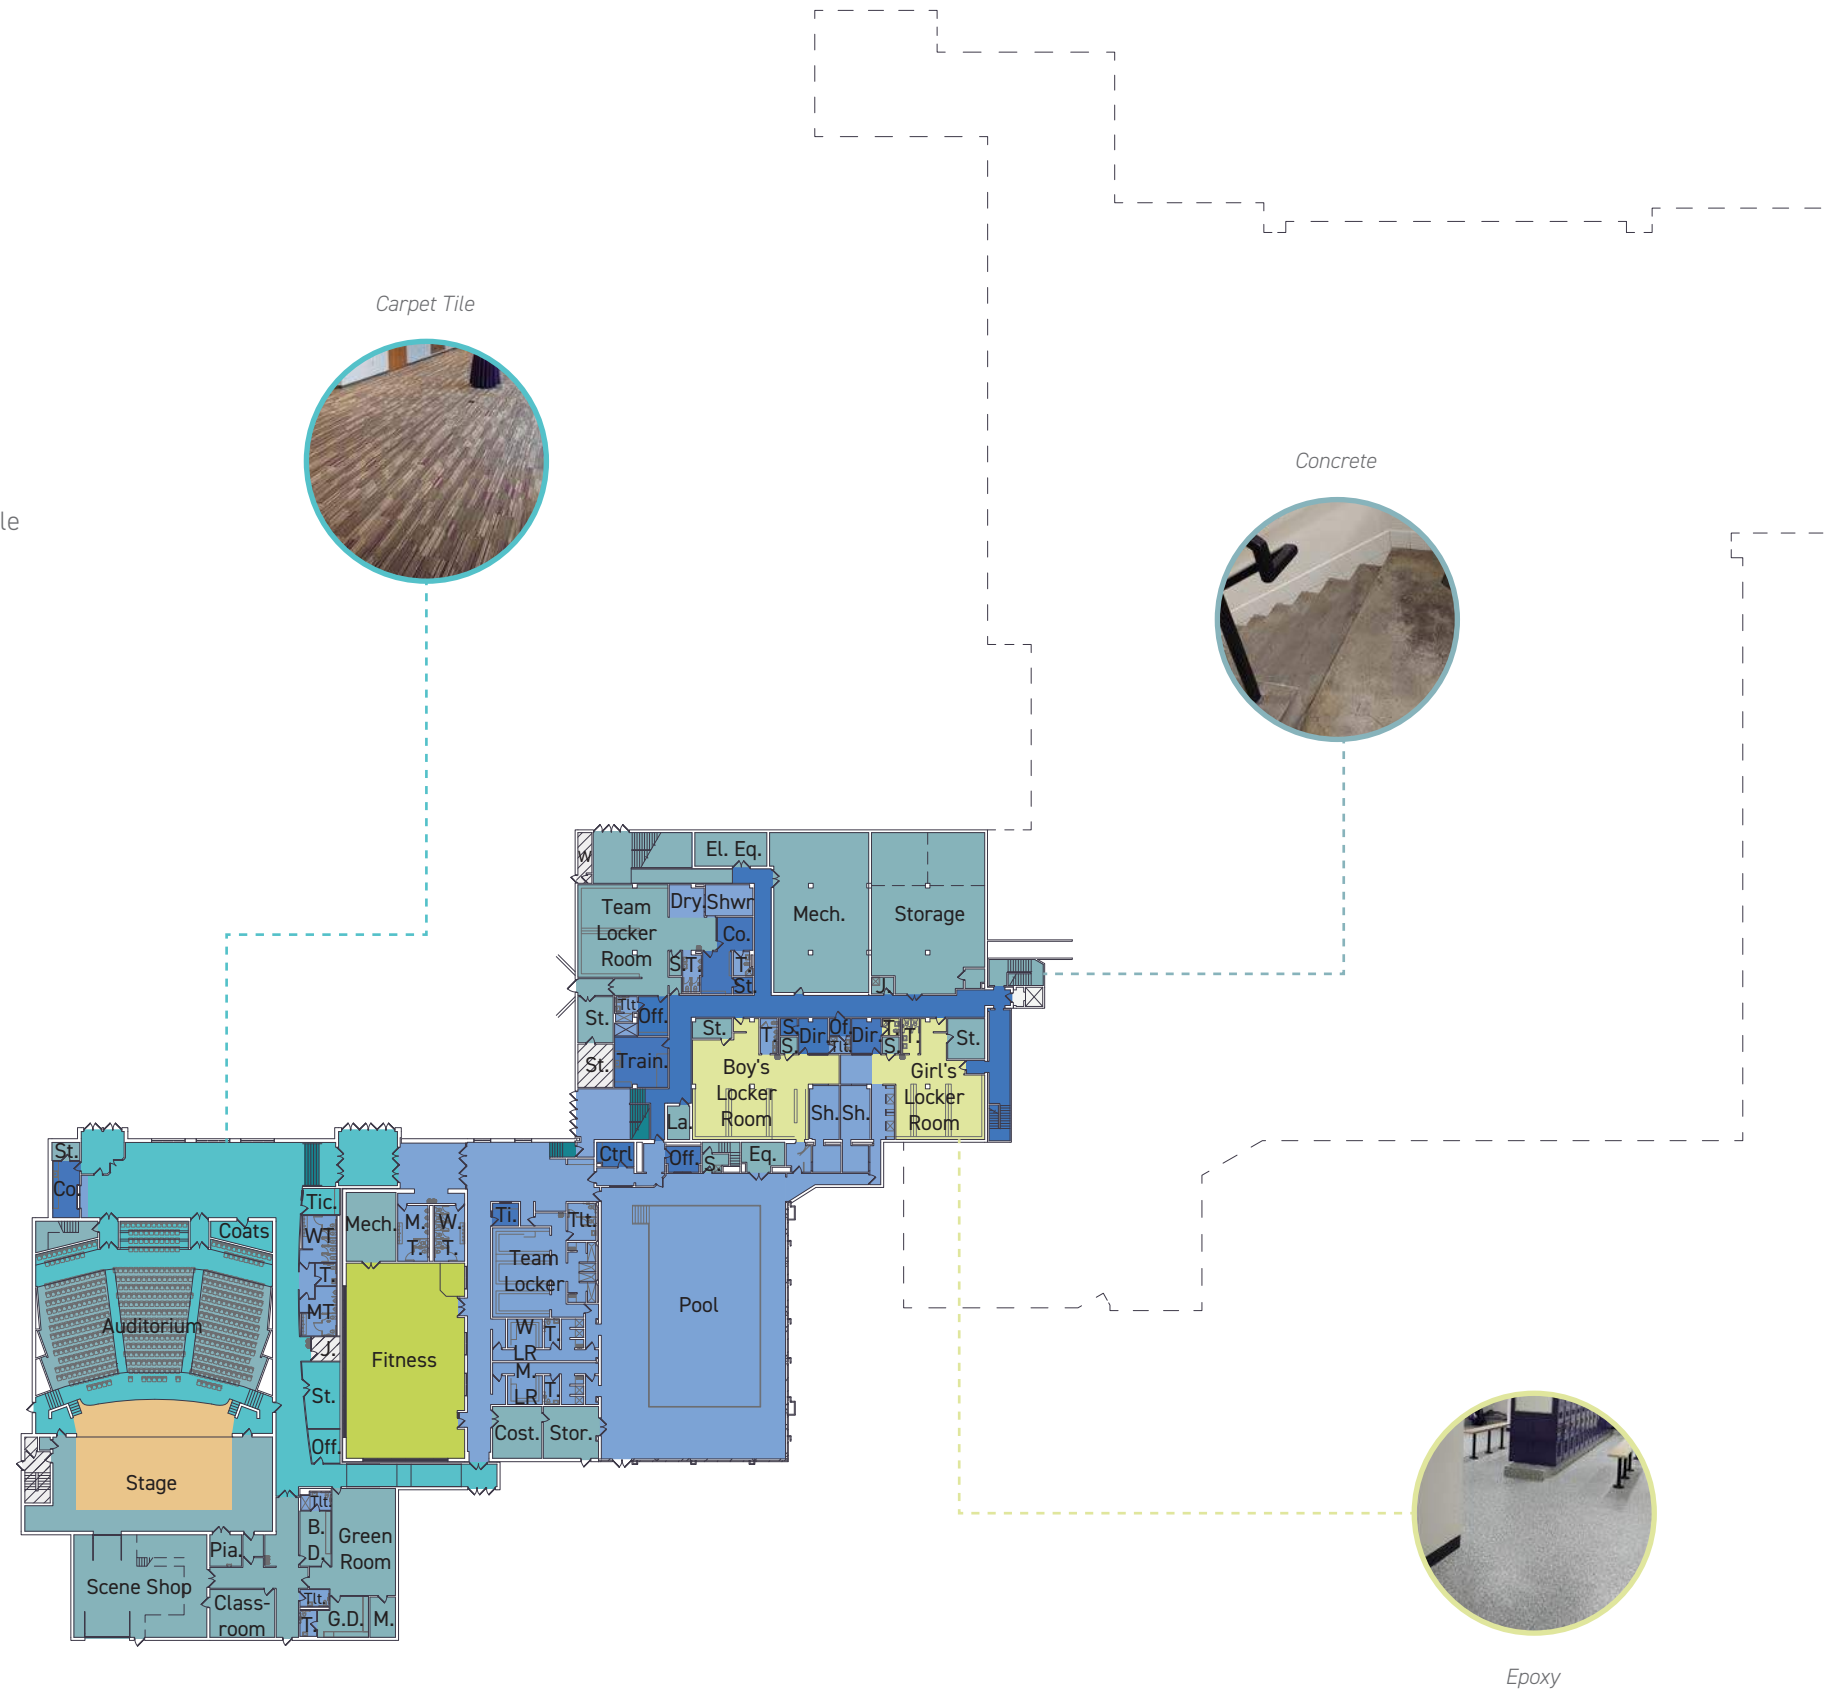
- Tile flooring in the pool and locker rooms is in fair condition due to instances of cracked tiles.
- Majority of the vinyl composite tile flooring is in fair condition due to surface scratching.
- There are instances where concrete flooring in the lower level is in poor condition due to staining and cracking.

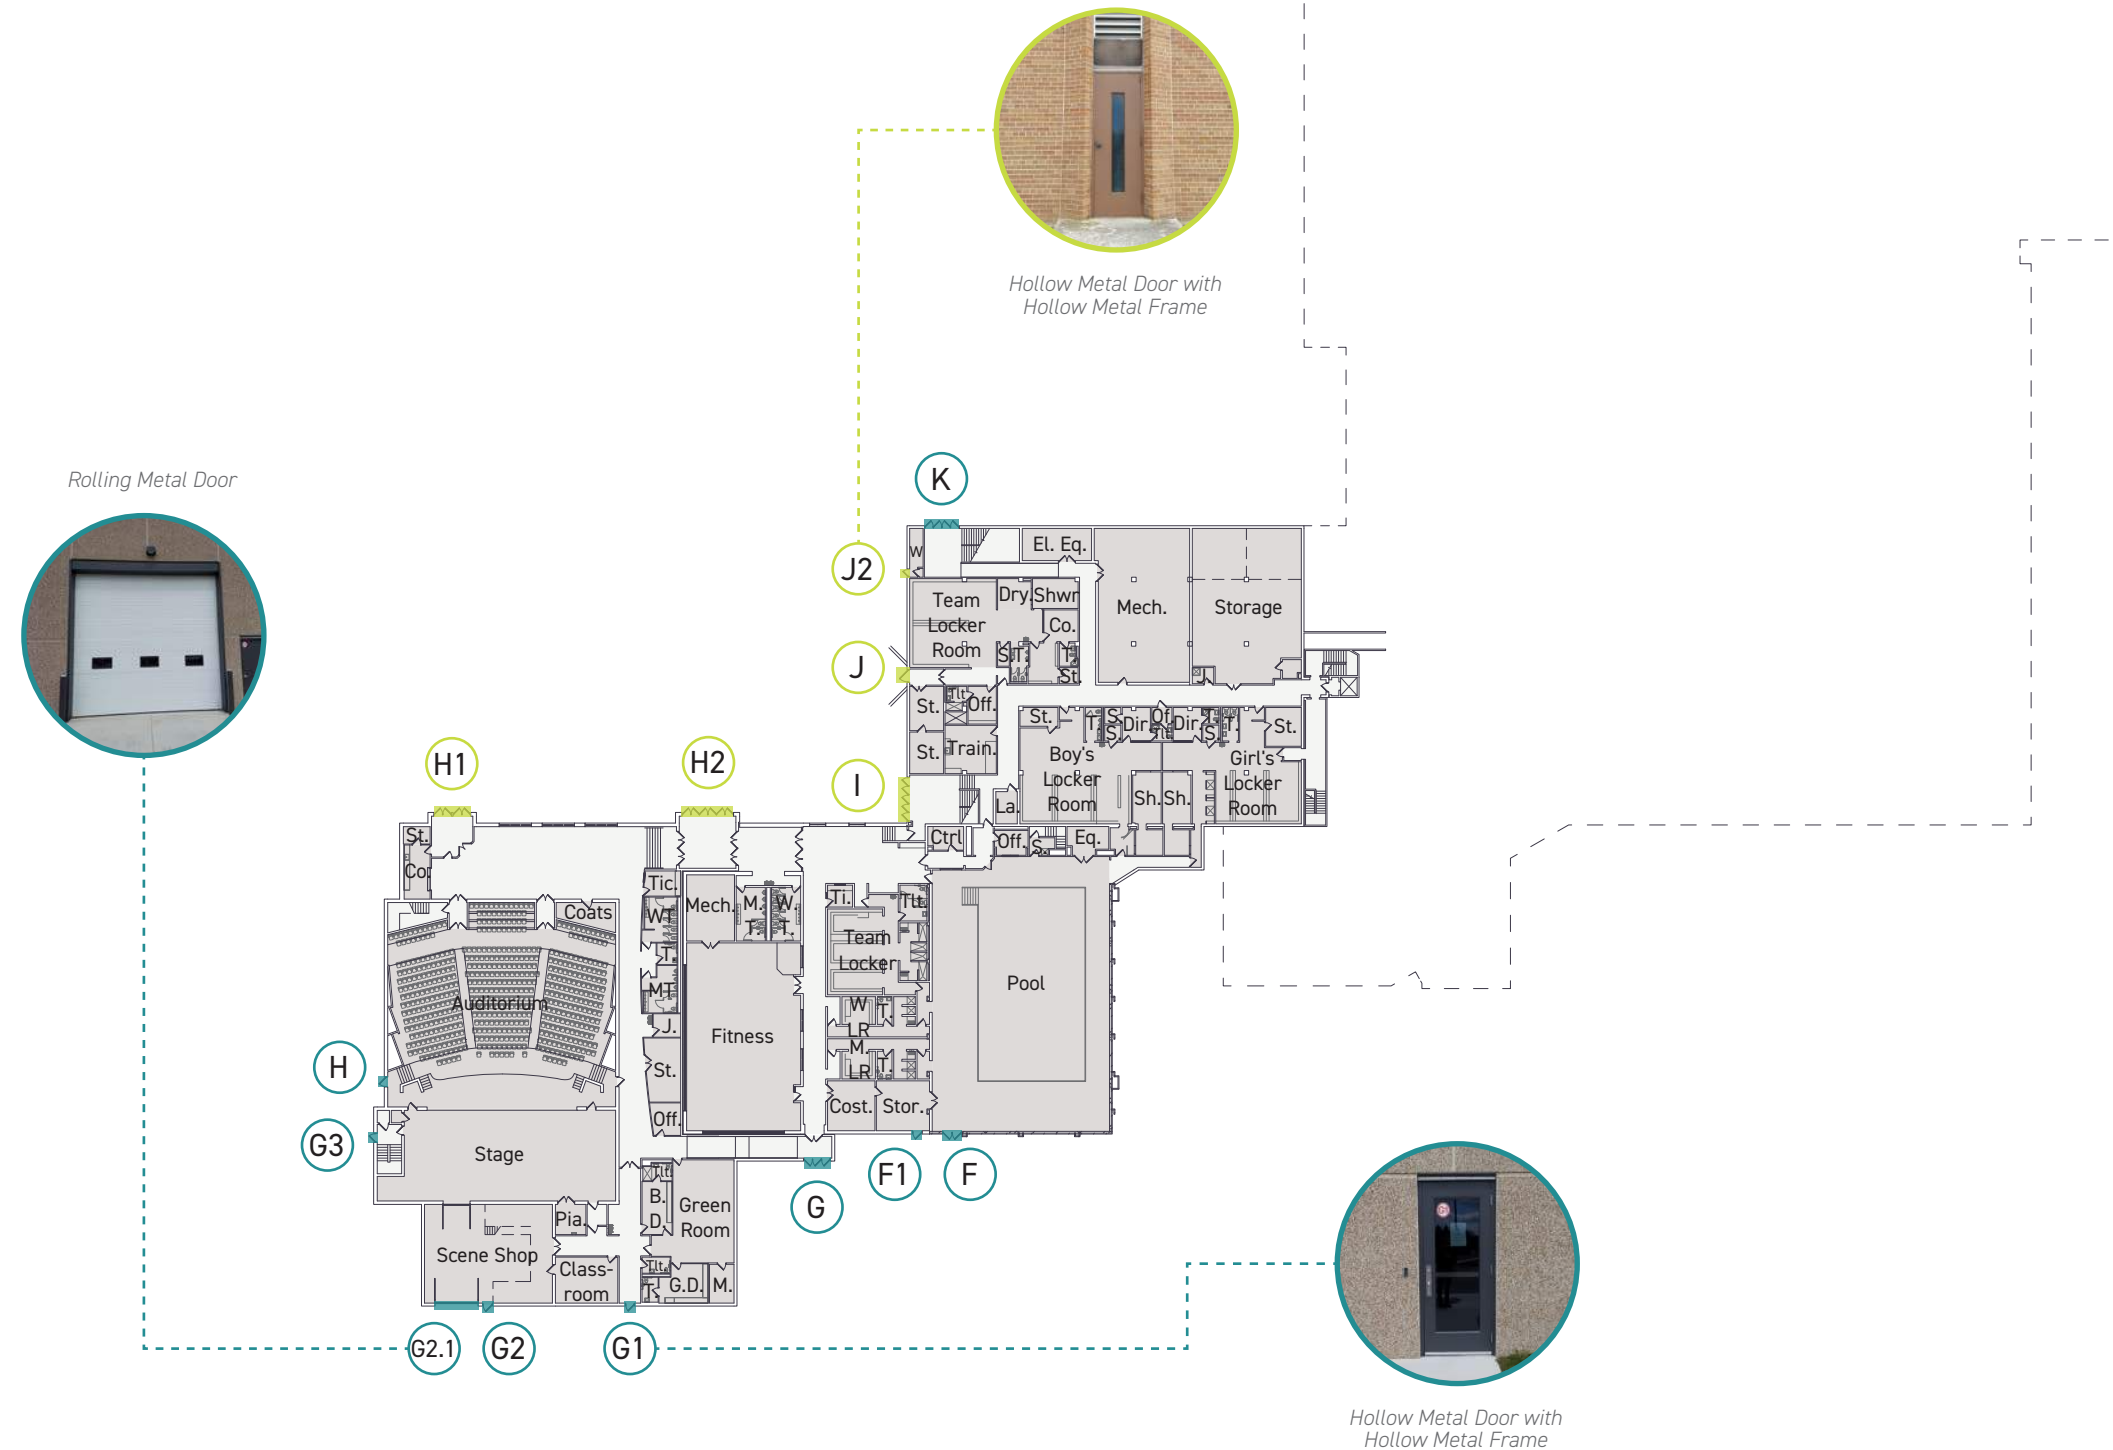
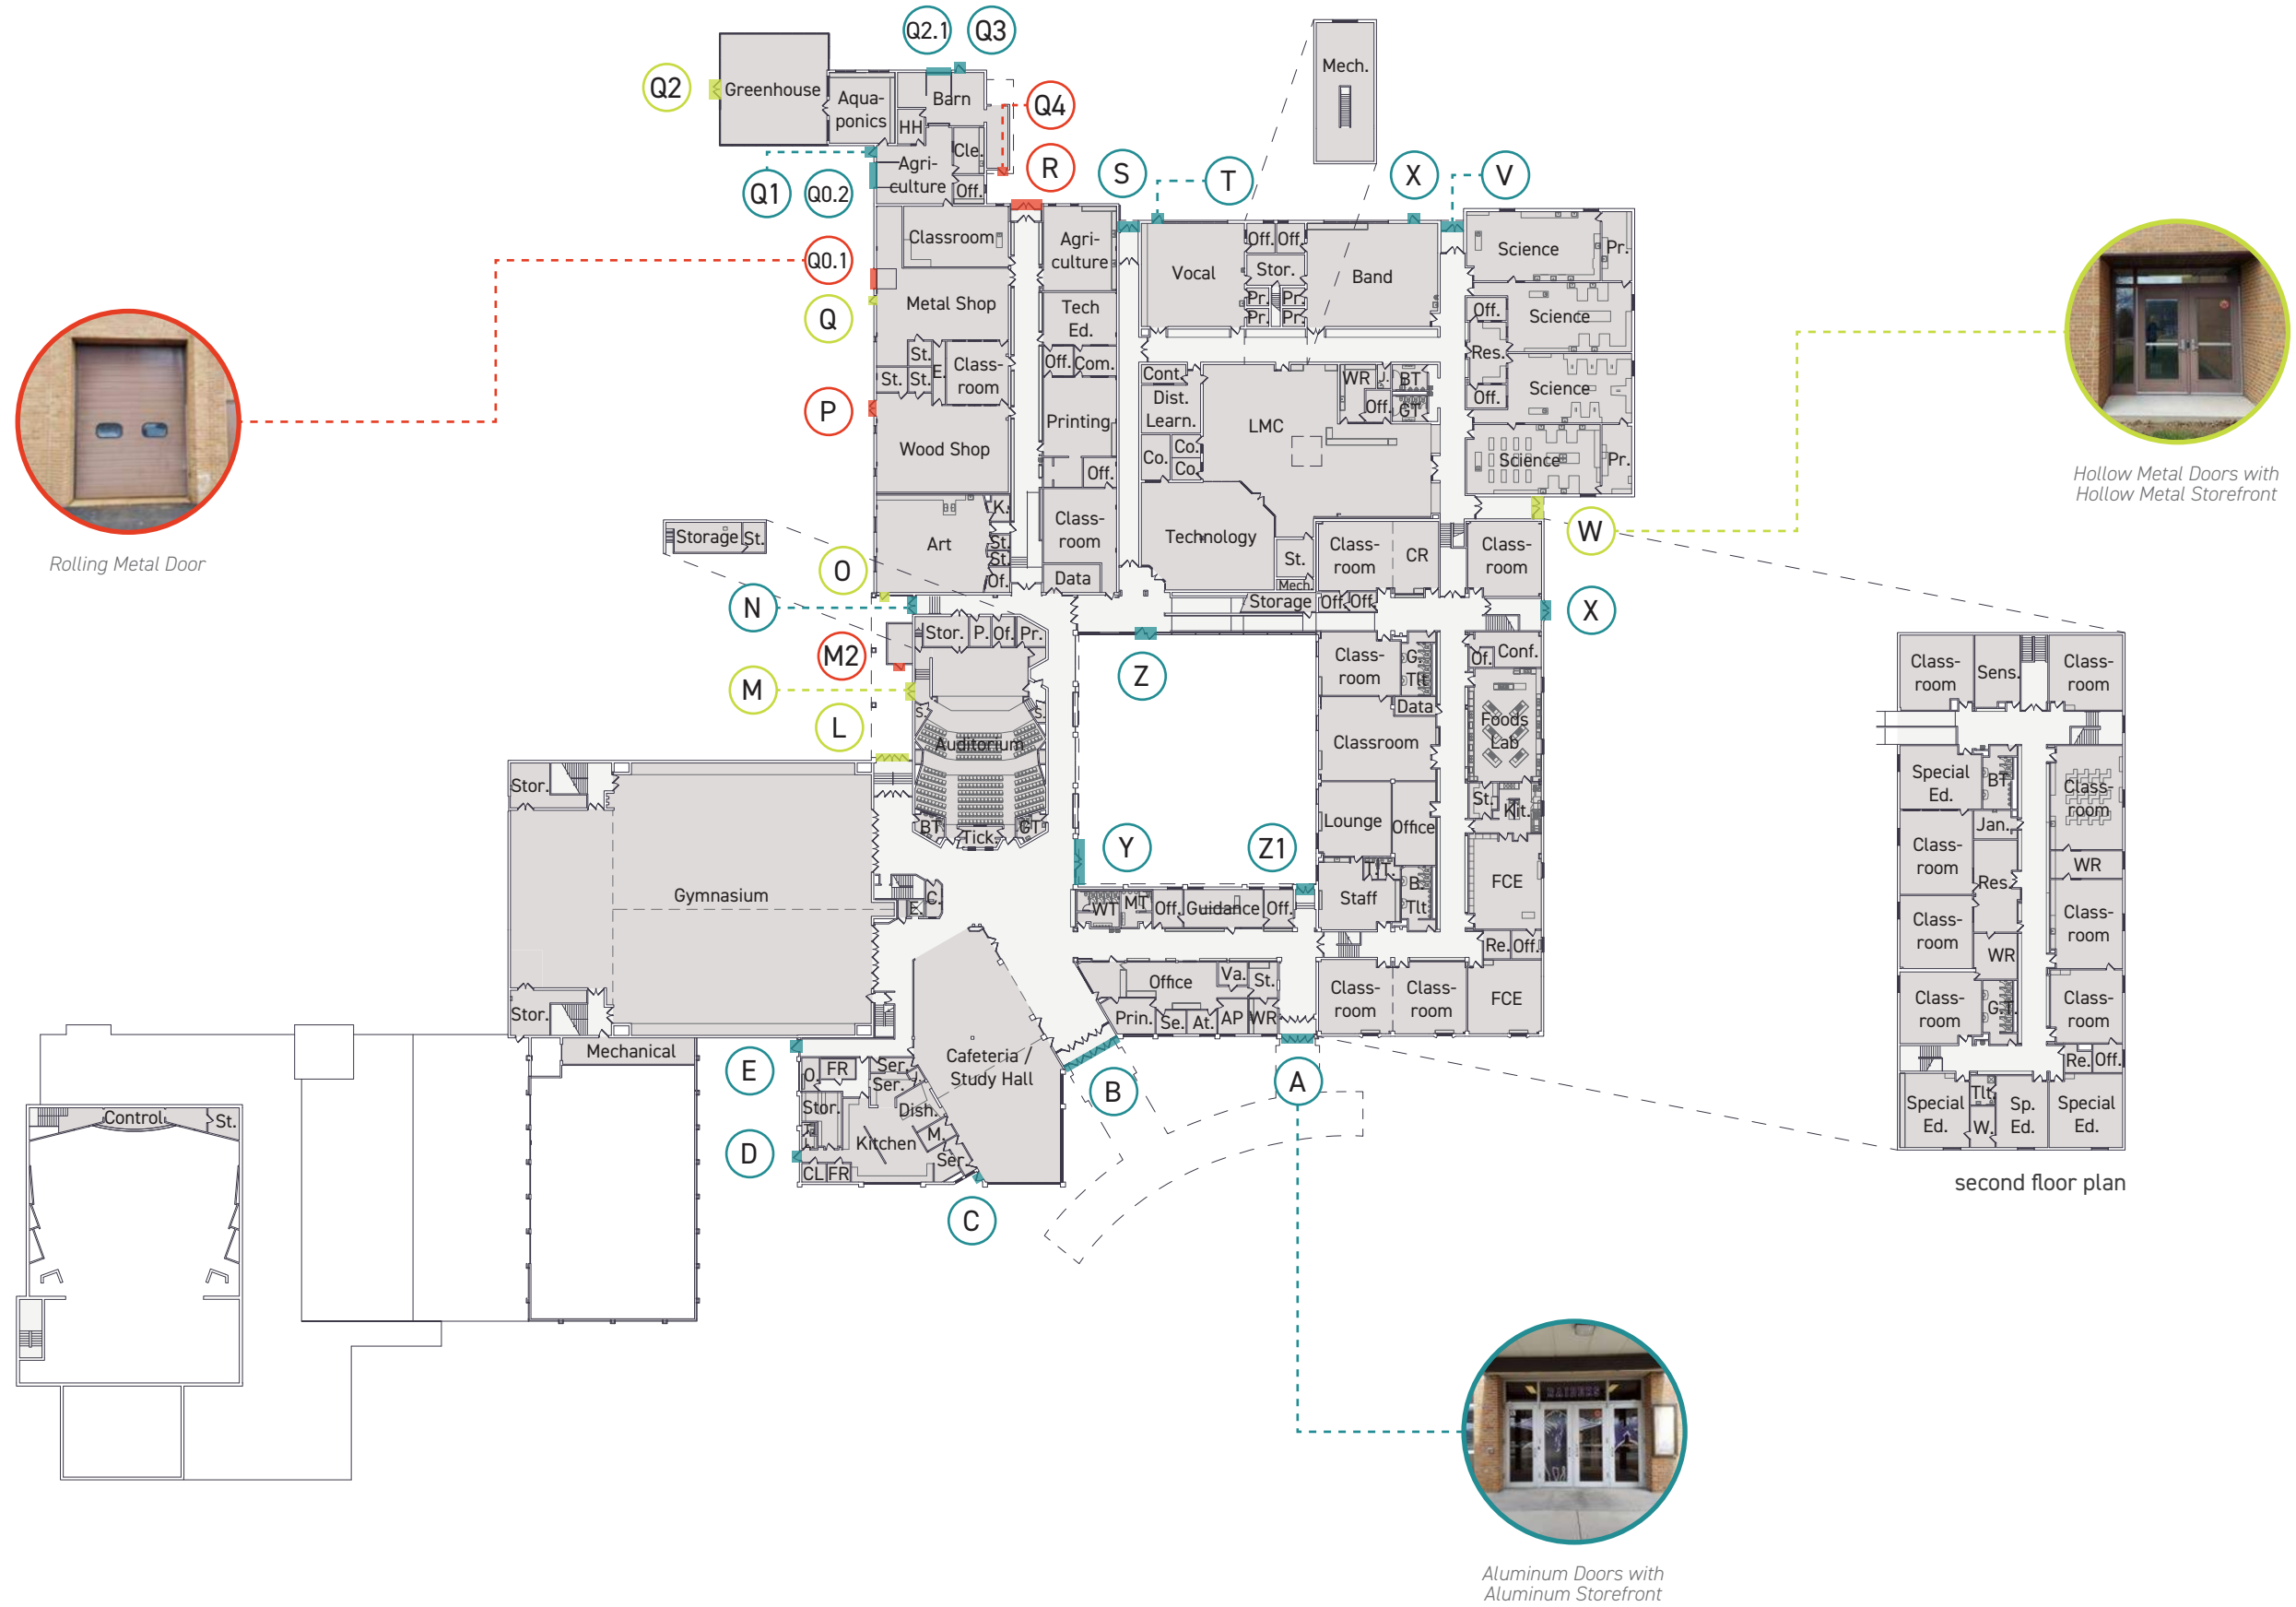
- Exterior doors on the south side of the building appear to be in good condition.
- Door Q4 is in poor condition due to staining, weathering, and paint peeling off.

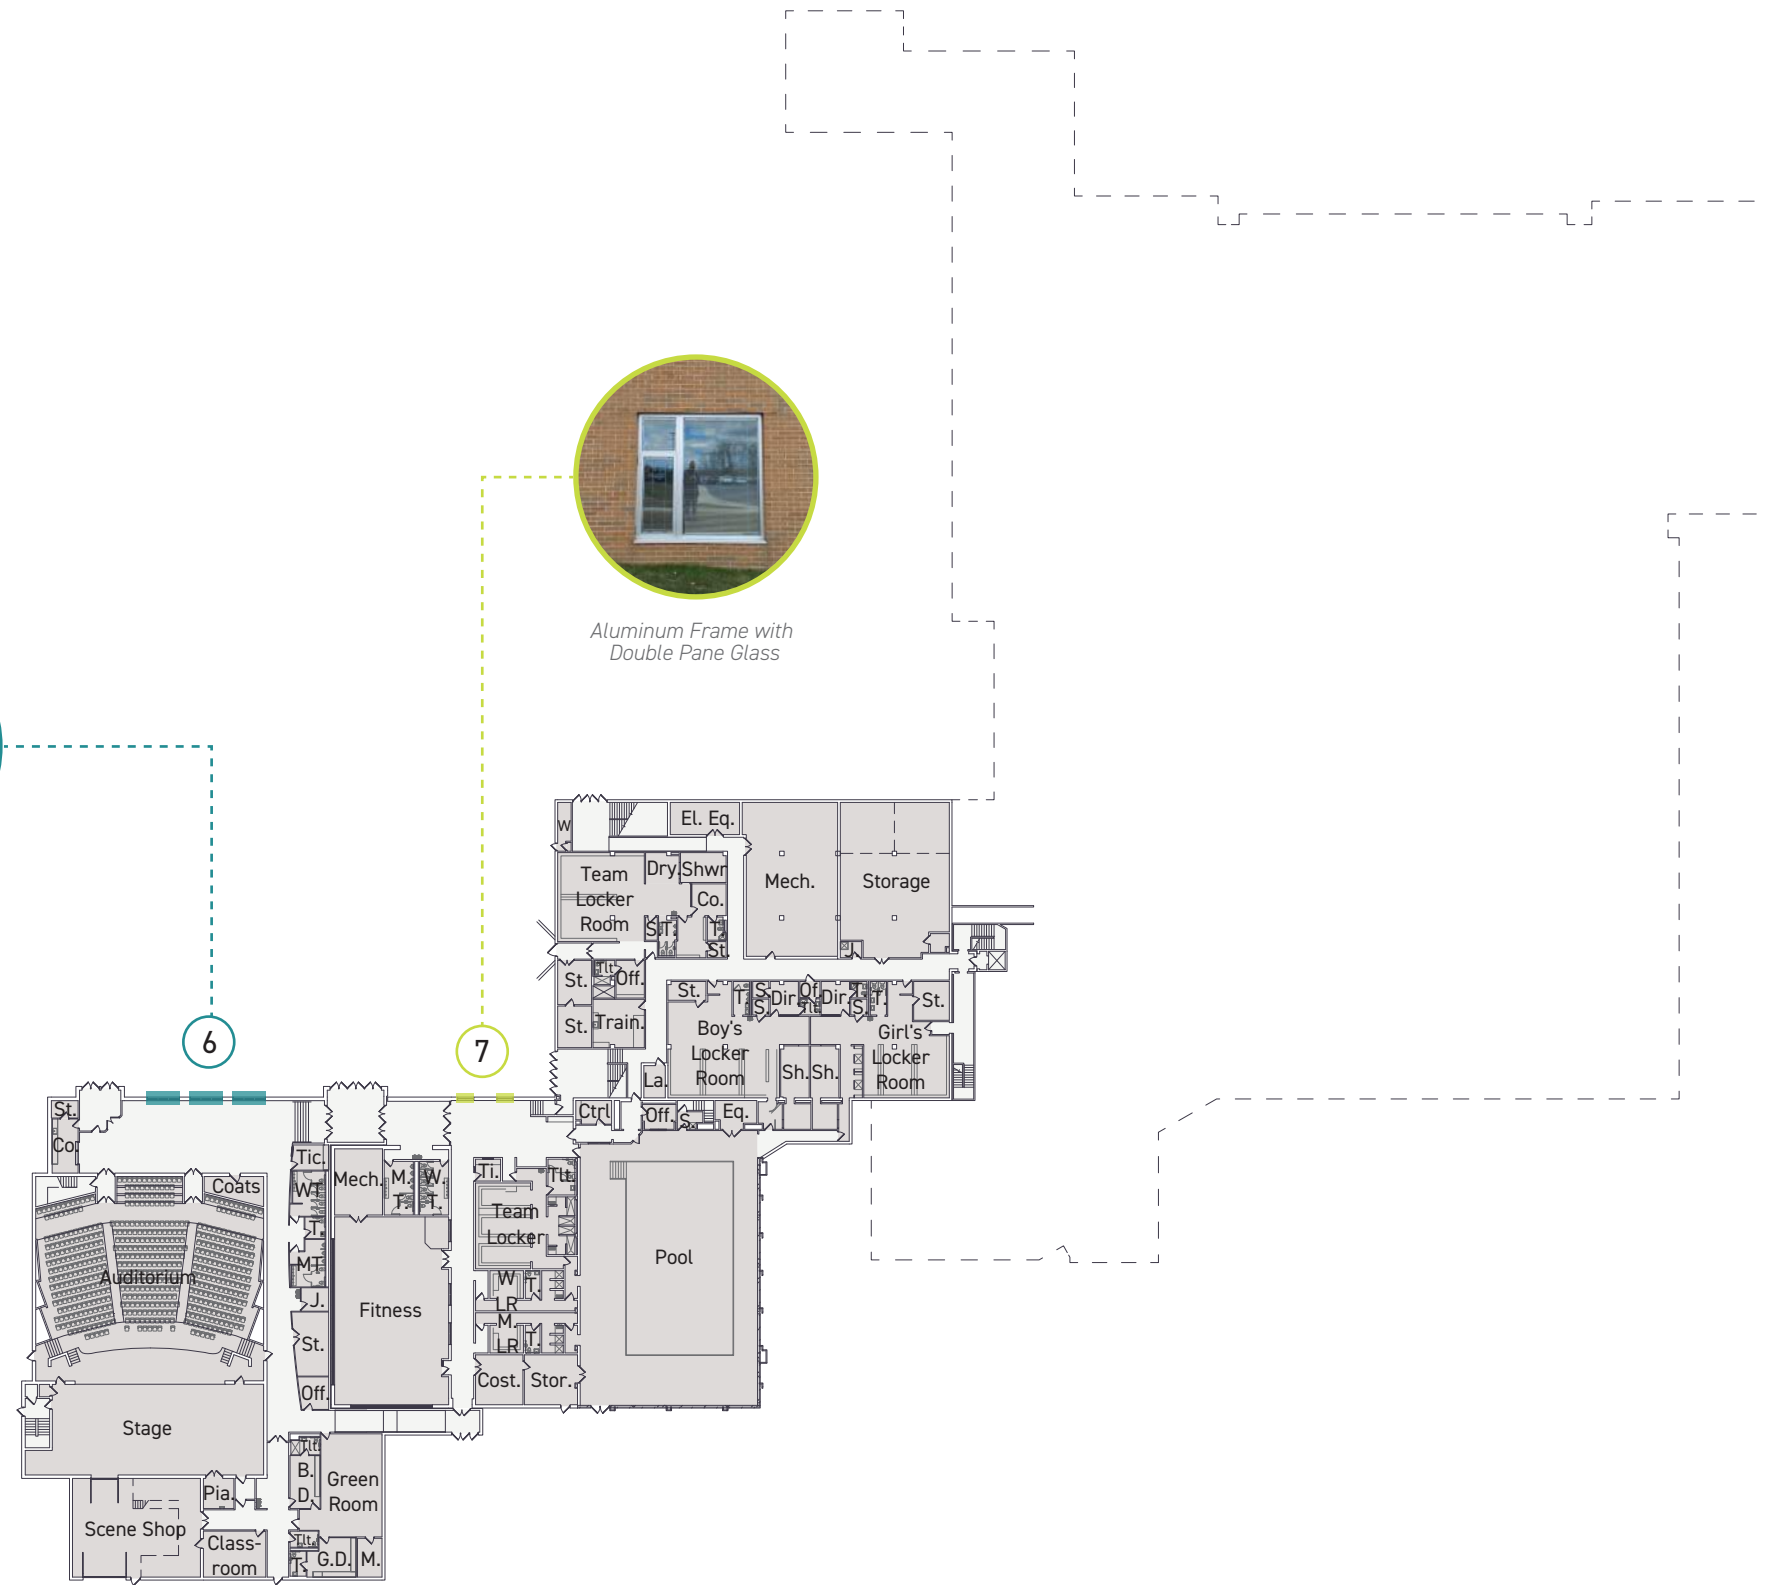
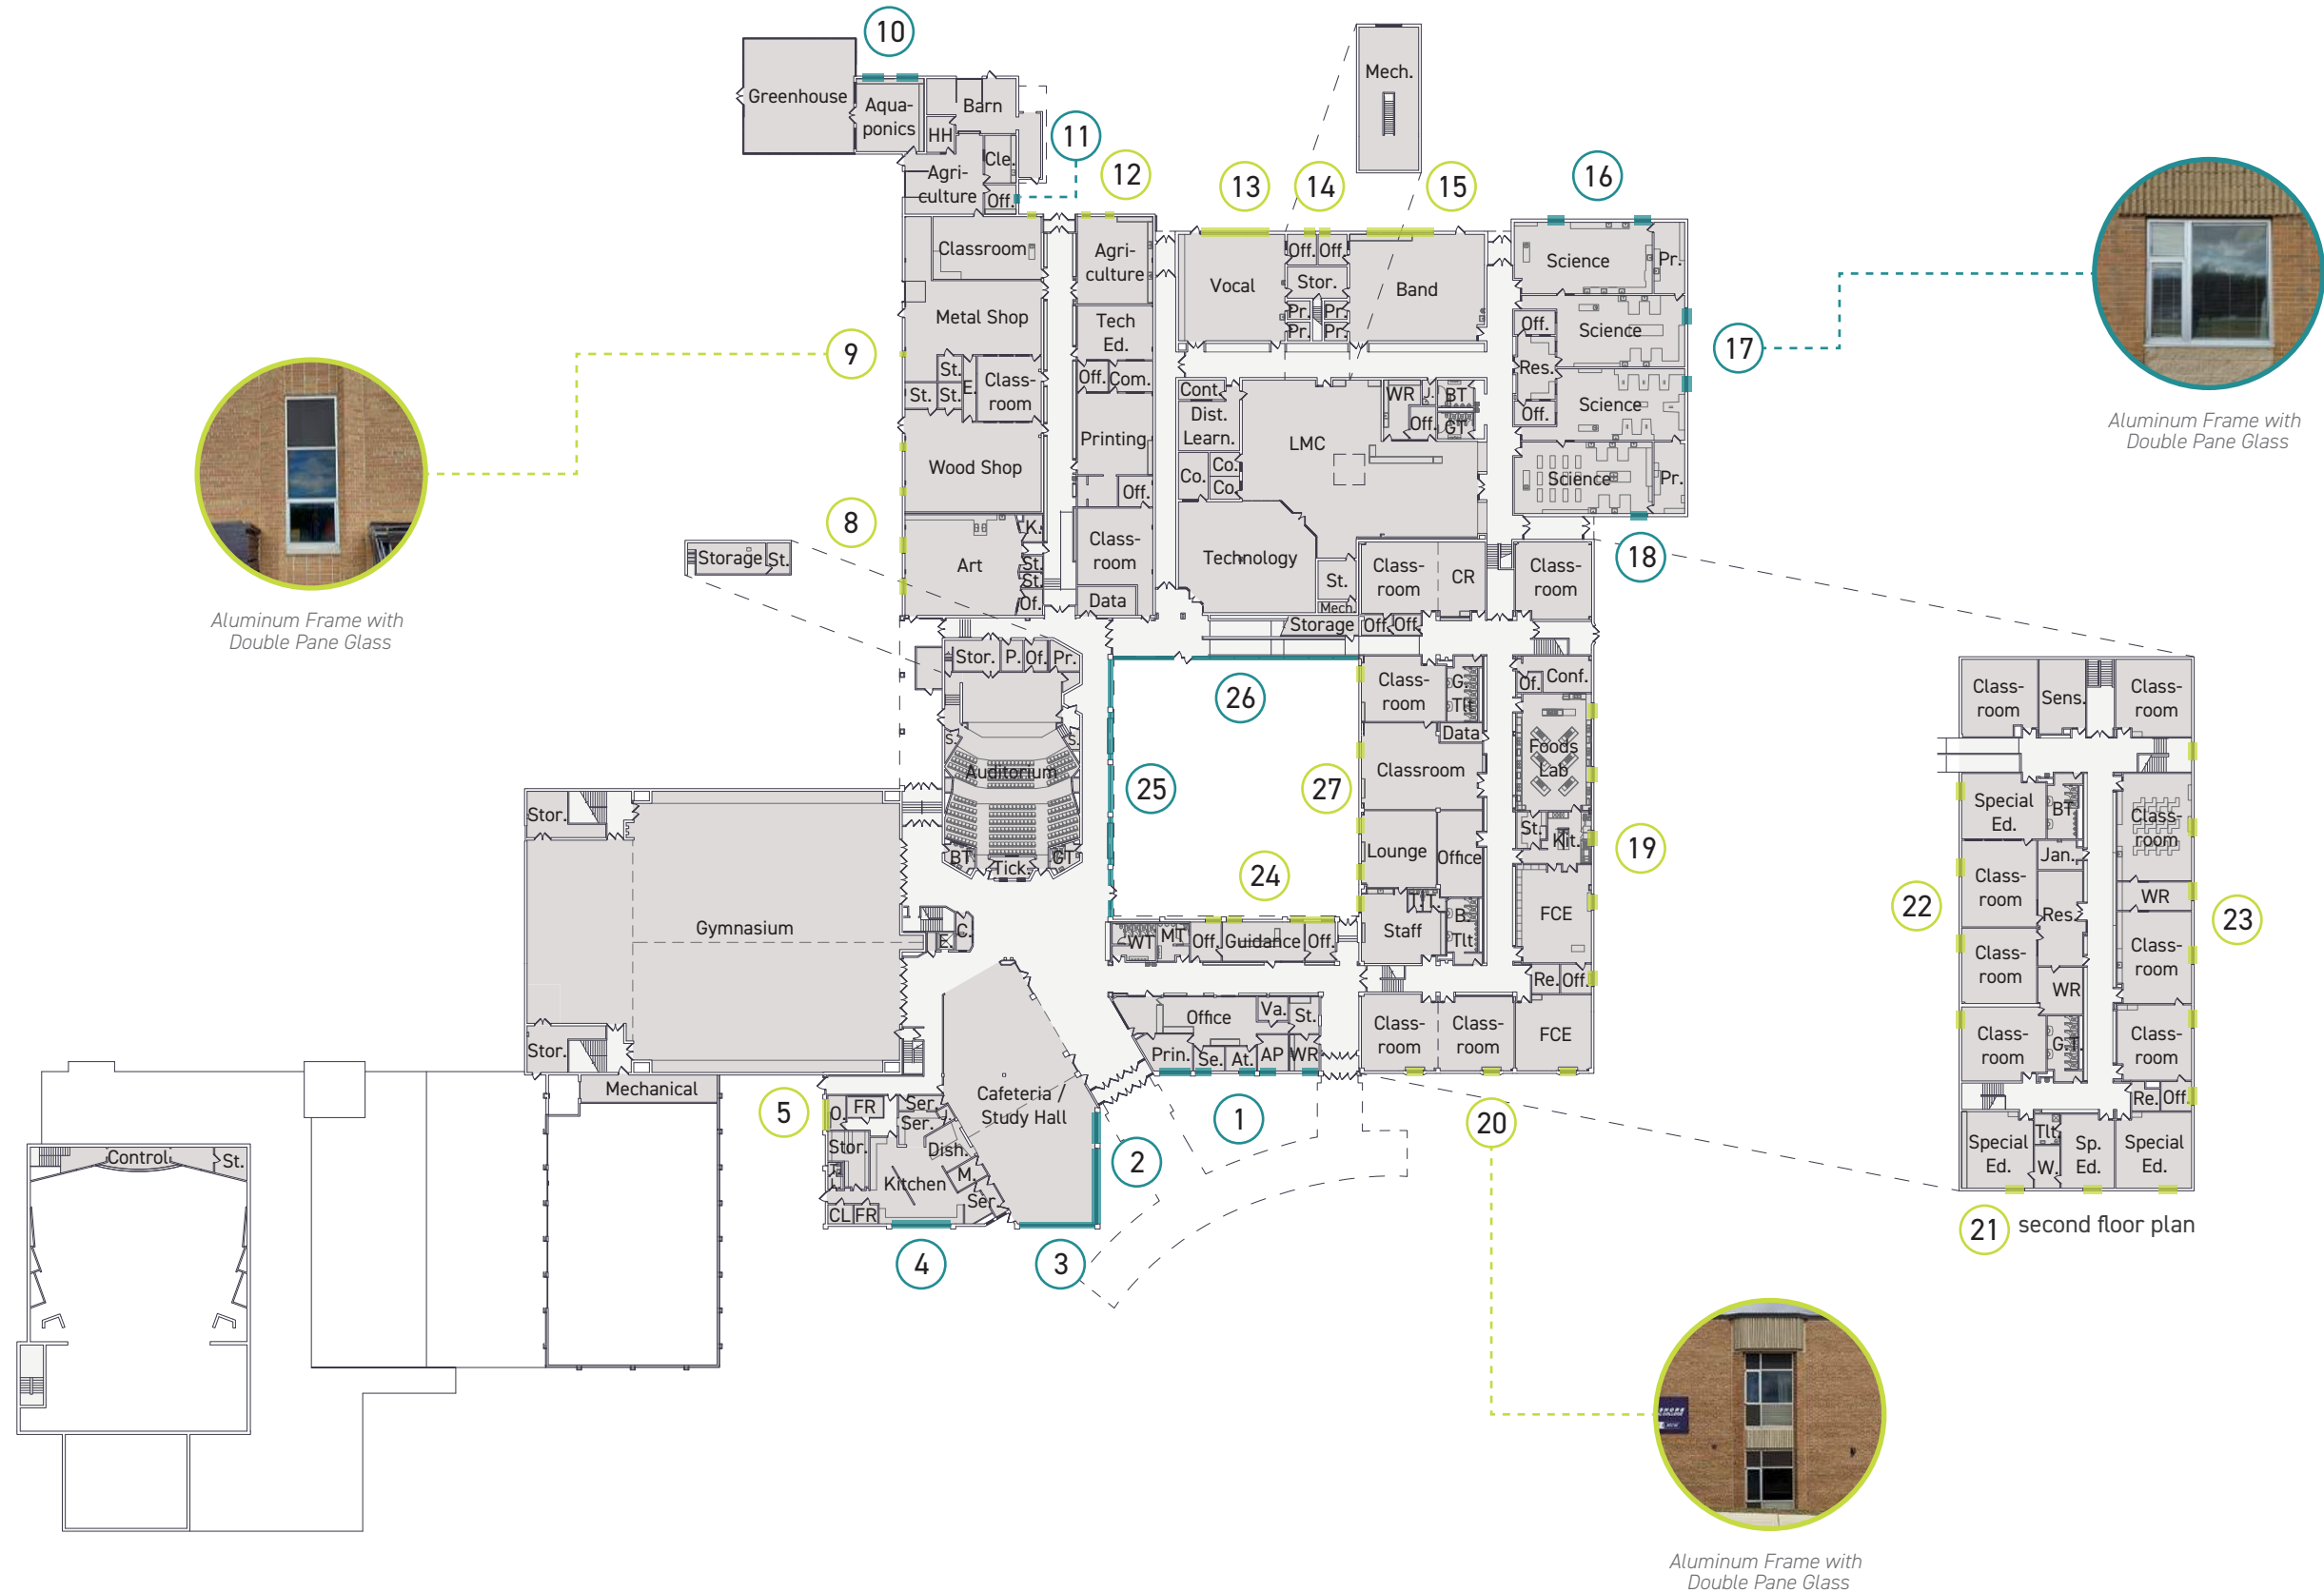
kiel high school exterior window identification + analysis | first and second floor

- There are no windows that appear to be in poor condition.
- Windows on the south-east side of the building are in fair condition due to cracking.
