kiel middle school

SUMMARY

Kiel Middle School provides a comprehensive program for 5th grade - 8th grade students.

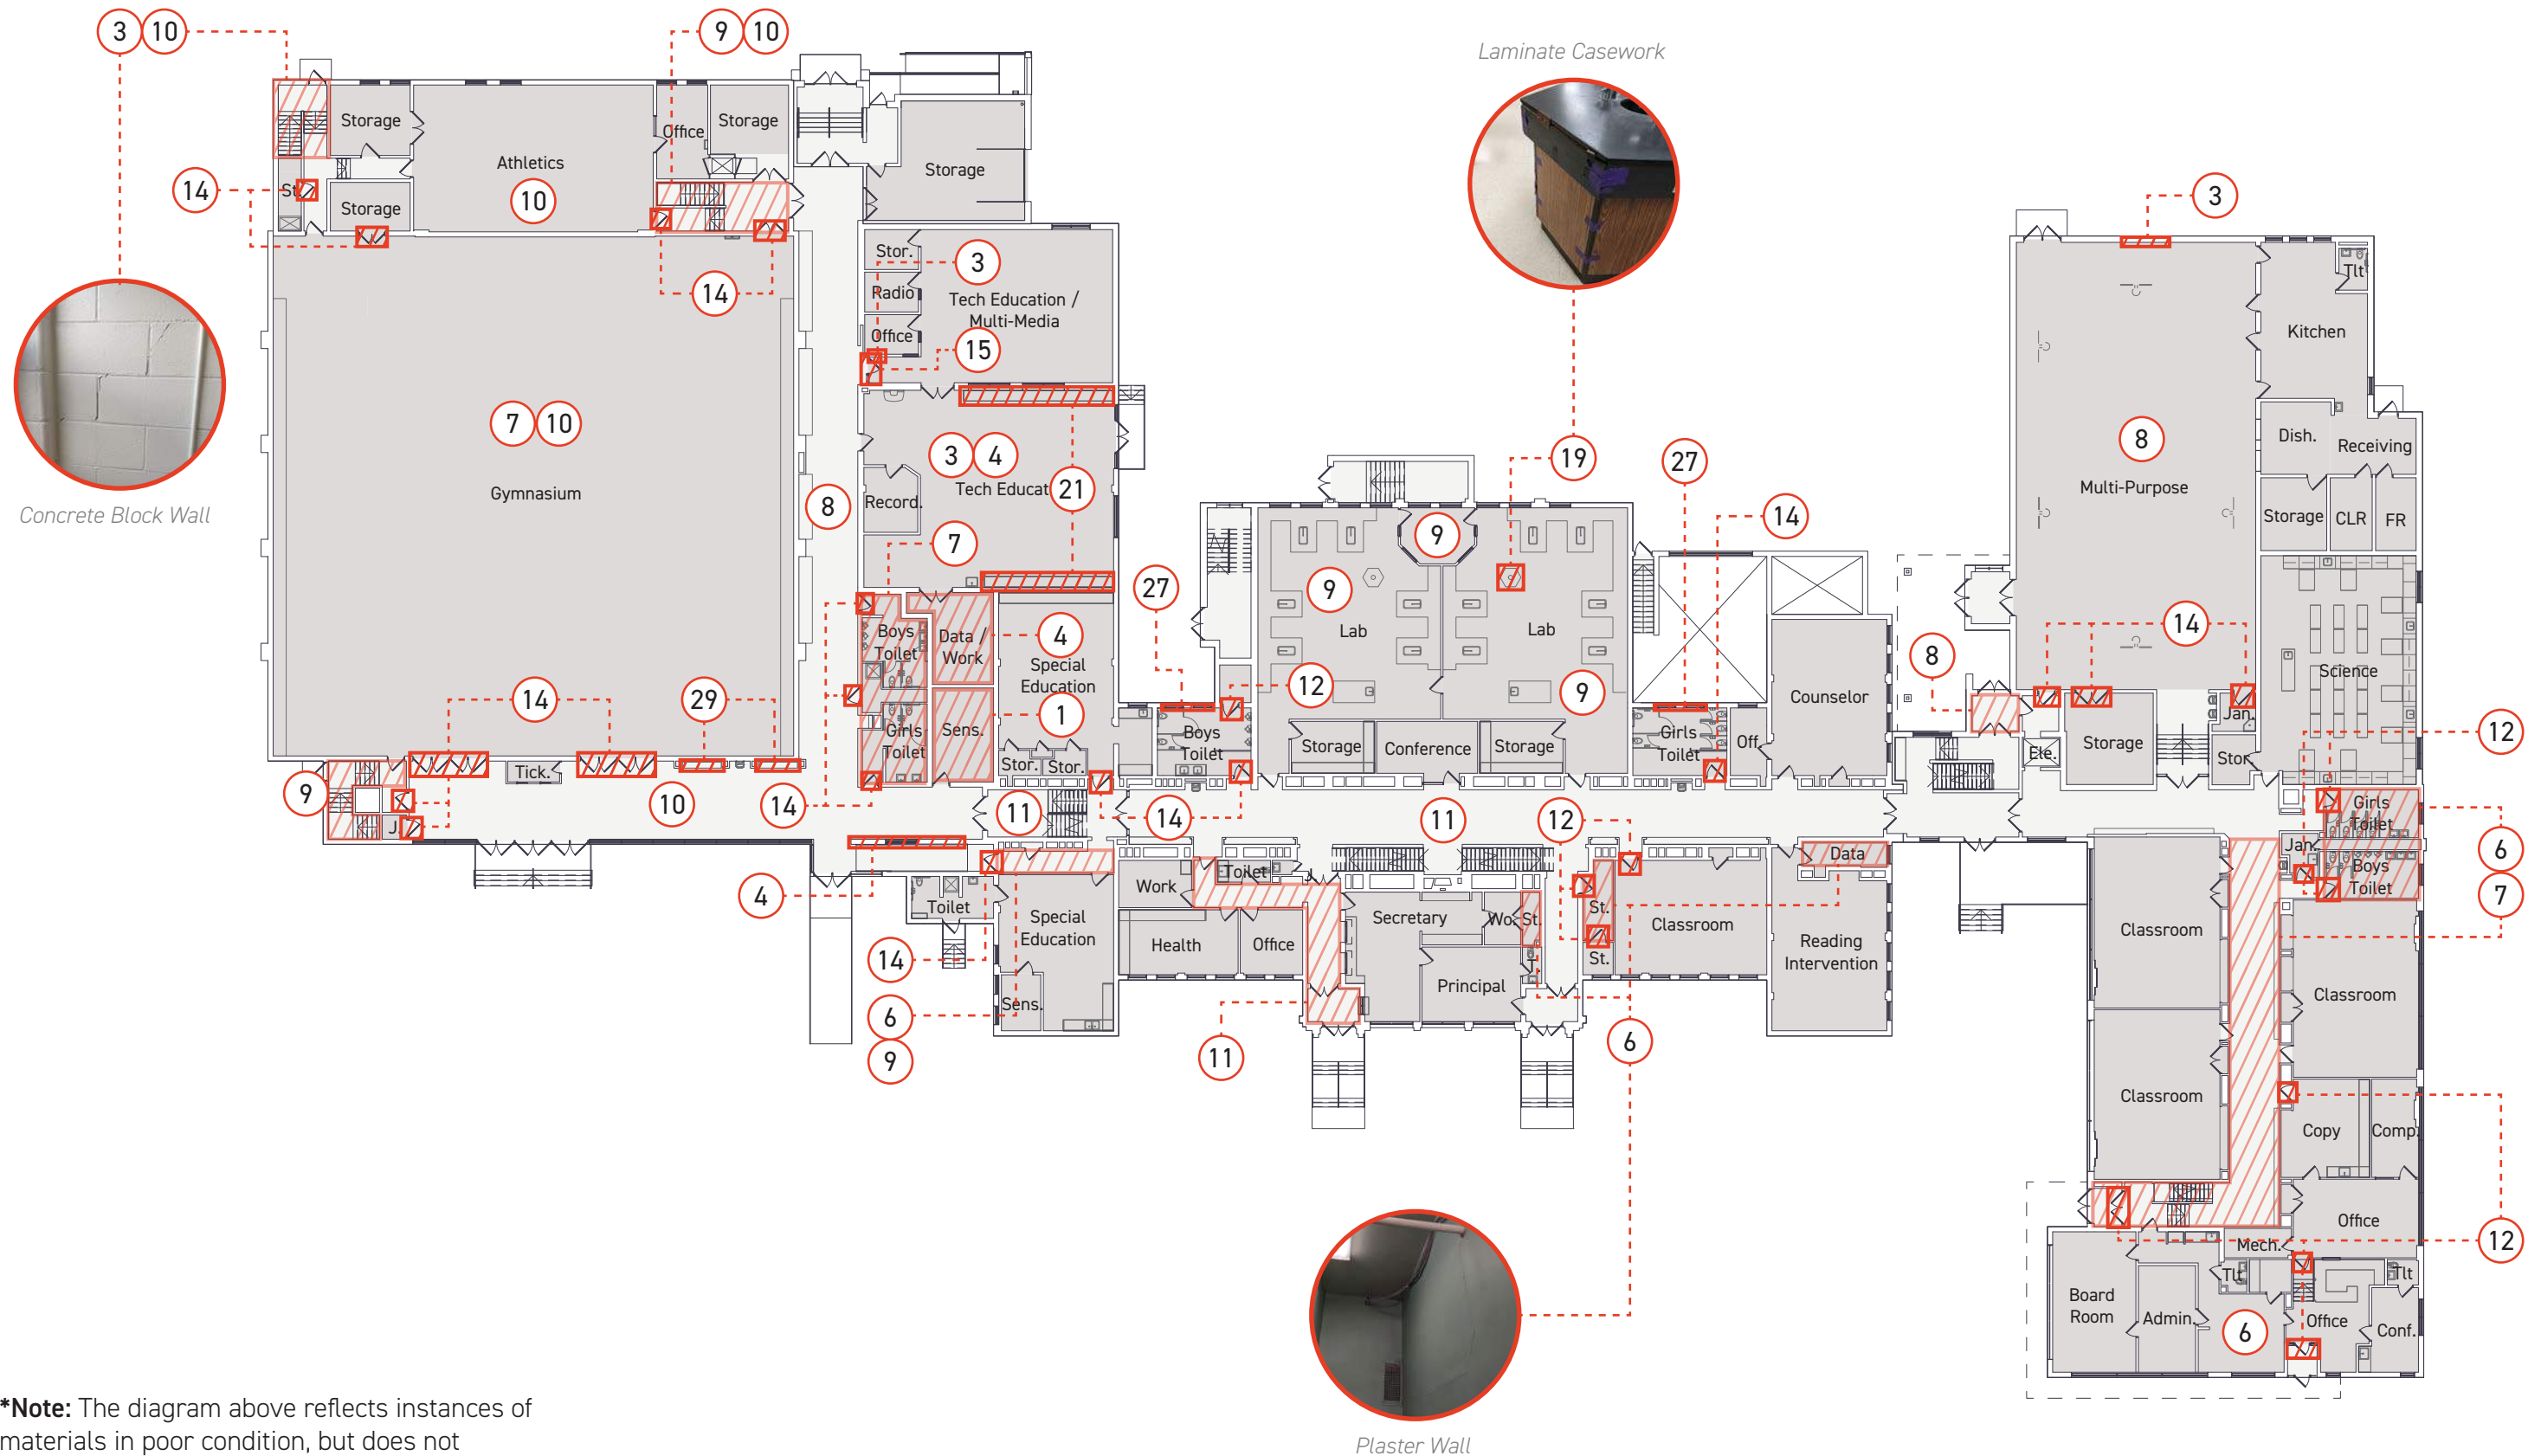
kiel middle school interior identifications + analysis | first floor

- Majority of concrete walls in the lower level are in poor condition due to cracking and staining.
- Terrazzo base throughout the building is in poor condition due to cracking and crumbling.
- Majority of wood doors throughout the building are in poor condition due to denting and surface scratches.
- There are some instances where metal lockers are dented and have surface scratches.

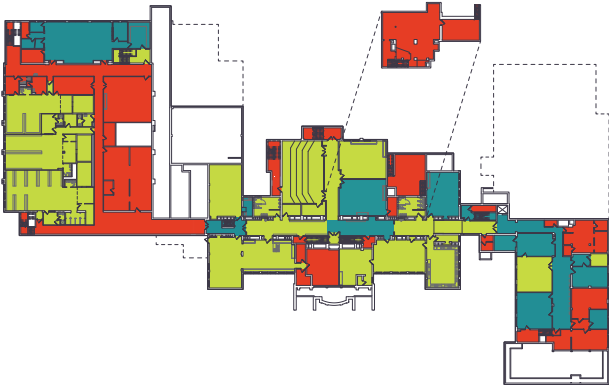
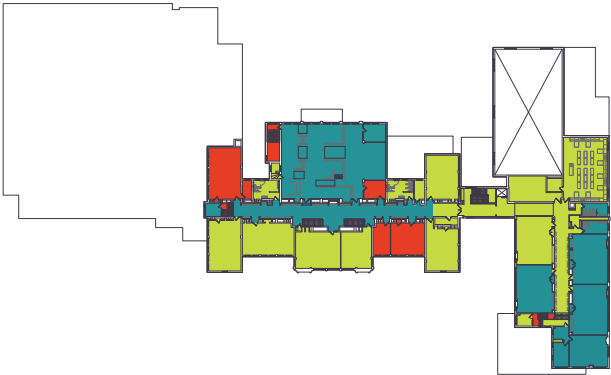
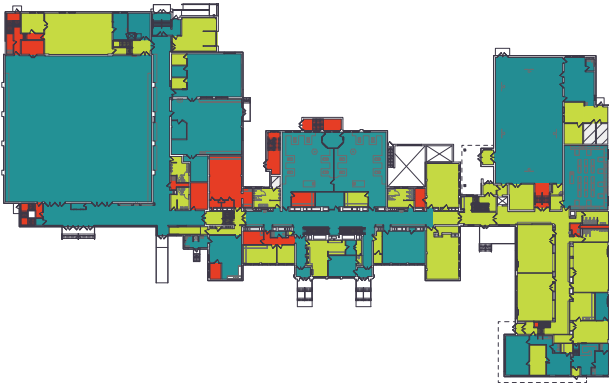
kiel middle school ceiling analysis

- Concrete ceilings in the lower level of the building are in poor condition due to cracking, staining, and crumbling.
- There are instances of acoustical tile ceilings in poor condition due to missing tiles.
- Materials identified as potentially containing asbestos are considered to be in poor condition.
- Spline ceilings are identified as potentially containing asbestos.

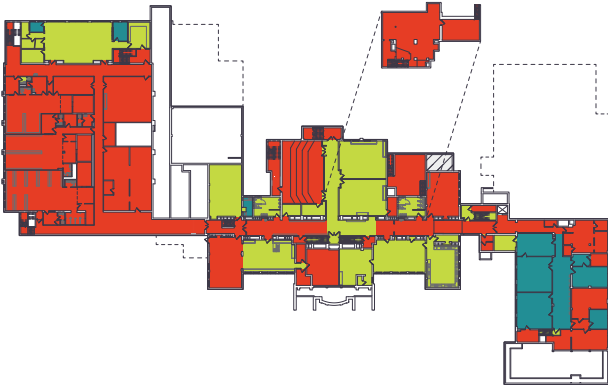
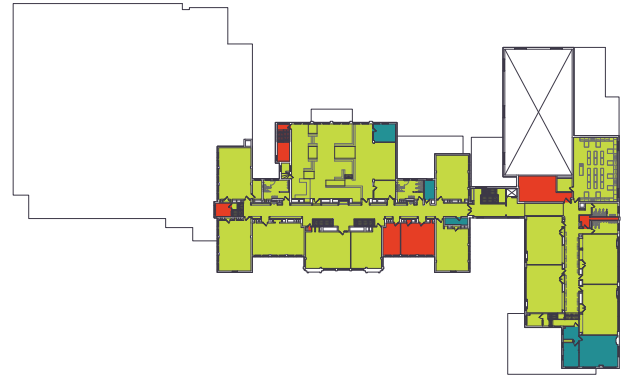
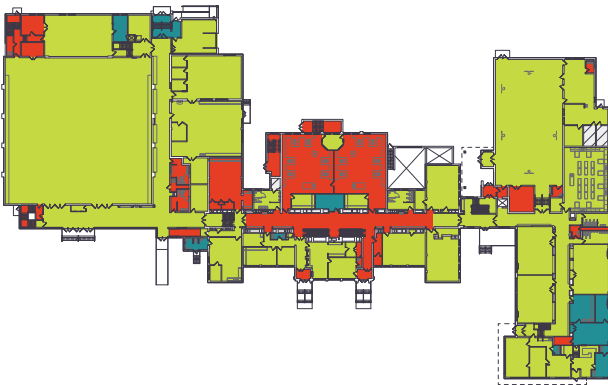
kiel middle school flooring analysis

- Majority of floors in the lower level are in poor condition due to scratching and staining.
- There are instances where terrazzo flooring is in poor condition due to cracking.
- 9" x 9" vinyl tile is identified as a material potentially containing asbestos.
- Materials identified as potentially containing asbestos are considered to be in poor condition.

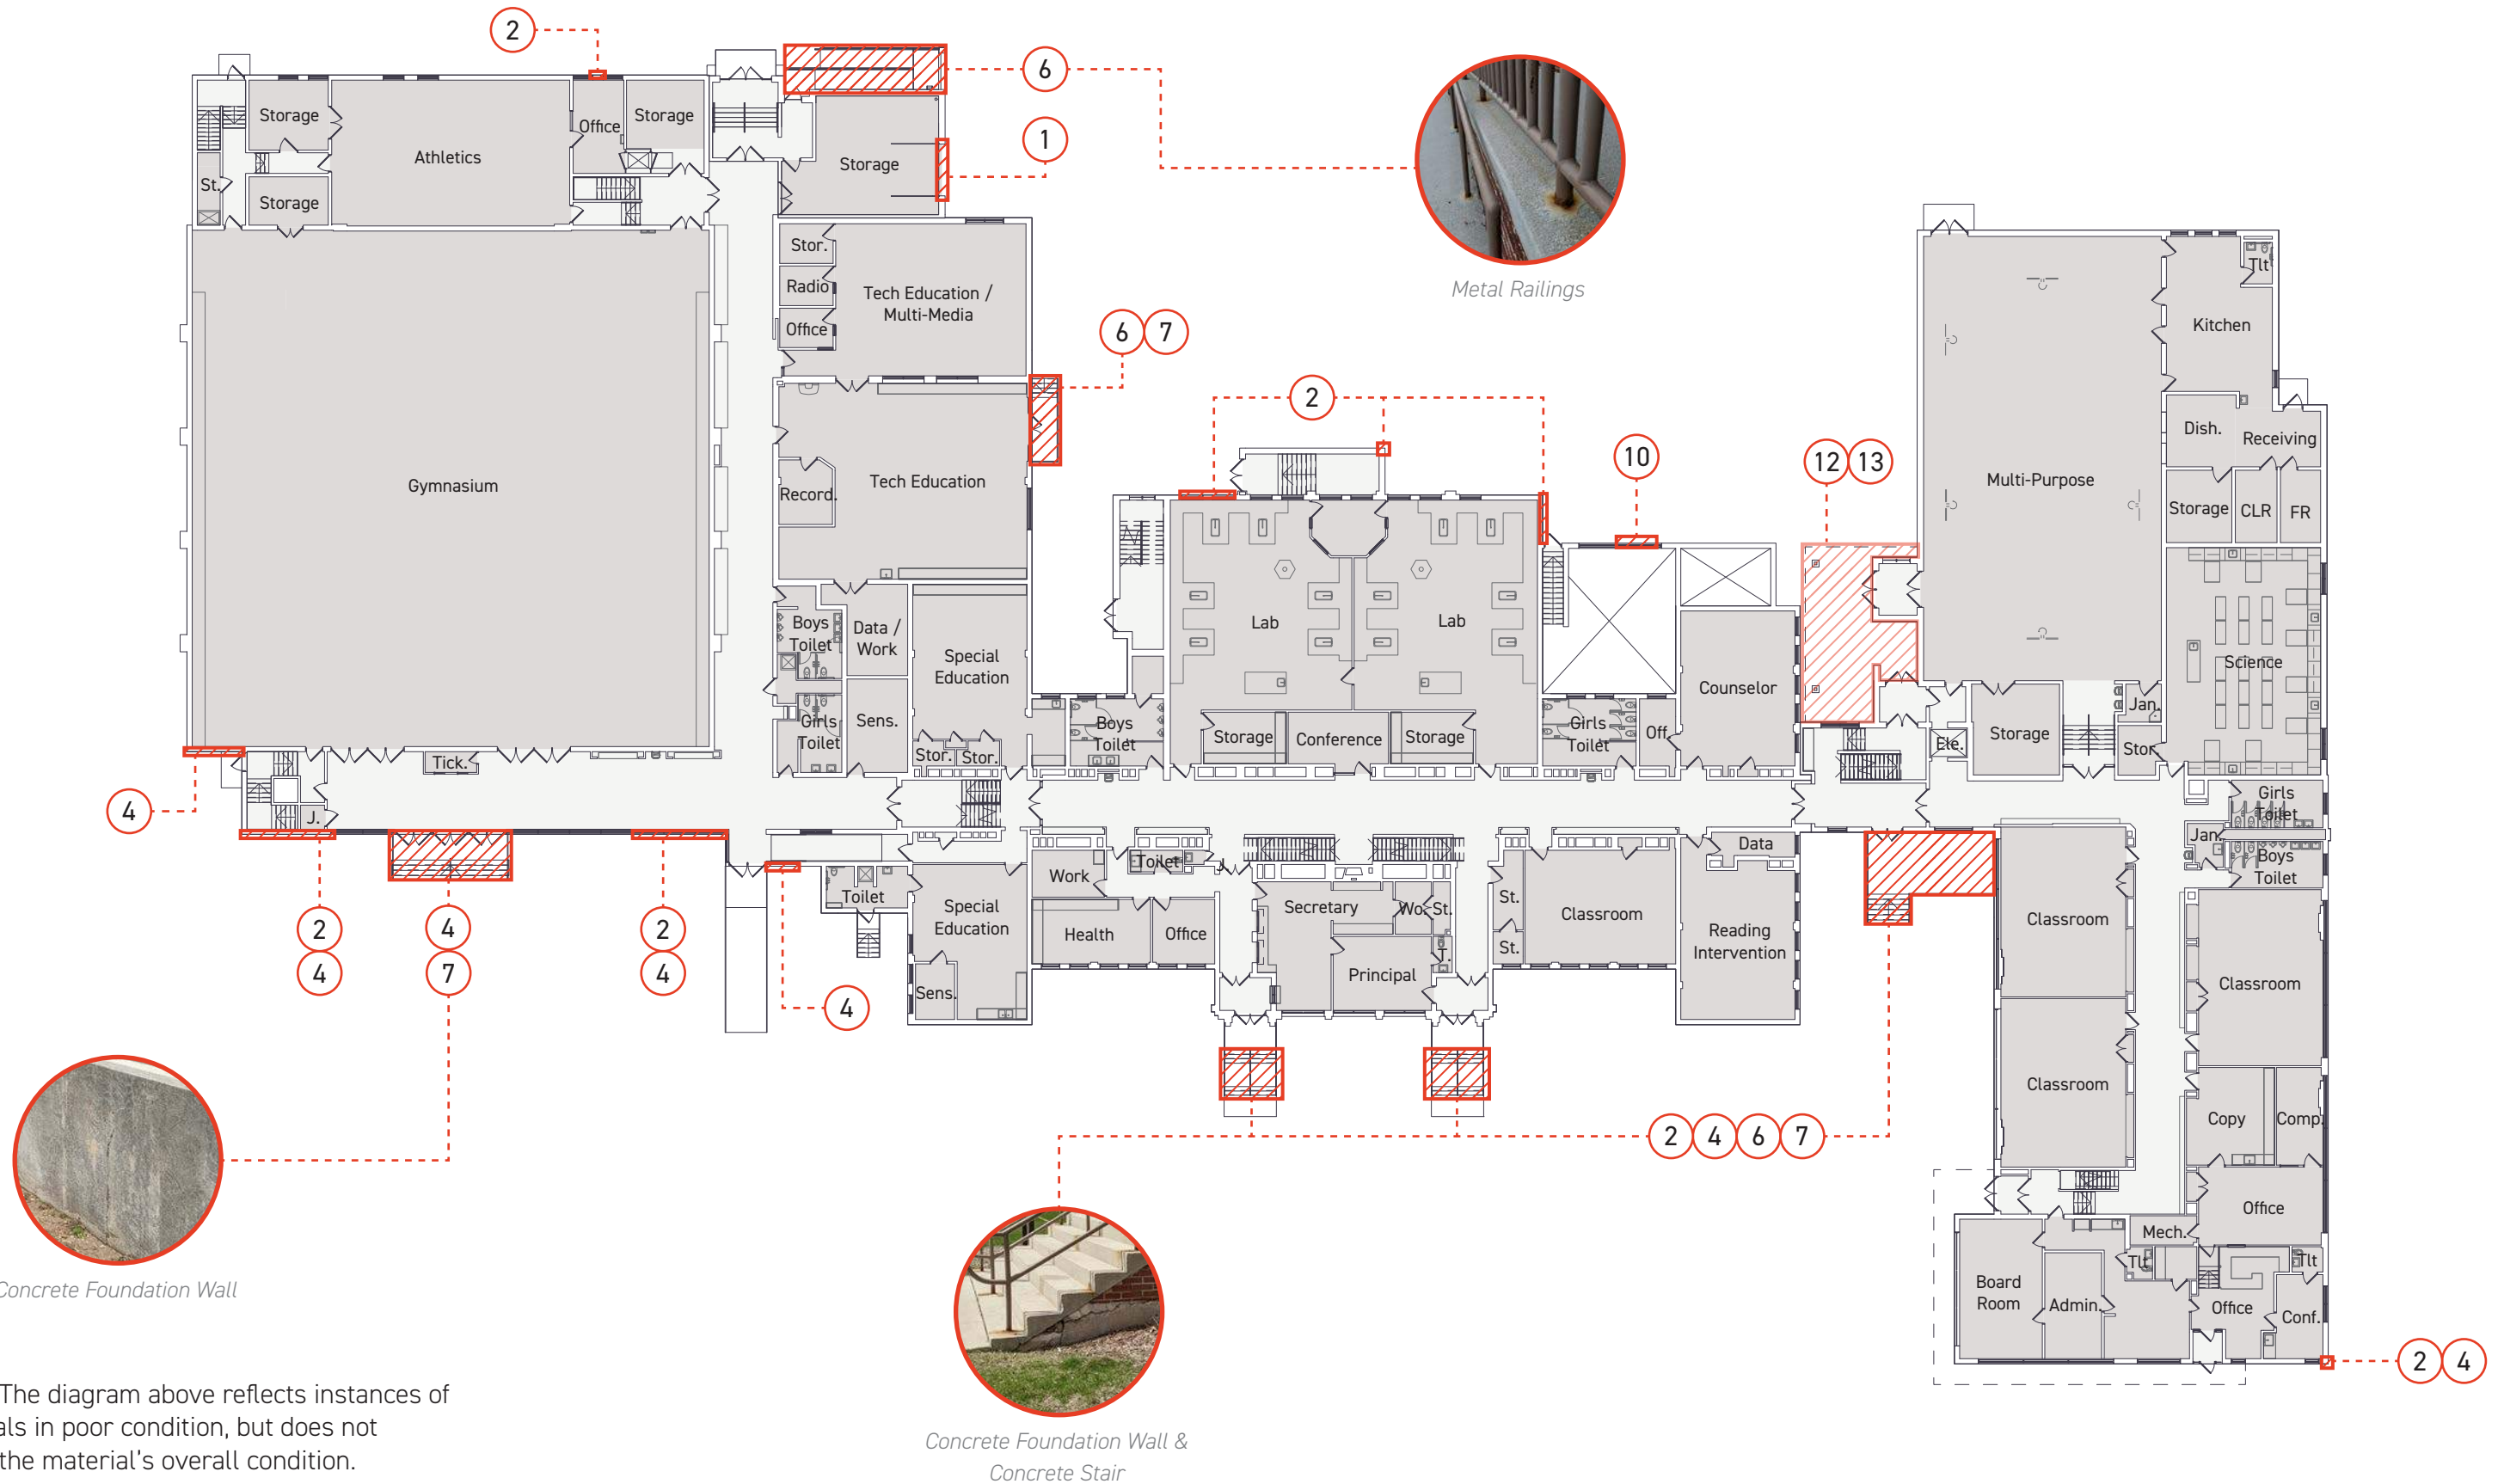
kiel middle school exterior identifications + analysis | first floor

- Wood paneling in the lower level is in poor condition due to staining, wearing, and paint peeling off.
- There are instances where metal railings are in poor condition due to rusting.
- Concrete foundation walls are in poor condition due to cracking and crumbling.
- Majority of brick walls are in fair condition due to instances of crackling and crumbling.

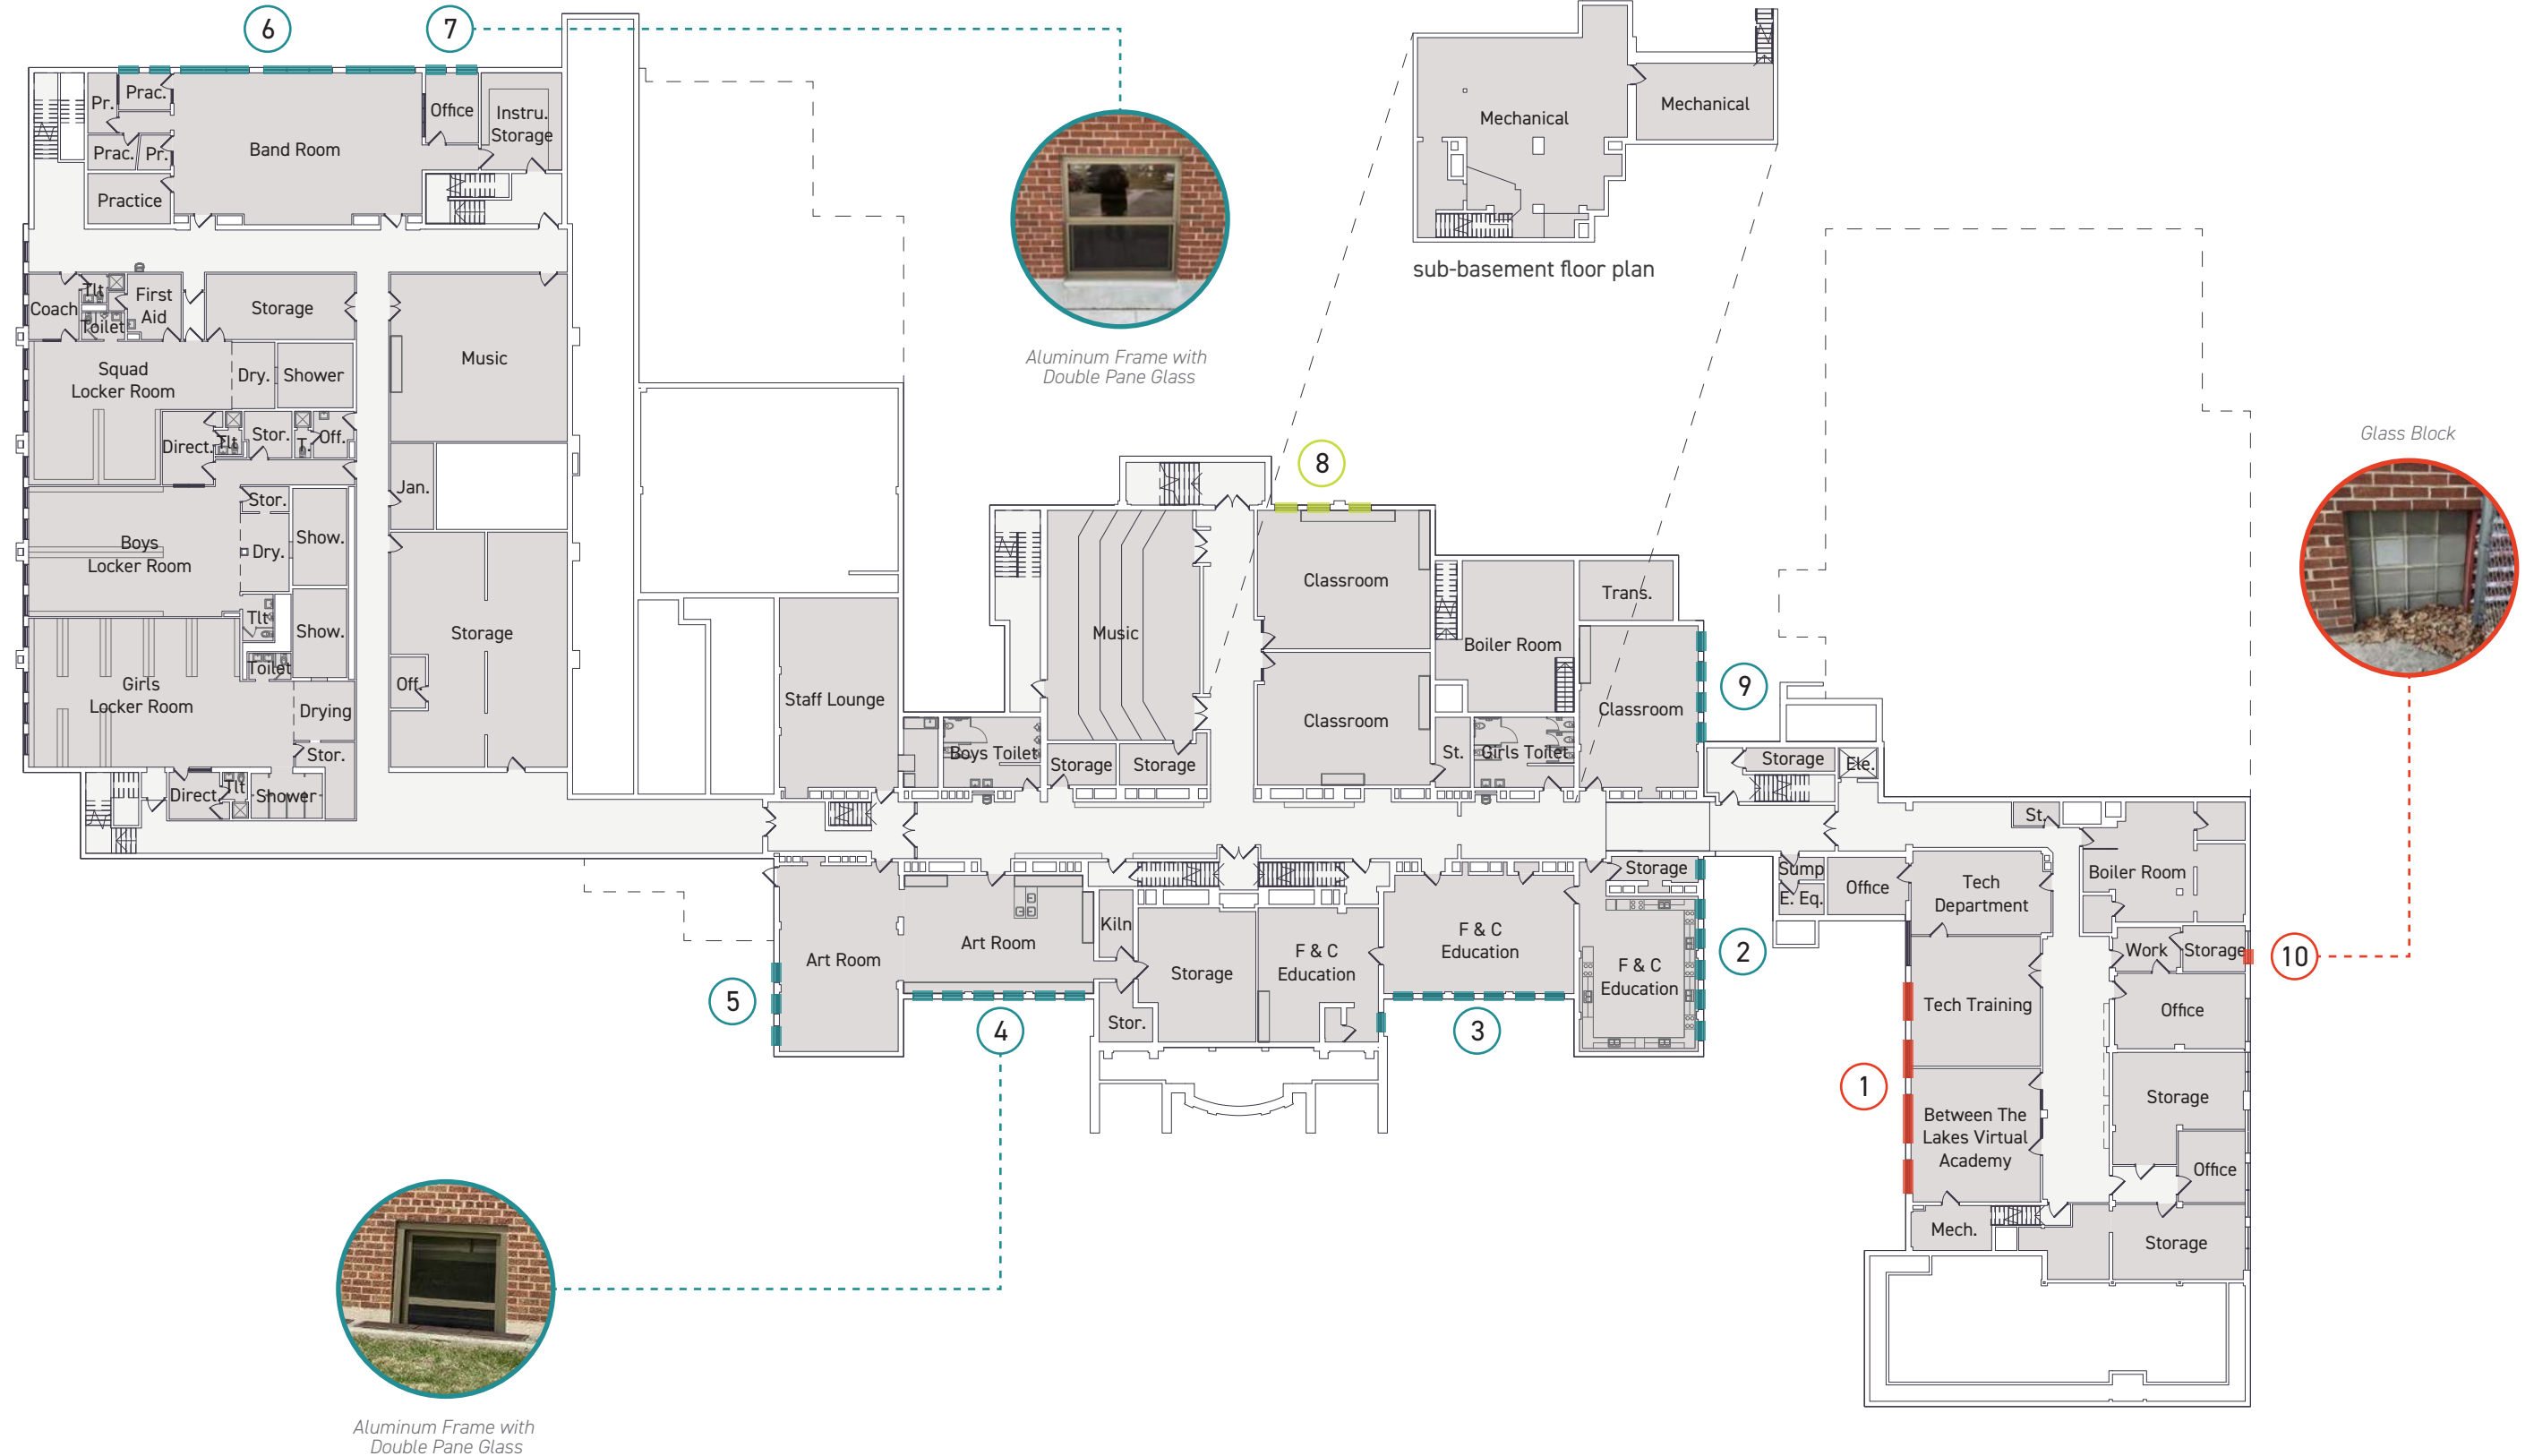
kiel middle school exterior window identification + analysis | lower level

- Majority of aluminum frame windows with double pane glass are in good condition.
- There are instances where glass block windows are in poor condition due to wearing and staining.
- There is an instance of surface scratches at window 25.
