zielanis elementary

SUMMARY

zielanis elementary building systems summary

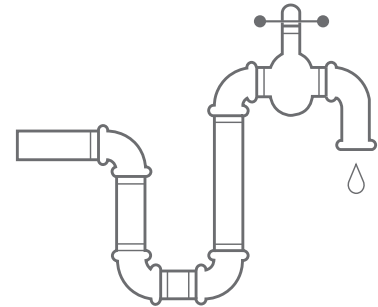
PLUMBING

| Sanitary Waste System | ● | Cast iron is original, with PVC repairs. Tunnel area was replaced with PVC sanitary piping. No comments were made by the owner in regards to the underground piping. |
| Sanitary Drain, Waste + Vent Piping | ● | Cast iron is original, with PVC repairs. Tunnel area was replaced with PVC sanitary piping. |

Provide entire system with cleaning maintenance as required.

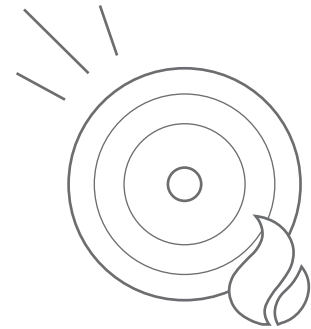
LIFE SAFETY

| Emergency Generator | ■ | Electronics issues reported with transfer switch. |

Replace Existing Fire Alarm System

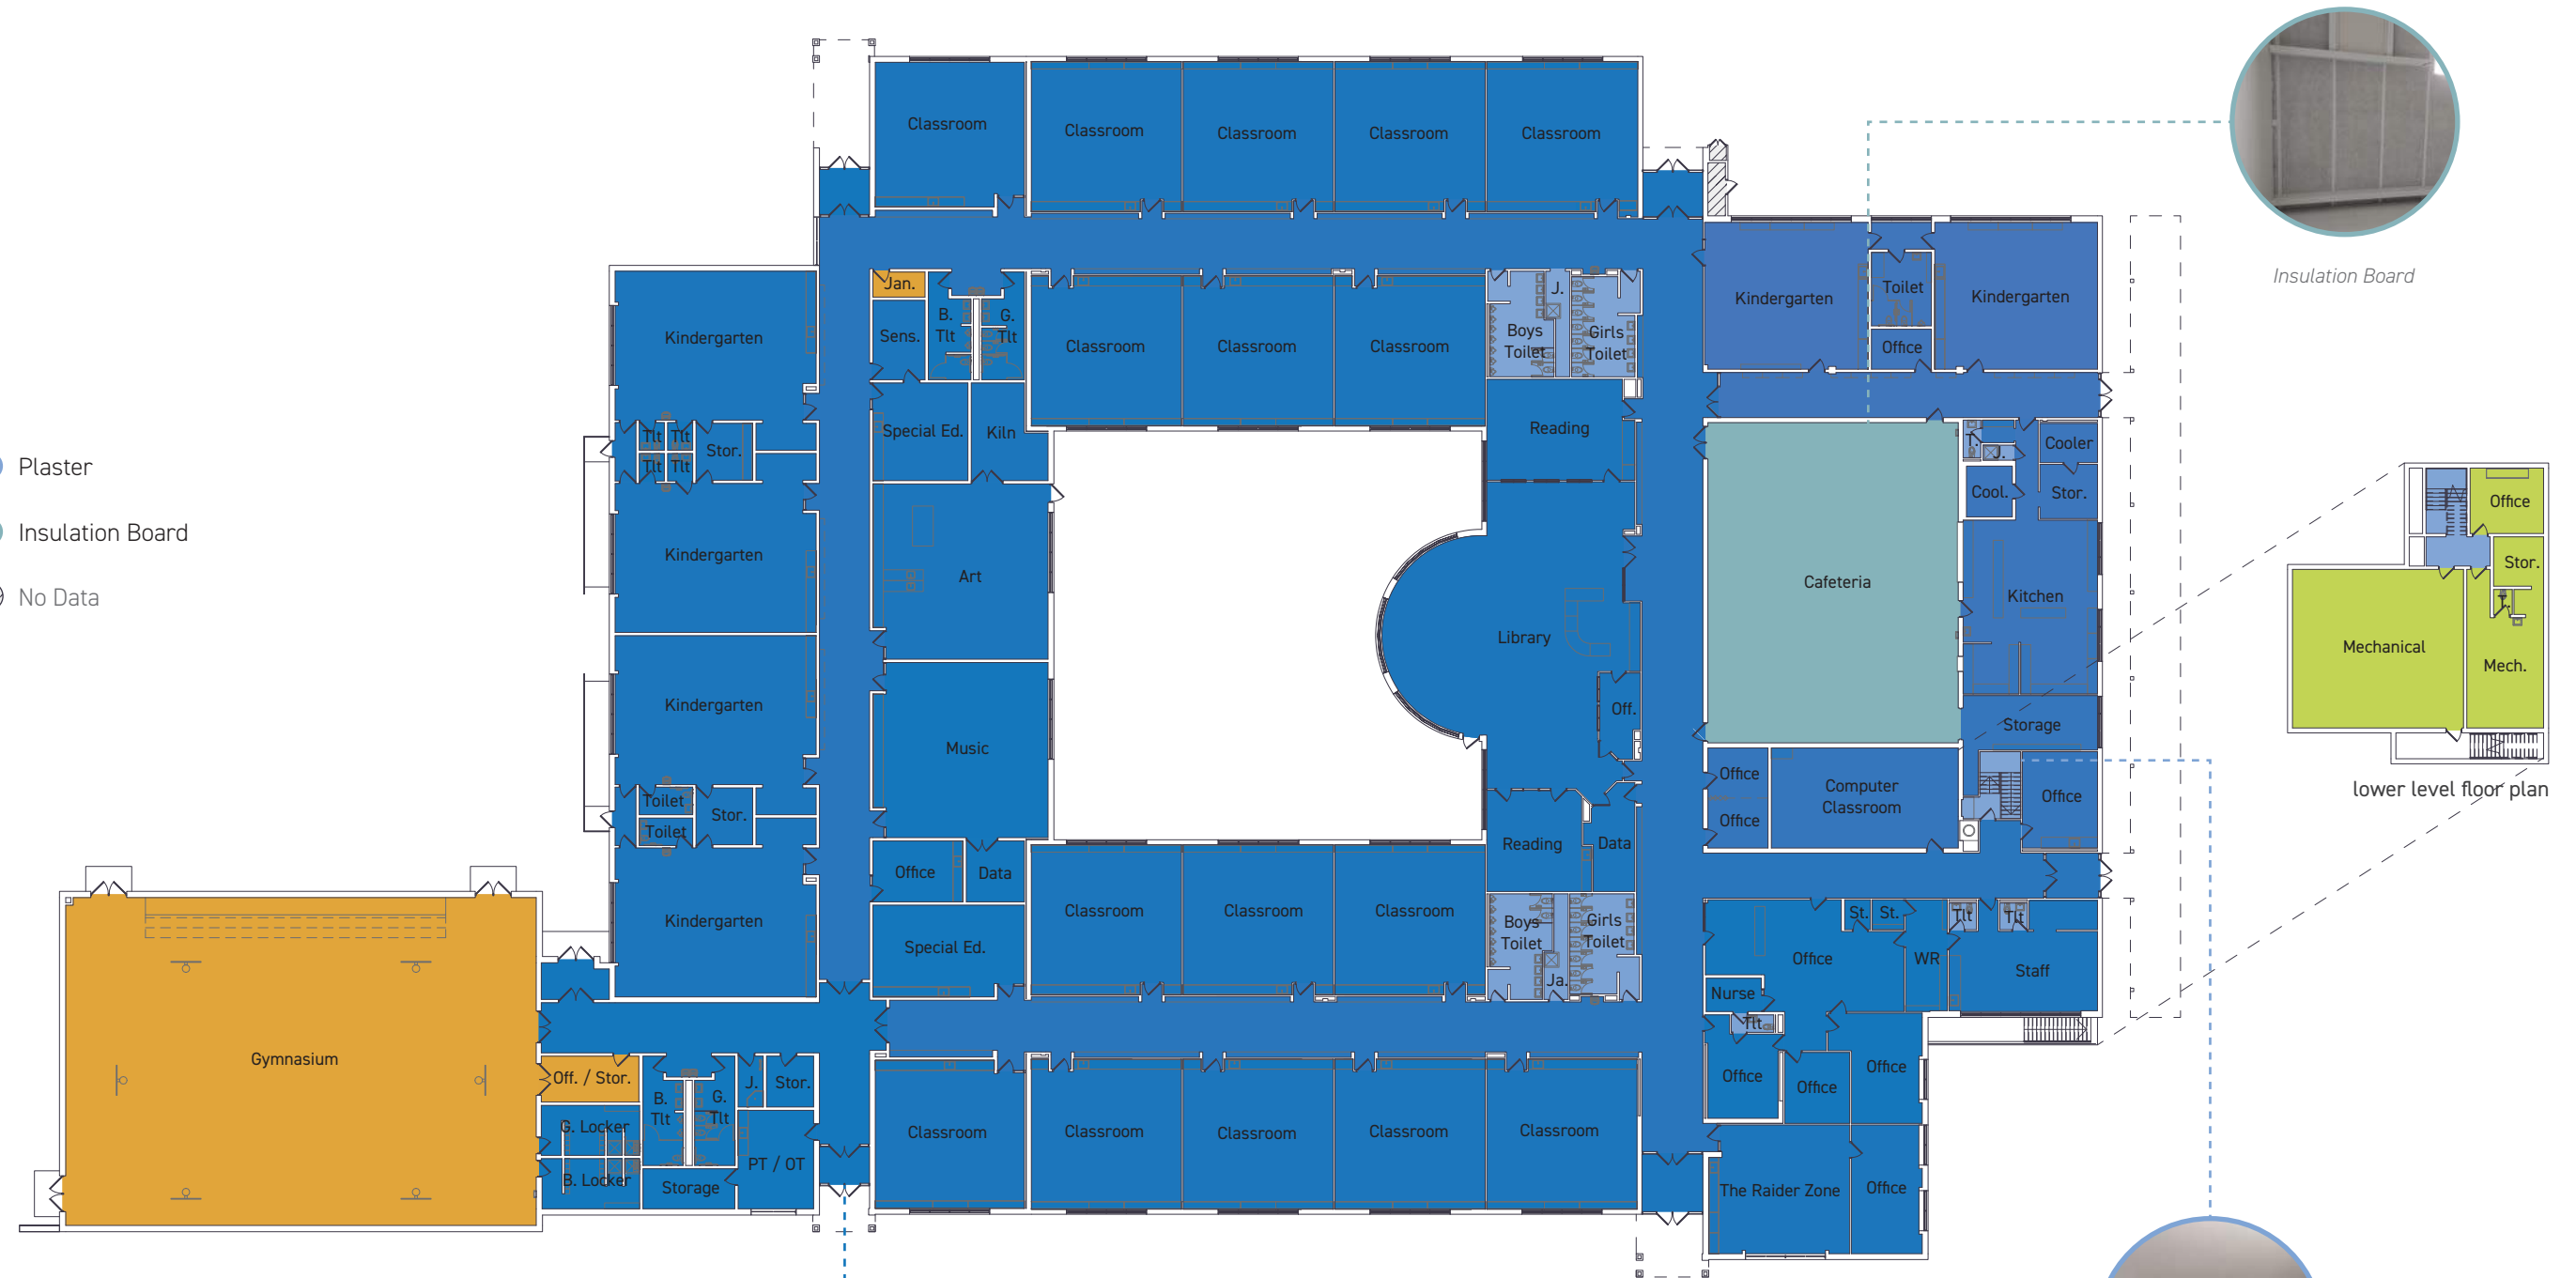
- Acoustical tile ceilings in the corridors and some classrooms are in fair condition due to having instances of stained or cracked tiles.
- Insulation board ceiling in the cafeteria is in fair condition due to having instances of staining.
- There are instances of acoustical tile ceilings in poor condition due to stained tracks.

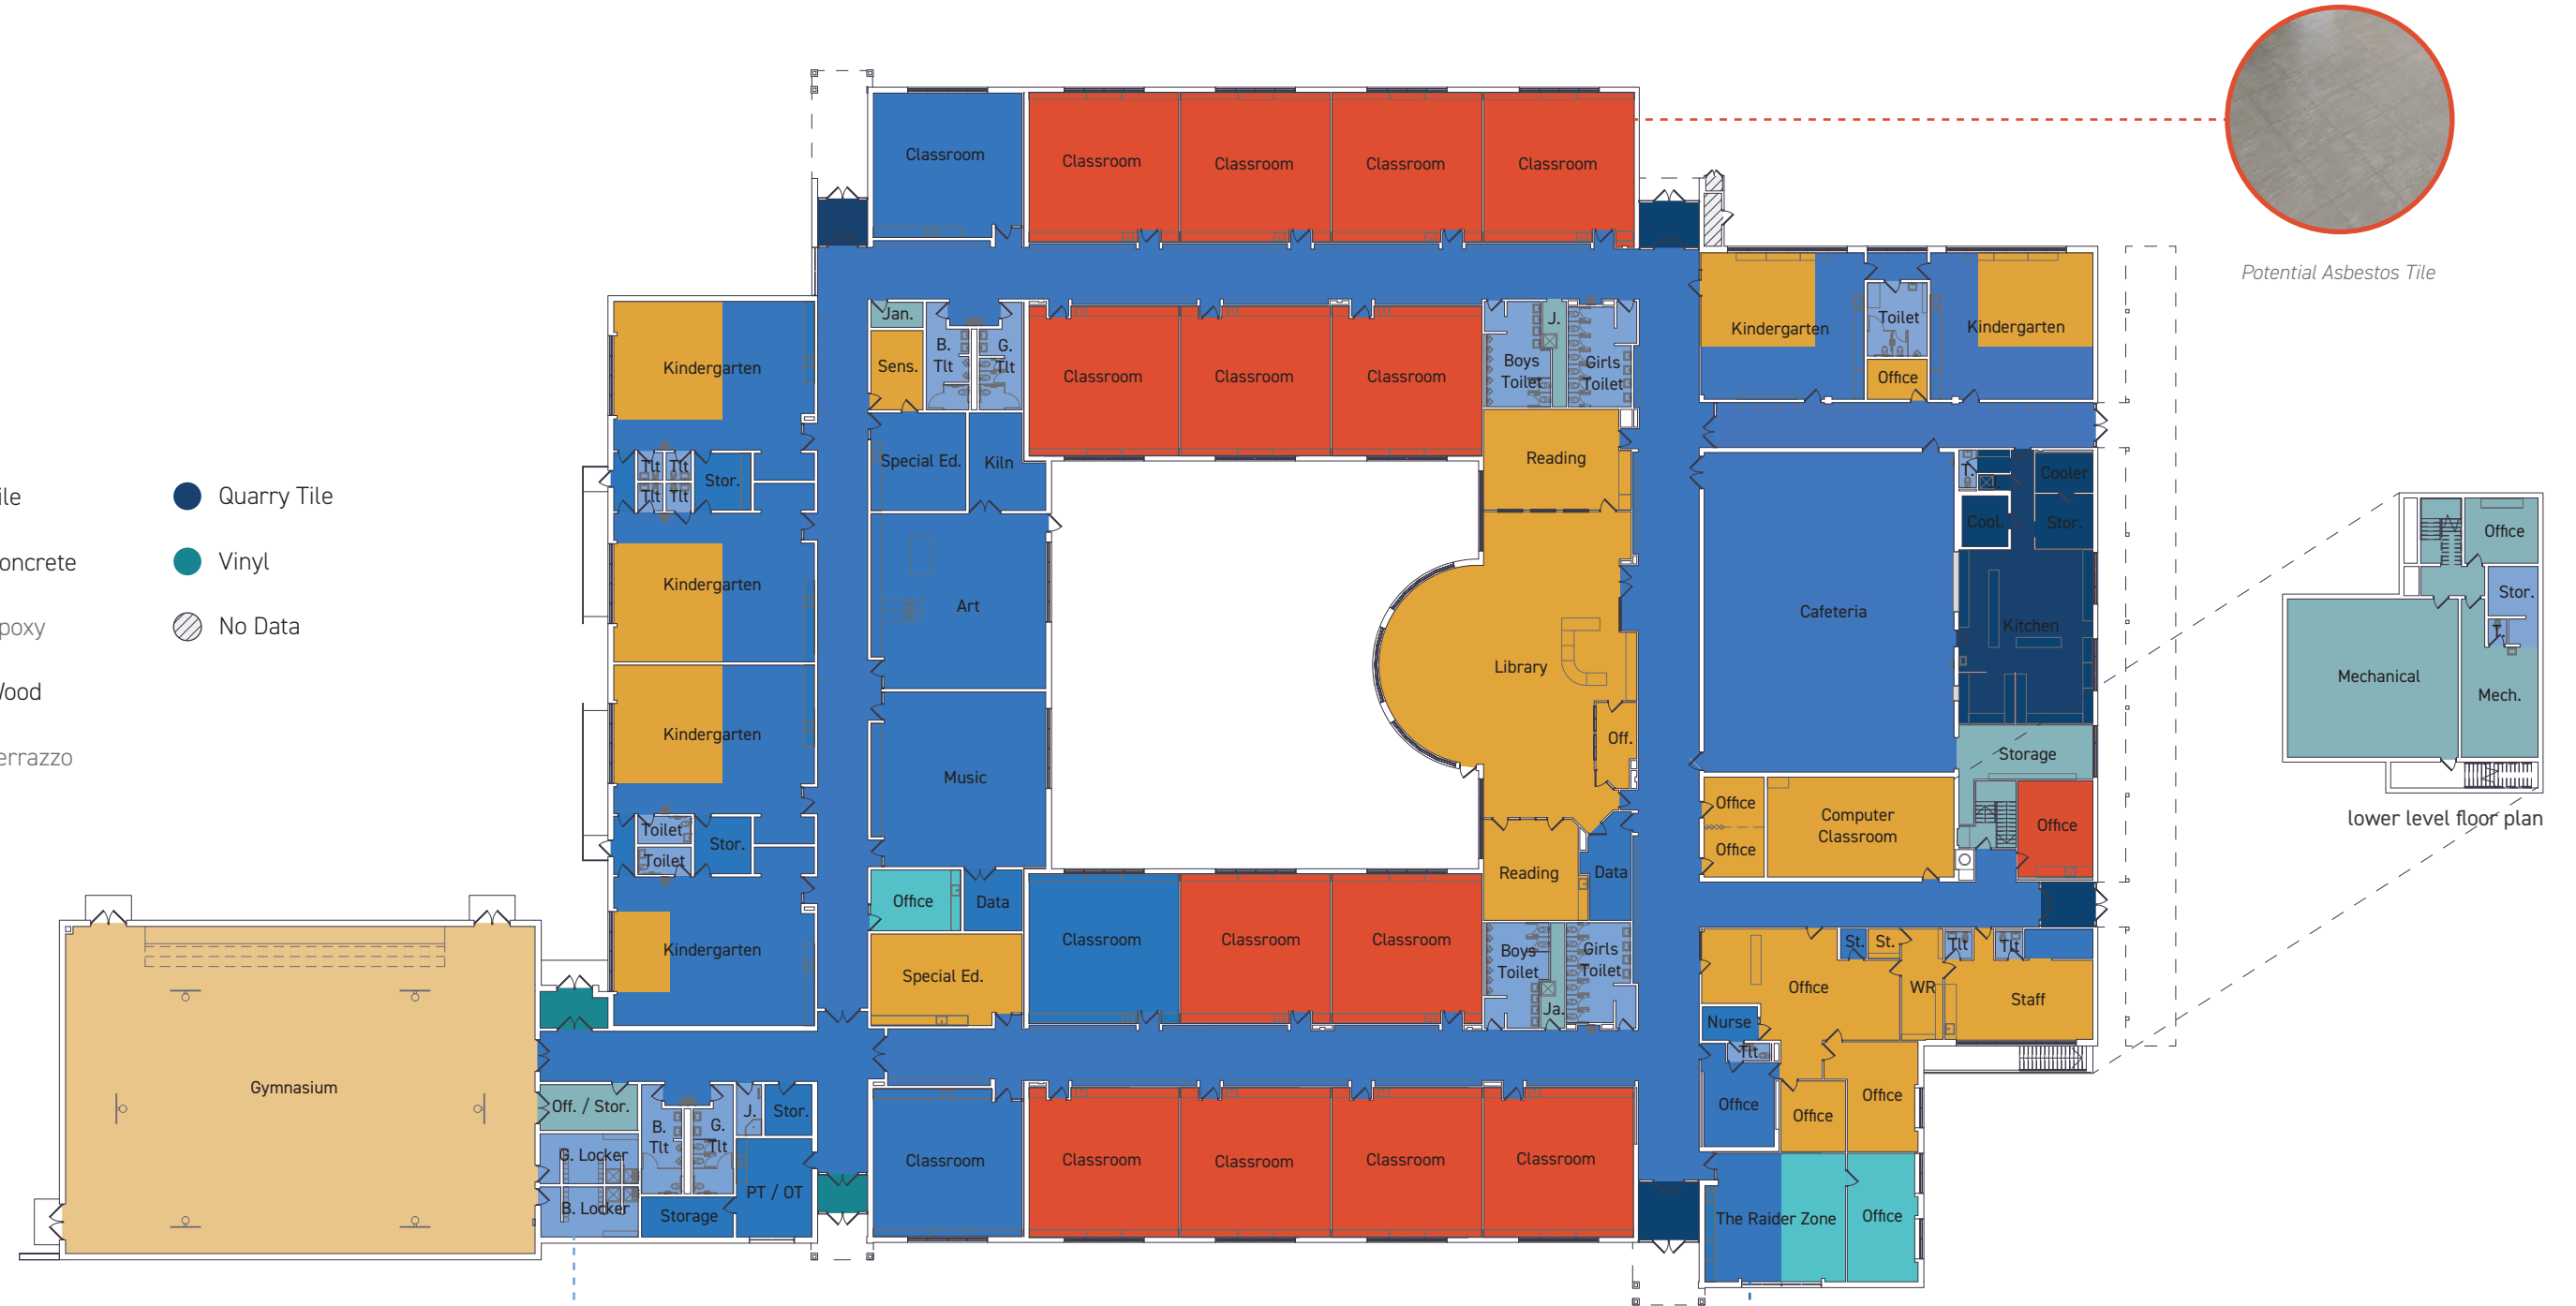
- Carpeting in the library is in poor condition due to staining and zippering.
- Concrete flooring and stairs in mechanical and storage areas are in poor condition due to cracking, staining, and paint peeling off.
- 9" x 9" vinyl tile is identified as a material potentially containing asbestos.
- Materials identified as potentially containing asbestos are considered to be in poor condition.
