# Kiel Area School District

District-wide Facilities Study

# STUDY DOCUMENT

August 2022

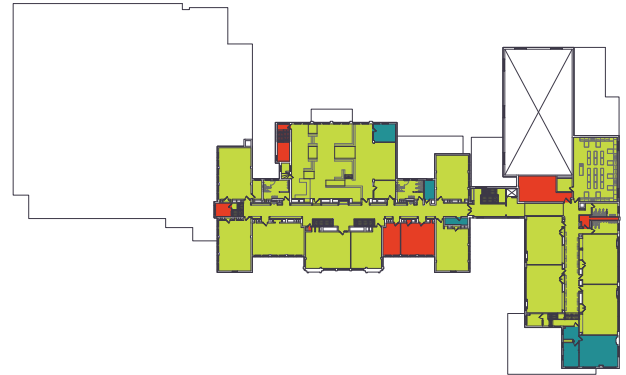
# kiel middle school flooring analysis

- Majority of floors in the lower level are in poor condition due to scratching and staining.
- There are instances where terrazzo flooring is in poor condition due to cracking.
- 9" x 9" vinyl tile is identified as a material potentially containing asbestos.
- Materials identified as potentially containing asbestos are considered to be in poor condition.

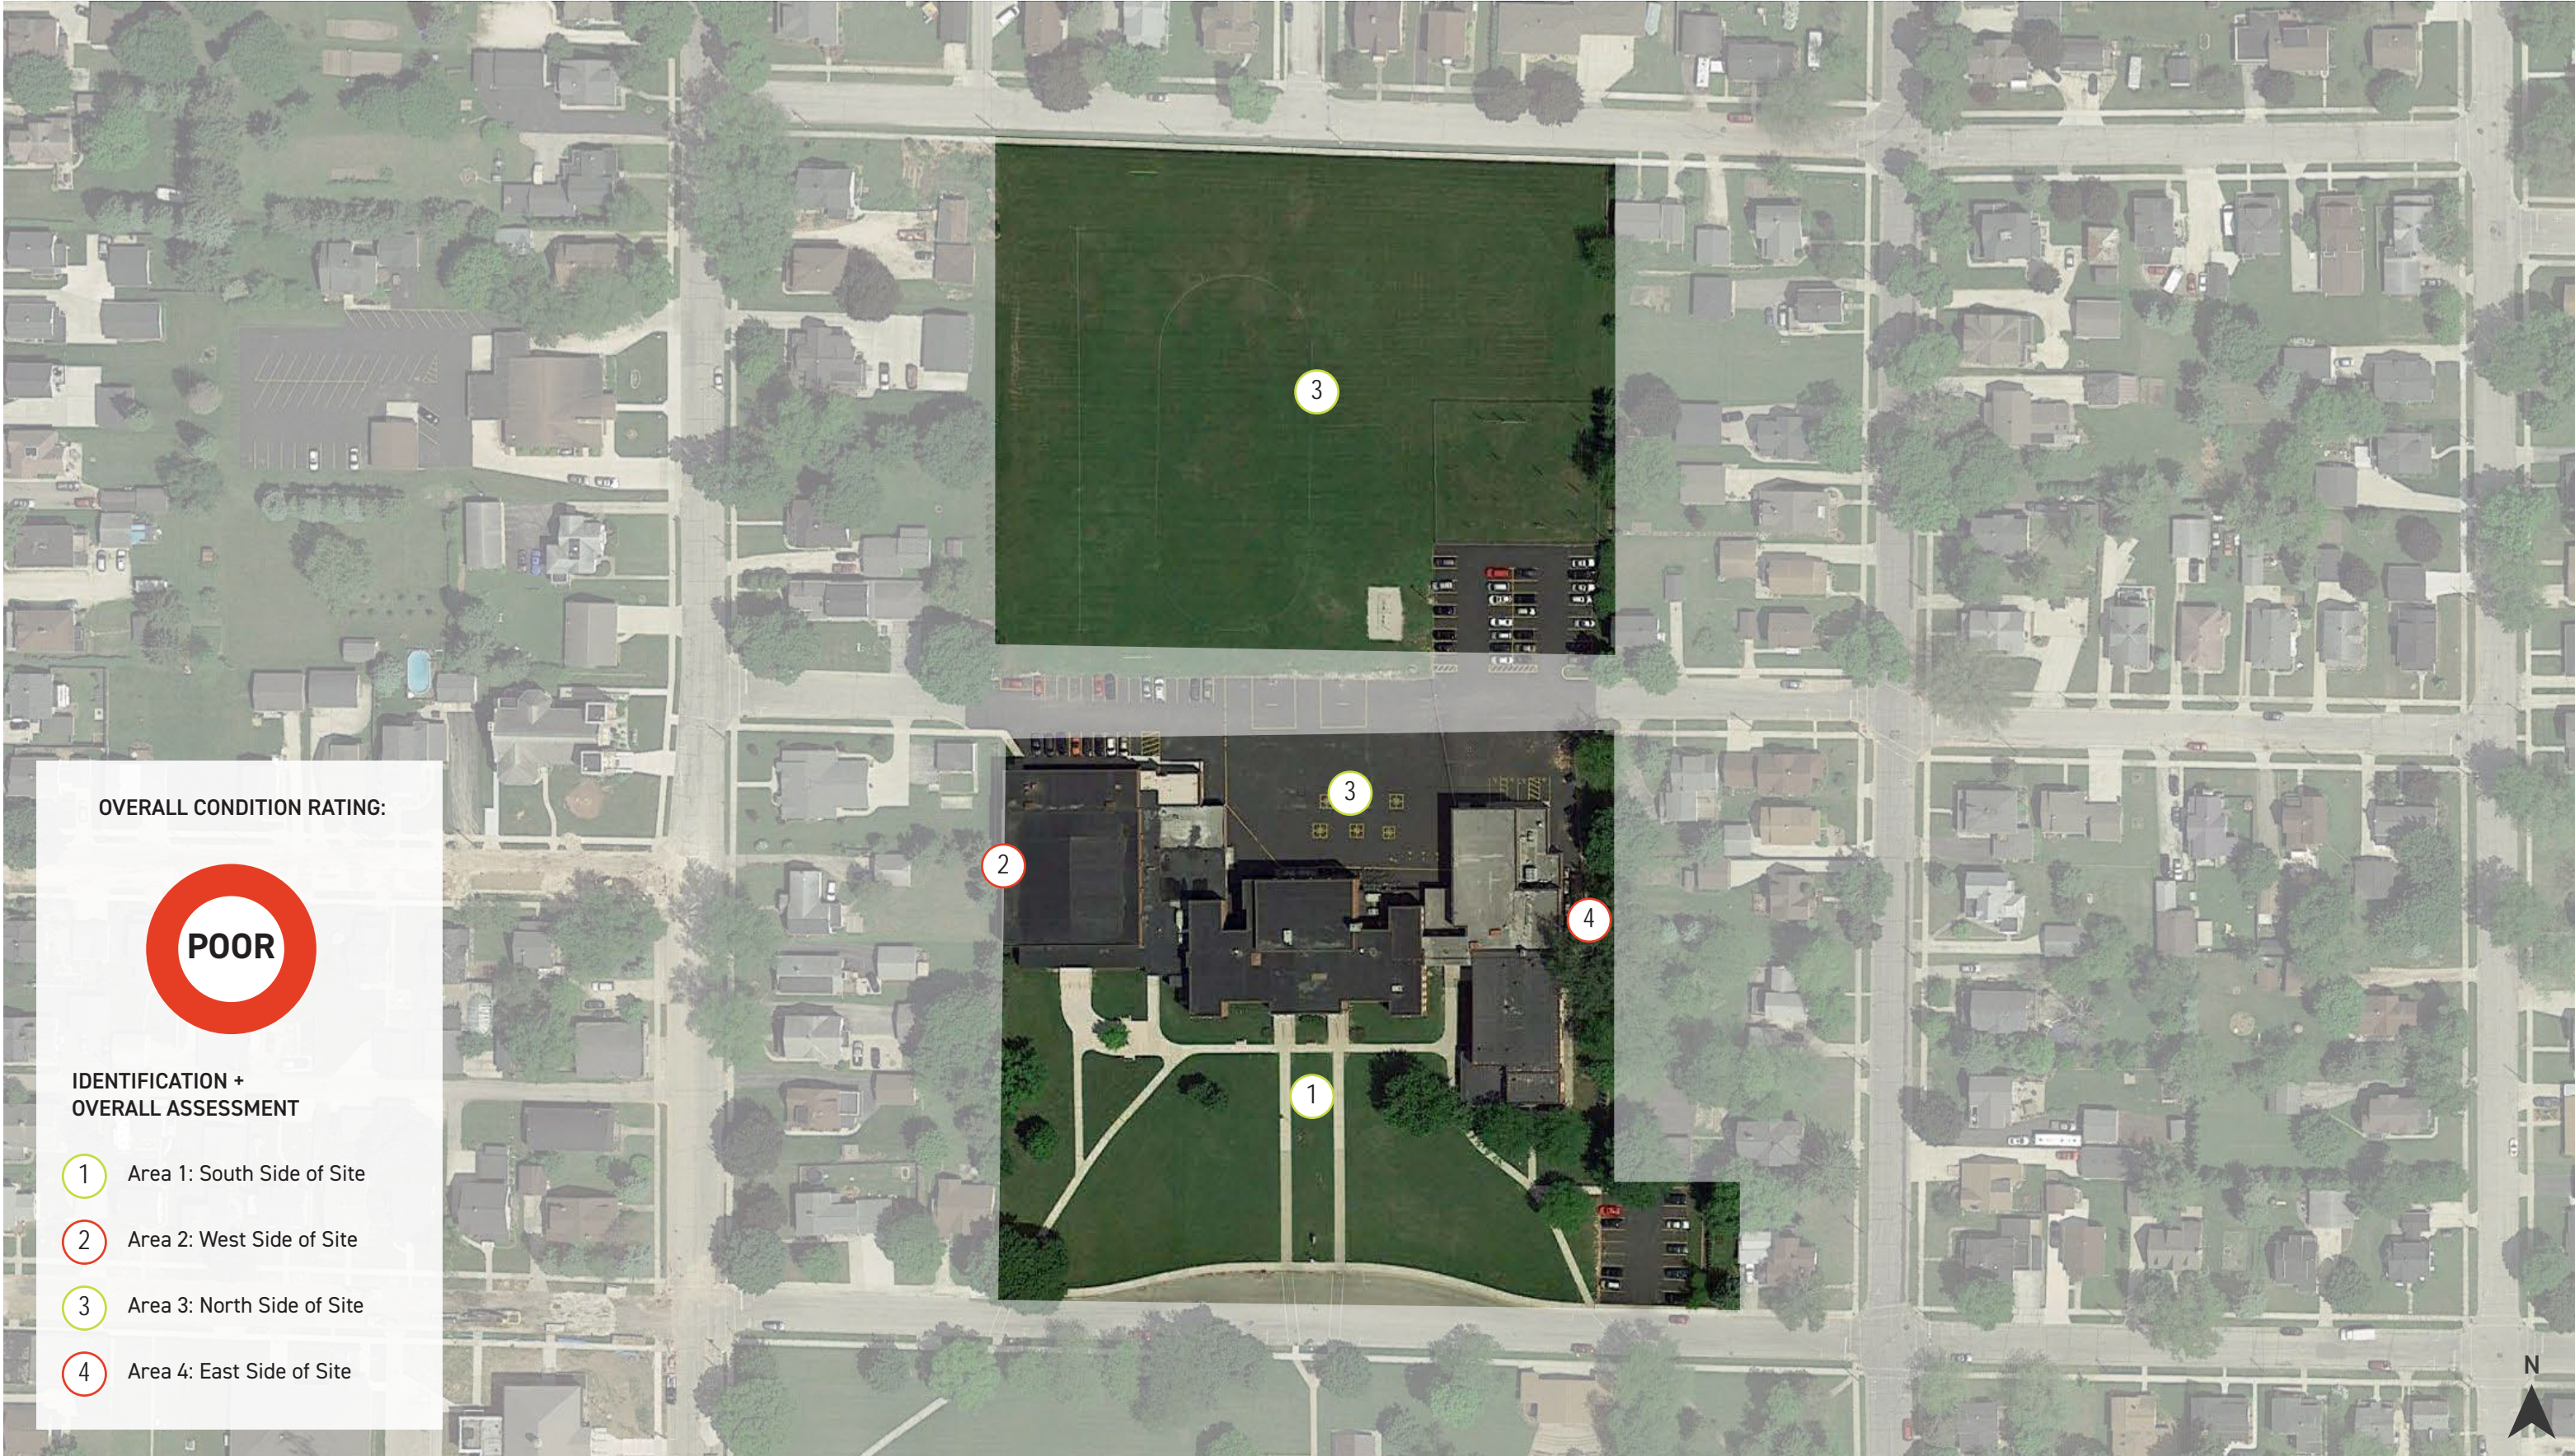
# kiel middle school site assessment

Northwest Parking Lot	<span style="color: lime;">●</span>	Significant longitudinal and transverse cracks throughout. Appears to be some settling near the catch basins.
Northwest Parking Sidewalk	<span style="color: teal;">●</span>	One slab with a large crack through it.
Back Concrete Ramp	<span style="color: lime;">●</span>	Minimal cracking. Railing is rusted especially at the base.
Back Play Yard	<span style="color: red;">●</span>	Majority of the pavement has alligator cracking, as well as longitudinal, transverse, and block cracks.
Back Concrete Stairway	<span style="color: red;">●</span>	Cinder block base is disintegrating in areas and the concrete steps are cracking and chipping. Metal railing is very rusted.
Back Mechanical Fence	<span style="color: lime;">●</span>	Appears to be damage on the top portion of the fencing.
Back ADA Parking Area	<span style="color: red;">●</span>	Majority of the pavement is covered in alligator cracking. Pavement marking is also wearing off.

Northeast Parking Lot	<span style="color: red;">●</span>	Pavement covered in alligator and block cracks. Pavement markings are chipping and fading.
Climbing Area Fencing	<span style="color: lime;">●</span>	Tipping over in some areas and the bottom is coming unraveled.
Playground Equipment	<span style="color: lime;">●</span>	Some gravel base is missing. Some cracks in concrete pad.

Asphalt Pavement	<span style="color: red;">●</span>	Many longitudinal and transverse cracks.
Concrete Sidewalk	<span style="color: red;">●</span>	Cracks in the pavement and some settlement.
Concrete Sidewalk	<span style="color: teal;">●</span>	Minimal cracking.
Fencing	<span style="color: red;">●</span>	Overgrown with trees and tipping over in areas.

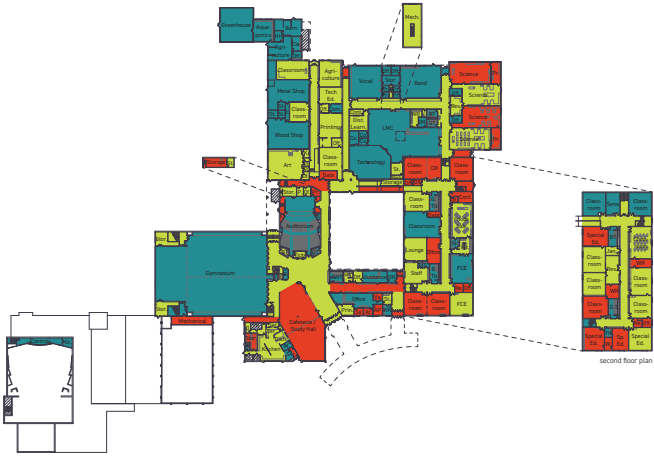
# kiel high school ceiling analysis

- Acoustical tile ceiling in the pool is in poor condition due to having instances of stained and missing tiles.
- There are instances of concrete ceilings in the lower level that are in poor condition due to staining and cracking.
- Materials identified as potentially containing asbestos are considered to be in poor condition.
- Spline ceilings are identified as potentially containing asbestos.

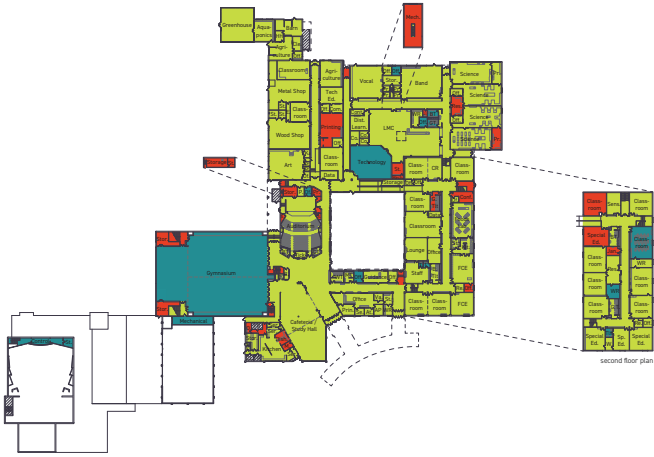
# kiel high school flooring analysis

- Tile flooring in the pool and locker rooms is in fair condition due to instances of cracked tiles.
- Majority of the vinyl composite tile flooring is in fair condition due to surface scratching.
- There are instances where concrete flooring in the lower level is in poor condition due to staining and cracking.

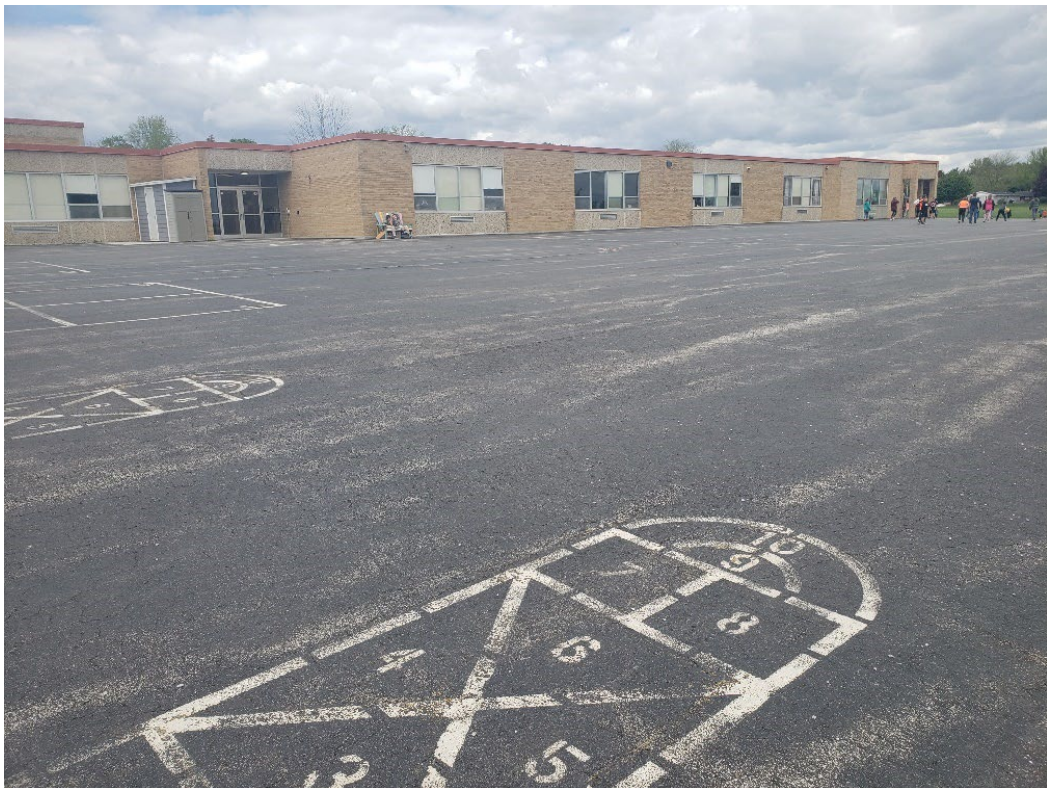
*Figure 19: Fading play area markings*

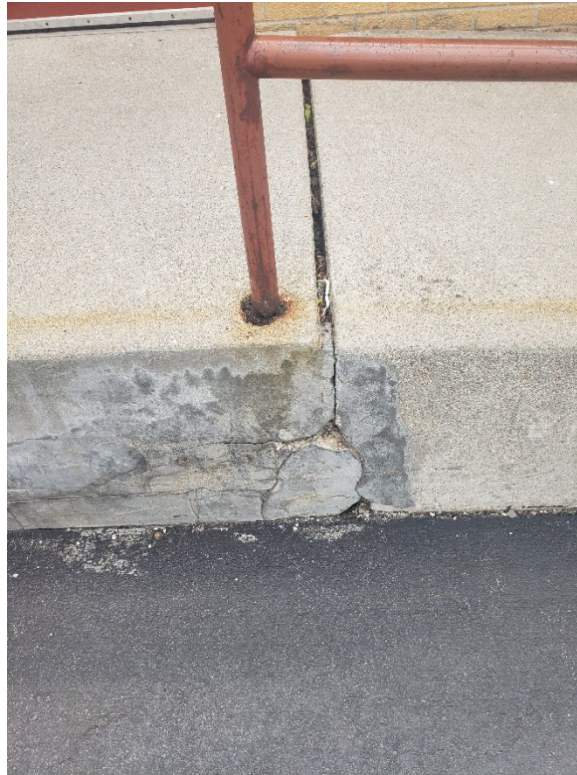
*Figure 20: Severe cracking in several areas on the north ramps for existing building doors*

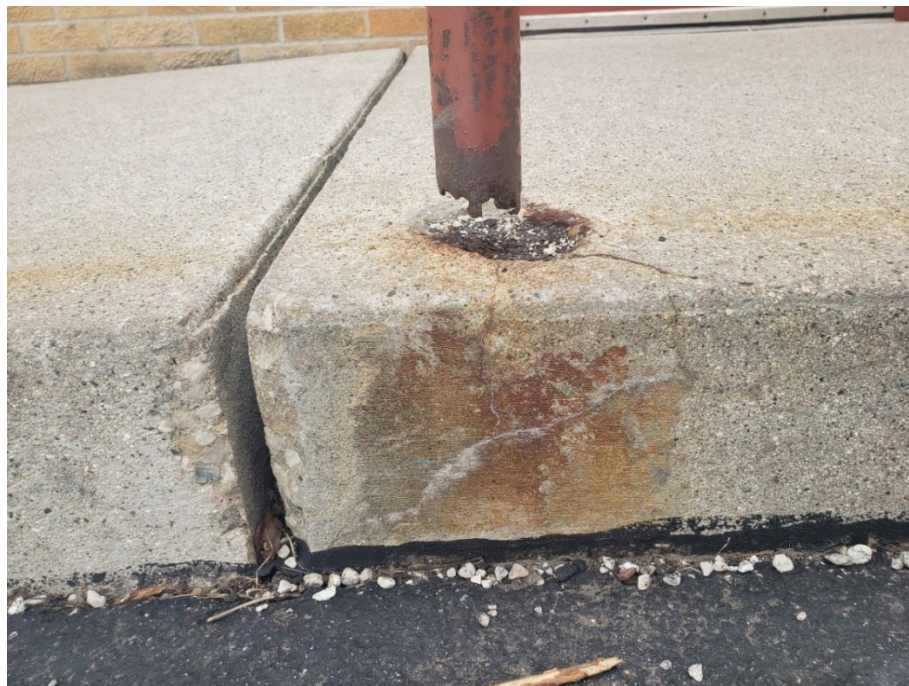
*Figure 21: Rusted railing with exposed sharp base on ramps*

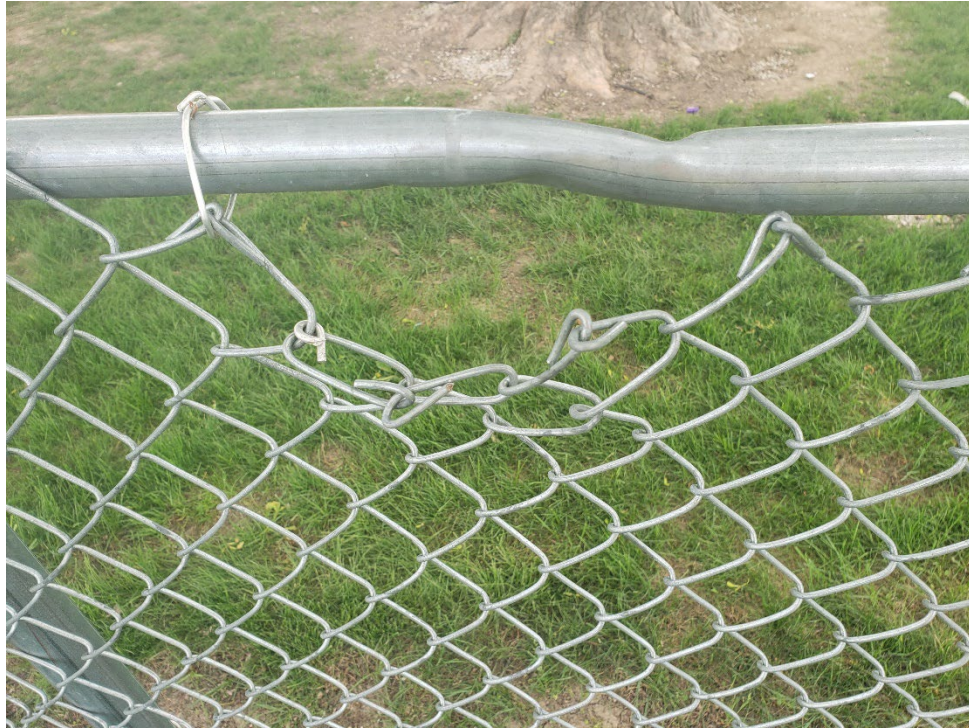
*Figure 23: Broken links in the fencing that must be repaired/replaced*

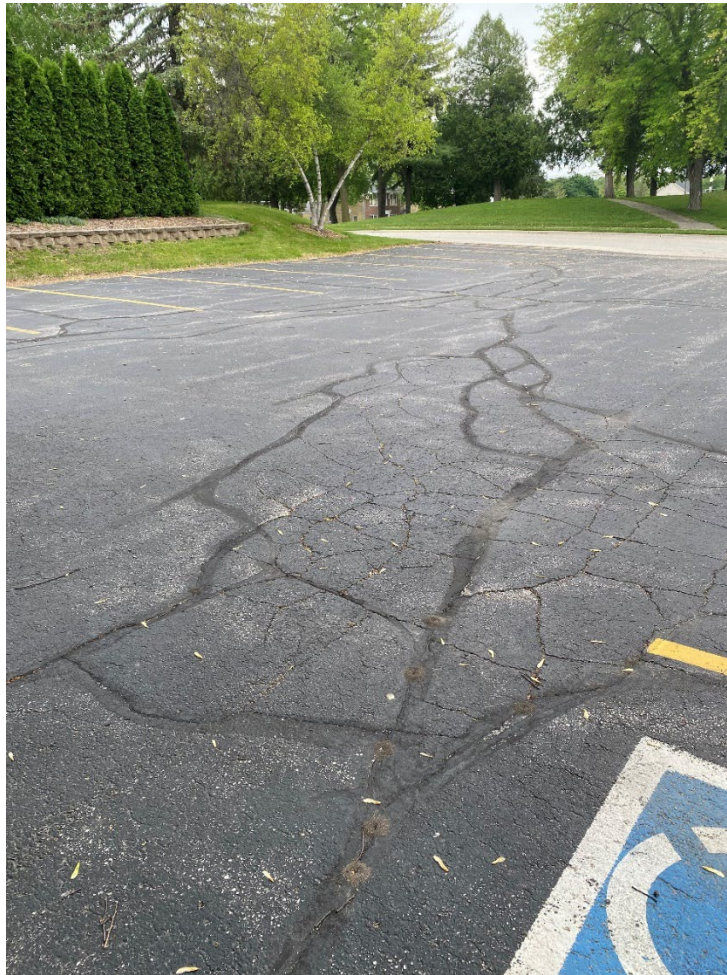
The southeast parking lot includes 17 regular stalls and 1 ADA stall. The stalls are all marked with pavement markings and the accessible stall also has a sign denoting it. There are transverse and longitudinal cracks in the parking lot. While many have been sealed some of the sealed cracks are expanding. There are also areas of block cracking that have not been sealed (Figure 2). These could turn into alligator cracking or potholes if left untreated. There is some settling occurring throughout the lot too, as there are discolored circles which indicate sitting water (Figure 3). The pavement markings are beginning to rub off in certain areas but are still visible. Overall, the condition of the southeast parking lot is fair to poor.

*Figure 2: Block, transverse, and longitudinal cracks in southeast parking lot.*

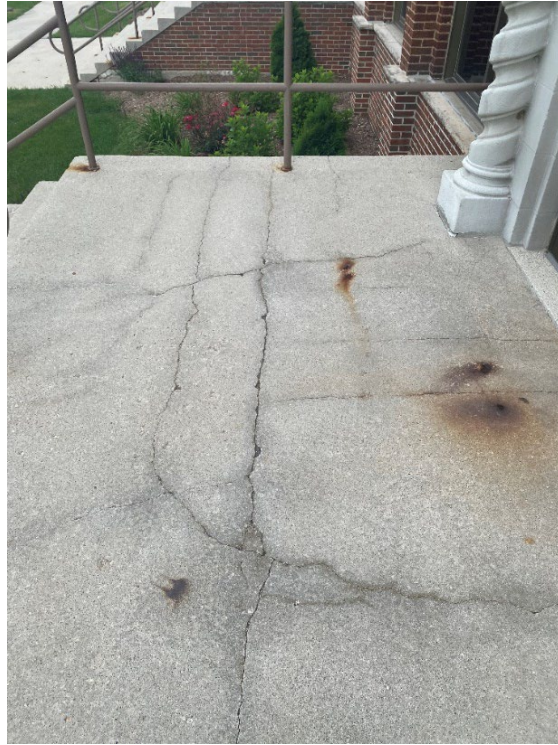
Figure 9: Top of center east concrete stairs in poor condition.

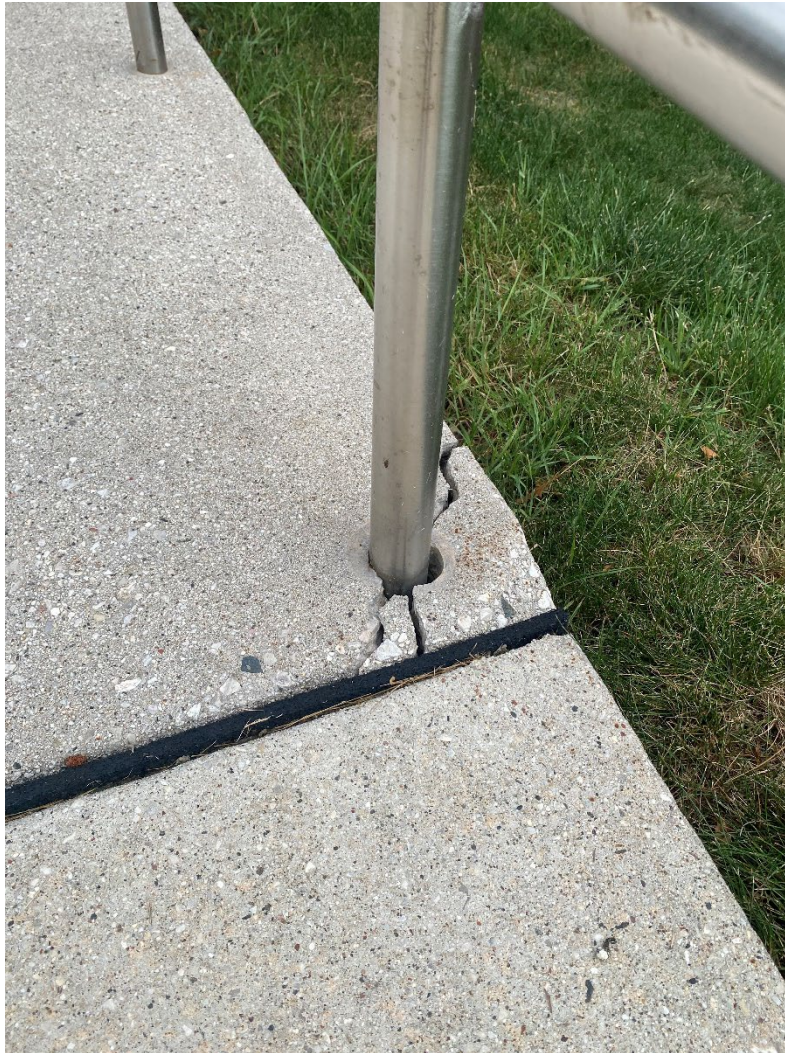
The front concrete ramp is in good to fair condition. The metal railing is in good condition with no rusting (Figure 19). The concrete ramp is in good condition, except for where the railing is attached to the concrete (Figure 20). There is cracked concrete around most of the metal posts, but the cracking is localized to the area around each railing post.

*Figure 20: Cracking concrete at railing poles on front concrete ramp.*

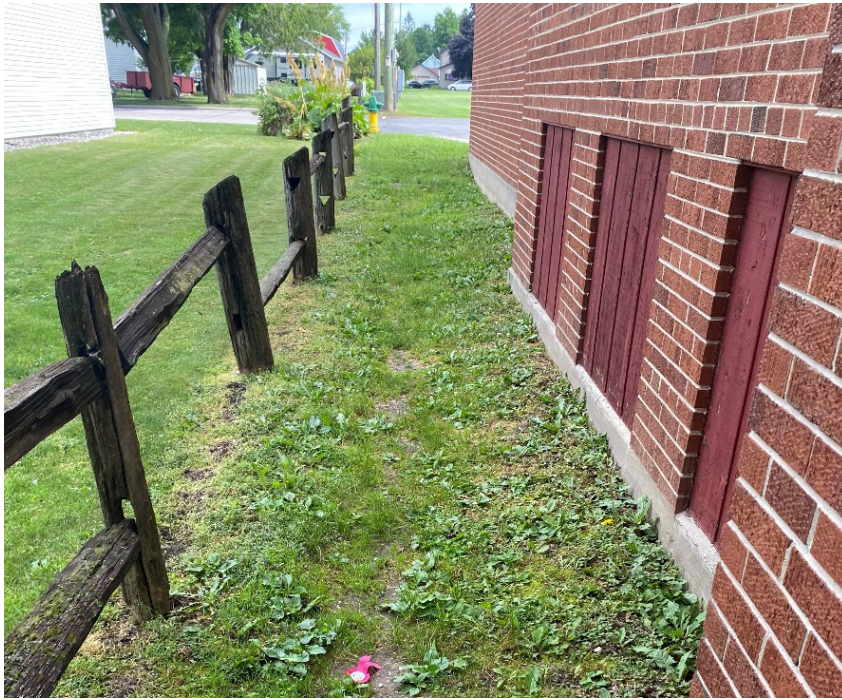
The wooden fence on the property line on the west side of the school is in poor condition. Many of the pieces are missing and the wood appears rotted and tipsy (Figure 32).

*Figure 32: Wood fence on west side of school in poor condition.*

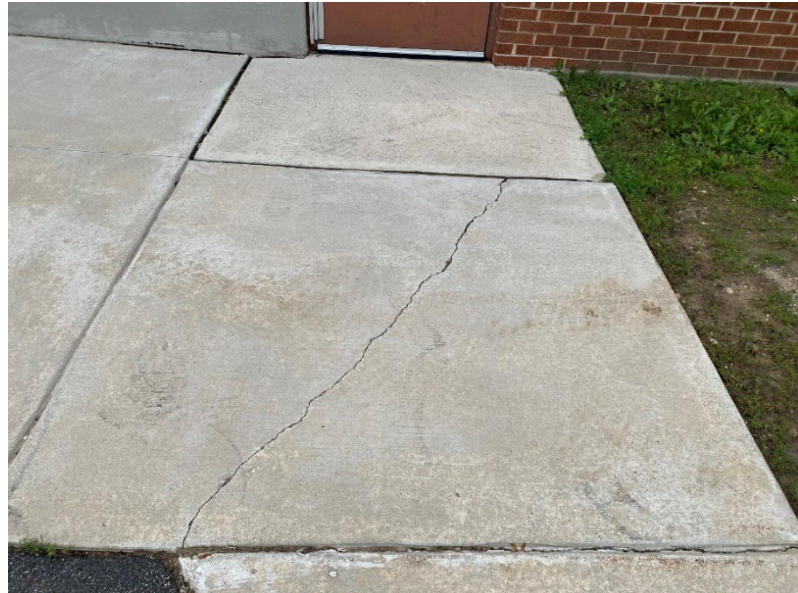
*Figure 33: Cracked concrete slab at west door on back side of school.*

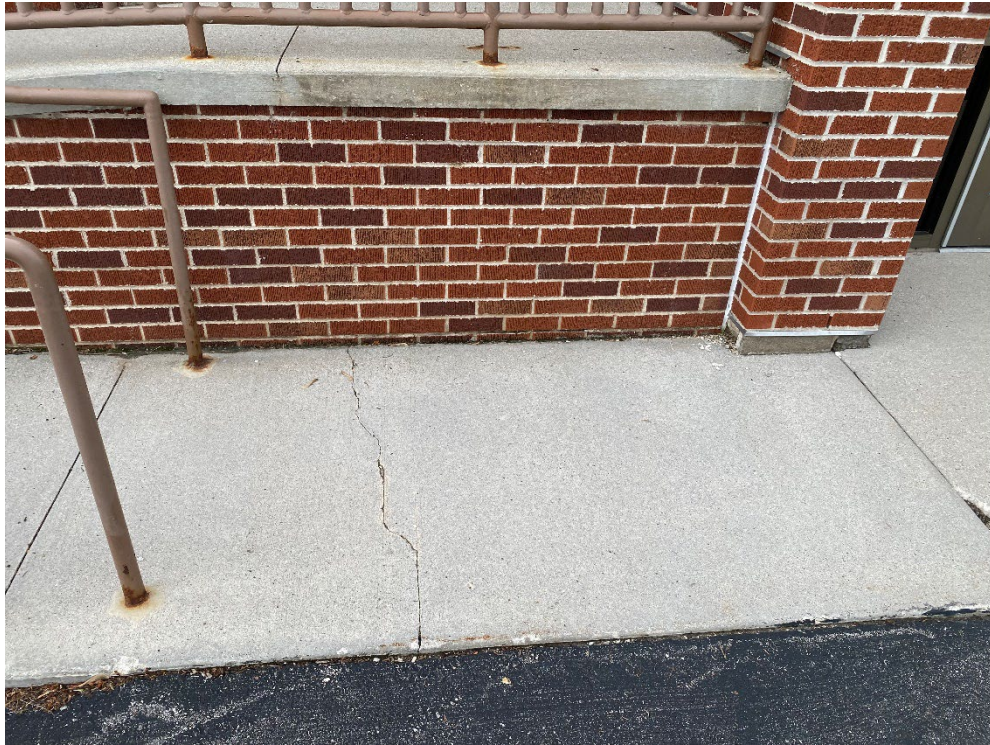
*Figure 40: Cracked slab at landing of back concrete ramp.*

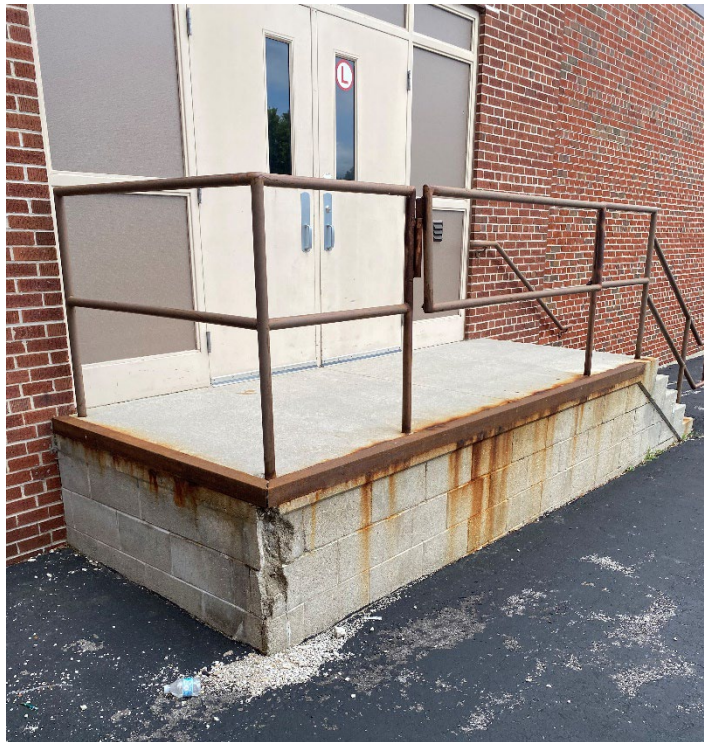
The back concrete stairway is in poor condition. The cinderblock base is disintegrating in areas and the concrete steps are cracking and chipping (Figure 46). The metal railing is very rusted and deteriorated as well.

*Figure 46: Concrete stair in back play yard in poor condition.*

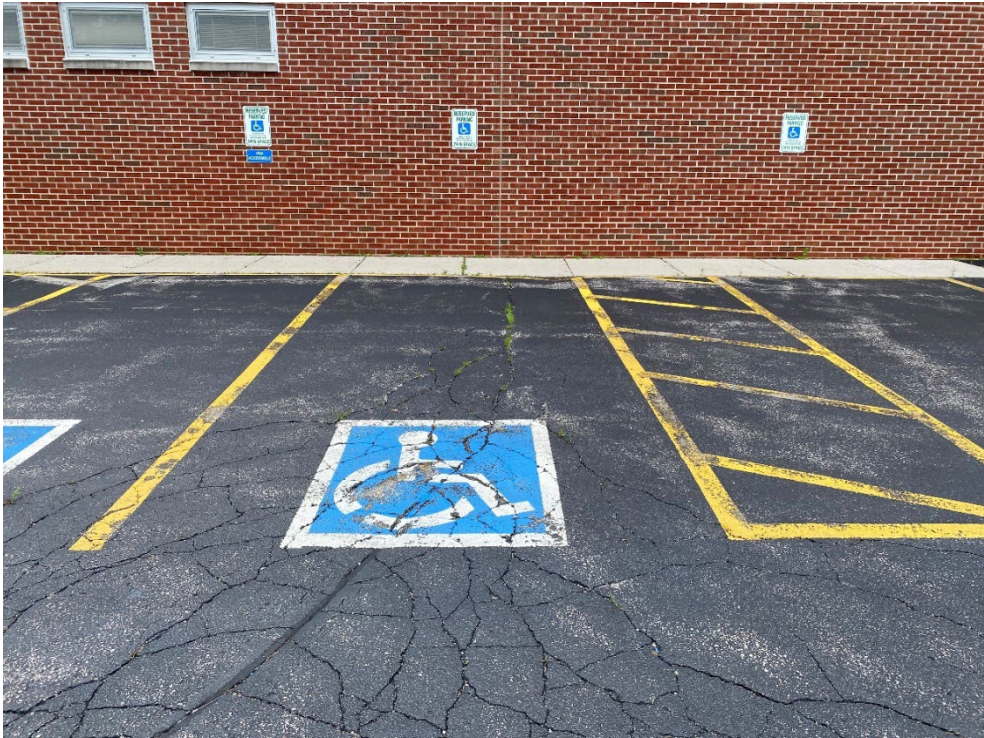
Figure 49: Alligator cracking in ADA stalls on east side of back of school.

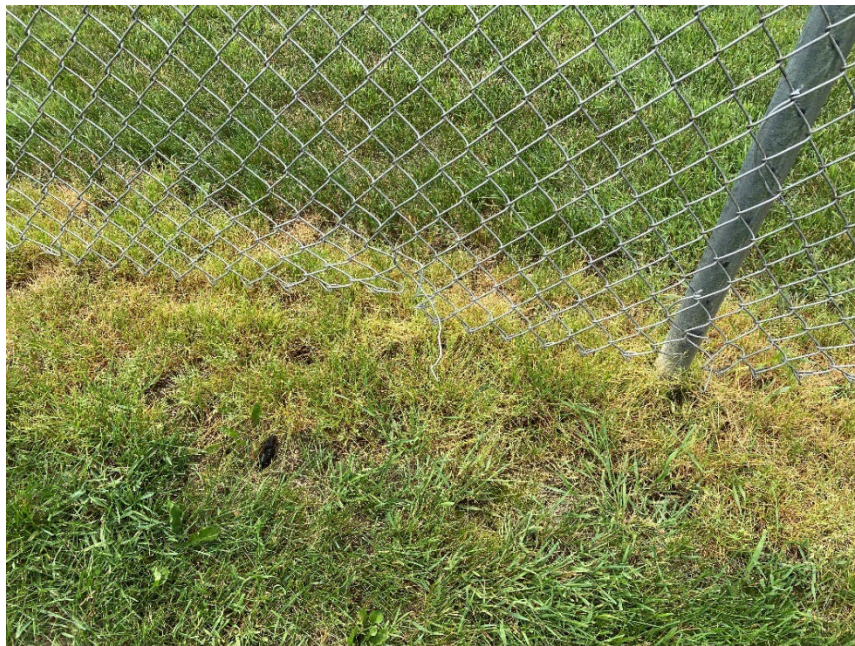
The fencing surrounding the climbing area is in fair condition. It is tipping over in some areas and the bottom is coming unraveled causing sharp wires to stick out (Figure 54&55).

*Figure 55: Exposed wire on bottom of fence surrounding climbing equipment.*

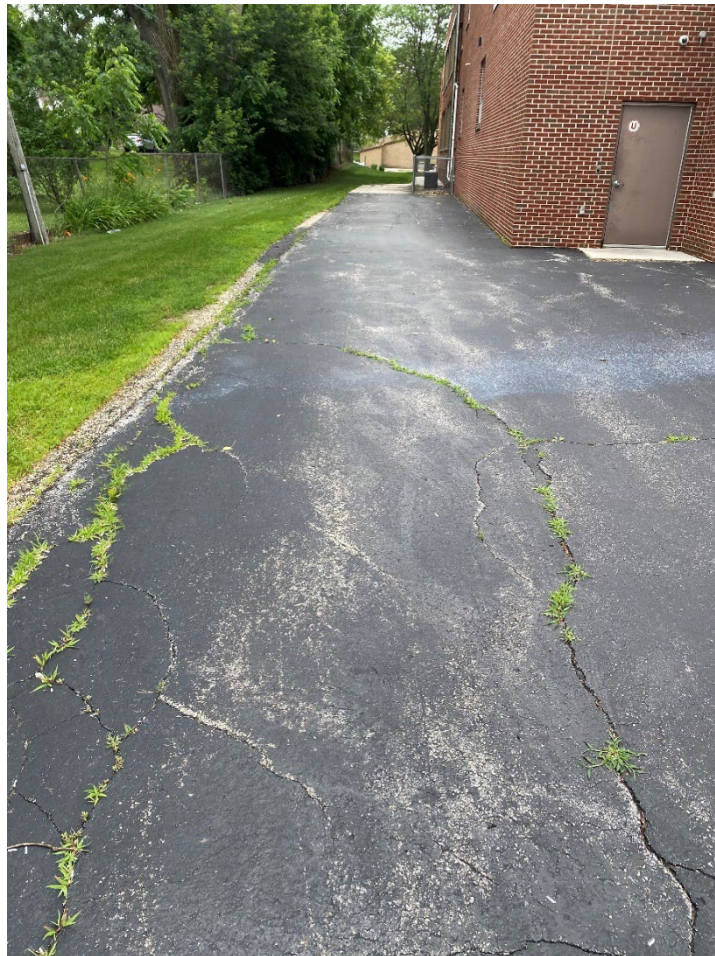
The asphalt on the east side of the school is in poor condition. There are many longitudinal and transverse cracks with weeds growing up through them (Figure 59). The older concrete sidewalk near the fenced in mechanical equipment is in poor condition. There are cracks in the pavement and some settlement causing standing water (Figure 60). There is also newer concrete sidewalk to the south of the mechanical equipment that is in good condition with minimal cracking. The grass on the east side of the school is patchy and having trouble growing in the shade. The metal fencing enclosing the mechanical equipment is in good condition. The metal fence on the property line is in poor condition (Figure 61). It is overgrown with trees and tipping over in areas.

*Figure 59: Longitudinal, transverse and block cracking in asphalt on east side of school.*

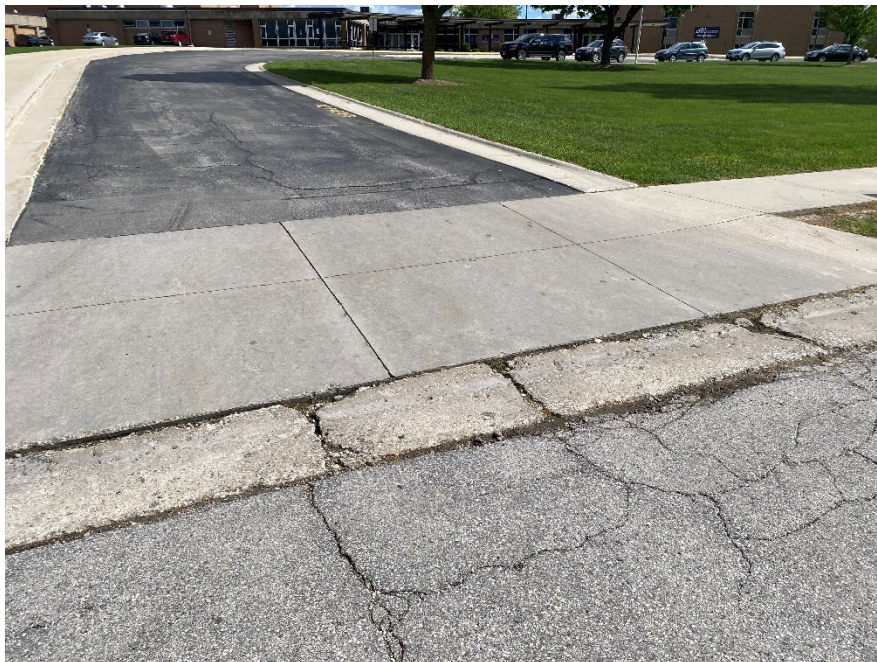
*Figure 5: Cracked curb and gutter at exit driveway in Bus/Visitor Parking Loop.*

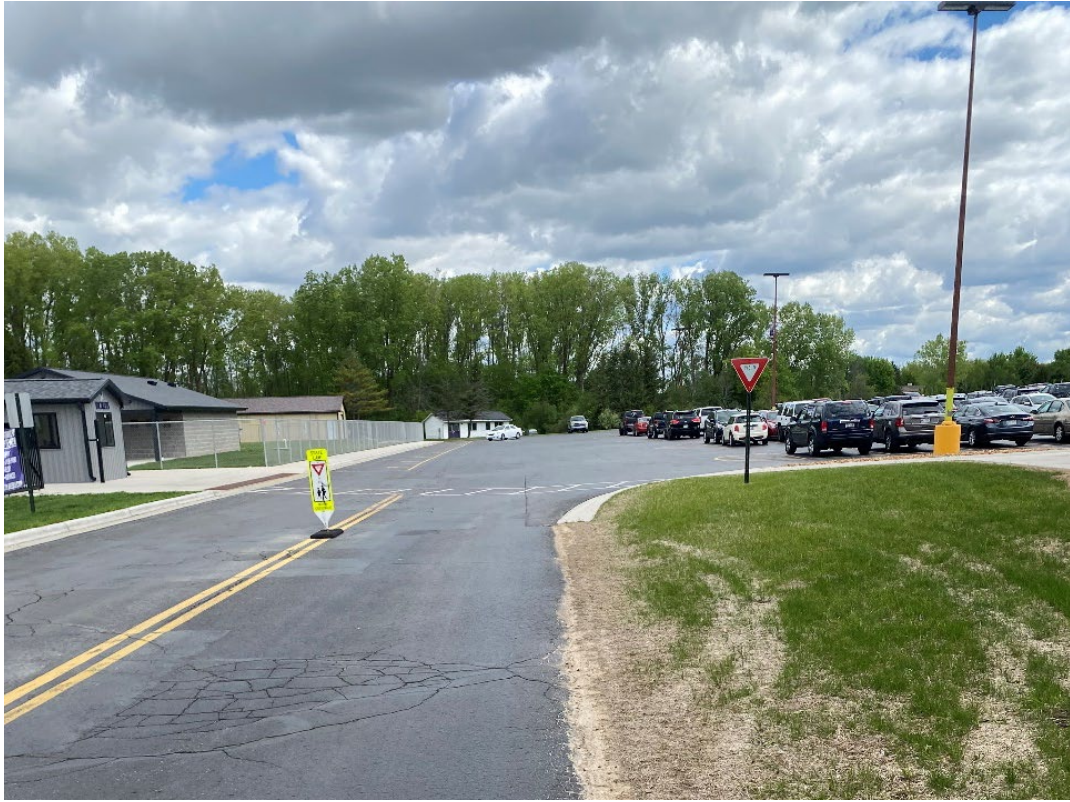
building and extends north. The condition of the asphalt drive is fair from the southwest corner of the school building to the south (Figure 11). The portion of the roadway that borders the west side of the school is in poor condition due to block and alligator cracking (Figure 12). There are many longitudinal and transverse cracks throughout the entire drive (Figure 13). There are multiple patches on the roadway, but some of the patches are cracking. There is edge cracking along the edges of the drive where there is no curb and gutter. The concrete driveway is in good to fair condition. It shows signs of typical wear and tear, but few cracks in the concrete except for the curb and gutter portion and flares. Pavement markings are in good to fair condition with some fading beginning. The curb and gutter near the north portion of the roadway is in excellent condition, as it was recently installed.

Figure 12: Alligator Cracking on north portion of Access Drive.

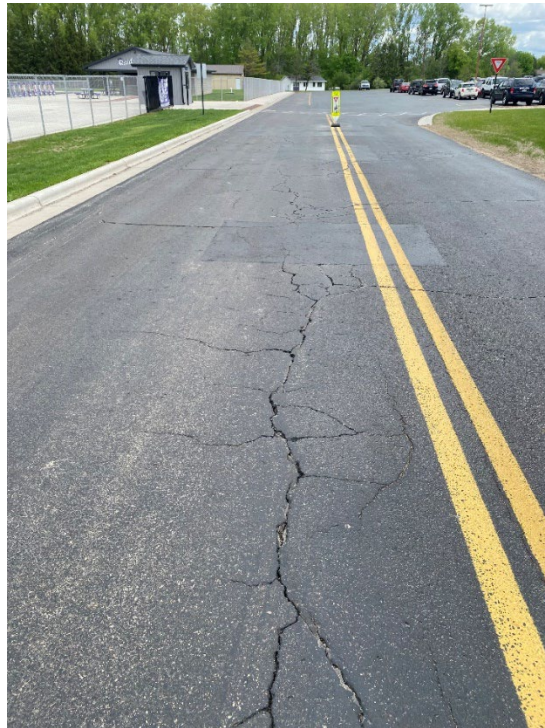
Figure 13: Longitudinal and Transverse Cracking on north portion of Access Drive.

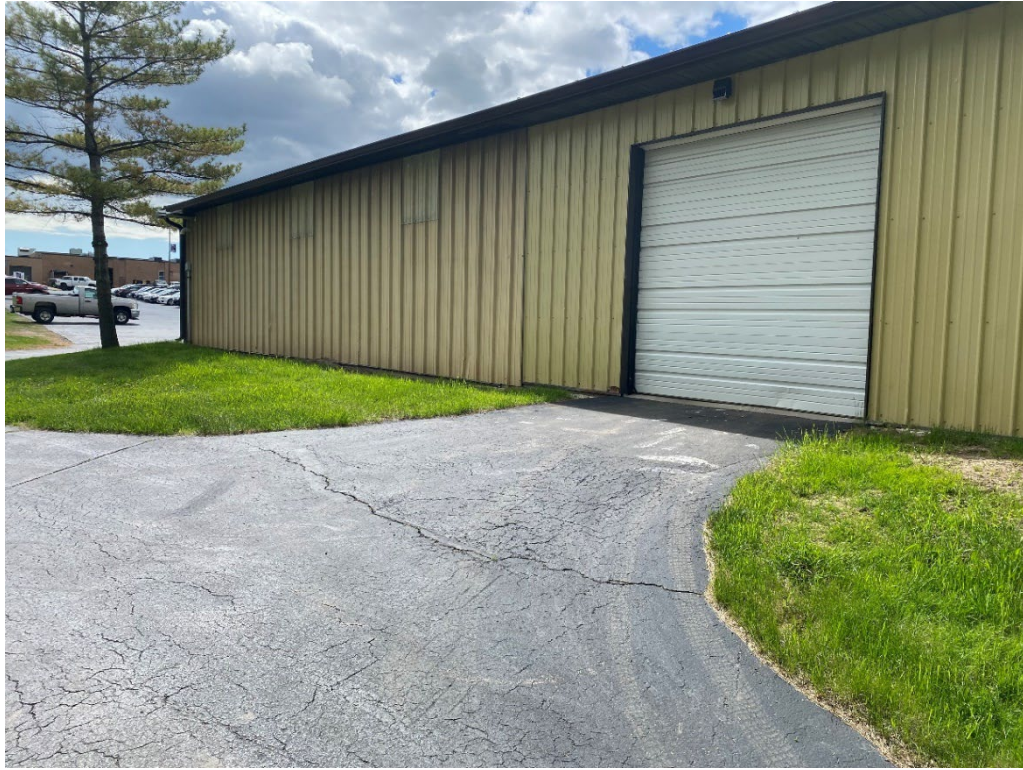
Figure 15: Pavement cracking near shed in northwest corner of Student Parking Lot

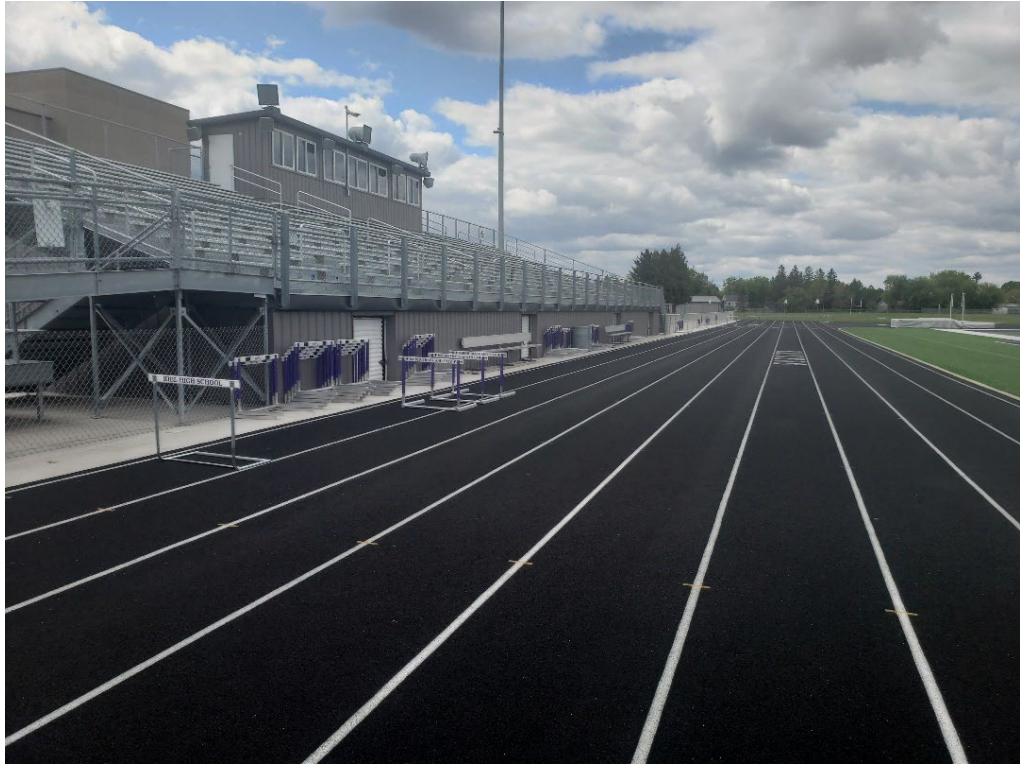
Figure 23: Running track in excellent condition.

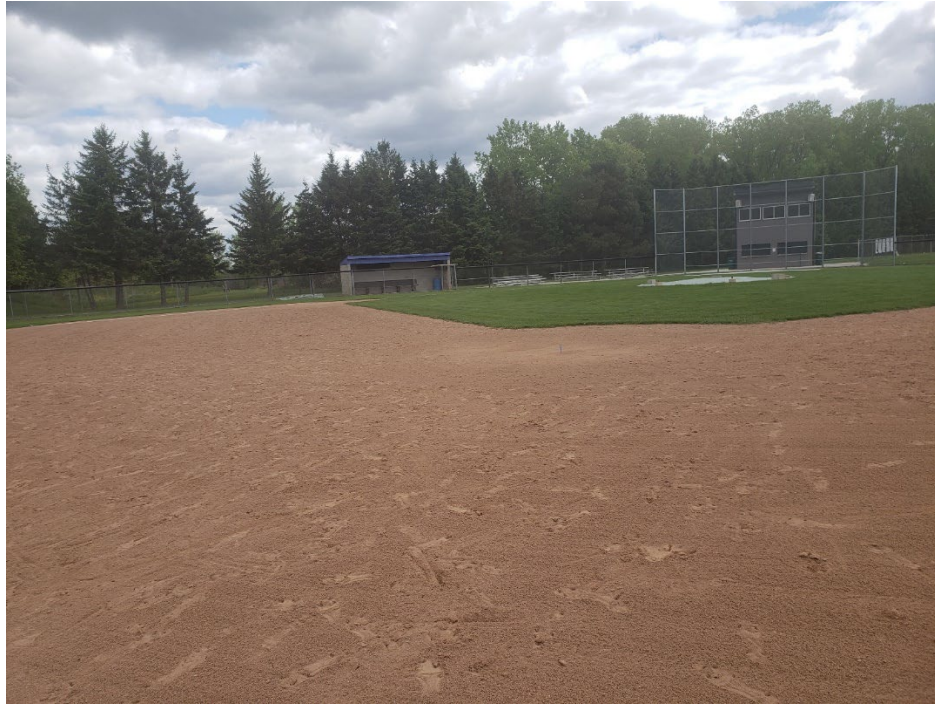
Figure 31: Varsity baseball field

The Varsity Baseball Field consists of the field, dugouts, concession stand, bleachers, and fencing. The field is in good condition (Figure 31). Some areas outside of the fenced in field have no grass growing (Figure 34). The new concession stand, and pad are in good condition as well. One of the dugouts has concrete floors that are covered in rubber. The rubber is peeling away and ripping, and the condition of the concrete underneath was unknown due to being covered in rubber (Figure 32). The wood benches in the dugouts were old and have paint worn off them (Figure 33). The other dugout had no rubber on the floor, and the condition of the concrete pad was fair due to some large cracks. The wood benches were also old and worn. The metal bleachers are on gravel pads and were in good condition. The fencing around the field is in good condition.

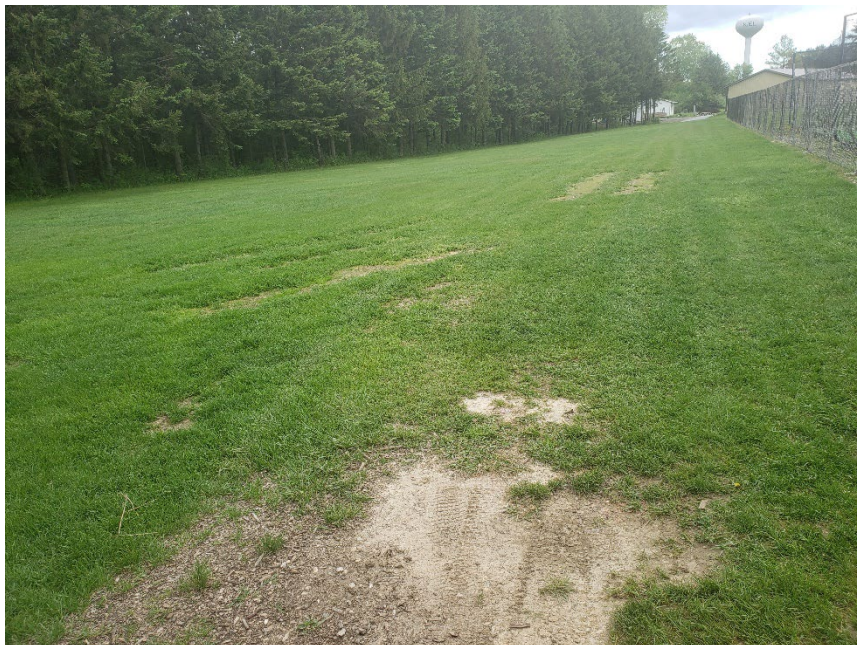
*Figure 34: Dead and rutted grass northeast of Varsity Baseball Field*

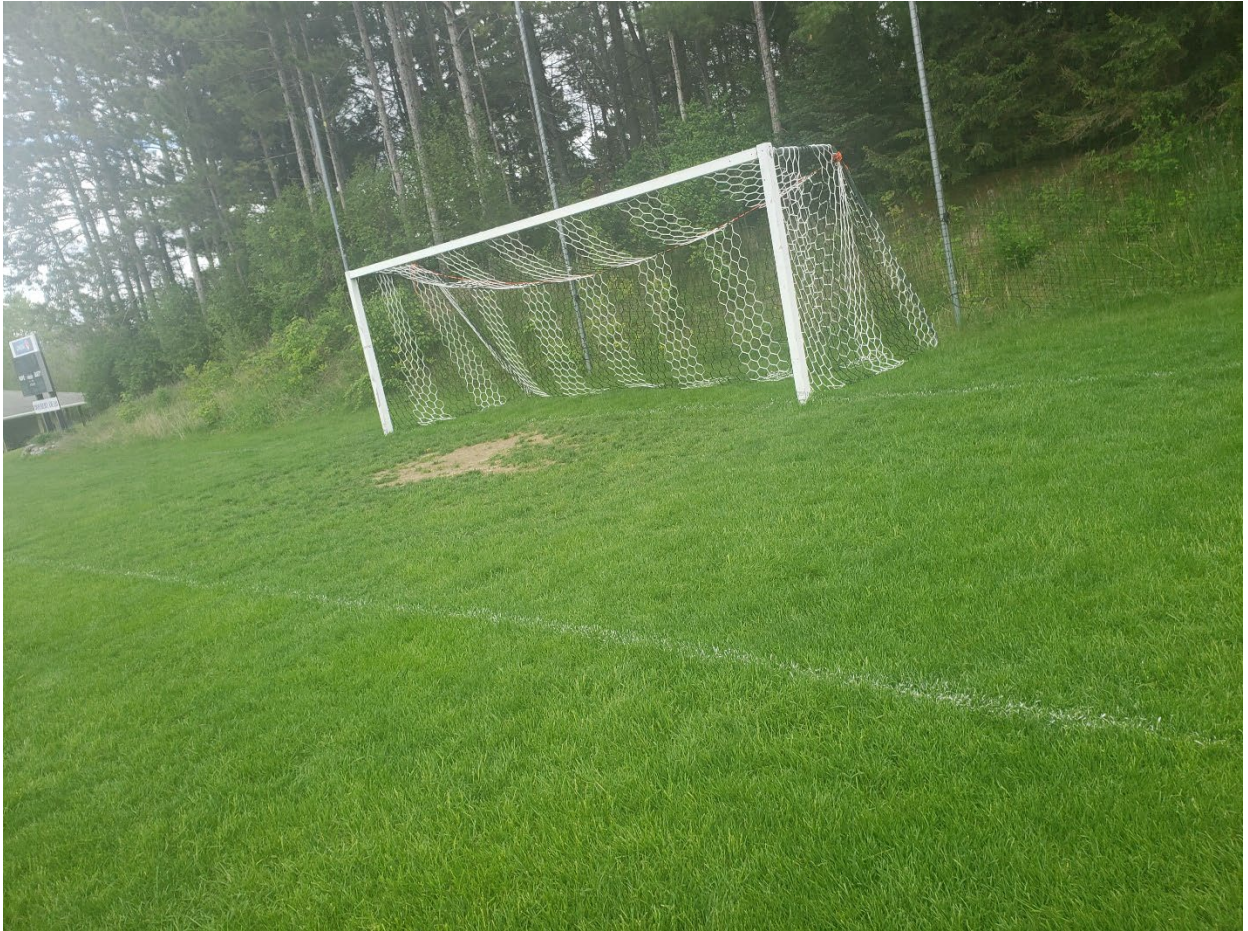
The Soccer Field consists of the field, three covered bleacher areas for players and a bleacher area for spectators. The field was in good to fair condition due to some dead patches of grass (Figure 36). The field appeared flat with no uneven areas. The bleachers were in good condition.

*Figure 36: Dead grass in soccer field*

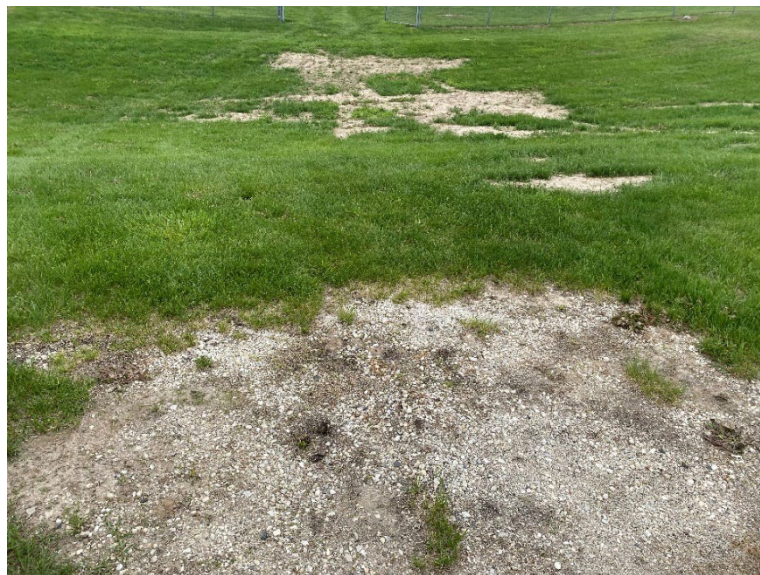
The Outdoor Climbing Area consists of a fenced in area with climbing walls and posts. The fence was in fair condition due to some unraveling at the bottom. There was some trees and brush growing into the west fence line (Figure 37). The grass area between the road and the north fence had a lot of patches of dead grass (Figure 38).

*Figure 38: Dead grass on north side of climbing area*

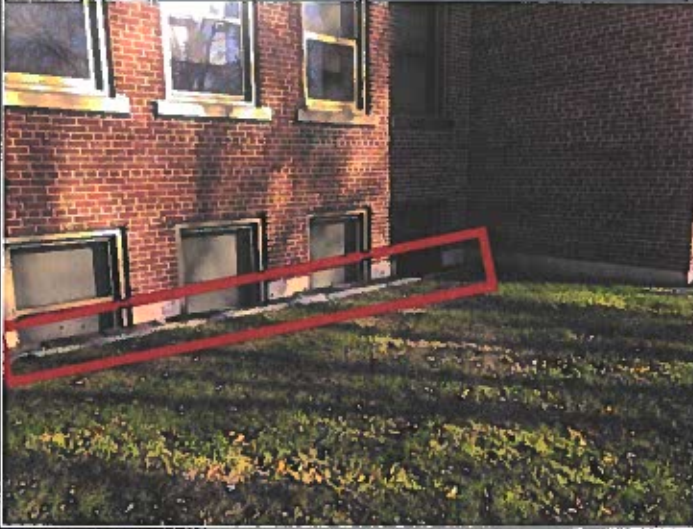
A photograph of the exterior wall of a brick building. The wall is made of red bricks and has several windows. A red rectangular box is drawn around a section of the wall and windows, indicating the area of interest for the description.	<p>2. This is the exterior wall of the home economics classroom. The picture shows how half of the home economics room is underground.</p>
