# Kiel Area School District

District-wide Facilities Study

# STUDY DOCUMENT

August 2022

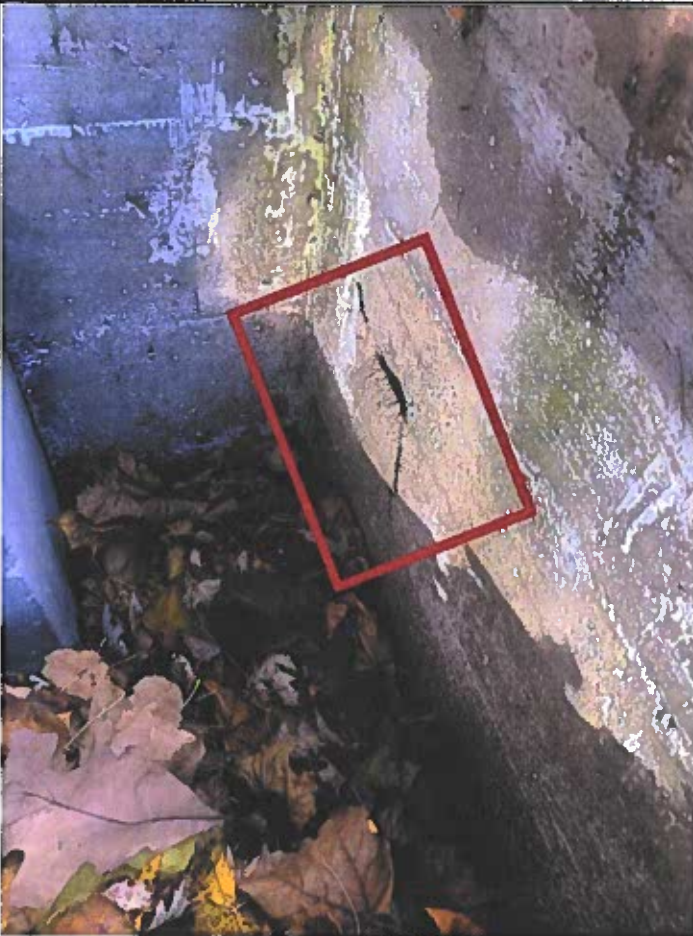
The water testing confirmed the source of the water entry into these classrooms as the cracks in the foundation in the areas of the lightwells. This issue is accentuated by the lack of drainage within the lightwell, creating pooling of water against the foundation, allowing water entry into cracks and wall deficiencies.

A close-up photograph of the foundation of a brick building. The foundation is made of concrete and shows a significant crack. A red rectangular box is drawn around the crack, highlighting it. There are some leaves and debris in the foreground.	<p>3. A crack observed in the foundation underneath the window. This was located on the south side of the building.</p>

In order to correct the water entry issue at these locations, it is recommended that the cracks in the foundation be repaired, new waterproofing applied to the foundation, with new drain tile and regrading of the site. This will require excavation of the soil to the footing of the building to expose the foundation wall in order for the required foundation repairs to be made. This would encompass the south elevation on both sides of the main entrance.

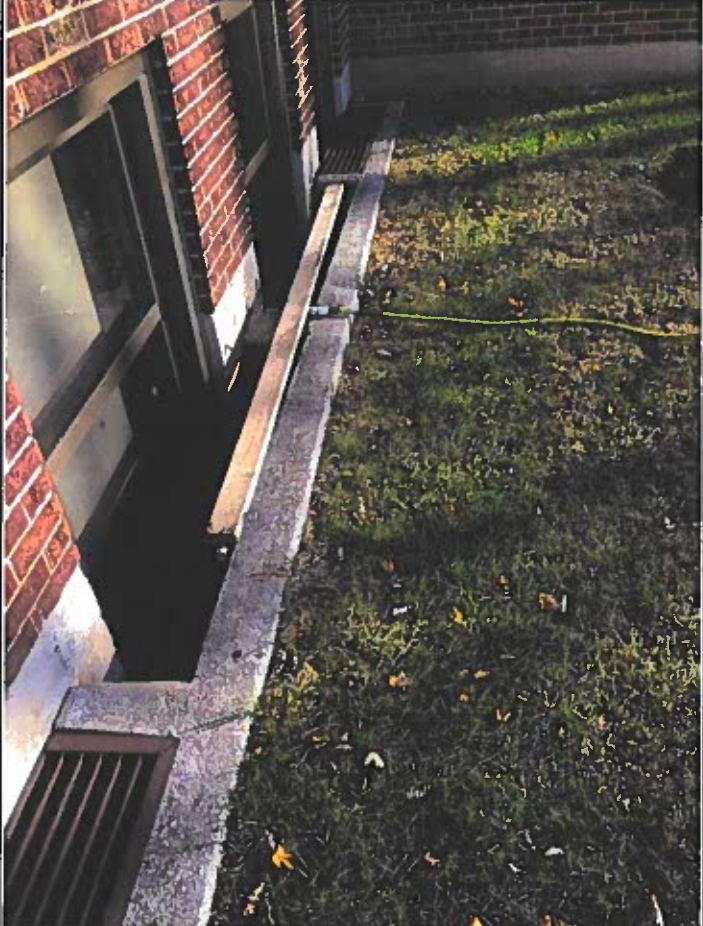
A photograph showing an exterior view of a building's light-well area. A concrete curb runs along the edge of a brick wall. A rain simulator is positioned over the light-well, and a yellow measuring tape is stretched across the area to indicate the extent of the test. The ground is covered with grass and some fallen leaves.	<p>5. Overview of light-well water test. The rain simulator was placed over two light-wells. One of the light-wells possessed a significant cracks.</p>

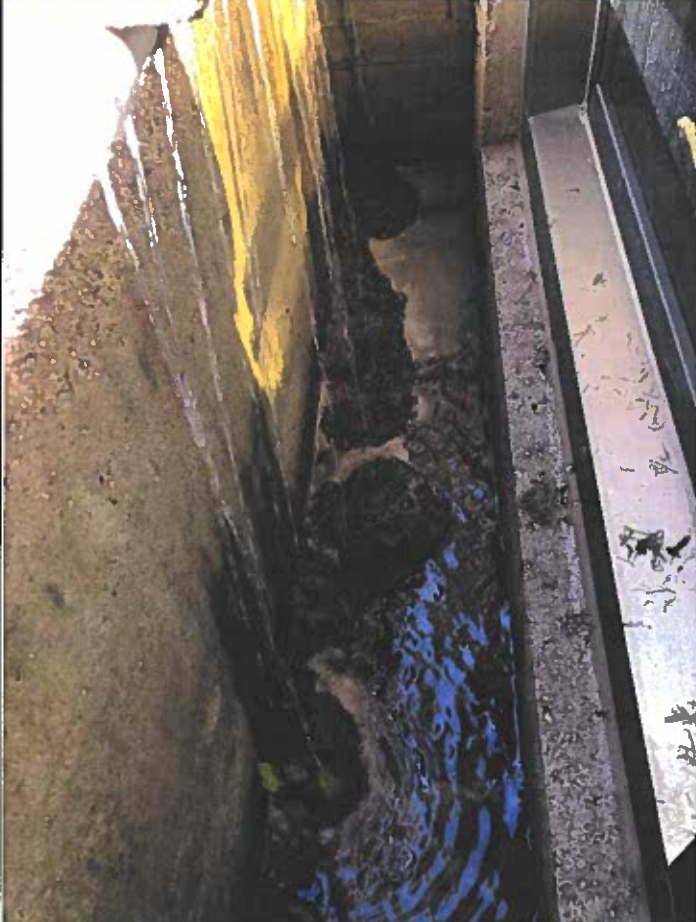
It was also noted during the testing that the water in the bottom of the lightwell did not exit from the lightwell area. During the testing and investigation, no drains were observed to allow water to drain out of or exit this area.

A photograph showing a narrow, dark channel or light-well. The left side is a corrugated metal surface, and the right side is a concrete wall. A significant amount of water is accumulated in the channel, reflecting light. The water appears to be seeping from the top of the channel.	<p>7. Water accumulation in the light-well. There was spacing between the building and the boxed concrete foundation. This lets the water weep between all light-wells. Every well started to fill up with water.</p>

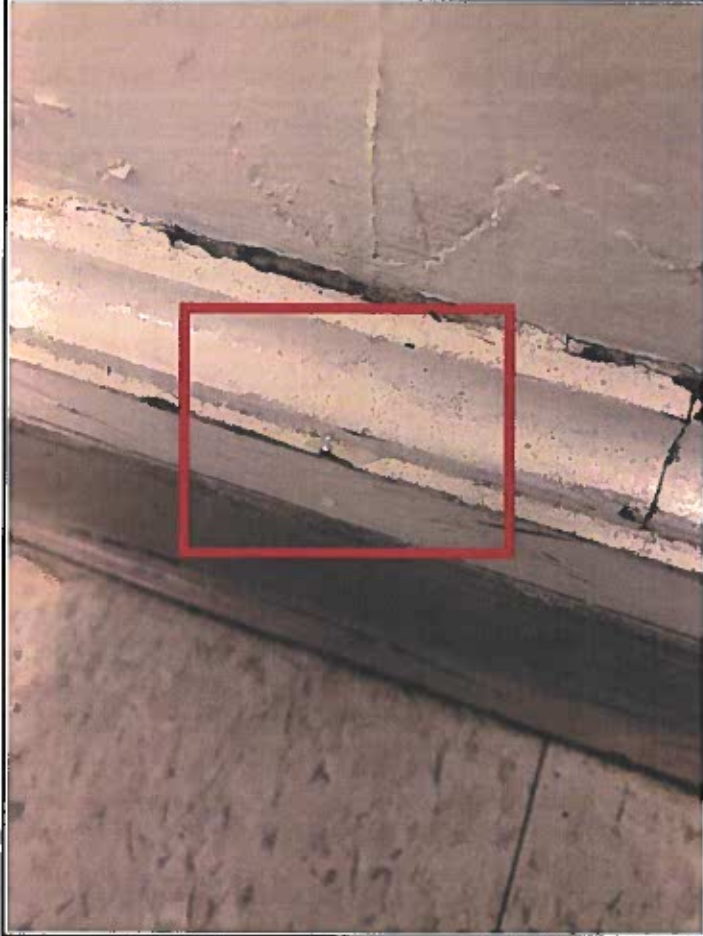
<p>9. Water was observed inside running down the wall and coming out of the trim. The water running down the wall from the inside matches up very well with the crack on the corner of the window sill outside. This took roughly 35 minutes to begin leaking.</p>

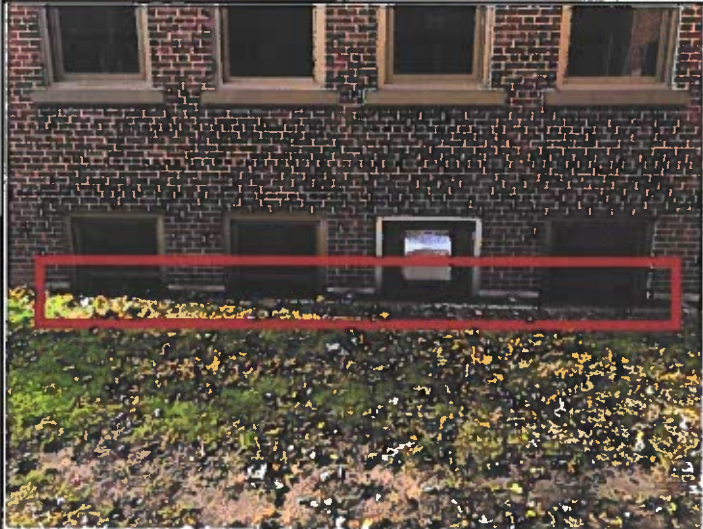
<p>10. The second home economics room has two exterior walls. The southern wall has no windows. It's a completely bricked side. The east side wall has the windows shown here.</p>

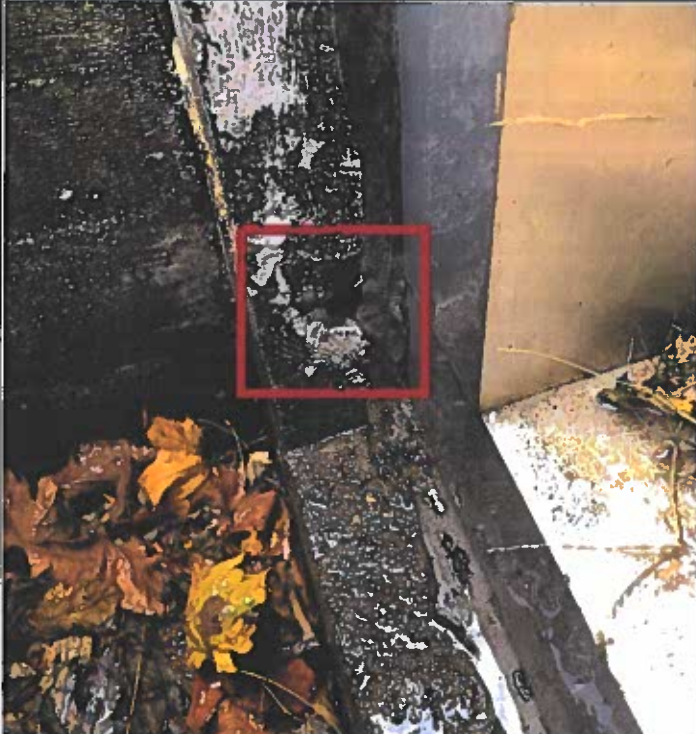
A photograph showing a close-up of a roof structure. A hole is visible in the roof material, and a red rectangular box highlights this hole. The surrounding area is dark and appears to be covered in debris or snow. A window frame is visible on the right side of the image.	<p>11. A hole was discovered by the window that has the vent coming out of it. See photo 10.</p>

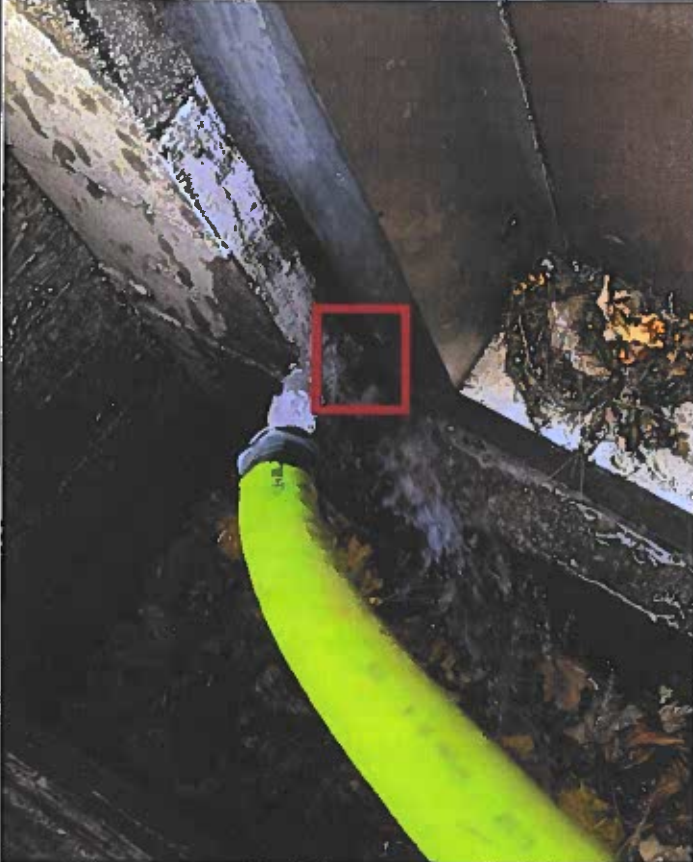
A photograph showing a roof leak test. A bright yellow fire hose is connected to a nozzle, spraying water onto a dark, textured roof surface. A red square highlights a specific area where the water is hitting, and a small amount of water is visible dripping from that spot. The surrounding roof area is dark and appears to be made of asphalt or a similar material.	<p>12. Following the information from the first test we were able to single out what were the problematic areas. Once those defects were detected we took a more direct approach on our testing. As shown here we simulated the rain directly on the defect. Leak shows up after twenty minutes.</p>

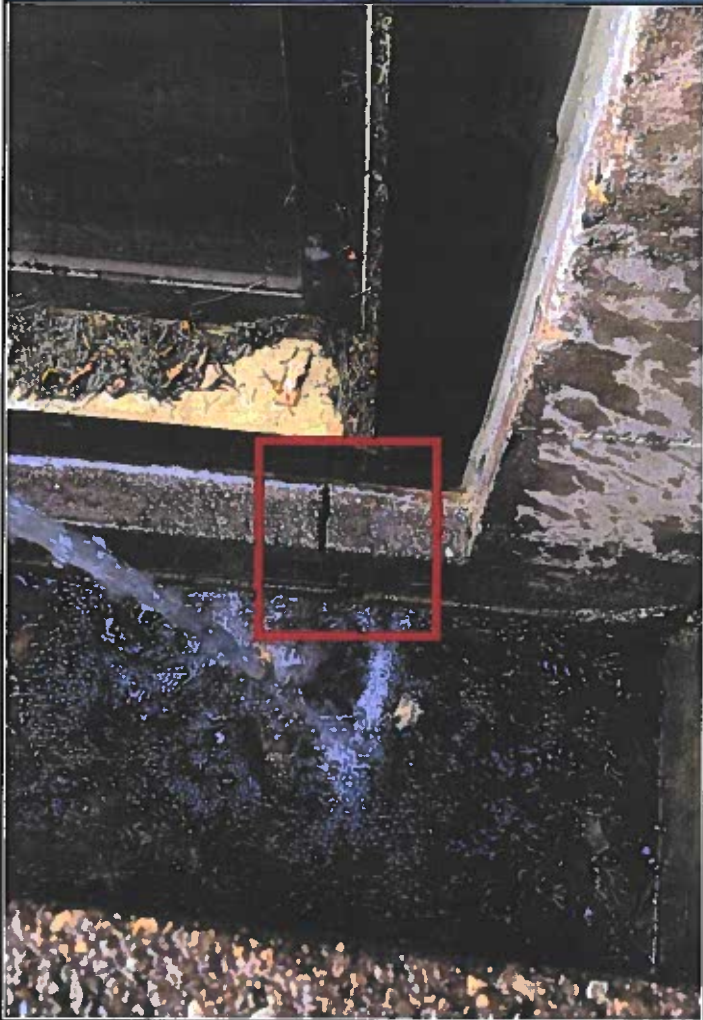
<p>13. This defect is in the most northern light-well on the east wall.</p>

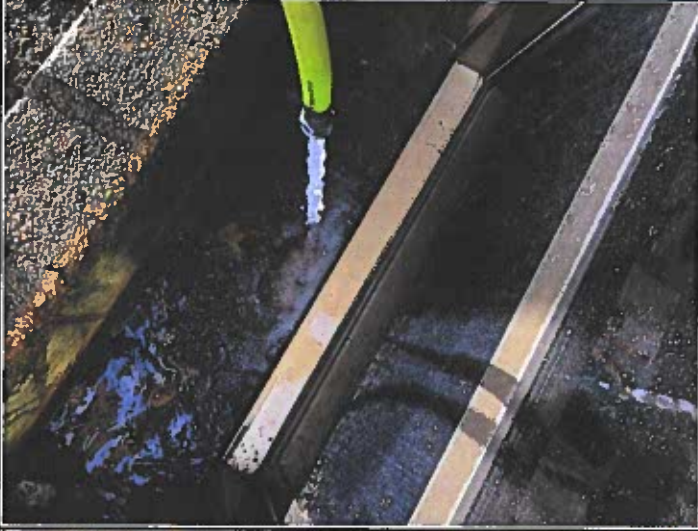
<p>18. We filled up the light-wells to simulate rain.</p>

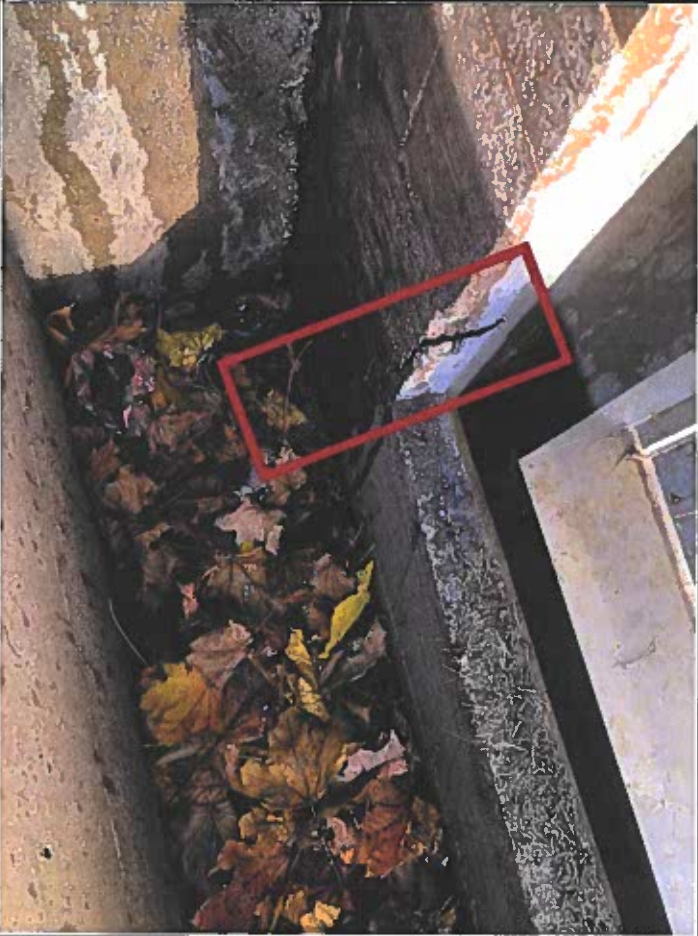
<p>19. This is a defect we observed. It's such a significant crack that we decided to do a direct simulator on it.</p>

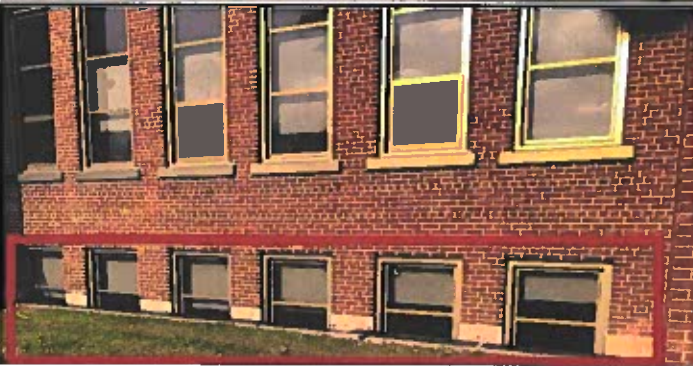
<p>17. This is an overview of the exterior wall for the art room. It was reported that water pools on the floor when it rain.</p>

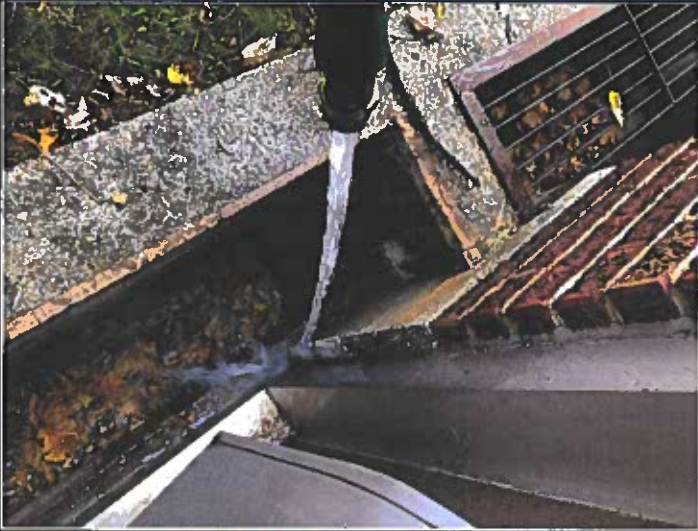
<p>20. This picture shows how we directly flooded the defect. This leak was present inside within a minute.</p>

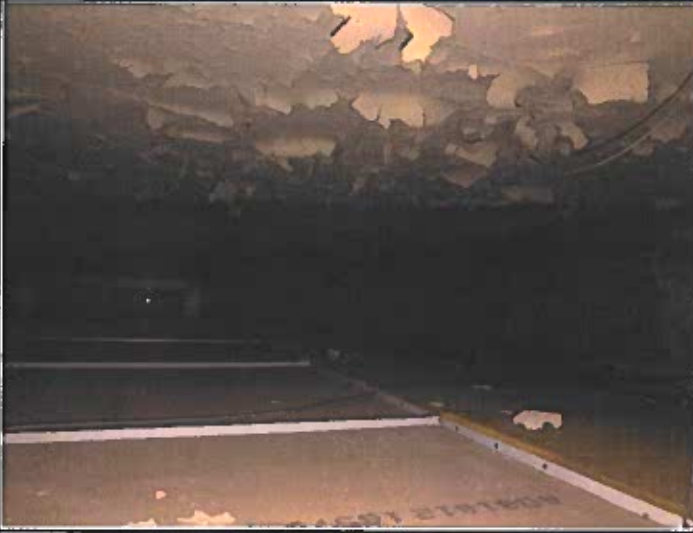
A close-up photograph of a ceiling surface. The paint is severely peeling and chipping away, revealing a dark, textured substrate underneath. The peeling is extensive and irregular, covering most of the visible area.	<p>2. The paint is peeling from the ceiling above the ceiling tiles in room 302.</p>

In summation, room 302 has a black roof system above it, two exterior walls, and an alley to let air hit it more directly. These constructions create conditions that are likely to result in high humidity and condensation, resulting in paint peeling from the fixed ceiling. In addition, our water testing of the exterior walls did not result in water entry into the building.

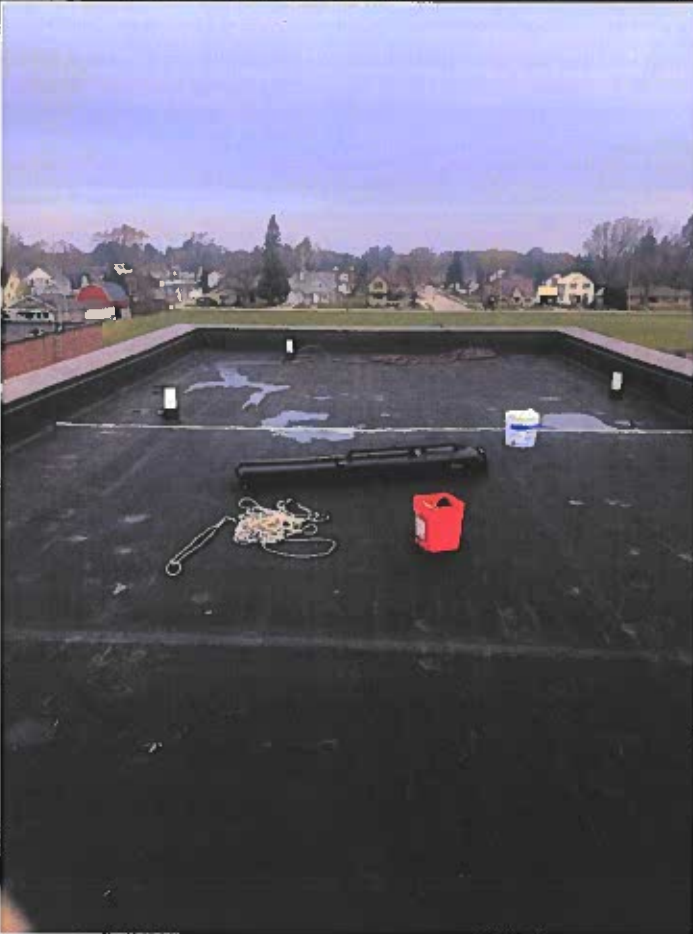
A wide-angle photograph of a flat roof system. The roof surface is dark and appears to be made of asphalt or a similar material. There are several white markers or stakes placed on the roof. A red bucket and some equipment are visible in the foreground. In the background, there are residential houses and trees under a clear sky.	<p>3. This is the roof system above room 302. It should be noted that three outside walls are present. Two of these walls do not have windows.</p>

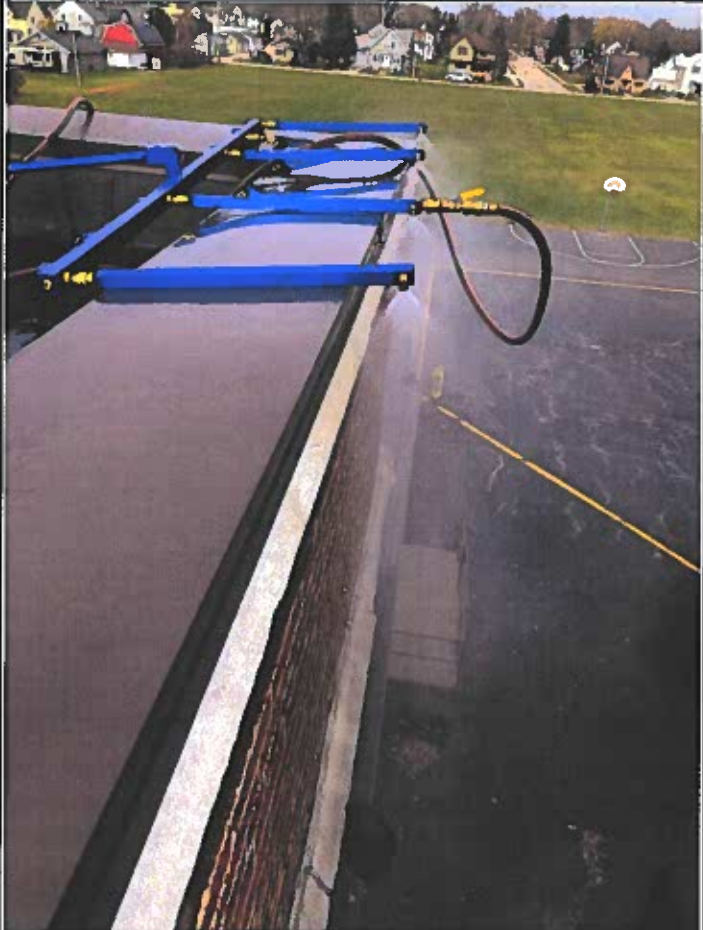
A photograph showing a blue metal rain simulator structure mounted on the edge of a roof. The simulator consists of several horizontal bars and a hose. The roof surface is dark, and a yellow line is visible on the roof. In the background, there is a grassy area and residential houses under a clear sky.	<p>5. The next step was to water test the walls and metal coping cap. The rain simulator was targeted on the two walls with no windows. The interior ceiling damage/peeling paint was worse there. Every 40 minutes we would move the simulator five feet down.</p>

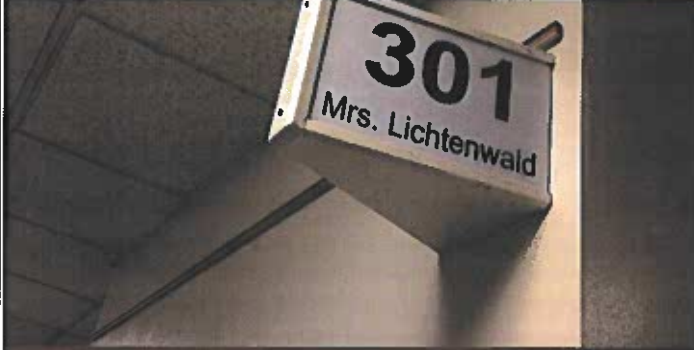
<p>A photograph of a white rectangular sign mounted on a wall. The sign has the number '301' in large black font and 'Mrs. Lichtenwald' in smaller black font below it. The background shows a portion of a ceiling with square tiles.</p>	<p>7. Room 301 was looked into to see if it too experienced the same situation as room 302. The bottom picture shows paint peeling.</p>

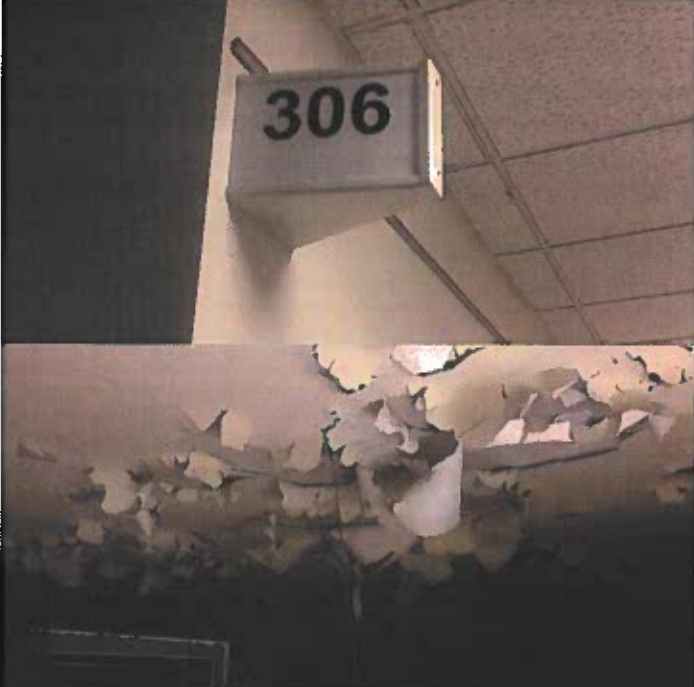
<p>A photograph showing a white rectangular sign with the number '306' in black font. Below the sign, the wall is severely damaged, with large areas of white paint peeling away, exposing the underlying surface. The ceiling above has square tiles.</p>	<p>8. This is room 306. Almost as severe peeling as room 302. It's on the east side of the building while 302 is on the west. It also appears that room 306 had walls exposed to the outside at one time. An addition to the school building is suspected to be built on from room 306 at sometime.</p>

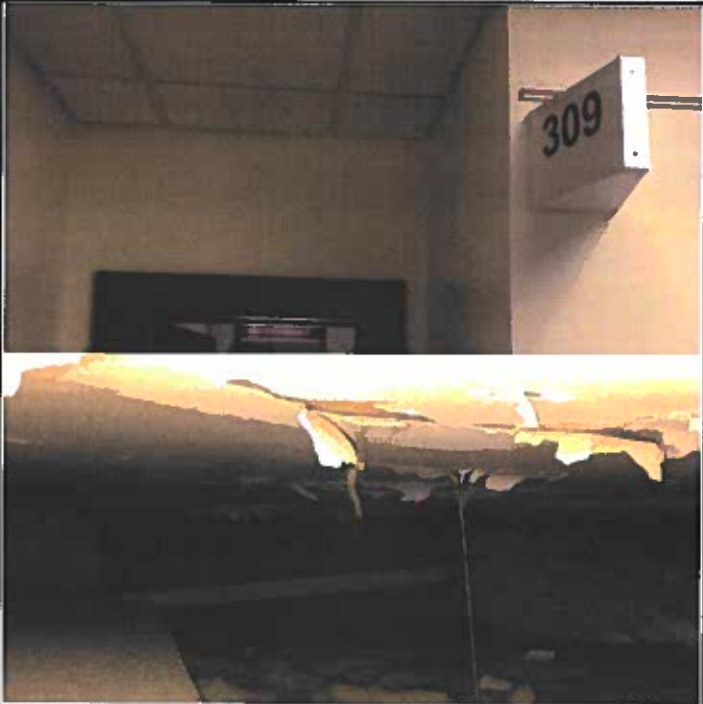
<p>10. Room 309 is located in the middle south side of the building. The ceiling shows signs of peeling paint.</p>

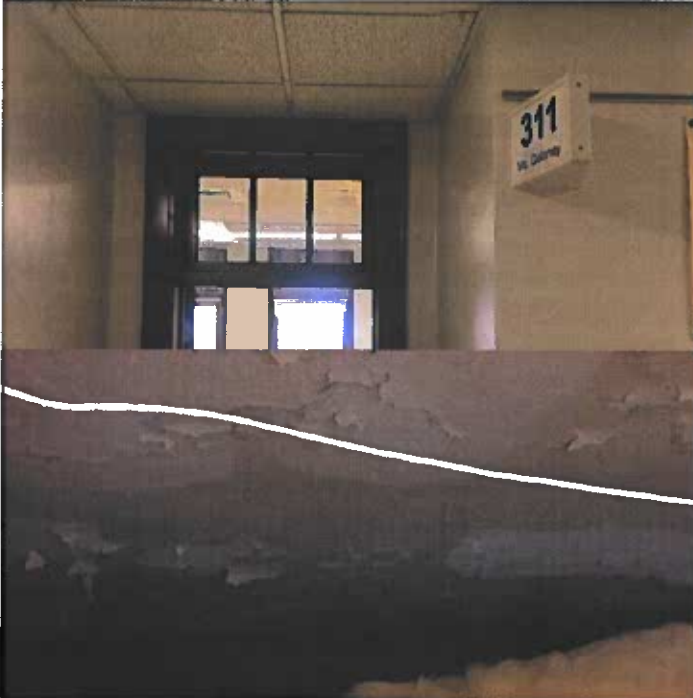
<p>11. Room 311 is located on the south side of the building. It shows peeling throughout the ceiling.</p>

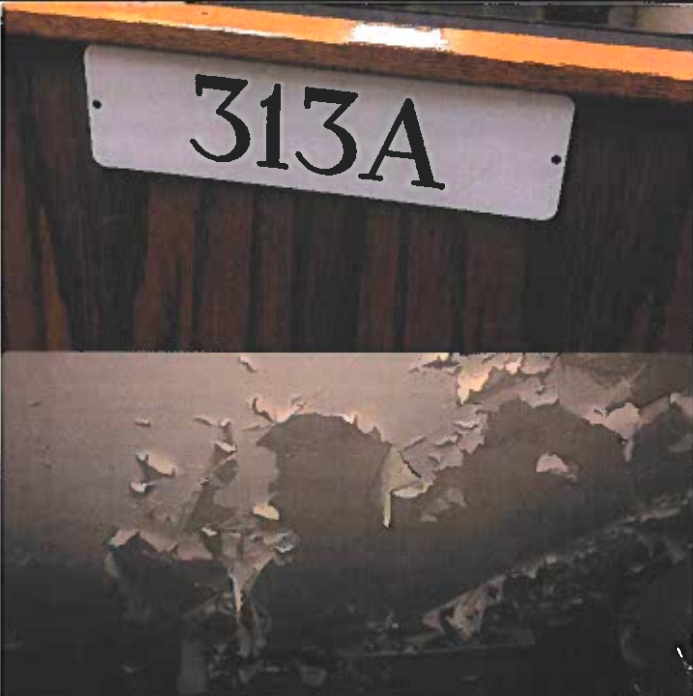
<p>12. Room 313A is located across from room 306. It is suspected that the school was added on to at room 306 and 313A. That room 306 and 313A had exposed outside walls at one point. The deck of the building changes to metal right after these rooms.</p>
